## ANACORTES PLANNING COMMISSION

**June 14, 2023**

- 1) Continuation of Open Record Public Hearing and Decision for Shoreline Substantial Development Permit SDP-2023-0002 Port of Anacortes 2nd Street and Curtis Wharf

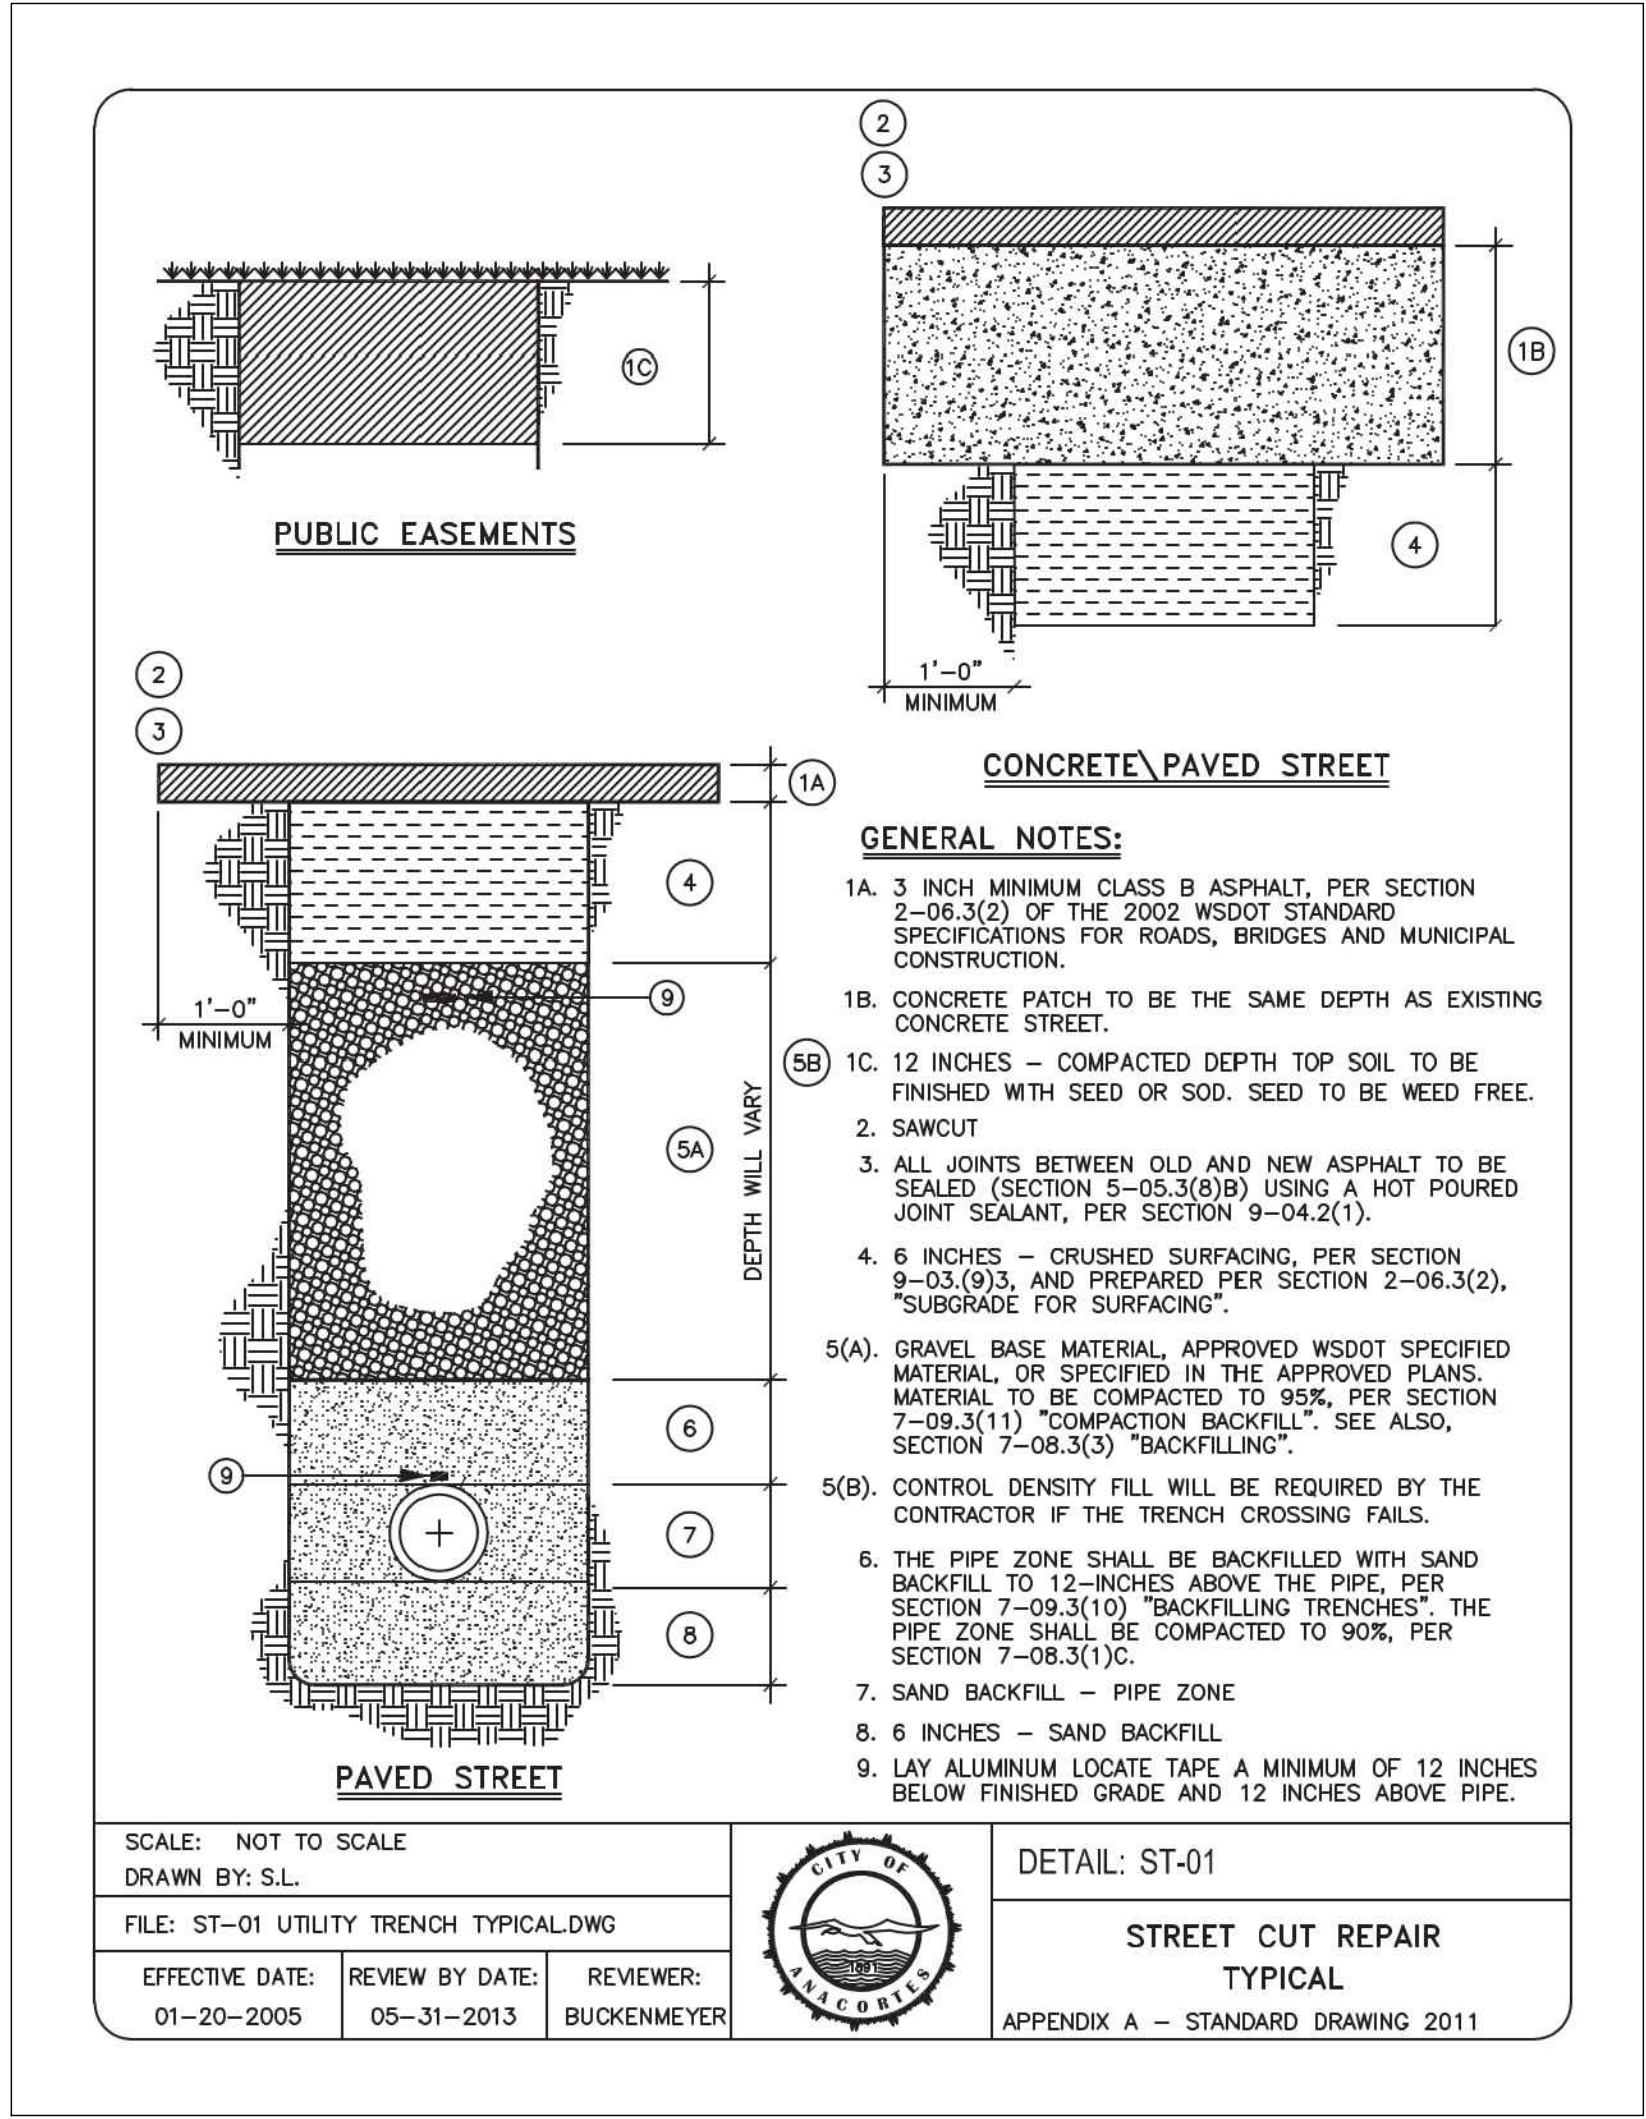
STREET REPAIR DETAIL  
PER ANACORTES STD DETAIL ST-01  
NTS

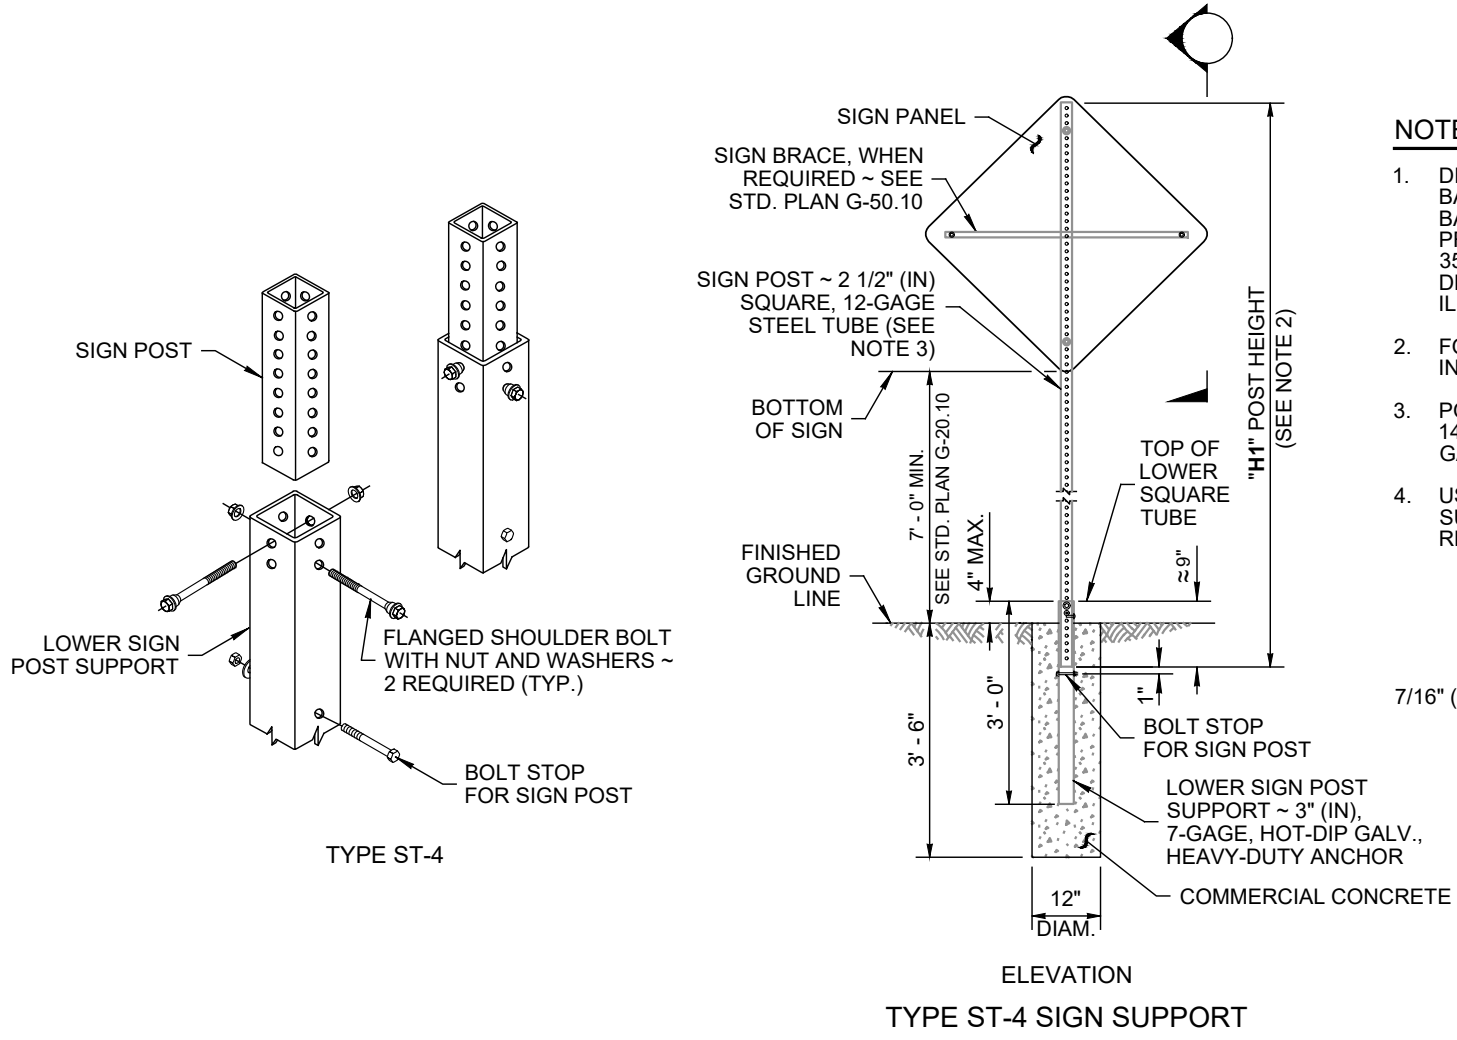
STREET SIGN INSTALLATION DETAIL  
PER WSDOT STD PLAN G-24.50-05  
NTS

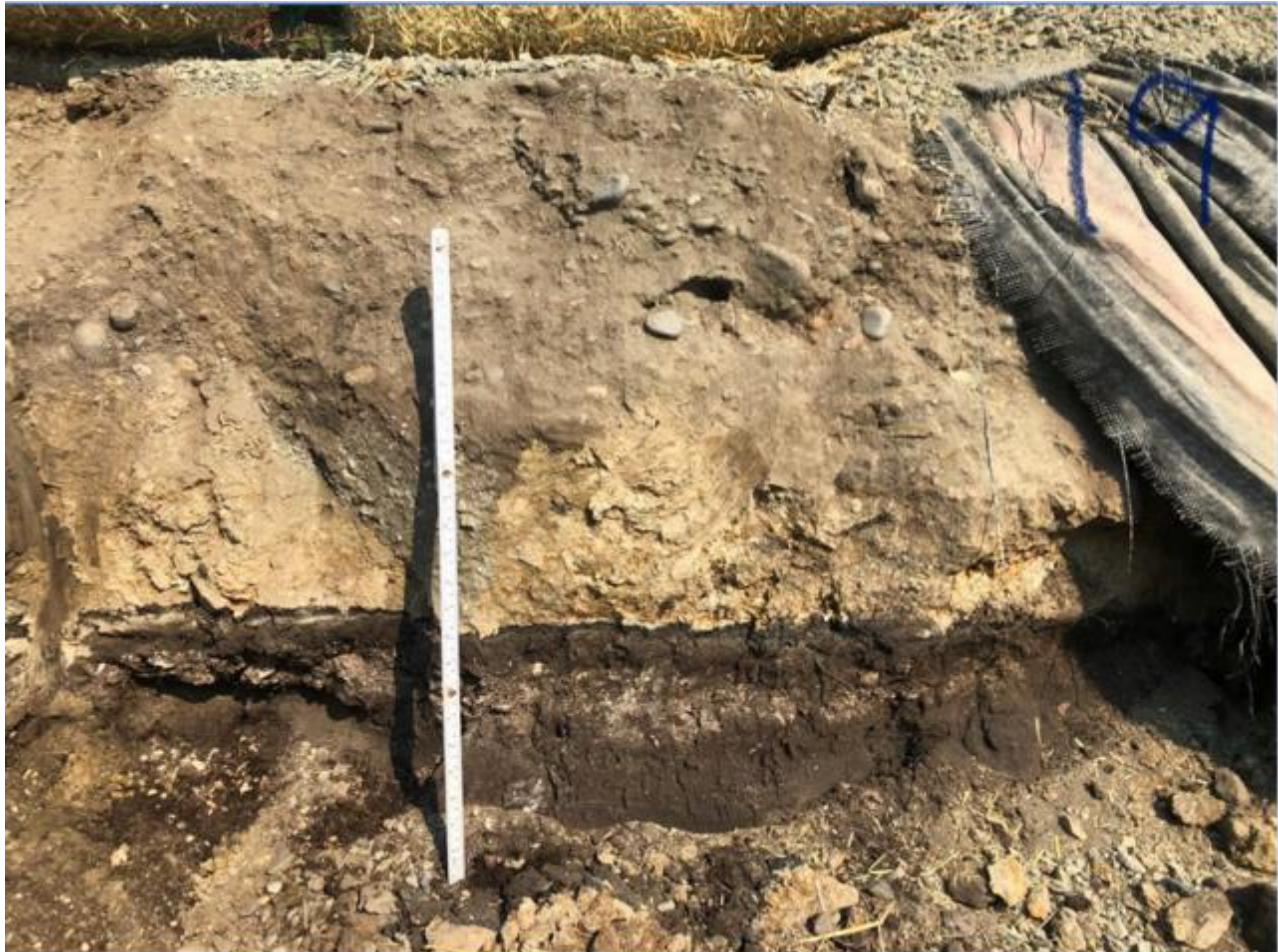
**Figure 8.** Shell midden at Quiet Cove

The exposed midden forms a crescent-shaped feature in the cutbank, measuring approximately one meter wide with a maximum thickness of 30cm. The buried surface of the midden is planar, indicating it was disturbed before burial. The original thickness of the deposit is unknowable. Regardless, the portion that remains is clearly intact and in place. Internal stratigraphy of the midden is typical of coastal middens, displaying alternating layers of highly organic sediment and pulverized shell. No shell identifiable to species was observed in the midden.

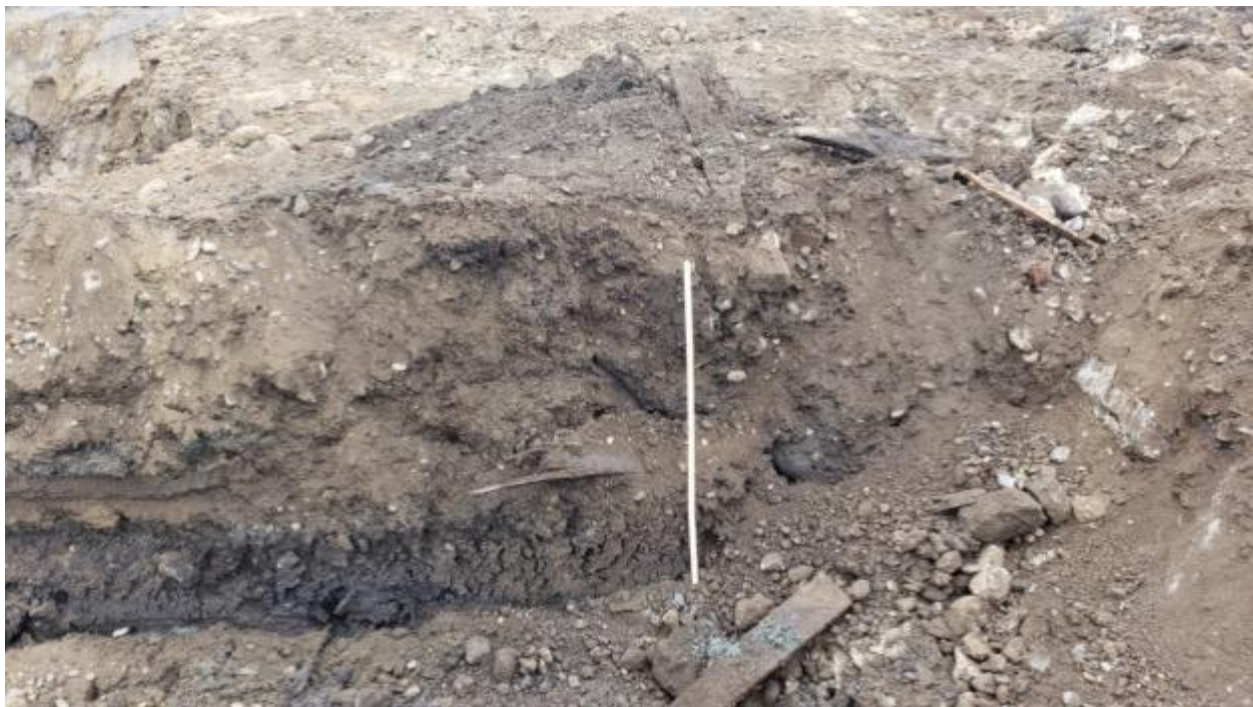
**Figure 22.** Historic debris throughout fill layer (Note “peat” layer at base of cut).

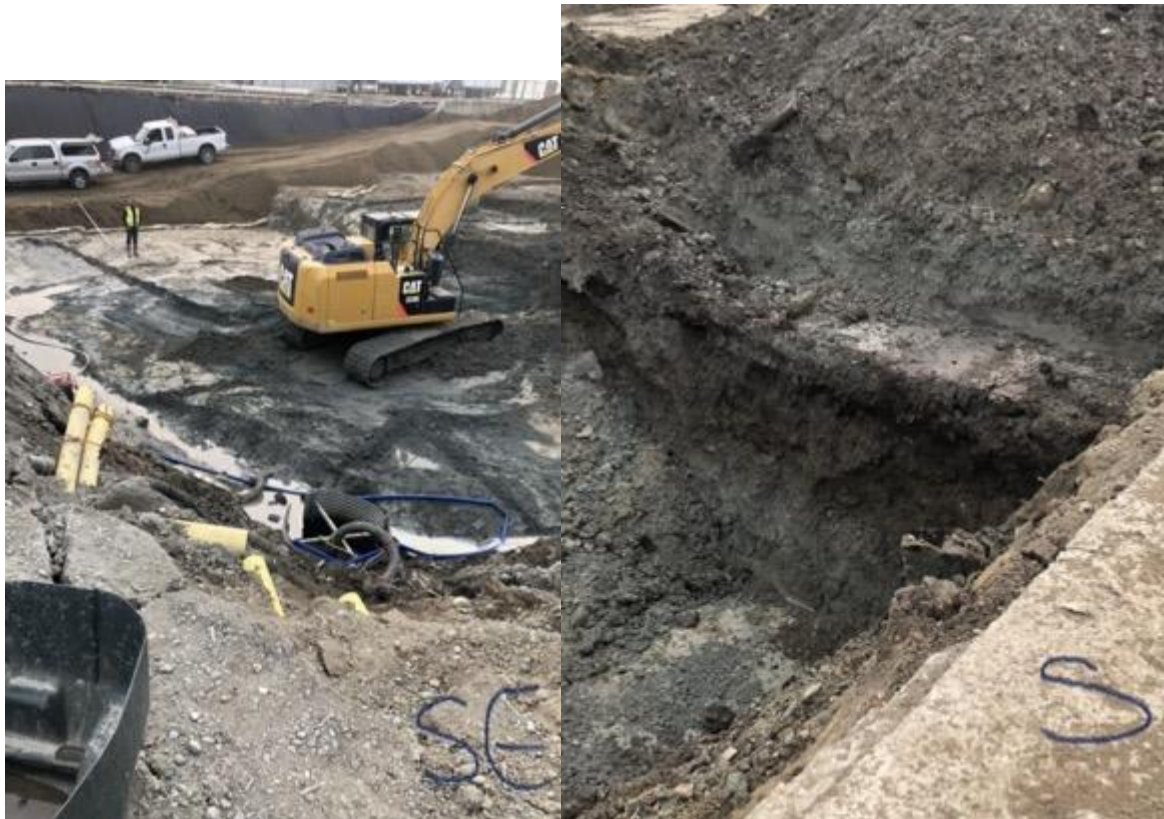
**Figure 54.** The site (eastern side) at the beginning of the day taken facing South East (left). The stratigraphy of the pit being dug with the refuse pile on top to be hauled away. Facing South (right)

Day started with cleanup in the bottom of the pit in the Eastern half of the site and leveling the bottom. No cultural deposits found as it was glacial till. A few whole bricks were found amongst the rubble, from the historic strata about 1.5-2 m deep. Additionally, more natural tree roots were uncovered at about 1 meter deep. Many large cobbles and boulders were removed from the glacial till layer, which was gray-blue and very clay rich; heavily compacted. The remnants of the terracotta red sewer pipe from the historic era were uncovered as well again on this side of the site.

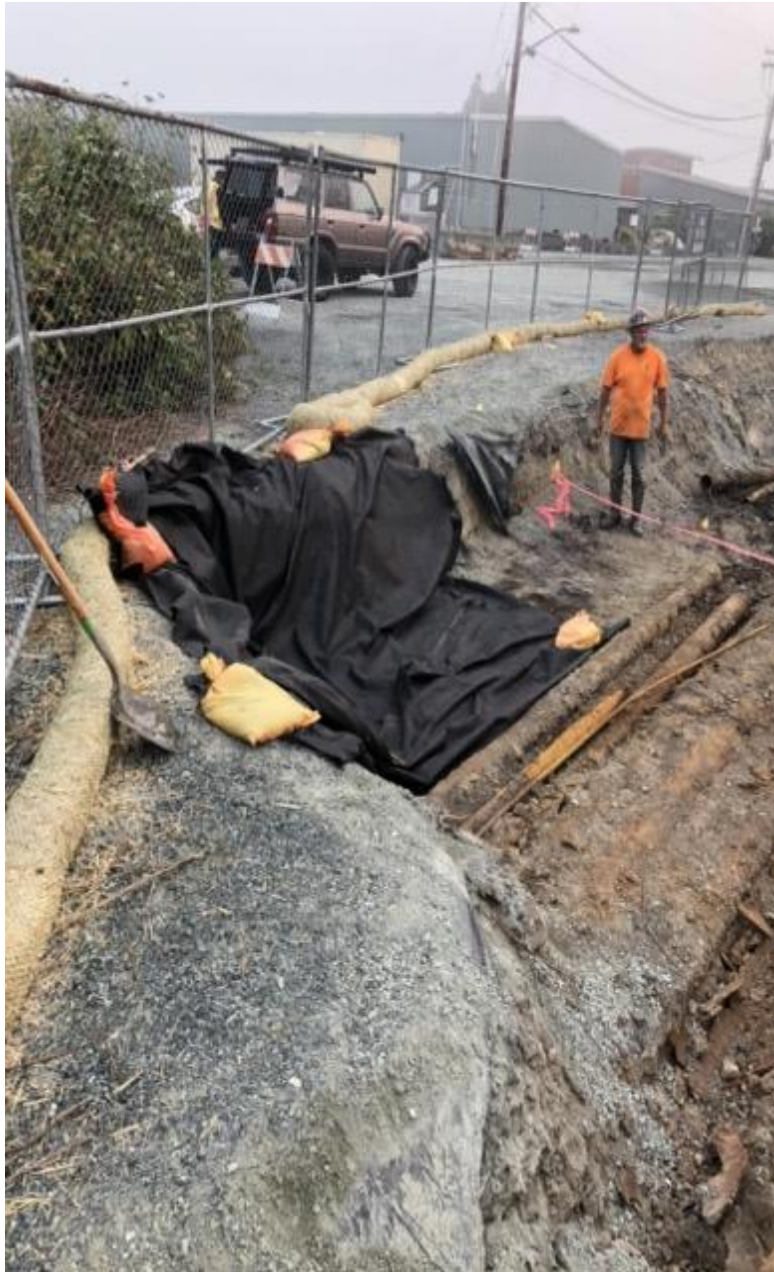
**Figure 63.** Covering shell midden with geotextile fabric.

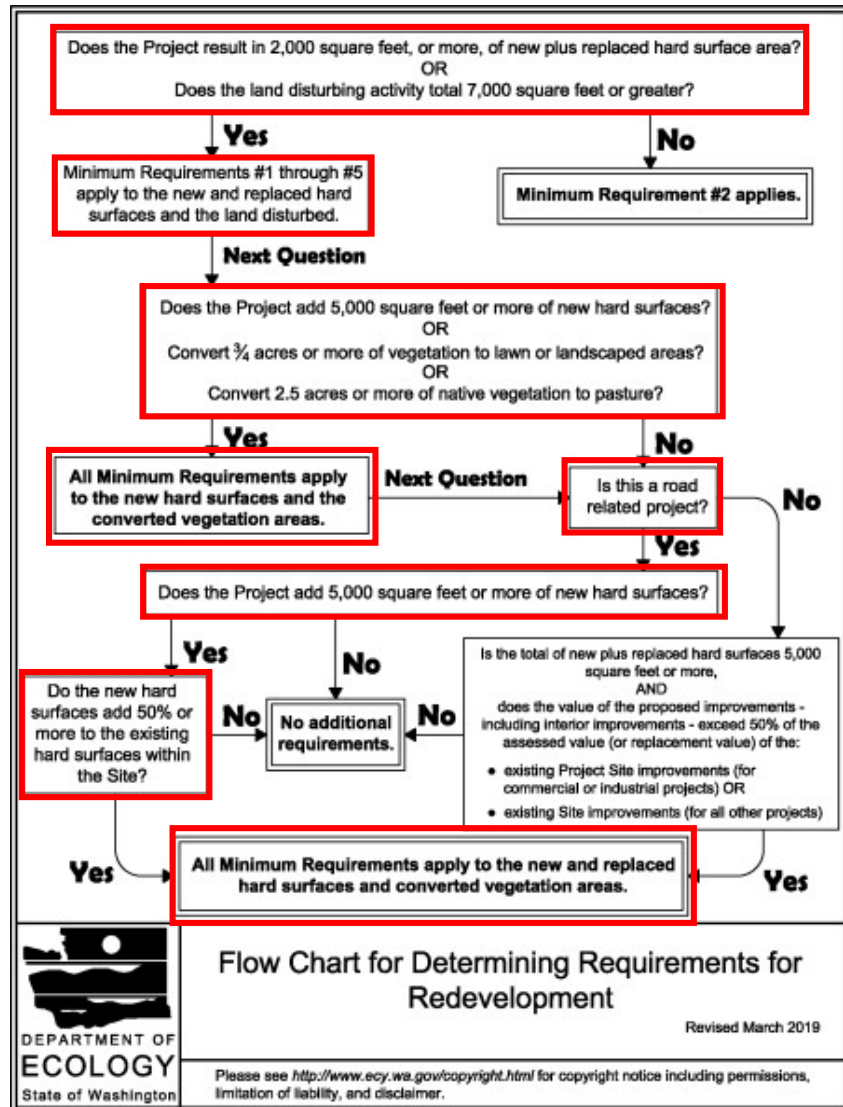
FIGURE 4 Stormwater Management Manual for Western Washington – Volume I – Figure 1-3.2

The City of Anacortes uses the Stormwater Management Manual for Western Washington (SWMMWW) for stormwater guidelines. Volume 1 of the SWMMWW outlines the Minimum Technical Requirements applicable to new development, redevelopment, and road-related projects. Figure 1-3.2 of the SWMMWW is a diagram to aid in the determination of the minimum technical requirements applicable to redevelopment projects. Figure 1-3.2 from the SWMMWW is included below in FIGURE 4.

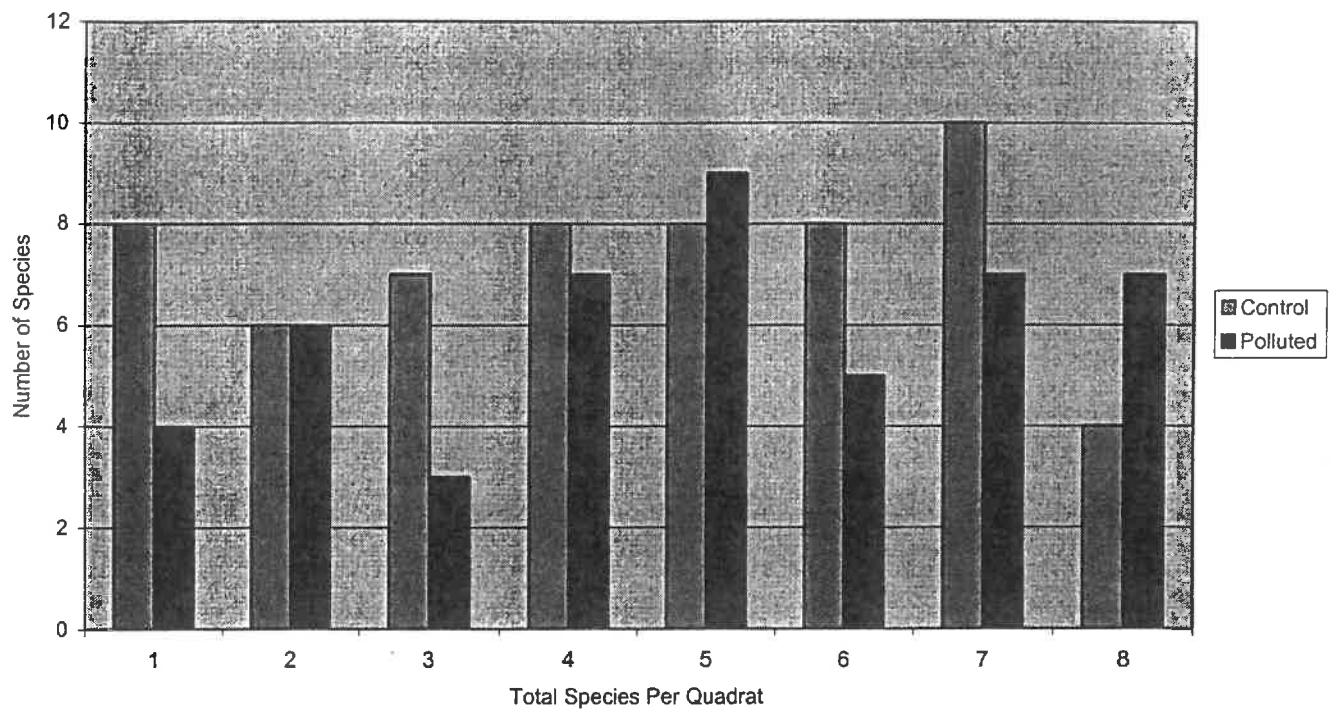
Figure 5: Comparison of species richness on each beach. No significant statistical difference was found.

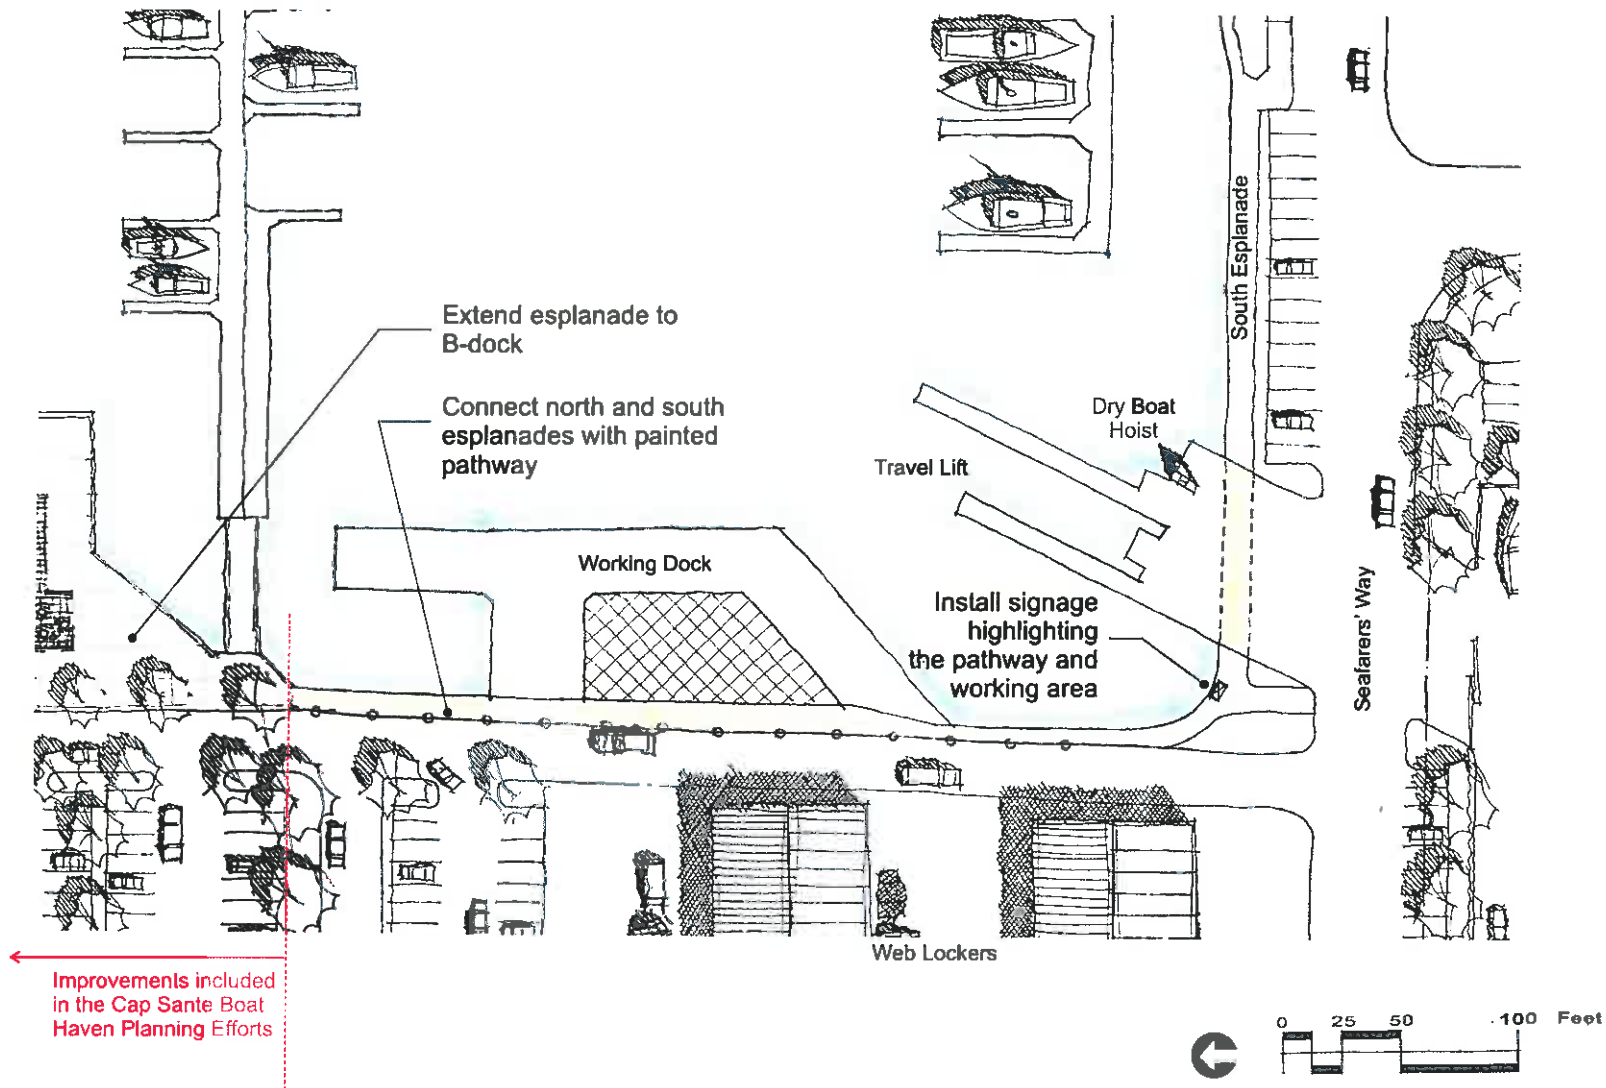
Figure 11. Cap Sante Boat Haven Esplanade Improvements Plan

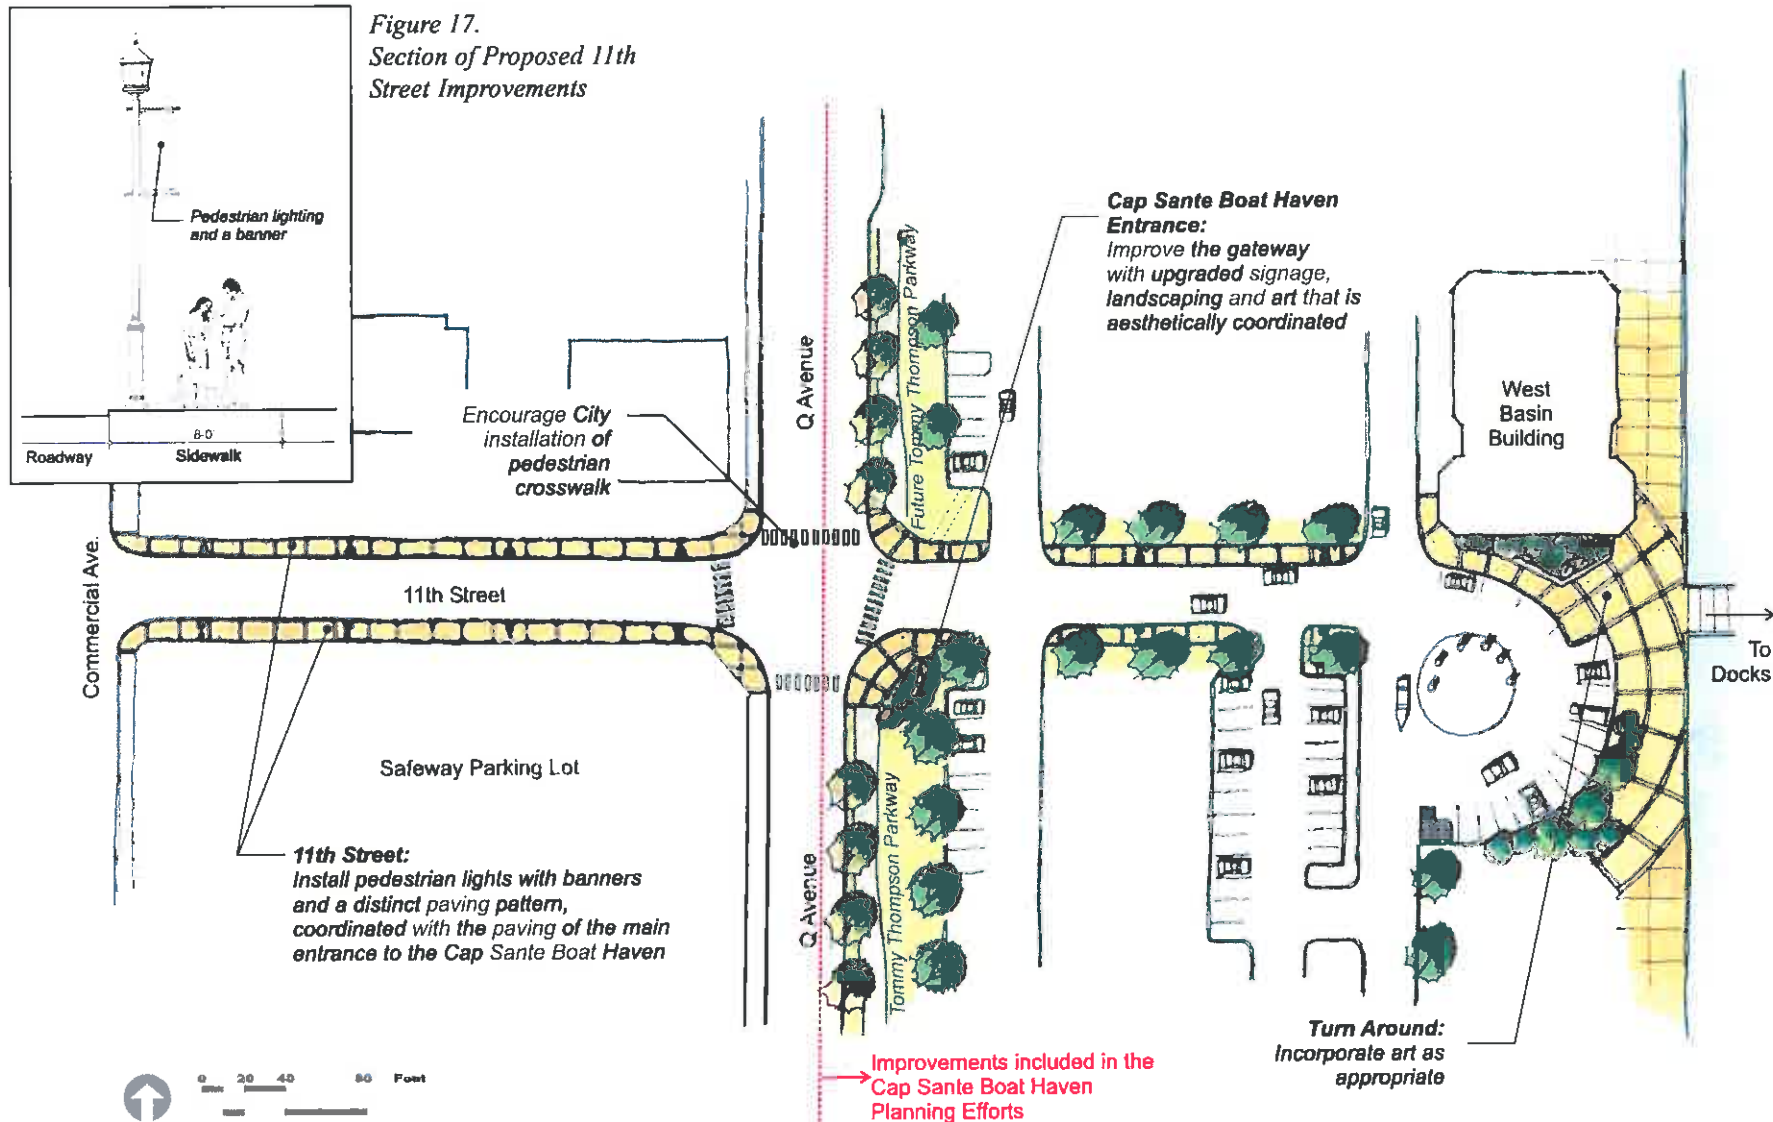
Figure 18. 11th Street Connection Improvements Plan

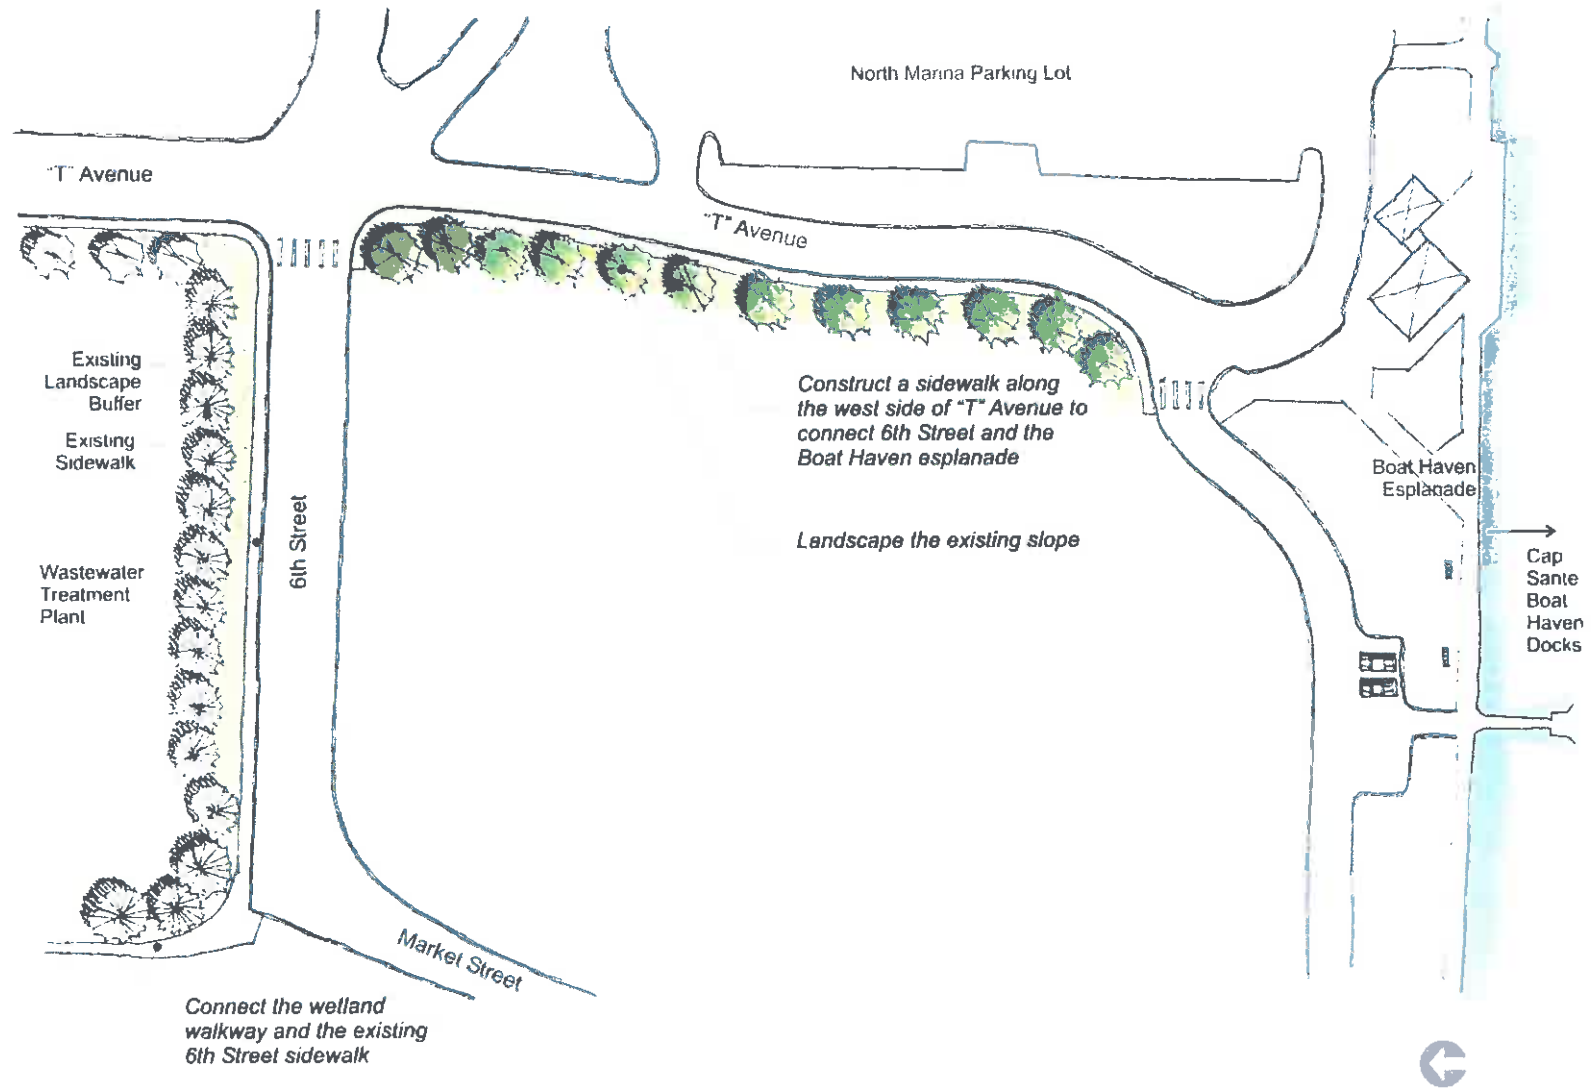
Figure 33. "T" Avenue Improvements Plan

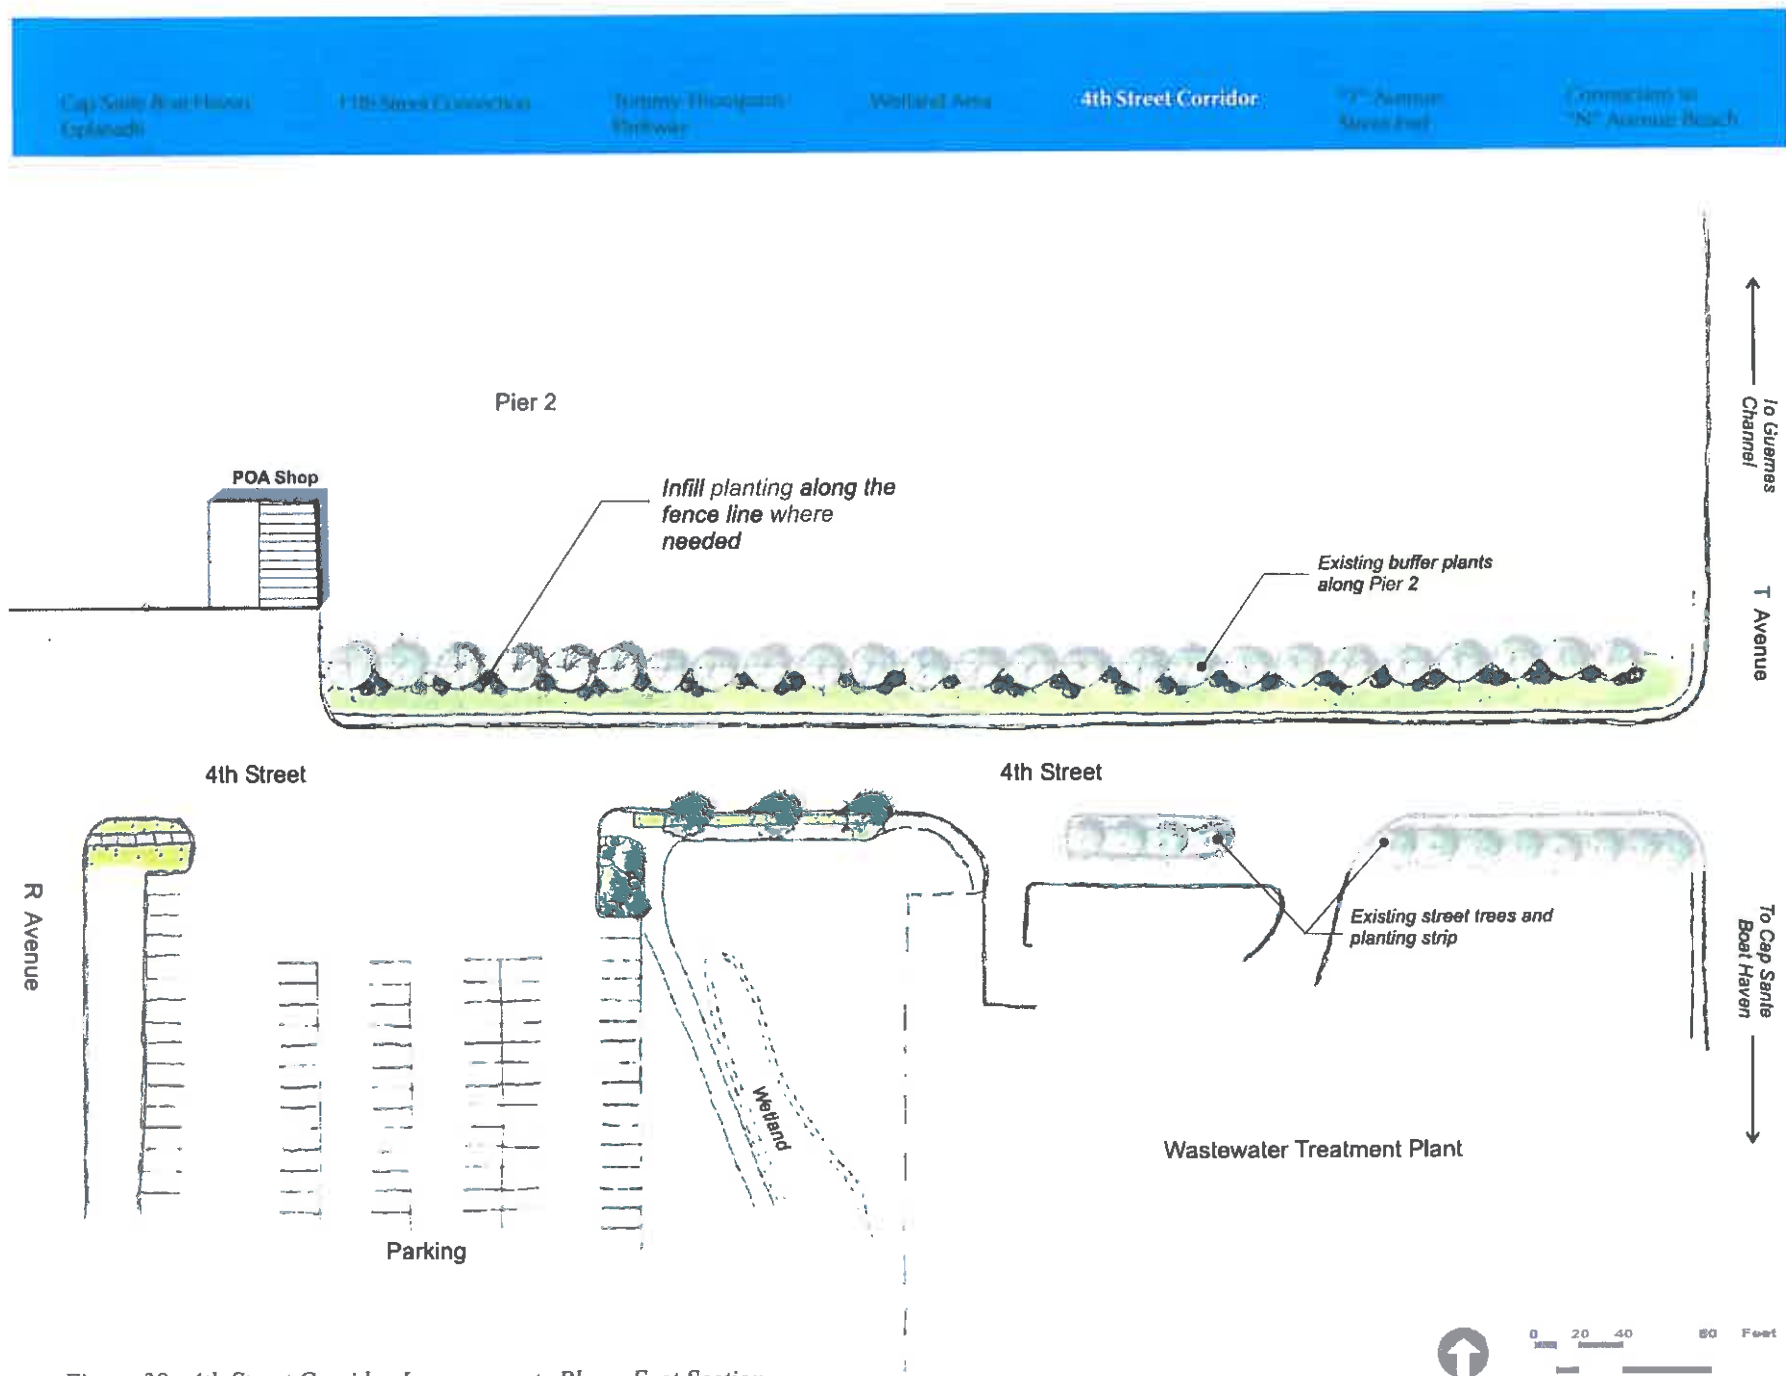
Figure 38. 4th Street Corridor Improvements Plan - East Section

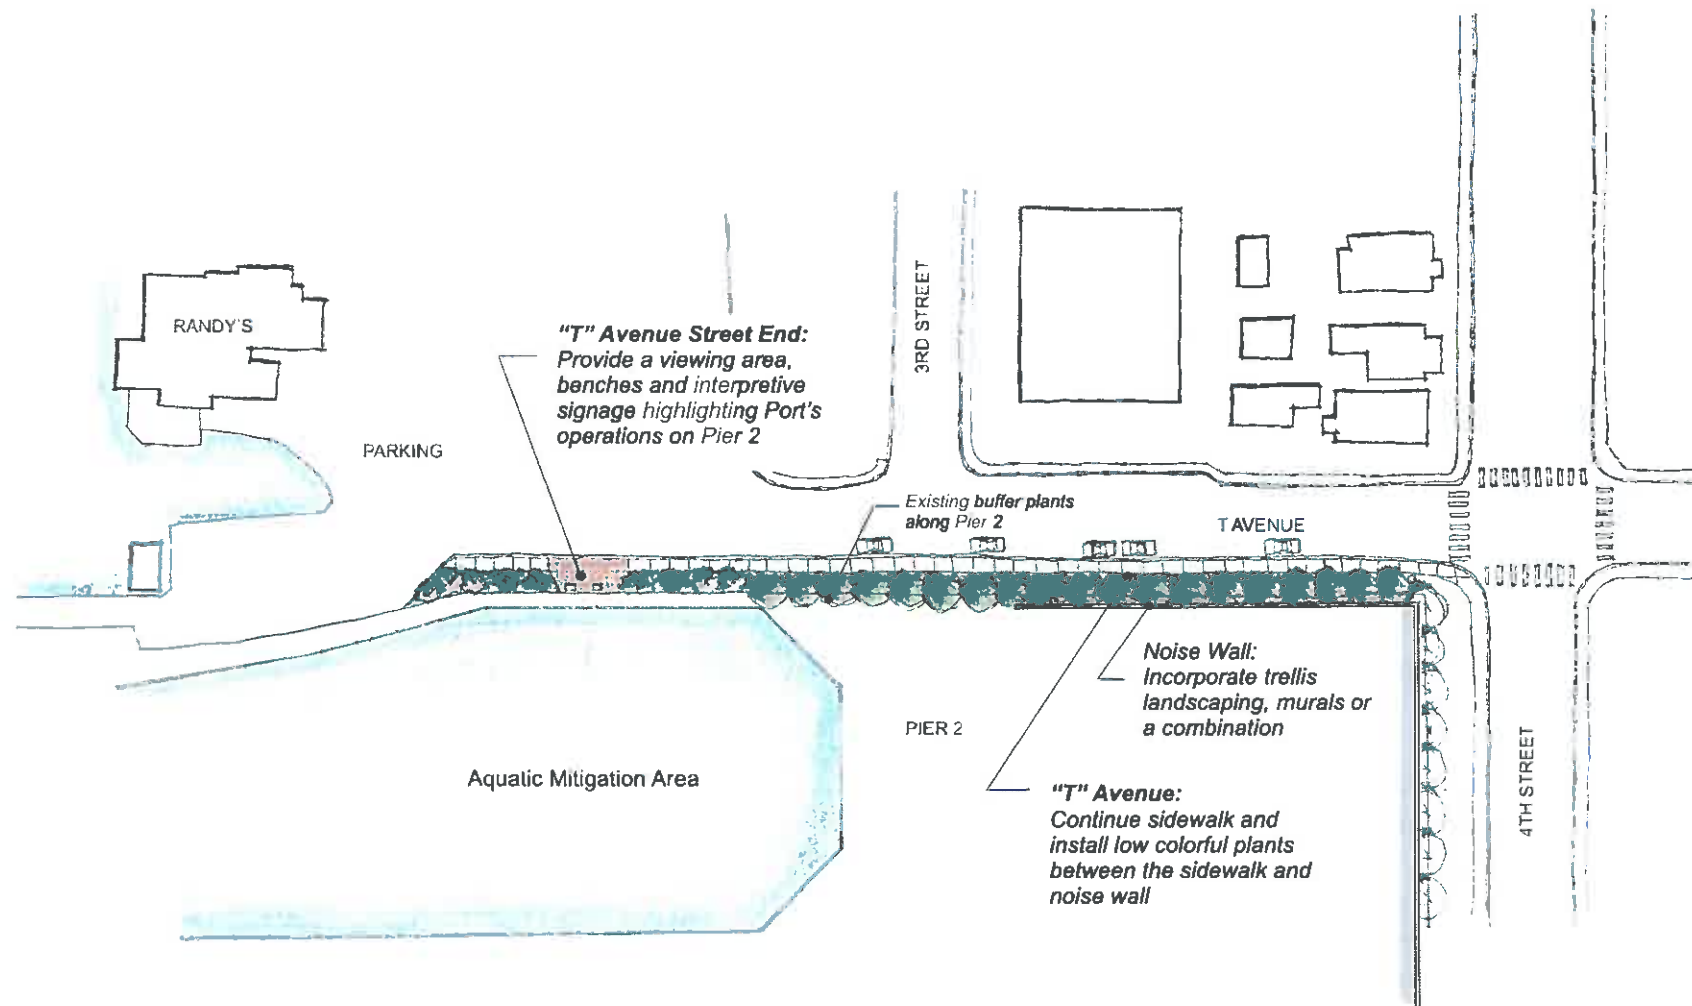
Figure 44. "T" Avenue Street End Improvements Plan

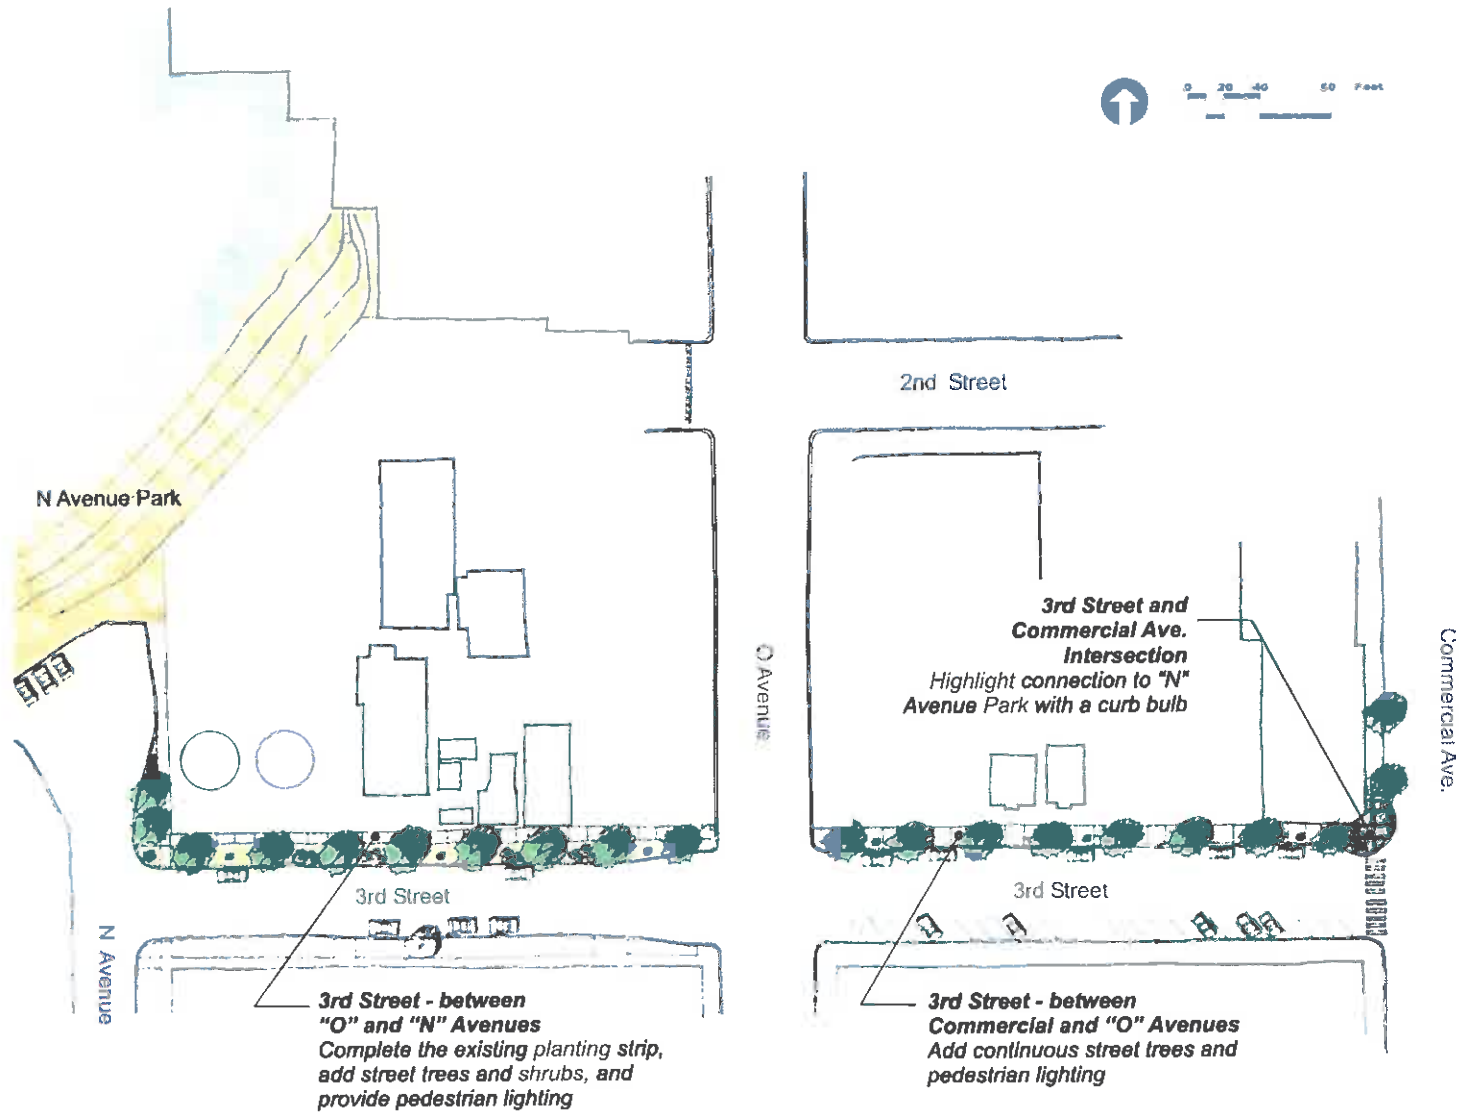
Figure 51. Connection to "N" Avenue Beach Improvements Plan
