# **ANACORTES PLANNING COMMISSION**

**PUBLIC HEARING:** The City of Anacortes' Public Works Department has applied for a Conditional Use Permit, Variance request, & SEPA environmental review to permit the construction of two 1.5 million gallon water tanks /reservoirs on the subject property. The existing 47 foot tall 3 million gallon water tank/reservoir located onsite will be removed. The Variance request is to increase the maximum permitted height of 35 feet to approximately 50 feet above grade for the two new reservoirs. Subject parcels involved are: P33173 & P33044. Per AMC 17.04.070(E), the subject applications are being reviewed via an integrated and consolidated permit review process. The source of the funding for the subject proposal is from the State of Washington's Department of Health Drinking Water State Revolving Fund Loans in the amount of approximately \$4,974,755

## Blue Heron Circle 3MG Reservoir Replacement Project

## 3 MG RESERVOIR AT 301 BLUE HERON CIRCLE INSPECTION, ANALYSIS, AND RECOMMENDATIONS REPORT

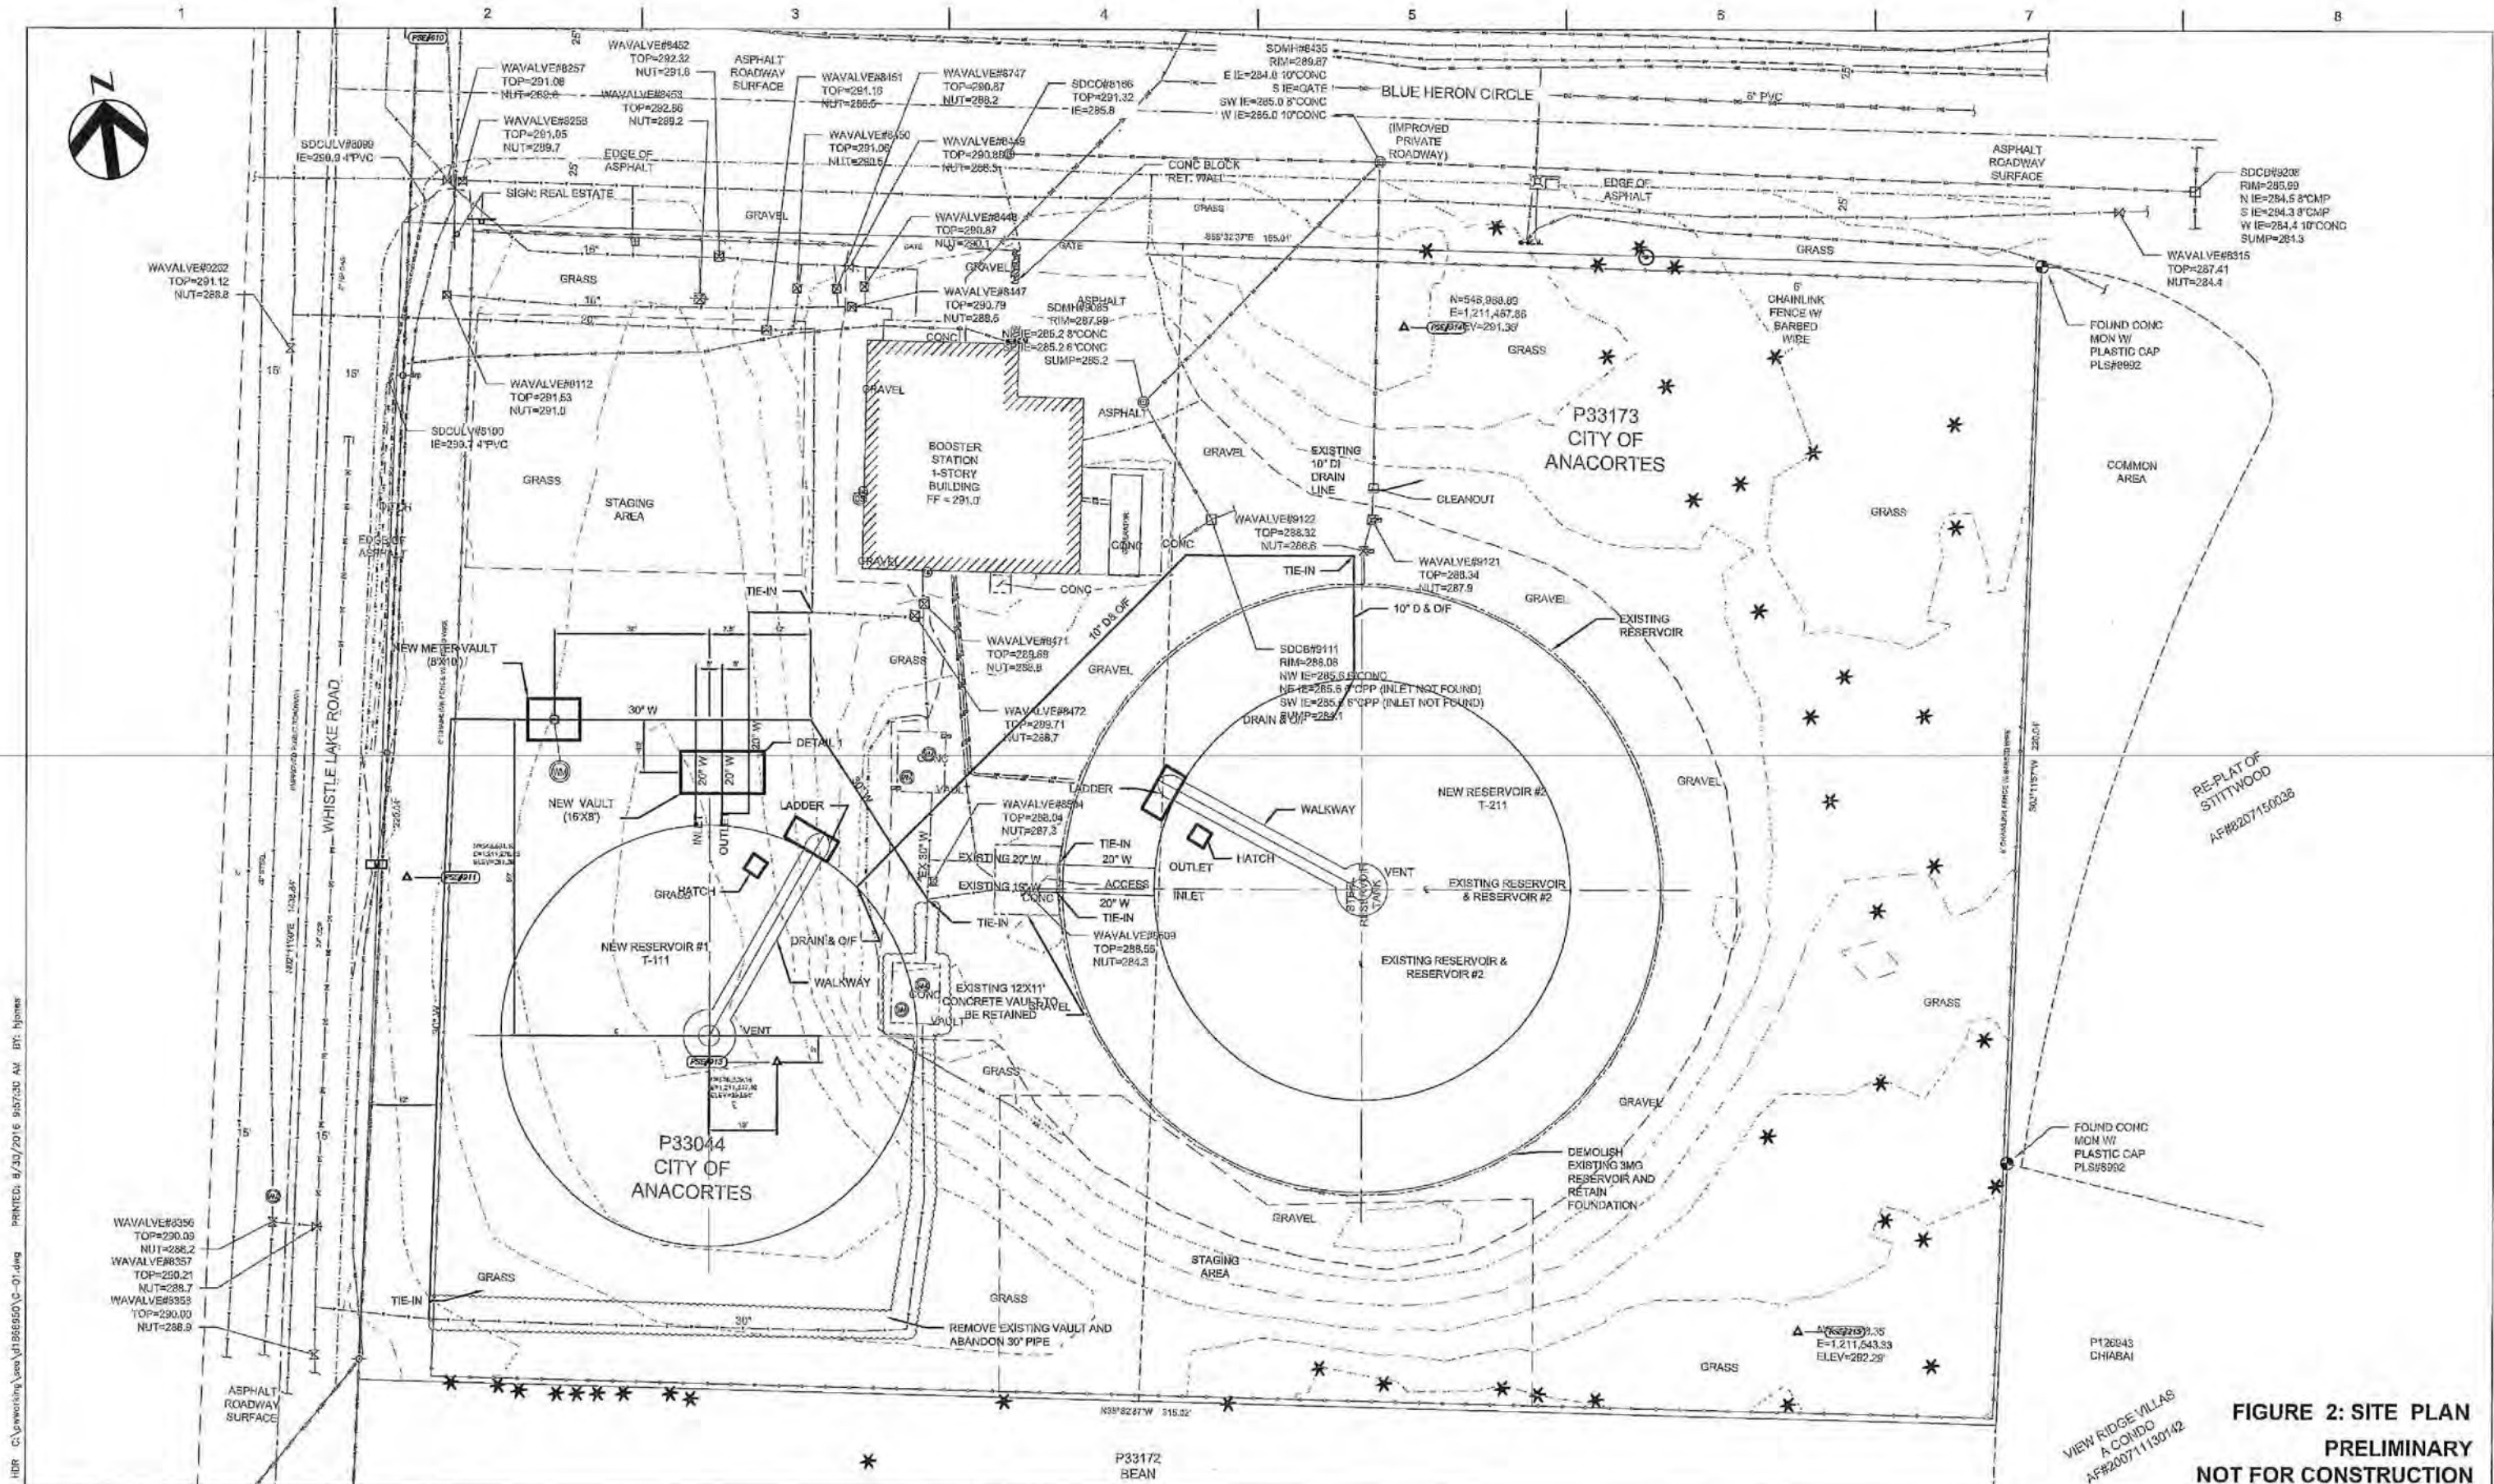
**FIGURE 2: SITE PLAN**  
**PRELIMINARY**  
**NOT FOR CONSTRUCTION**

**ANACORTES BLUE HERON CIRCLE RESERVOIR**  
**PROPOSED LOCATIONS FOR NEW RESERVOIRS**  
**AND ASSOCIATED WATER PIPE**

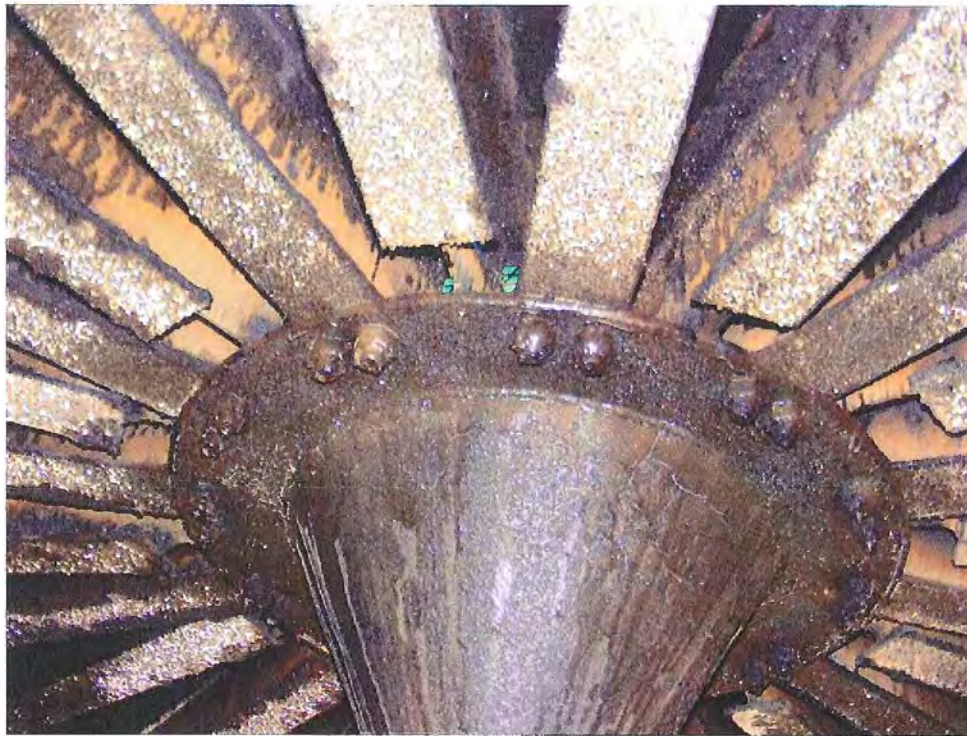
**FIGURE 1**  
Top of Center Column

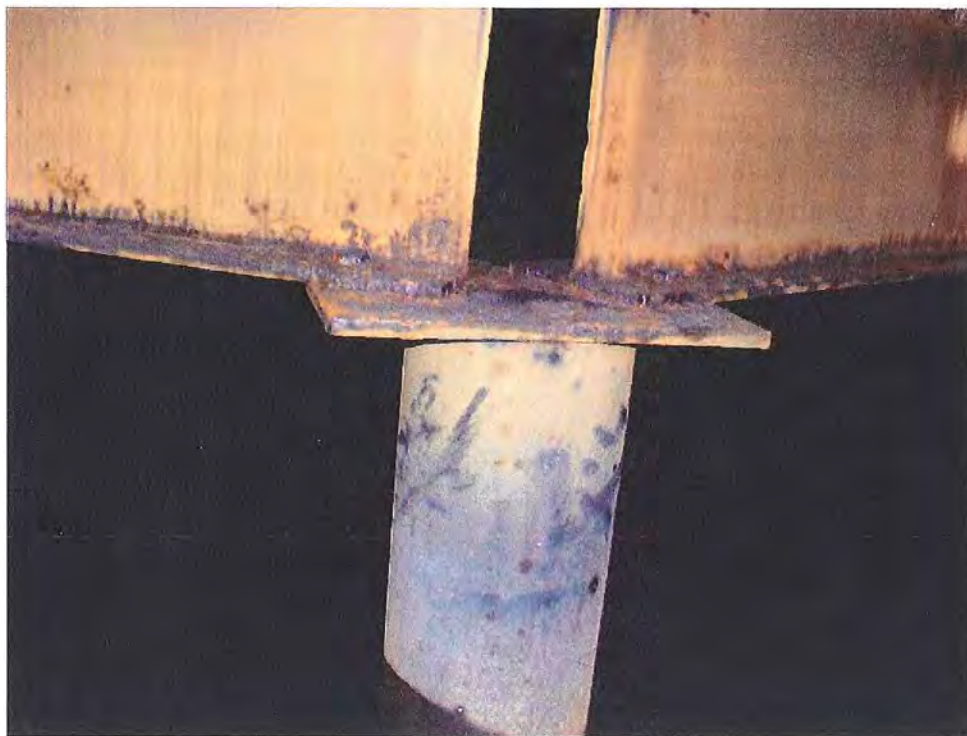
**FIGURE 2**  
Top of an Intermediate Column and Bearing Point of W16 Girders

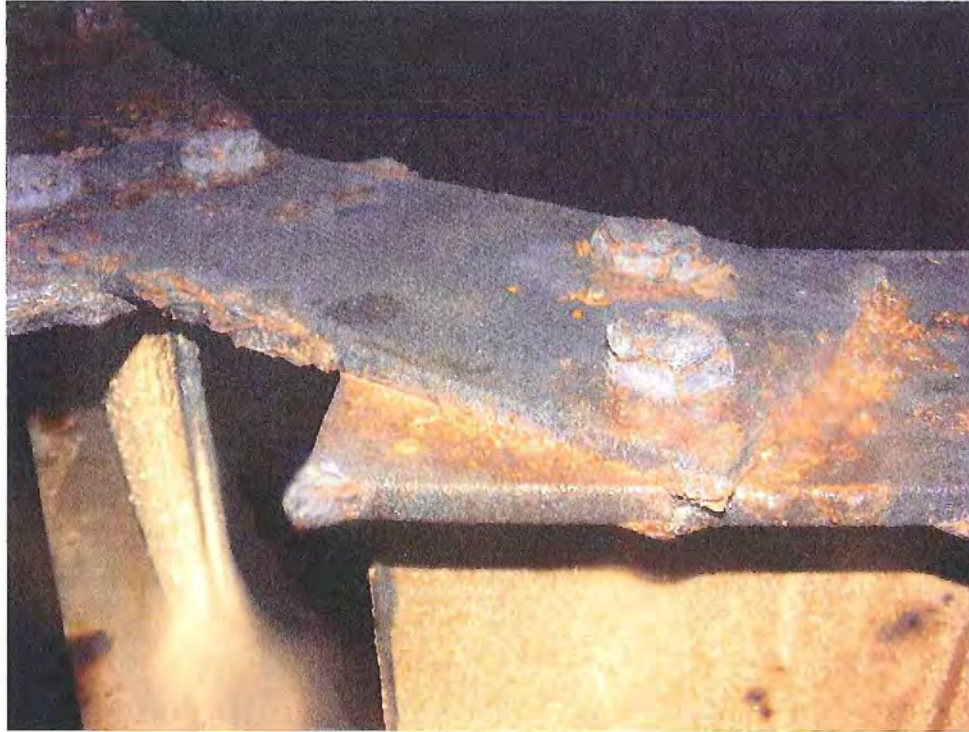
**FIGURE 3**  
Connection at Top of W16 Girders

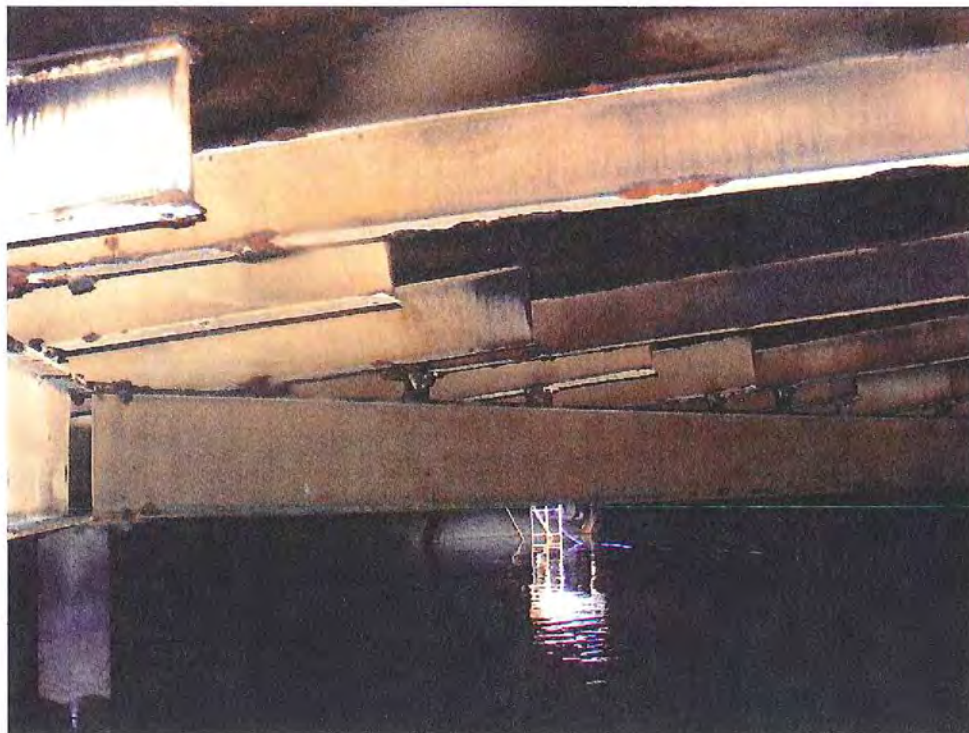
**FIGURE 4**  
Wide View of W16 Girders

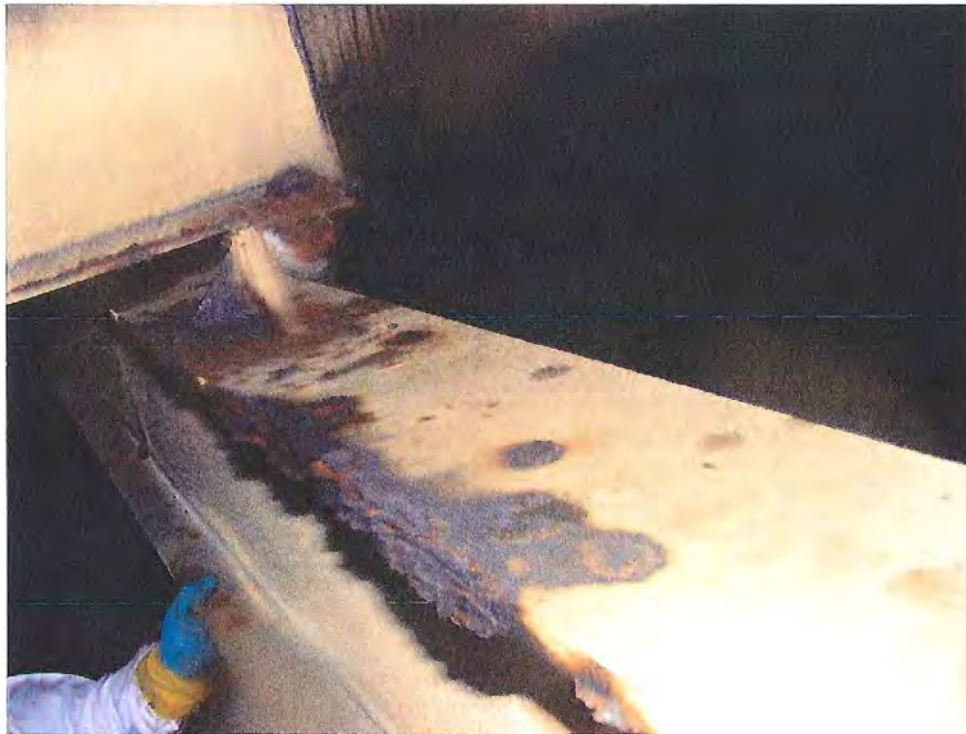
**FIGURE 5**  
Top of a W16 Girder Near a W8 Connection

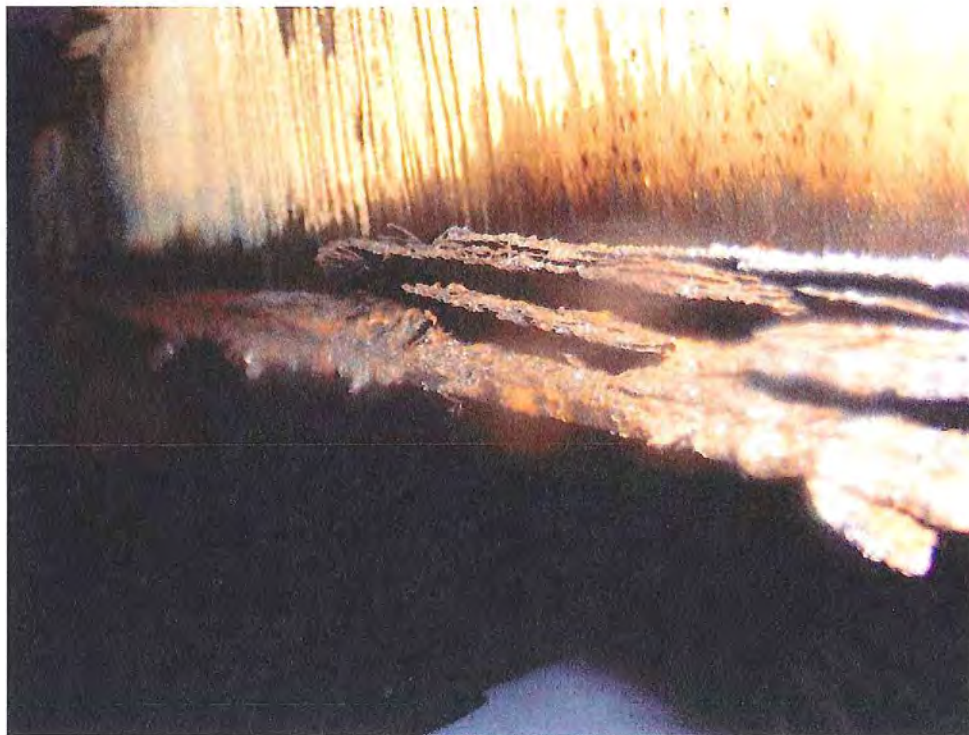
**FIGURE 16**  
Bottom Flange of a W10 Beam with Rust "Laminations"

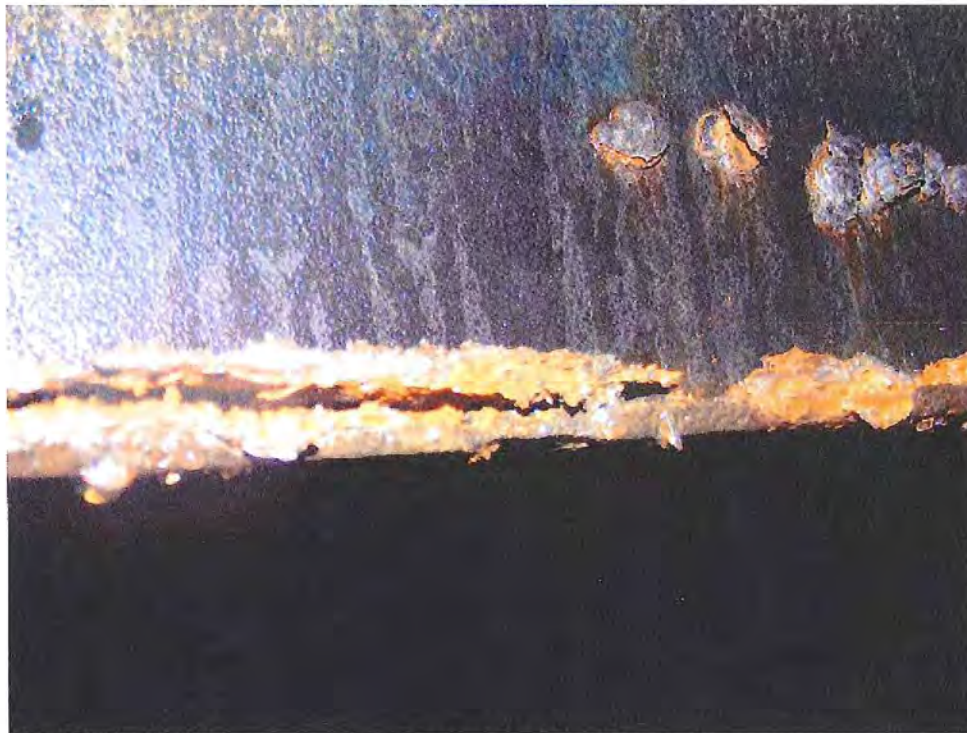
**FIGURE 17**  
Web and Flange Corrosion in a W10 Beam

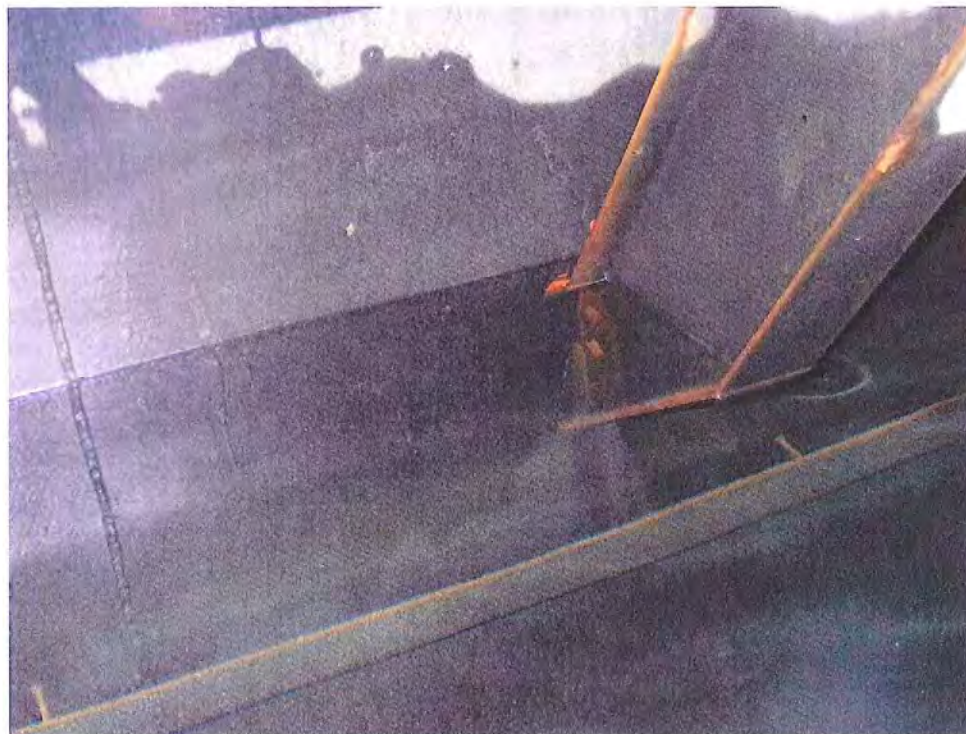
**FIGURE 20**  
W10 Connection to Tank Shell

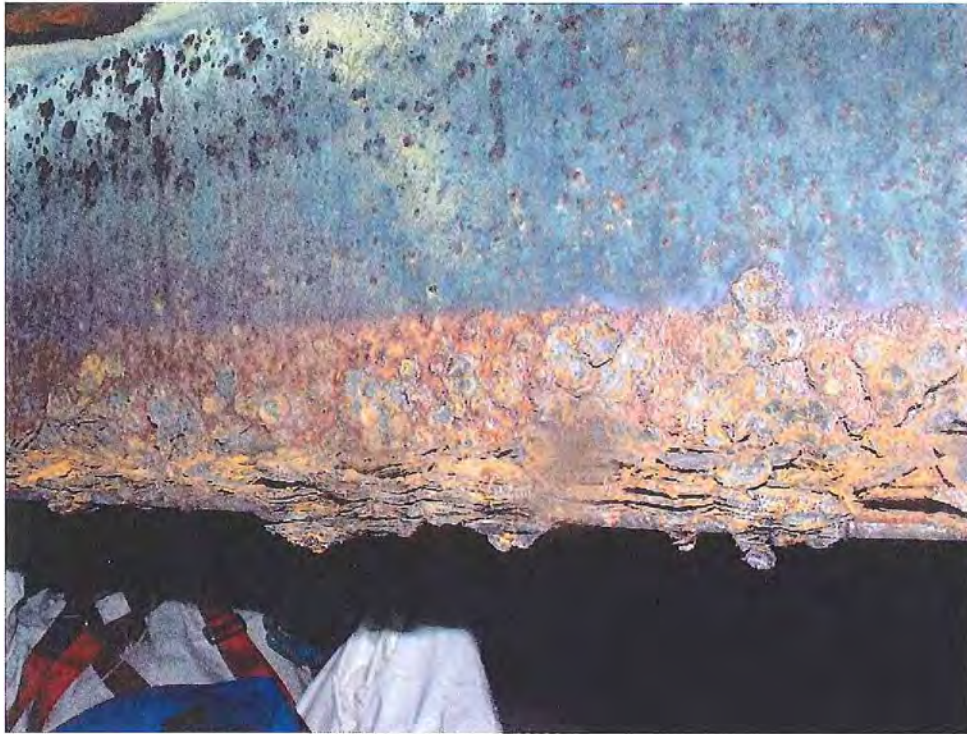
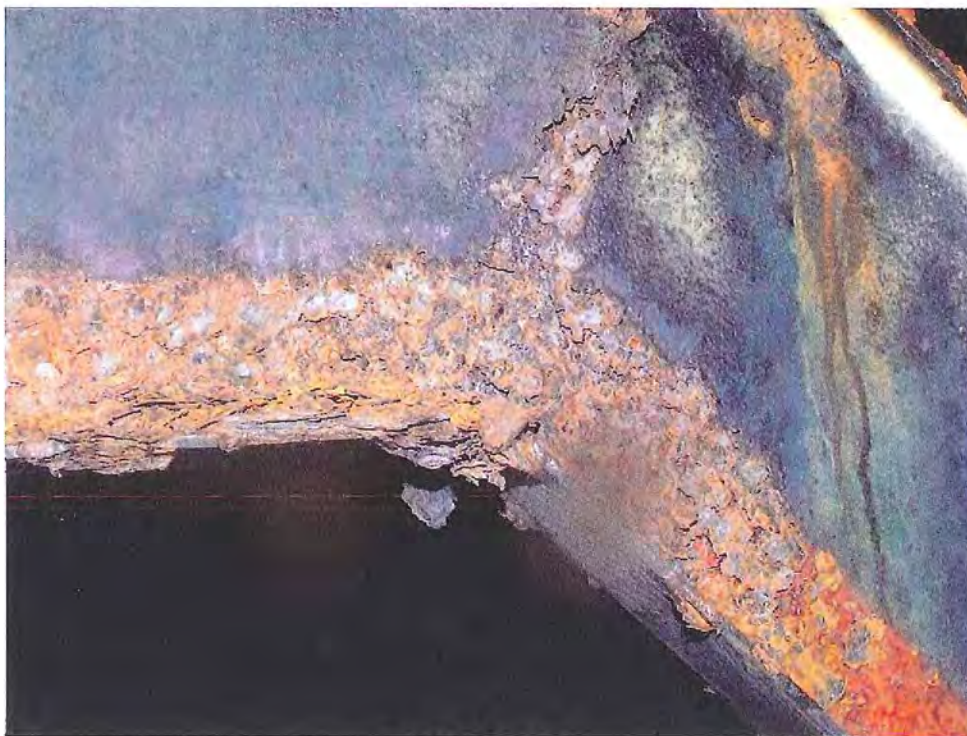
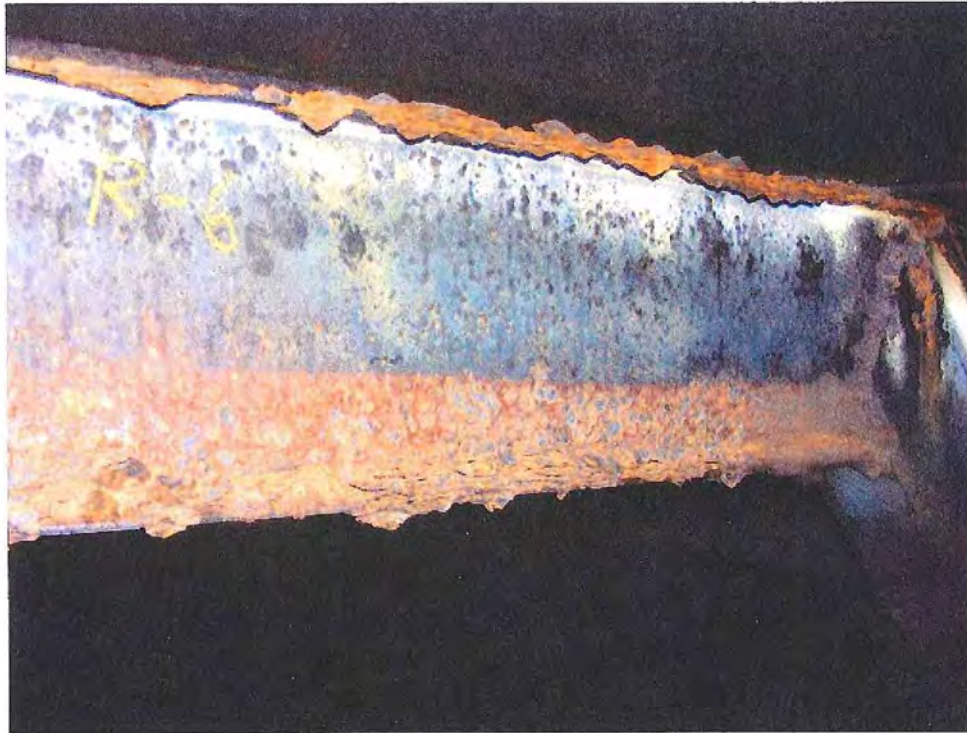
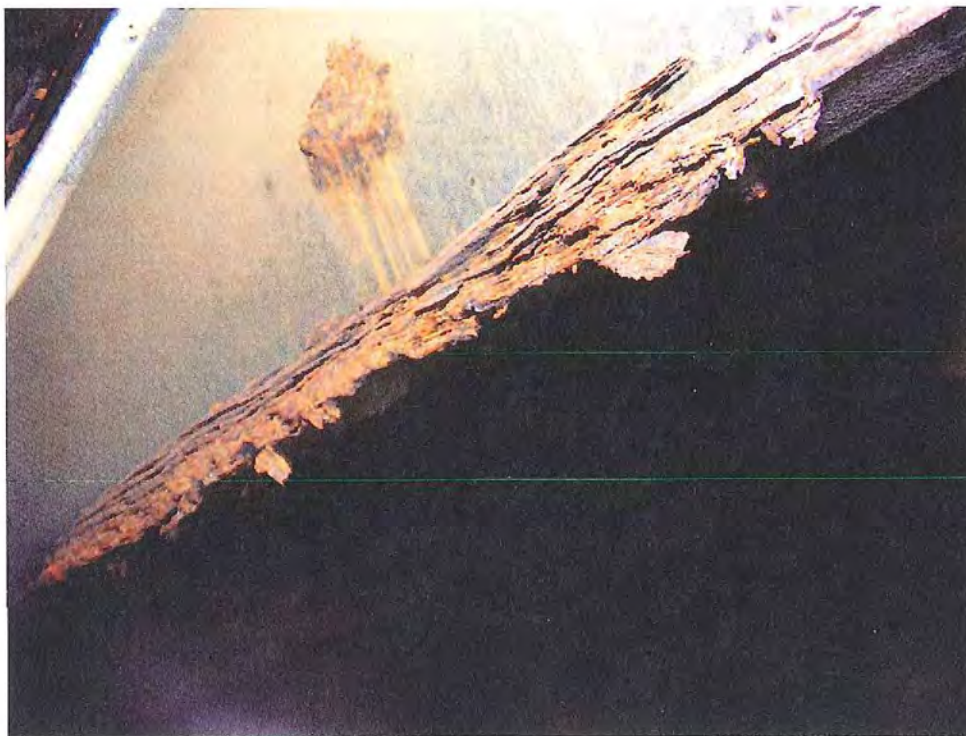
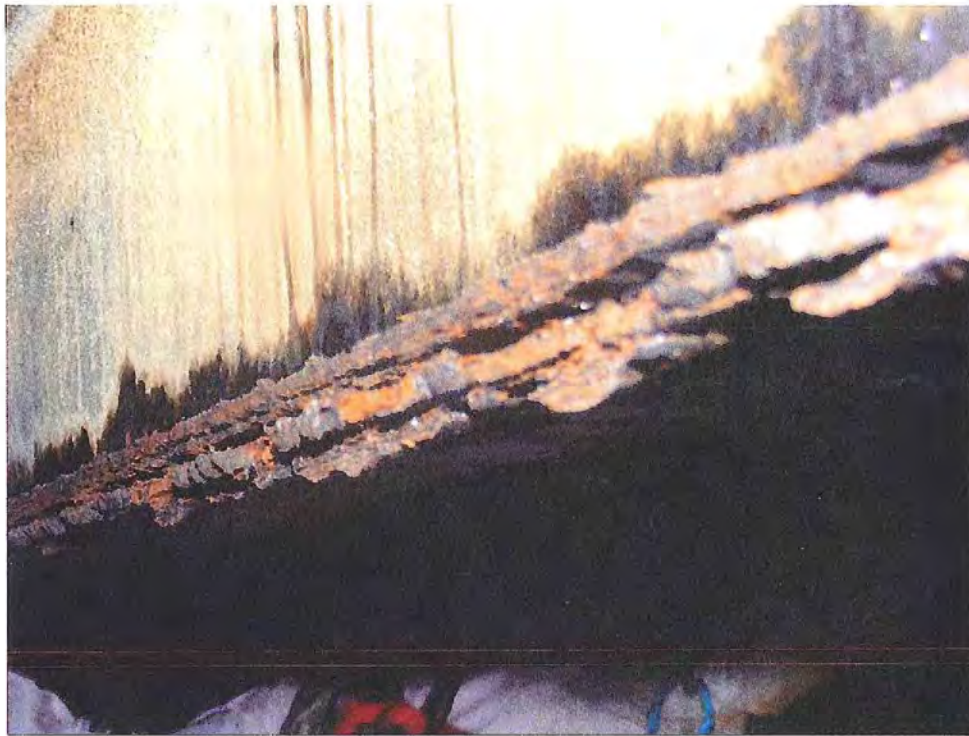
**FIGURE 21**  
Significant Corrosion at a W10 Beam

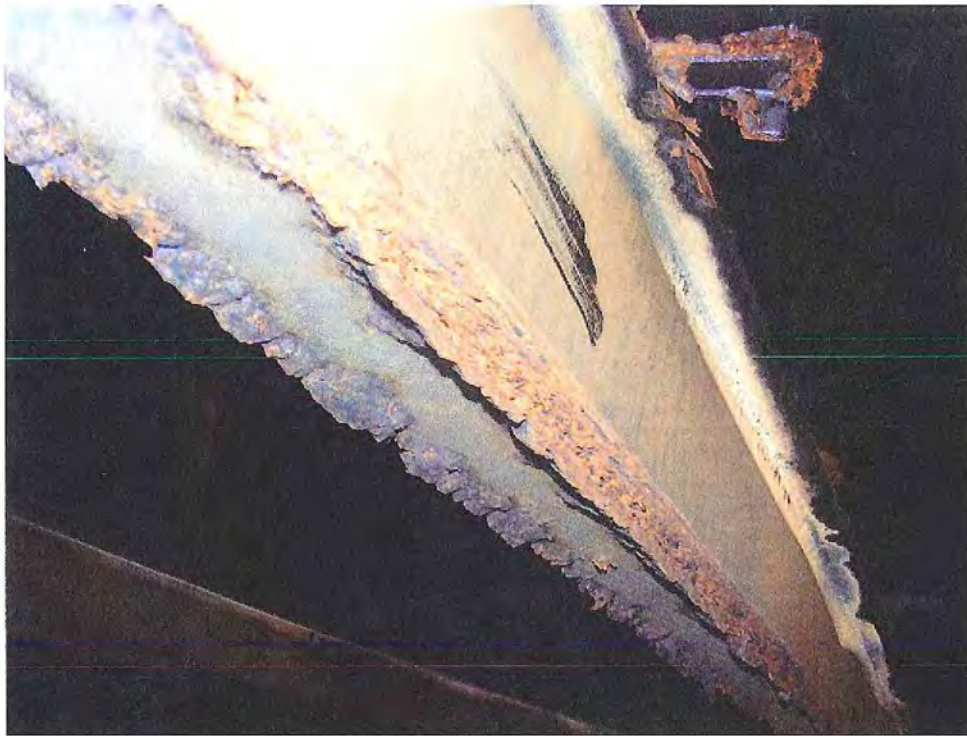
**FIGURE 27**  
Significant Bottom Flange Corrosion of a W10 Beam

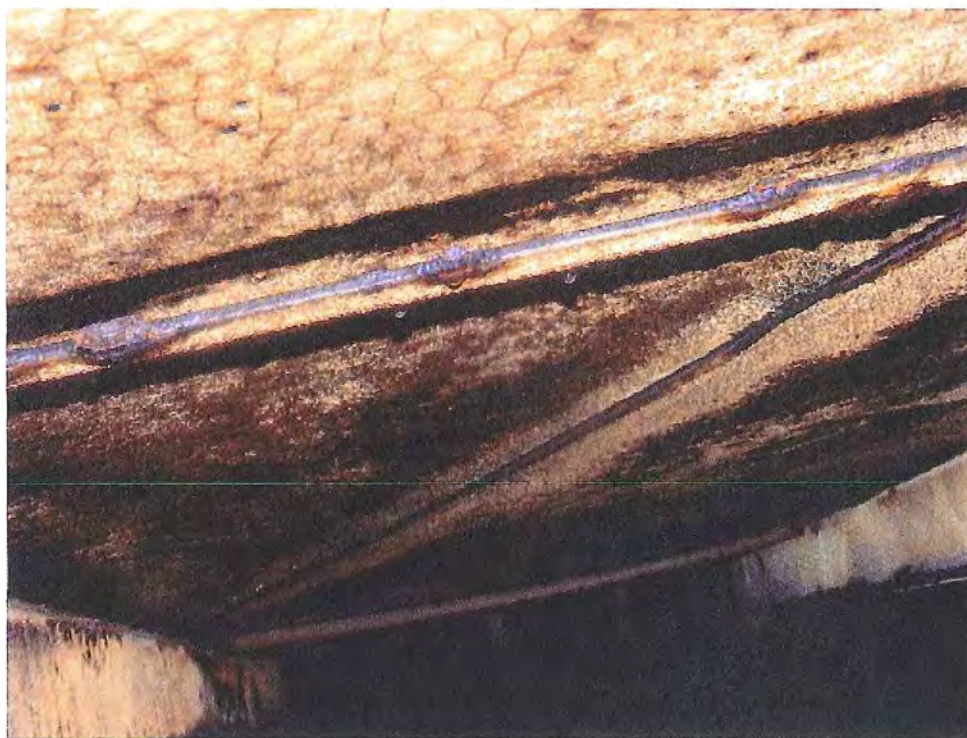
**FIGURE 28**  
Steel Bar Running Between W8 Beams

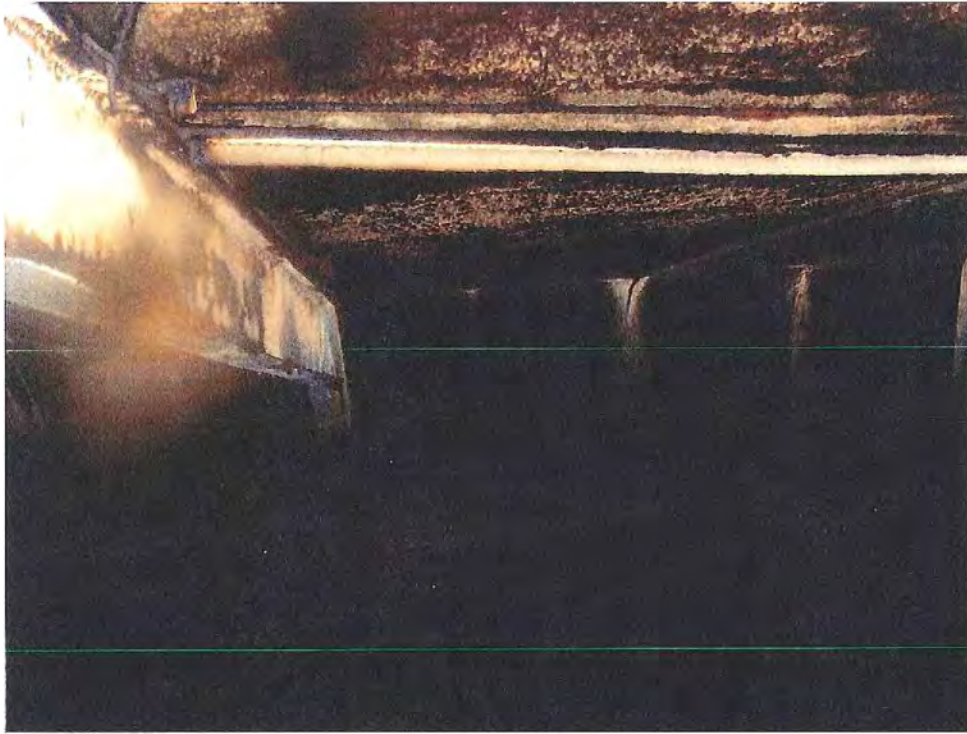
**FIGURE 29**  
Steel Angle Running Between W10 Beams

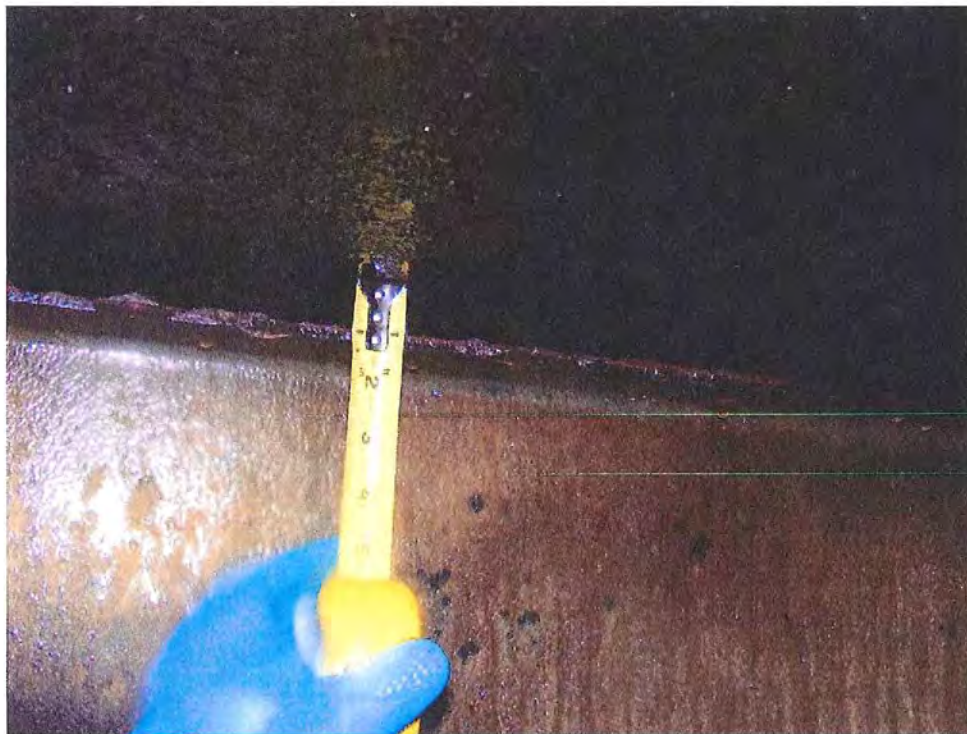
**FIGURE 30**  
Example of Gap Between Top of Beam and Underside of Roof Plate

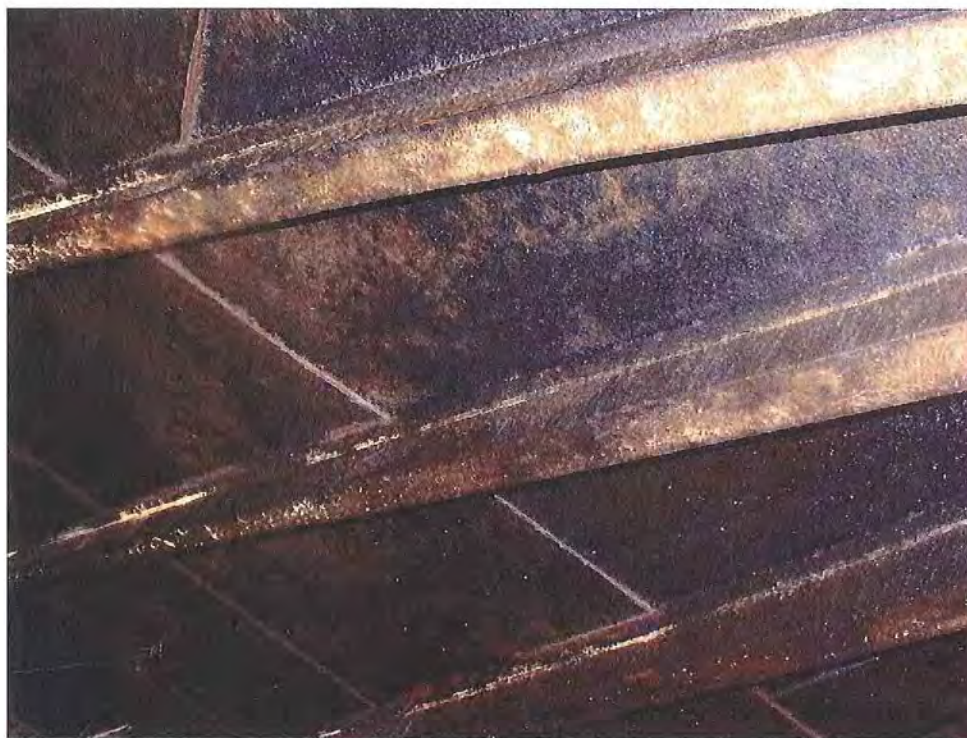
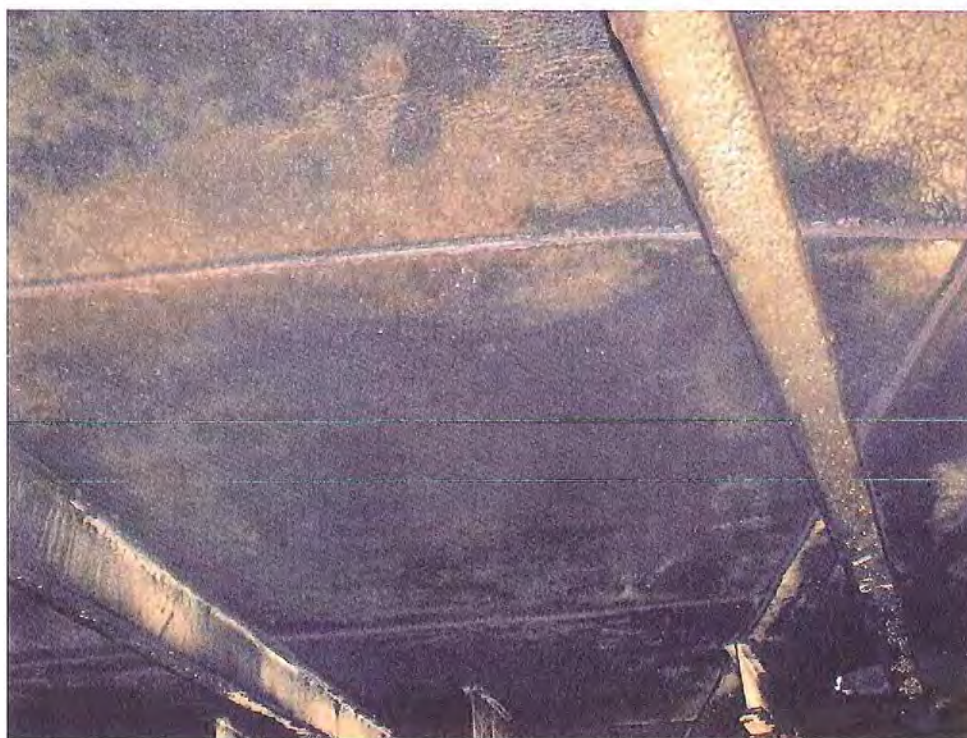
**FIGURE 31**  
Typical Roof Plate Condition Near Center of Reservoir

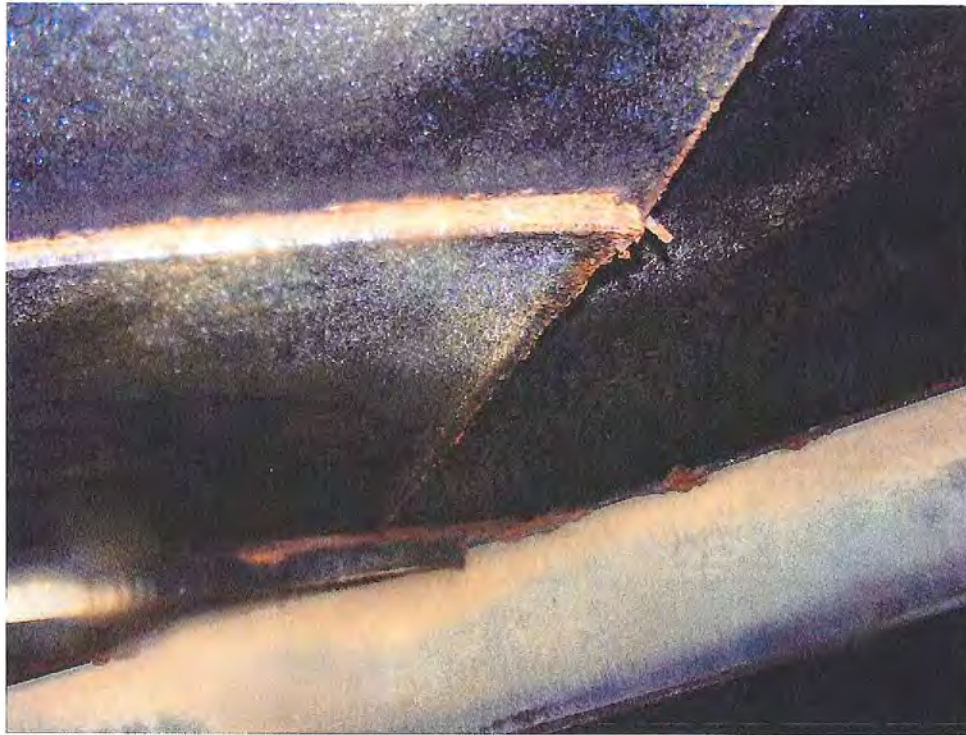
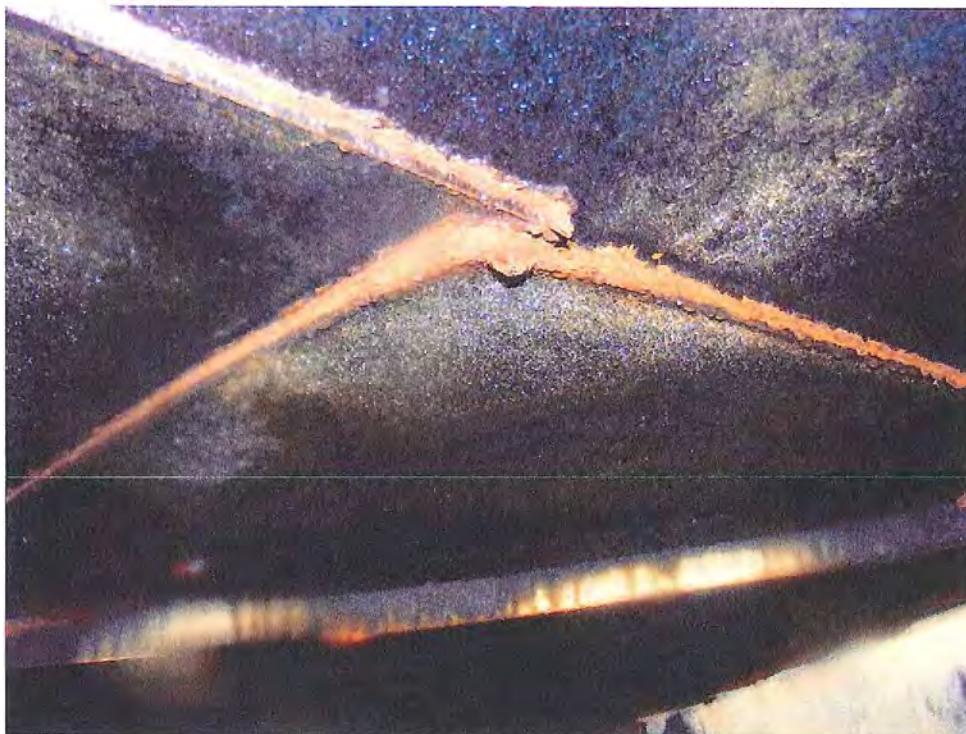
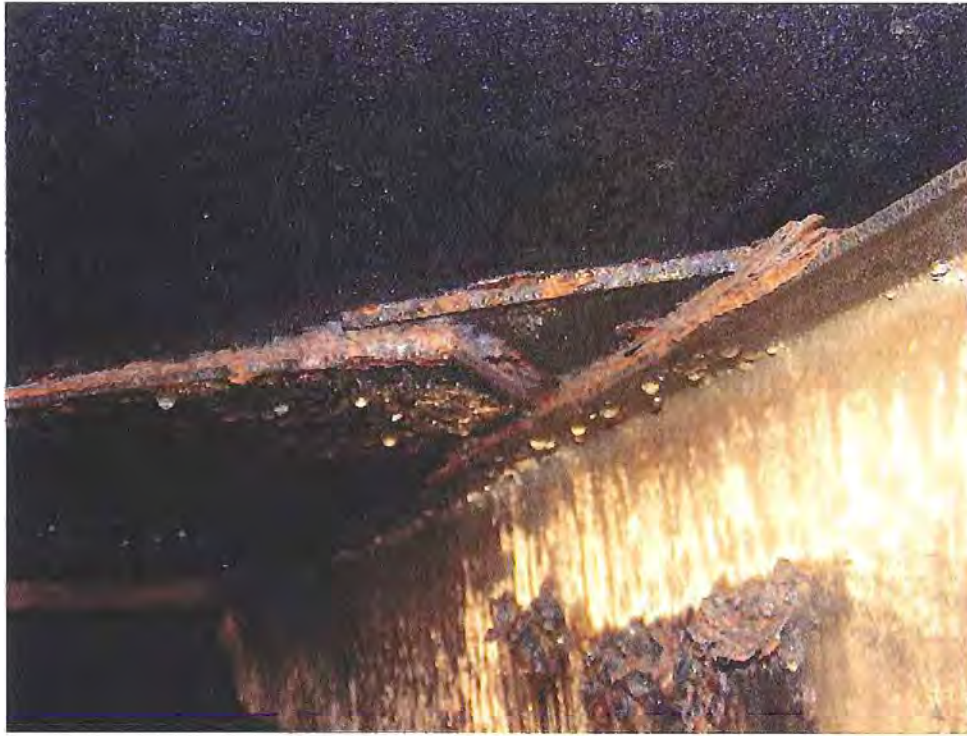
**FIGURE 33**  
Typical Roof Plate Condition Near Perimeter of Reservoir

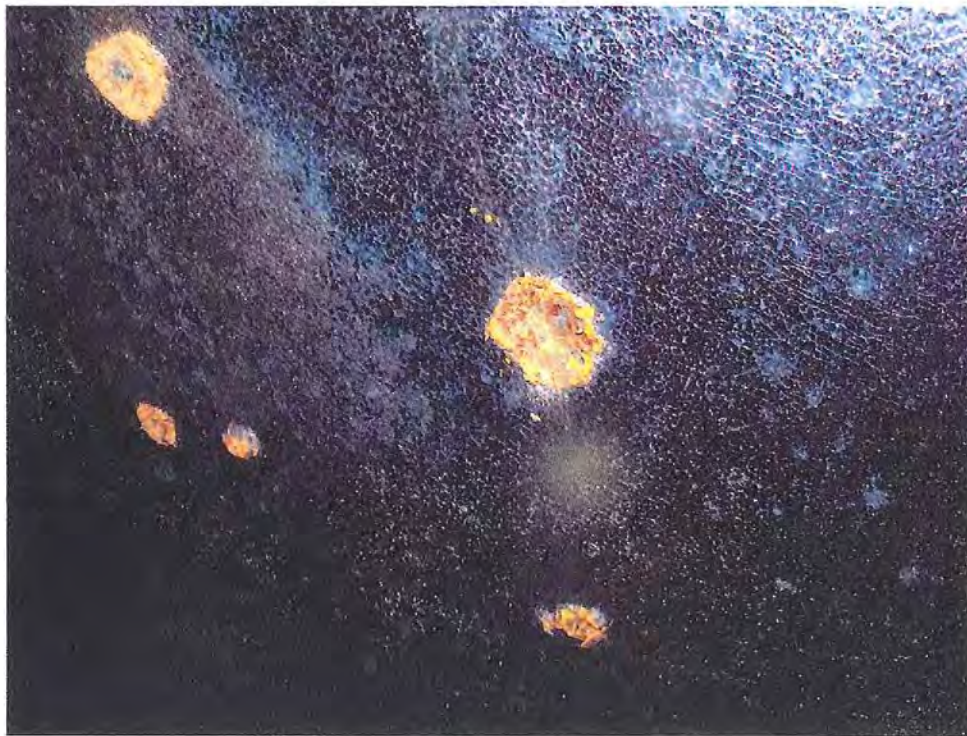
**FIGURE 36**  
Example of Pitting on Underside of Roof Plate

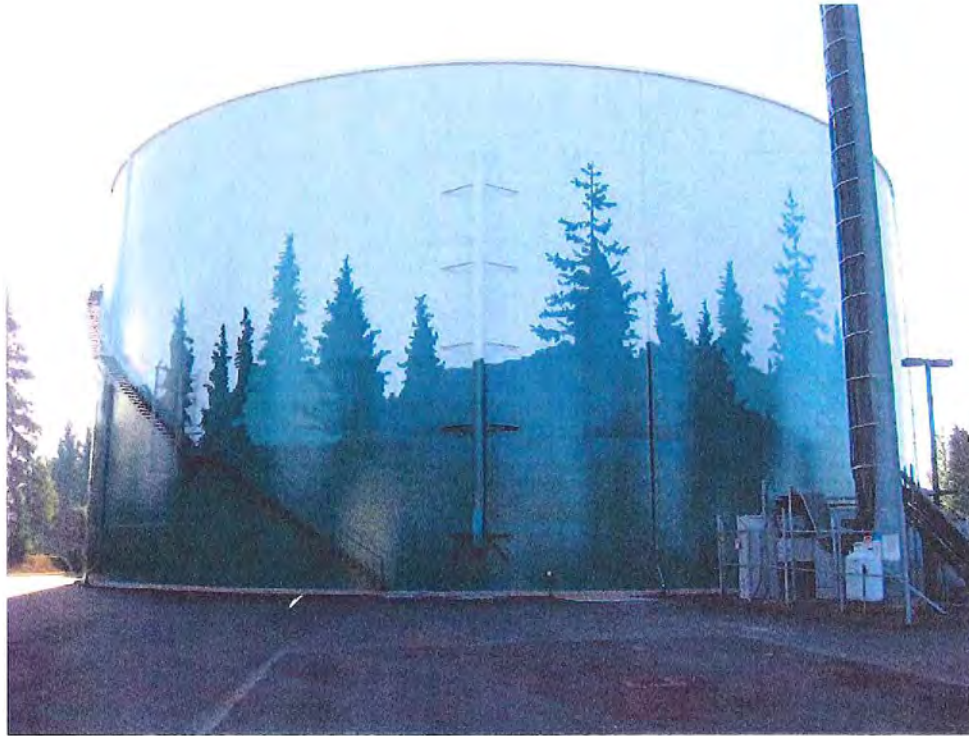
**FIGURE 37**  
Reservoir with Spiral Access Stairway

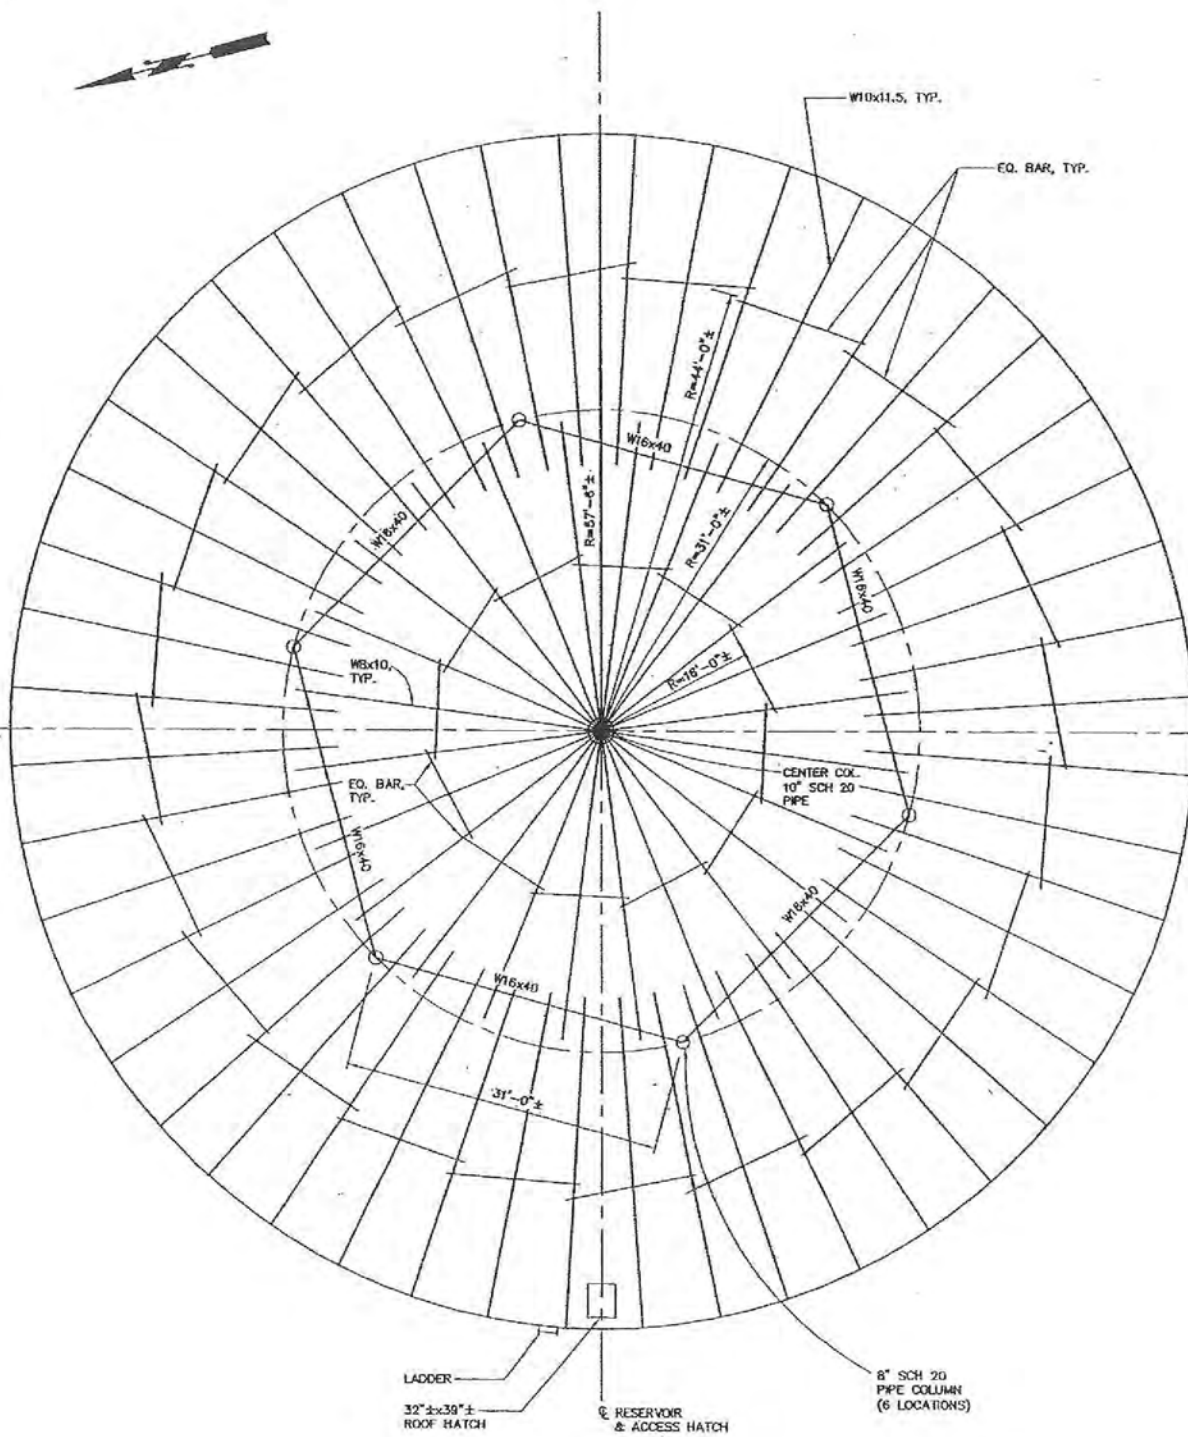
**FIGURE 38 - EXISTING ROOF FRAMING PLAN**  
NOT TO SCALE
