# **ANACORTES PLANNING COMMISSION**

**PUBLIC HEARING:** The City of Anacortes' Public Works Department has applied for a Conditional Use Permit, Variance request, & SEPA environmental review to permit the construction of two 1.5 million gallon water tanks /reservoirs on the subject property. The existing 47 foot tall 3 million gallon water tank/reservoir located onsite will be removed. The Variance request is to increase the maximum permitted height of 35 feet to approximately 50 feet above grade for the two new reservoirs. Subject parcels involved are: P33173 & P33044. Per AMC 17.04.070(E), the subject applications are being reviewed via an integrated and consolidated permit review process. The source of the funding for the subject proposal is from the State of Washington's Department of Health Drinking Water State Revolving Fund Loans in the amount of approximately \$4,974,755

## Blue Heron Circle 3MG Reservoir Replacement Project

## 3 MG RESERVOIR AT 301 BLUE HERON CIRCLE INSPECTION, ANALYSIS, AND RECOMMENDATIONS REPORT

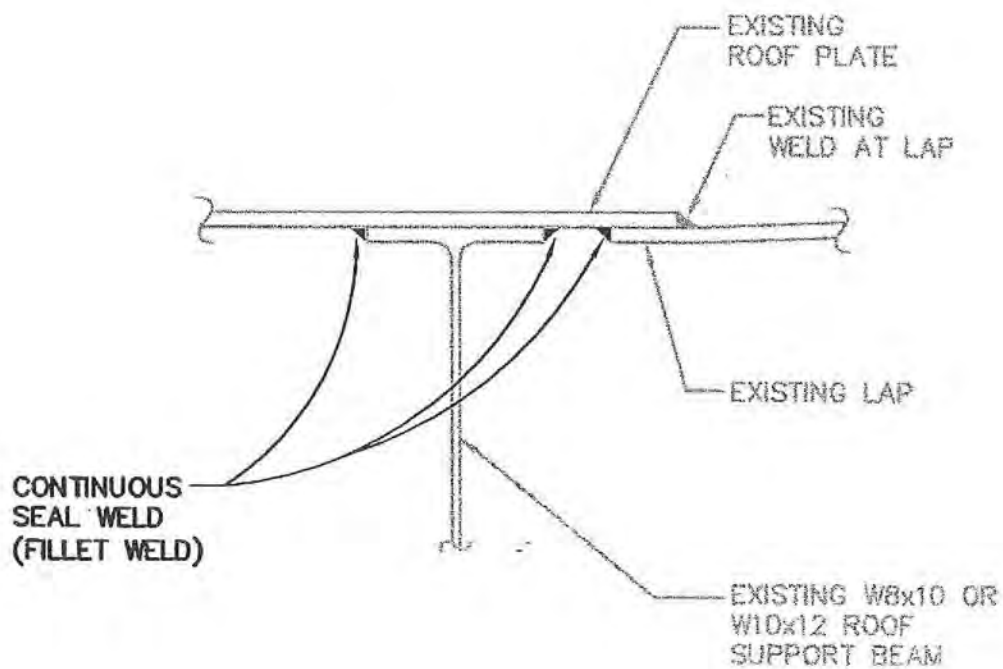
**FIGURE 39 - RECOMMENDED REPAIR**  
**AT TOP OF W8 & W10**  
**ROOF SUPPORT BEAMS (SECTION)**  
 NOT TO SCALE

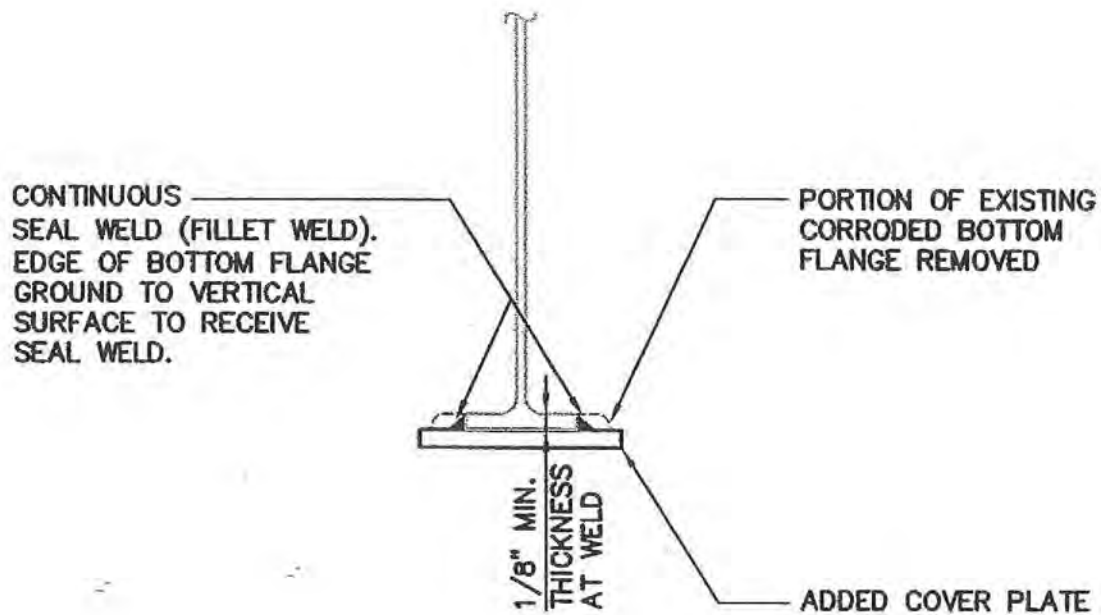
**FIGURE 40 - RECOMMENDED REPAIR  
AT BOTTOM FLANGE OF W10  
ROOF SUPPORT BEAMS (SECTION)**  
NOT TO SCALE

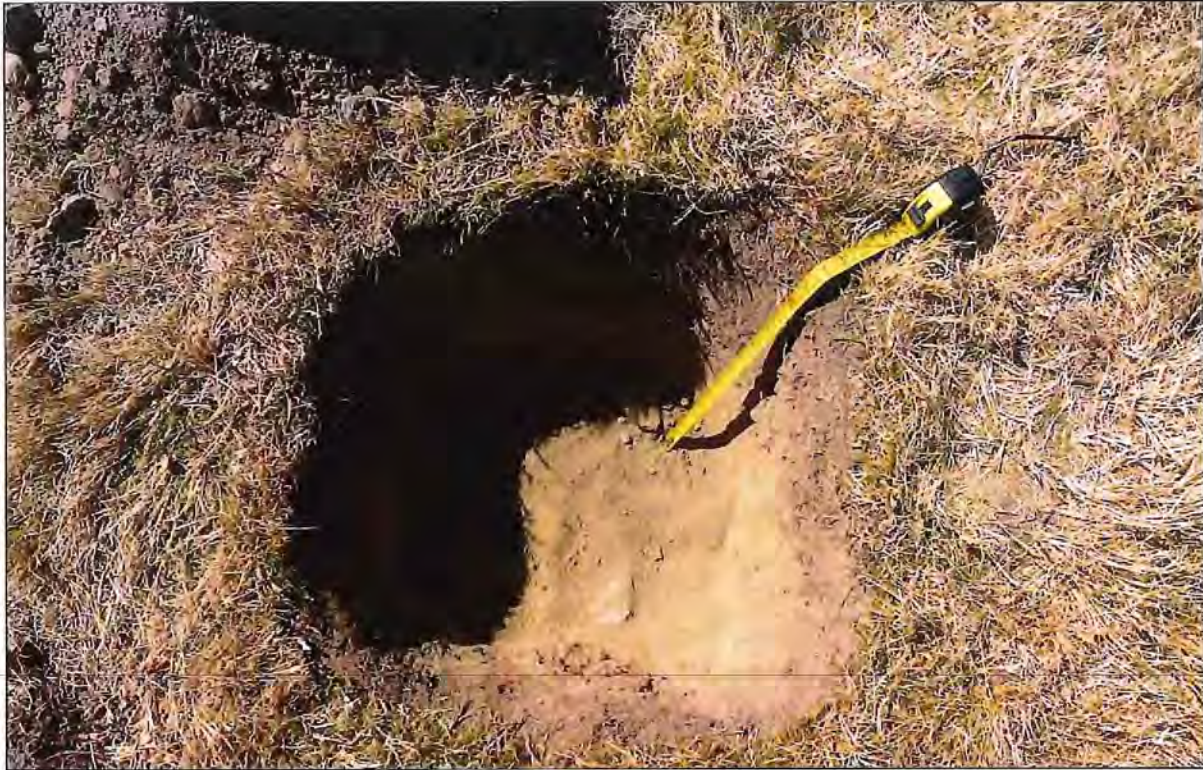
**Photo 3. Overview of SP1 showing soils encountered within the project area.**

One SP, was excavated within the project area (Figure 3). Soils observed were consistent with the Keystone series previously mapped by the USDA NRCS (n.d.) and UCDavis SoilWeb (n.d.) (Photo 3) with slight variations occurring across the area. No cultural material was encountered in any of the SPs.

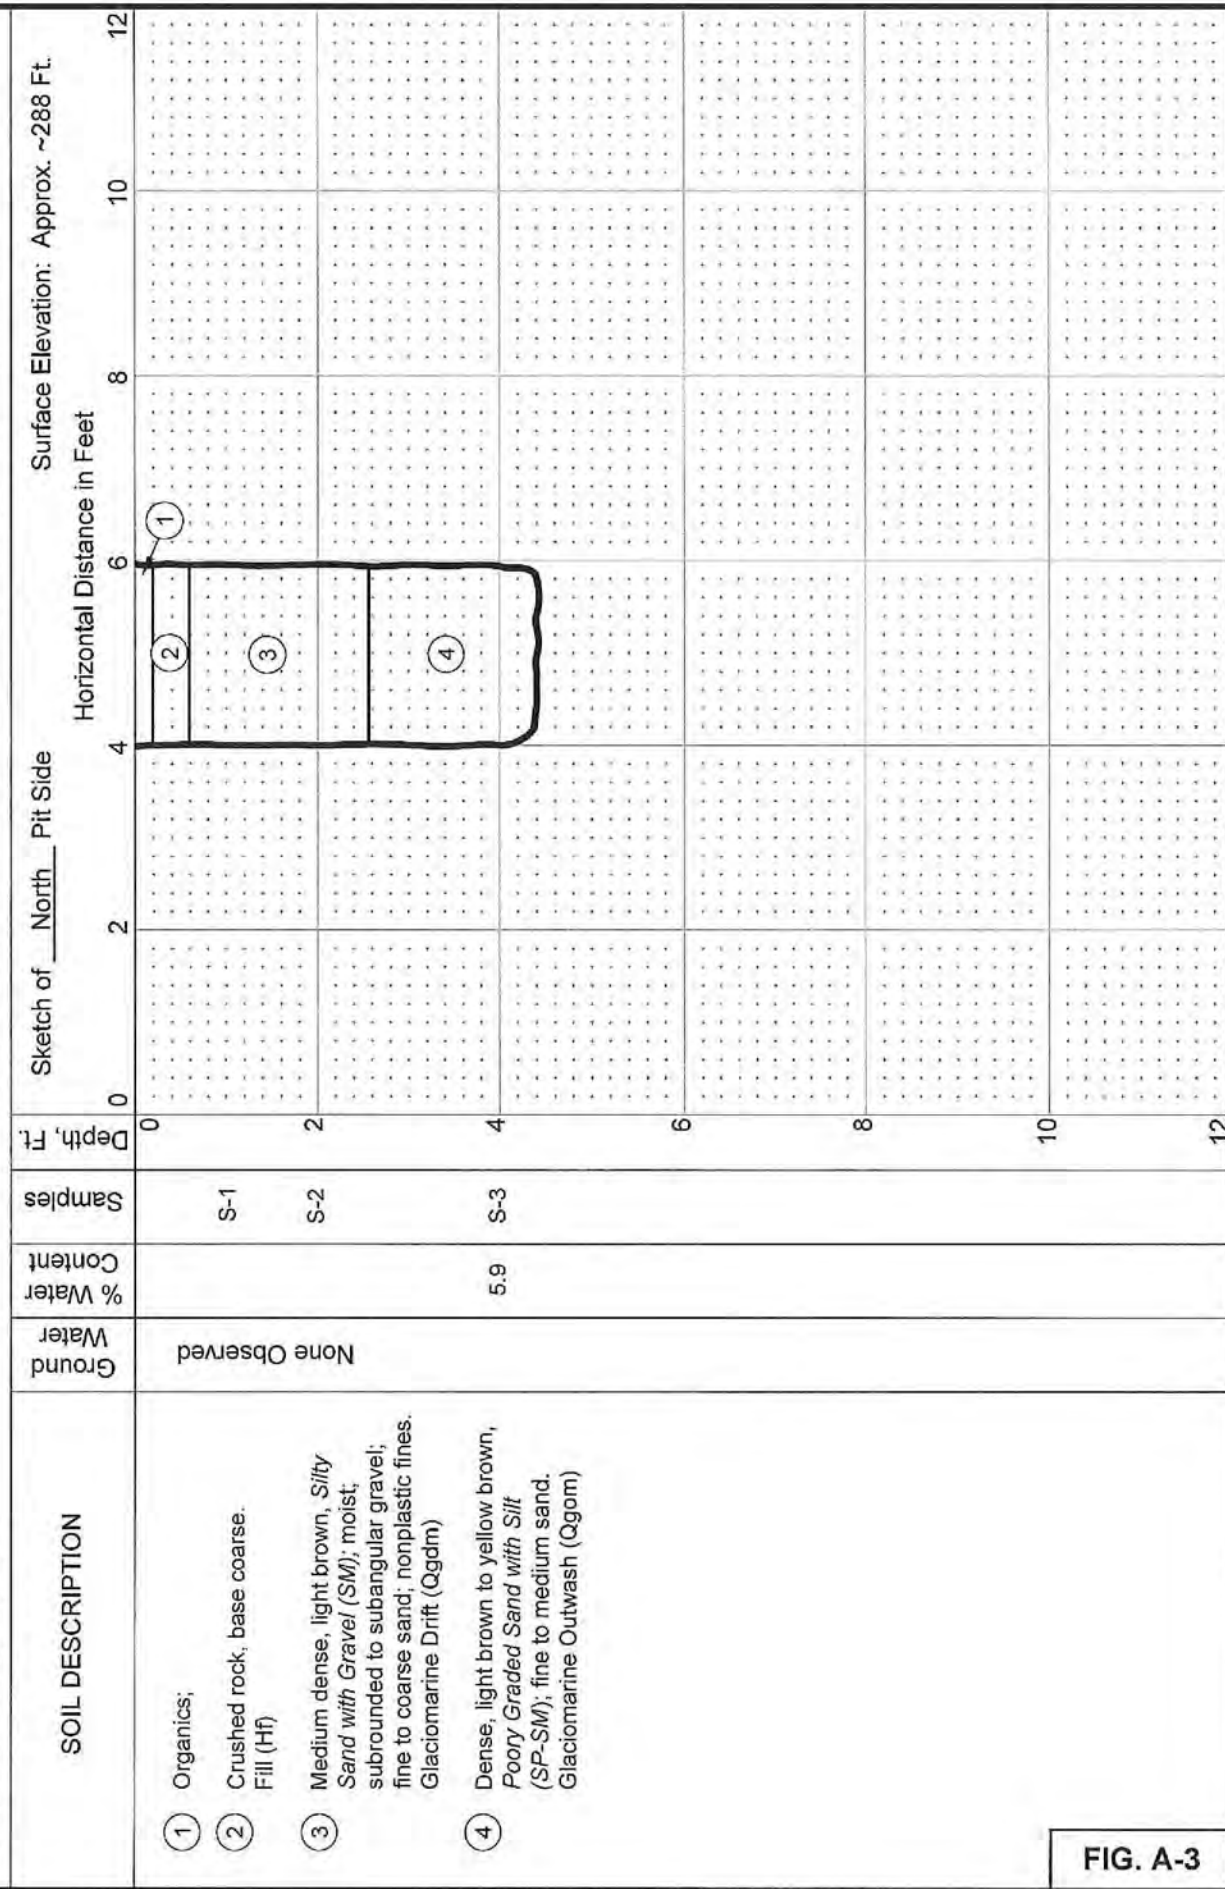
FIG. A-3

# LOG OF TEST PIT TP-1

JOB NO: 21-1-22259-001 DATE: 10-3-2016 LOCATION: See Site and Exploration Plan  
PROJECT: Anacortes Blue Heron Circle Reservoir, Anacortes, Washington

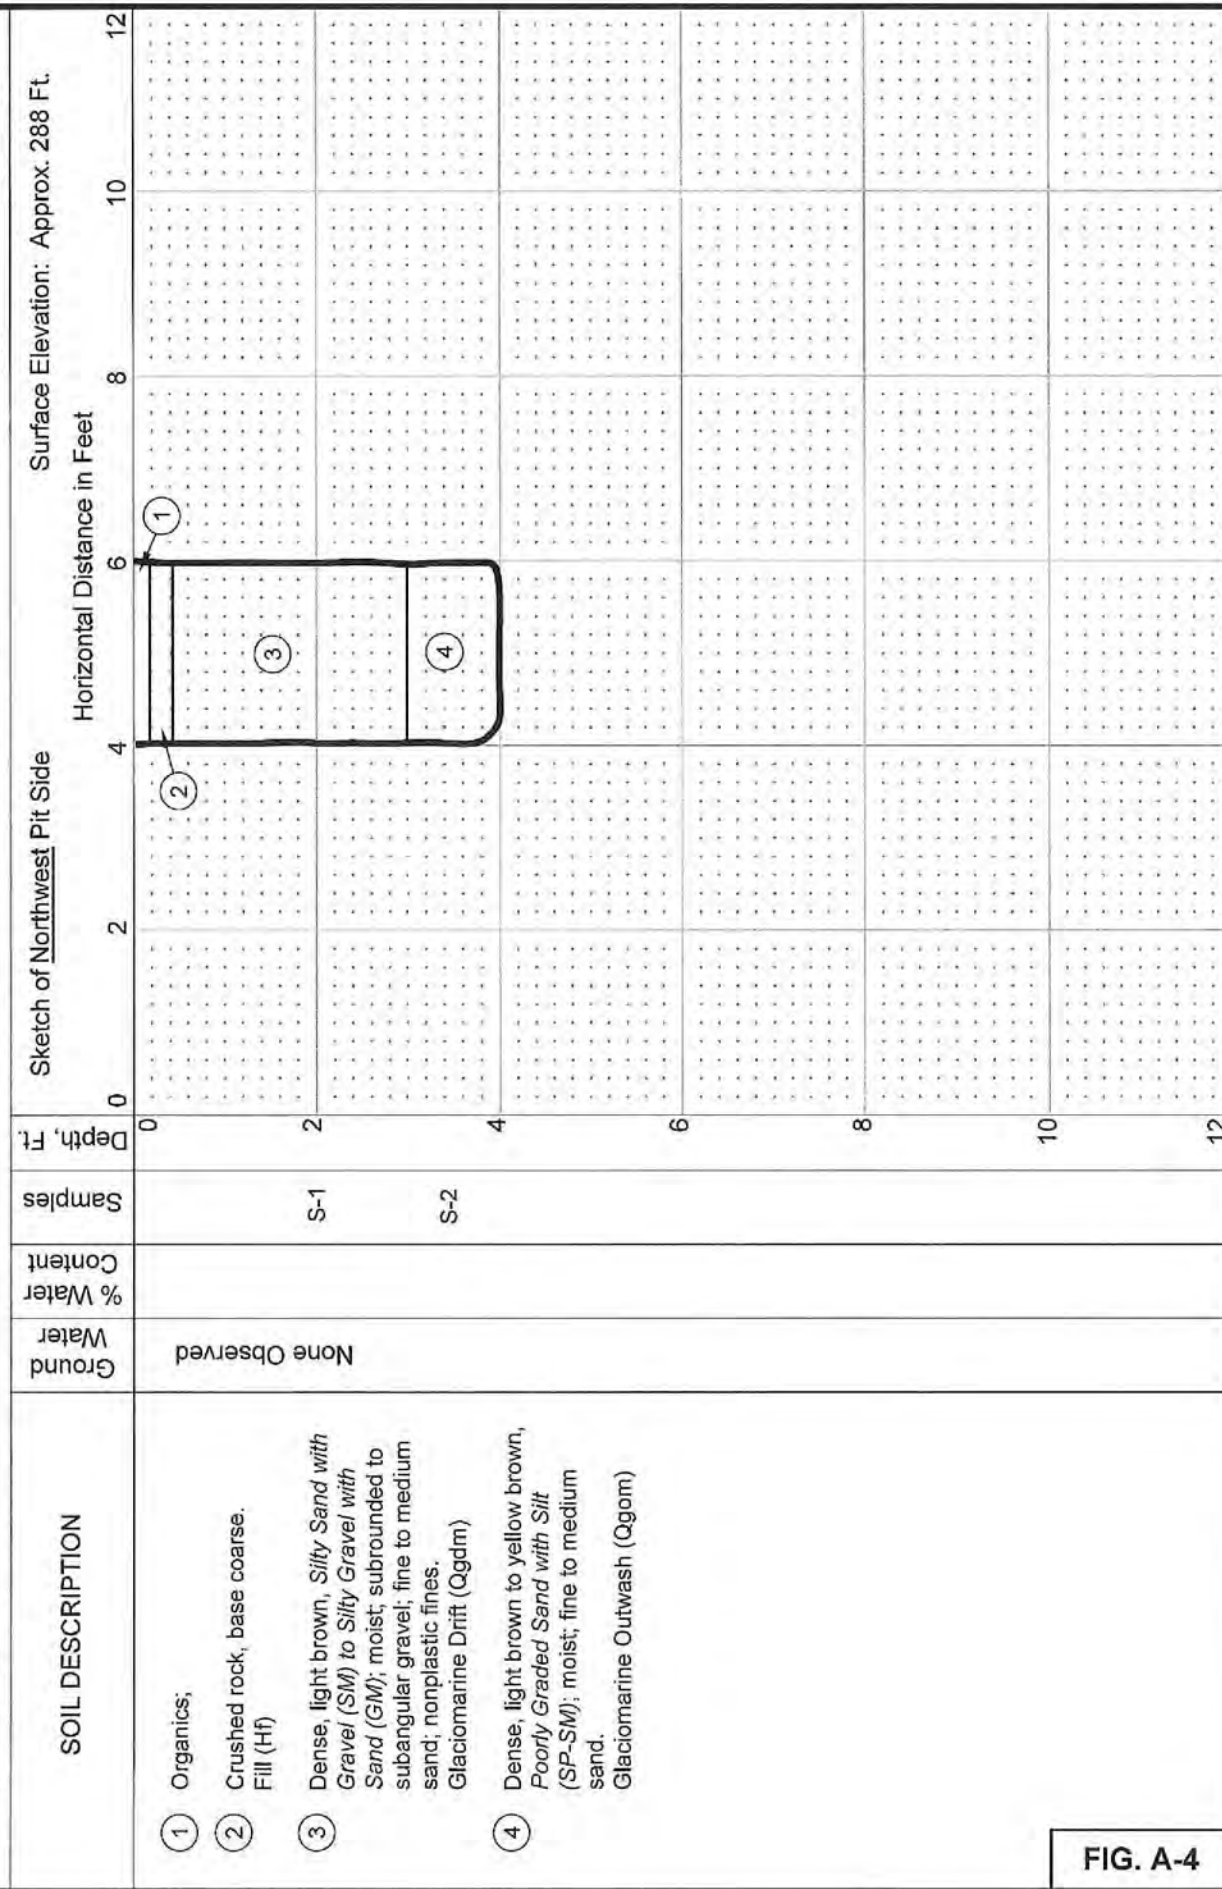
FIG. A-4

# LOG OF TEST PIT TP-2

JOB NO: 21-1-22259-001 DATE: 10-3-2016 LOCATION: See Site and Exploration Plan  
PROJECT: Anacortes Blue Heron Circle Reservoir, Anacortes, Washington

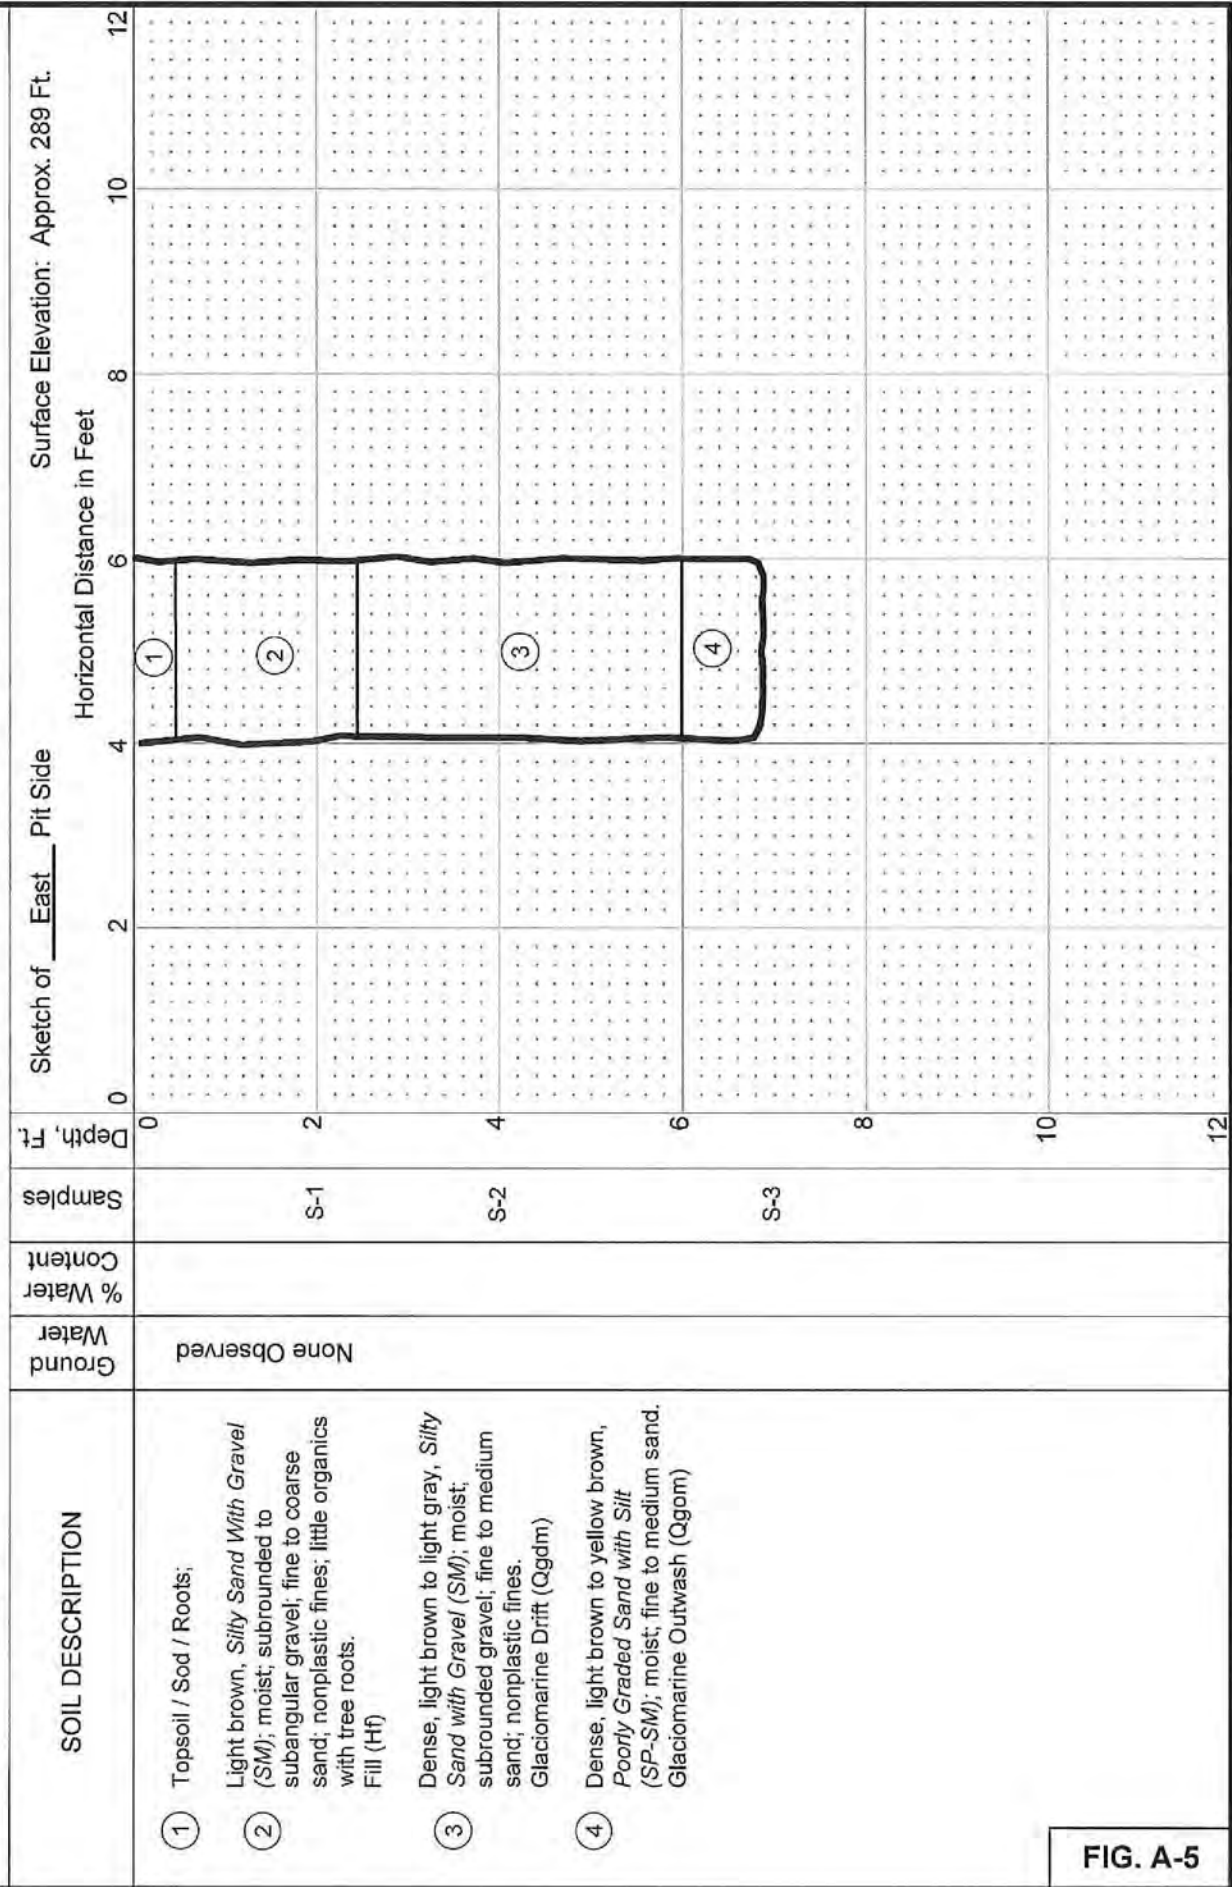
**FIG. A-5**

**SHANNON & WILSON, INC.**  
 GEOTECHNICAL AND ENVIRONMENTAL CONSULTANTS  
**LOG OF TEST PIT TP-3**

JOB NO: 21-1-22259-001 DATE: 10-3-2016 LOCATION: See Site and Exploration Plan  
 PROJECT: Anacortes Blue Heron Circle Reservoir, Anacortes, Washington
