## ANACORTES PLANNING COMMISSION

**May 24, 2023**

### **AGENDA**

- A. Roll Call**
- B. Minutes**
  - 1) Minutes of May 8, 2023
- C. Correspondence**
- D. New Business**
  - 1) Appoint new vice chair.
  - 2) Open Record Public Hearing and Decision for Shoreline Substantial Development Permit SDP-2023-0002 Port of Anacortes 2nd Street and Curtis Wharf project.
- E. Old Business**

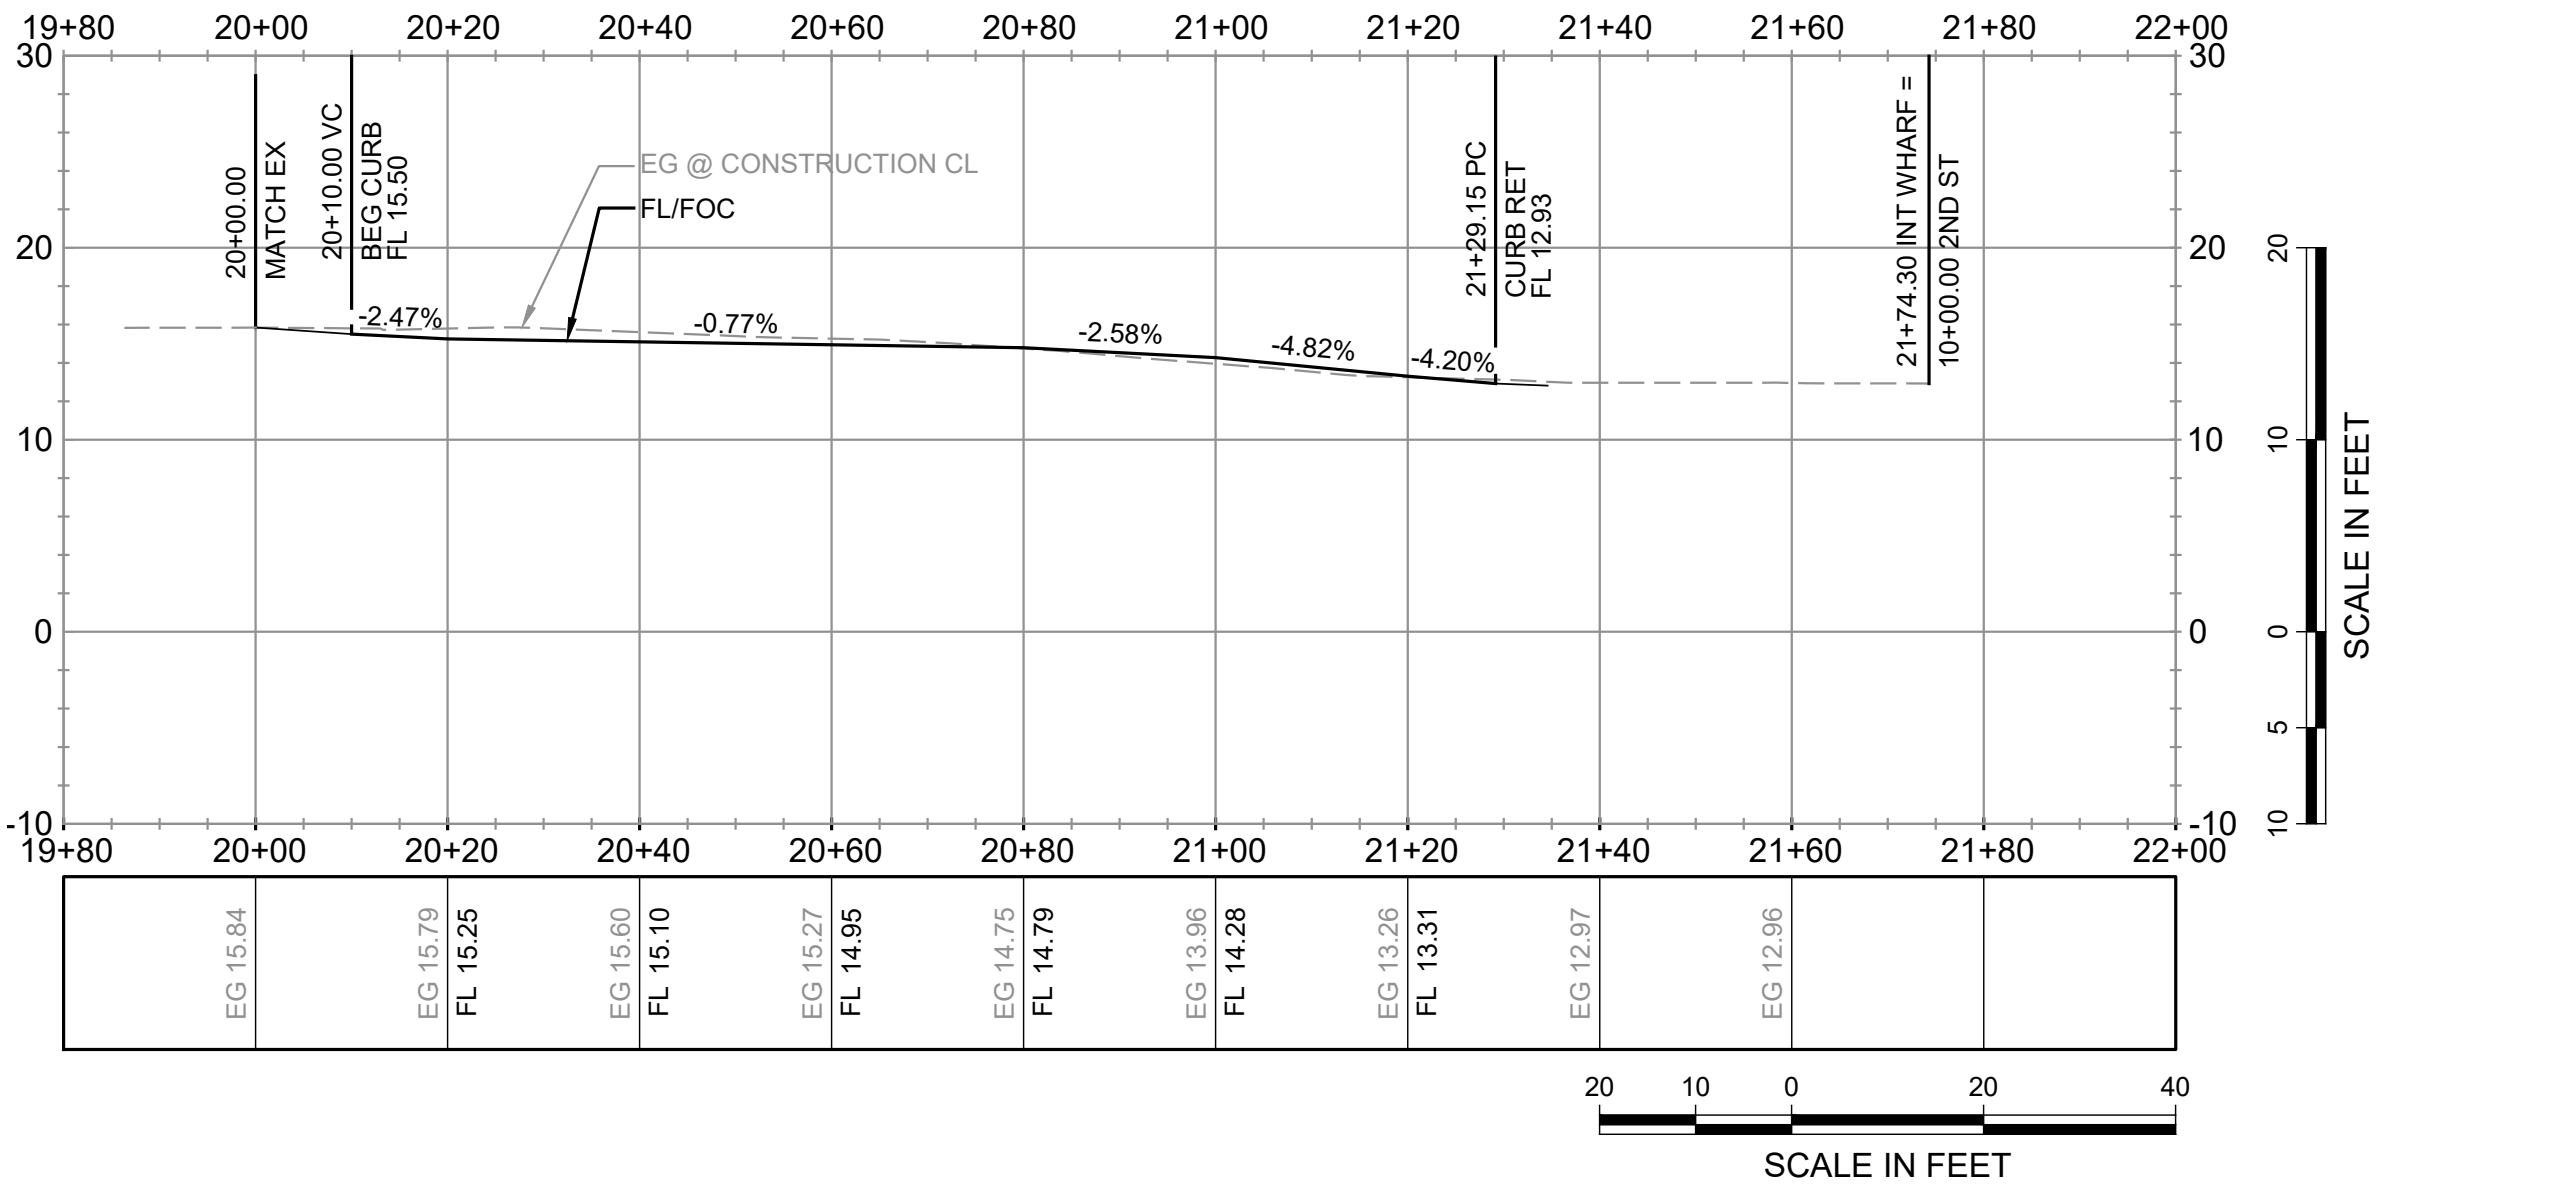
PROPOSED WHARF PROFILE  
SCALE AS SHOWN

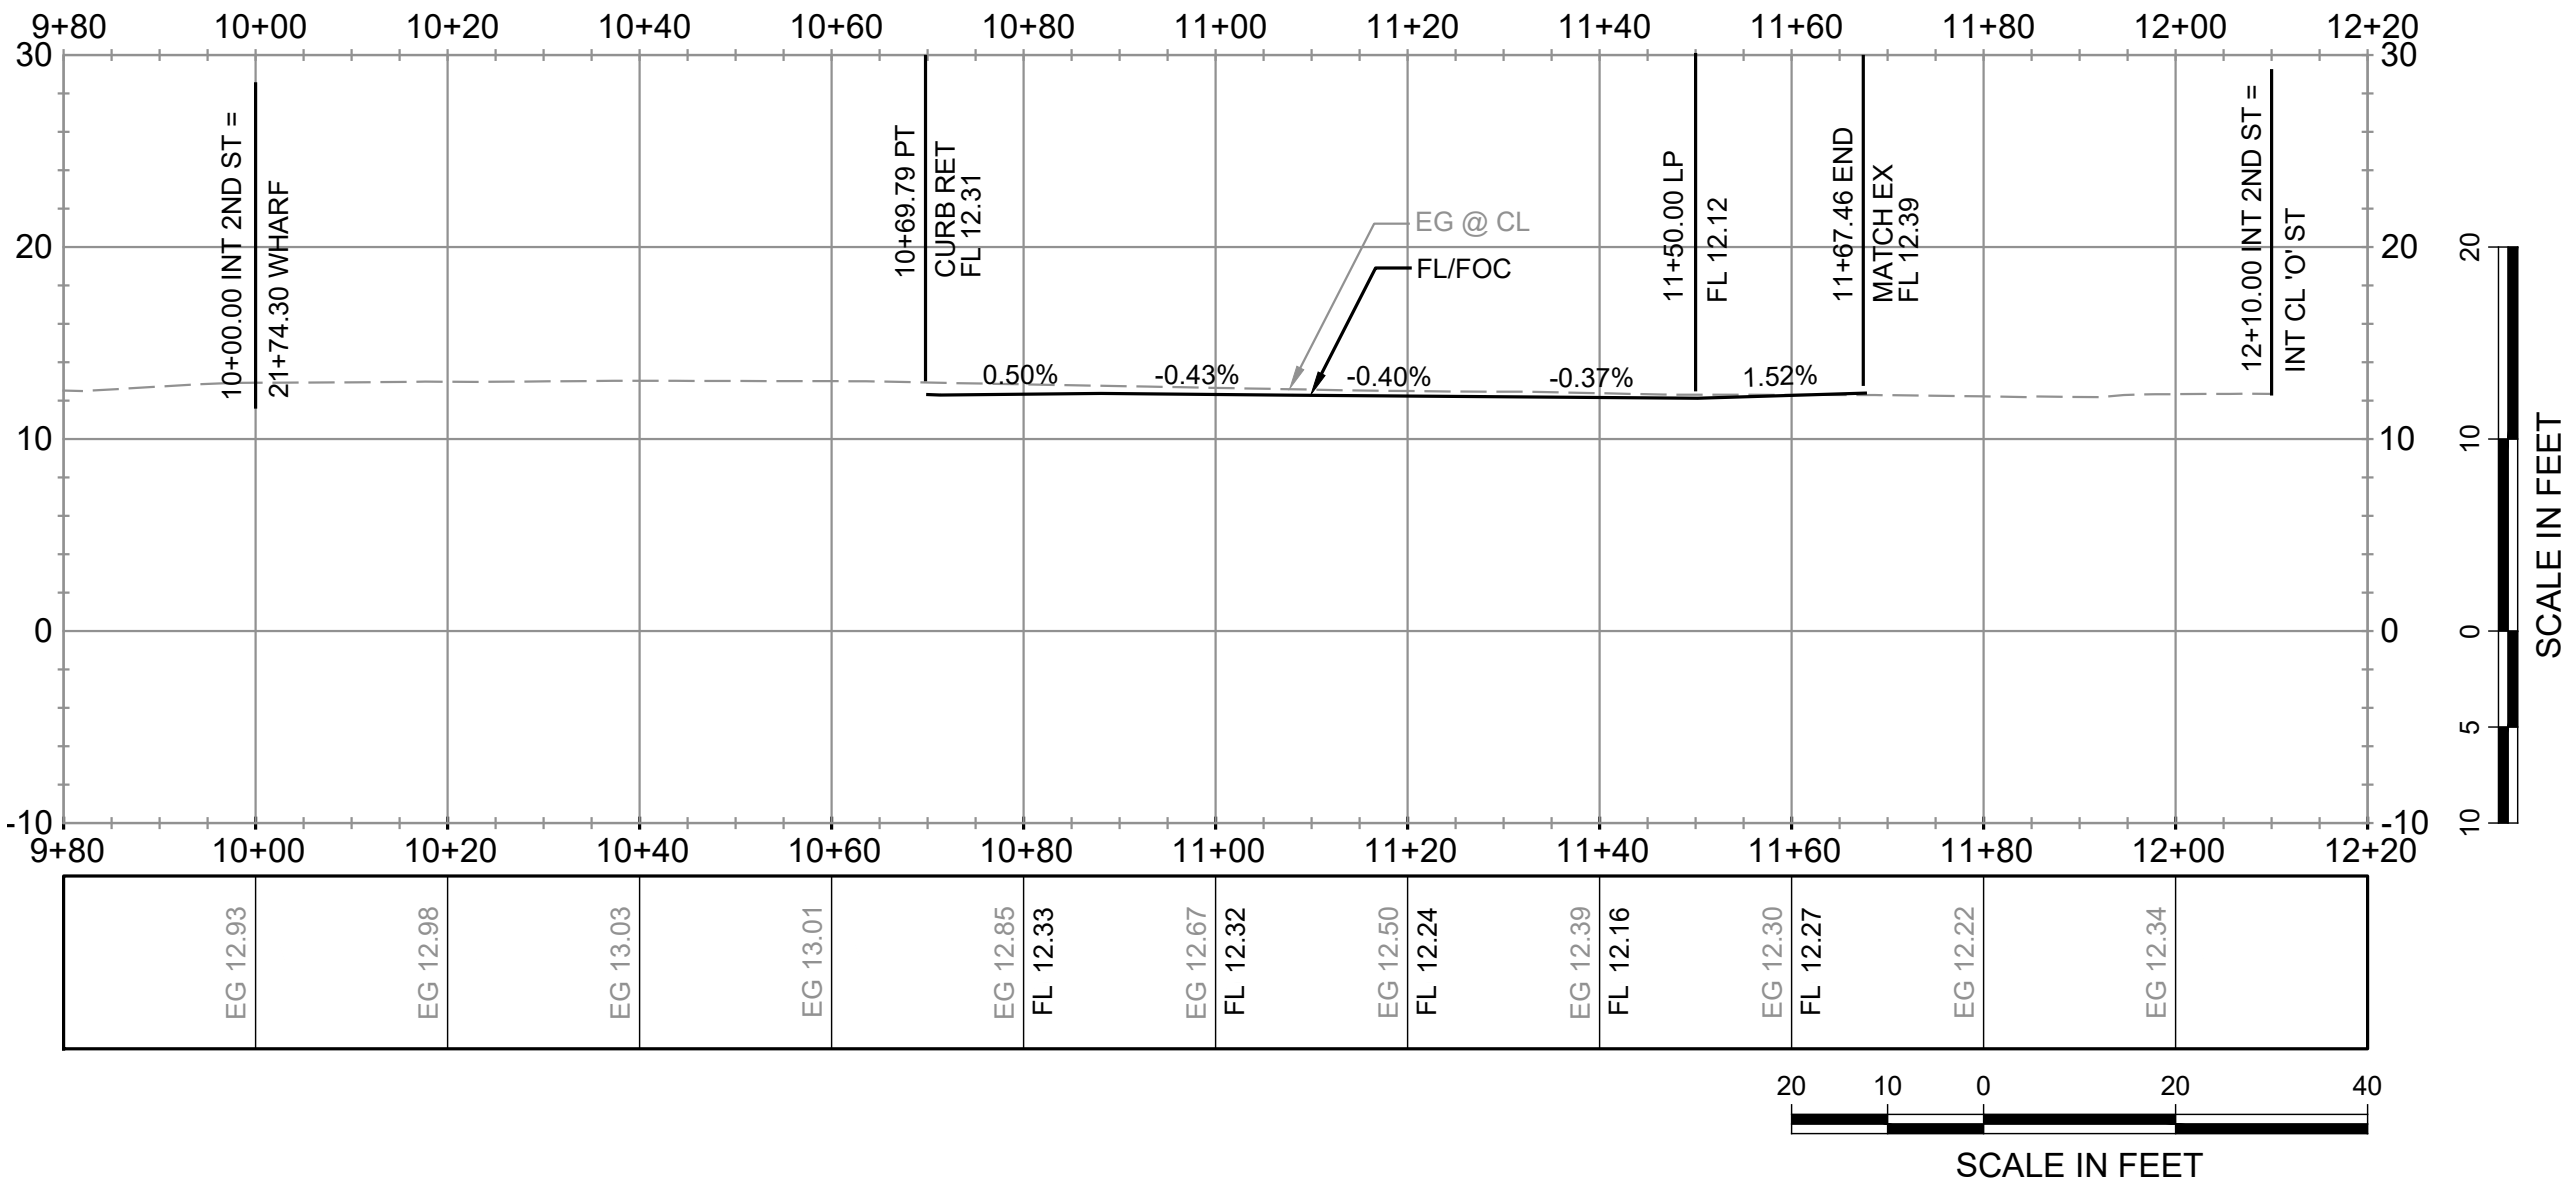
PROPOSED 2ND ST PROFILE  
SCALE AS SHOWN

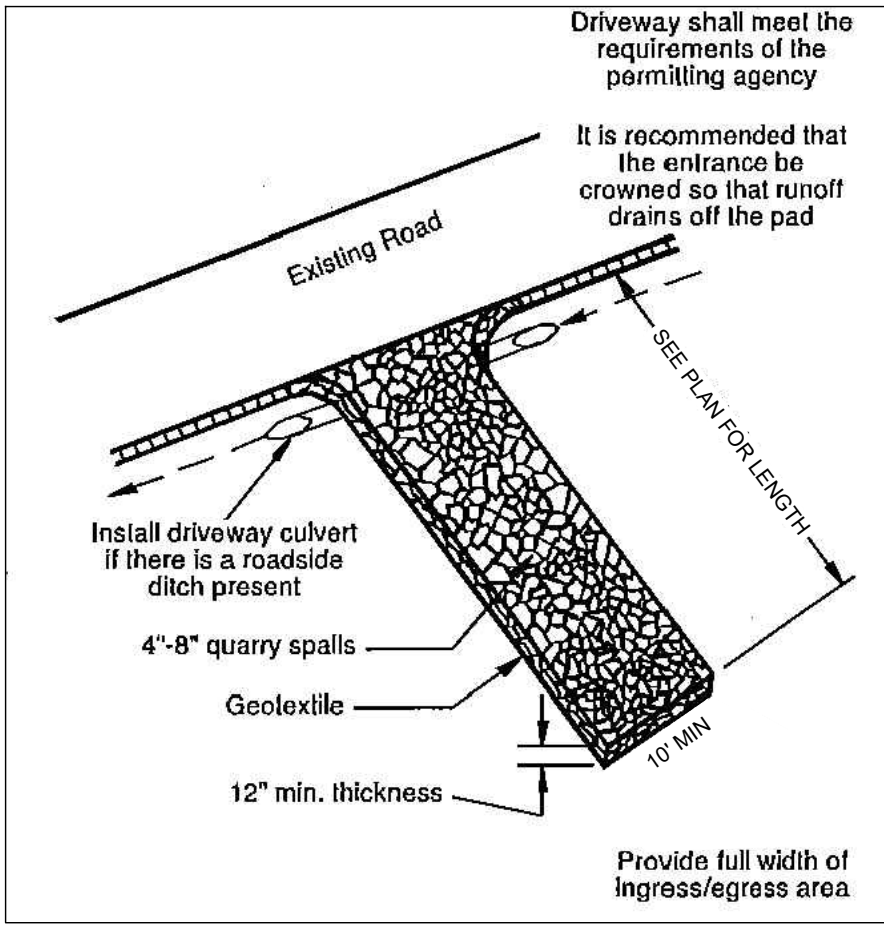
A  
C03

STABILIZED CONSTRUCTION ENTRANCE  
PER D.O.E. FIG. 4.2  
NOT TO SCALE

STABILIZED CONSTRUCTION ENTRANCE  
PER D.O.E. FIG. 4.2  
NOT TO SCALE

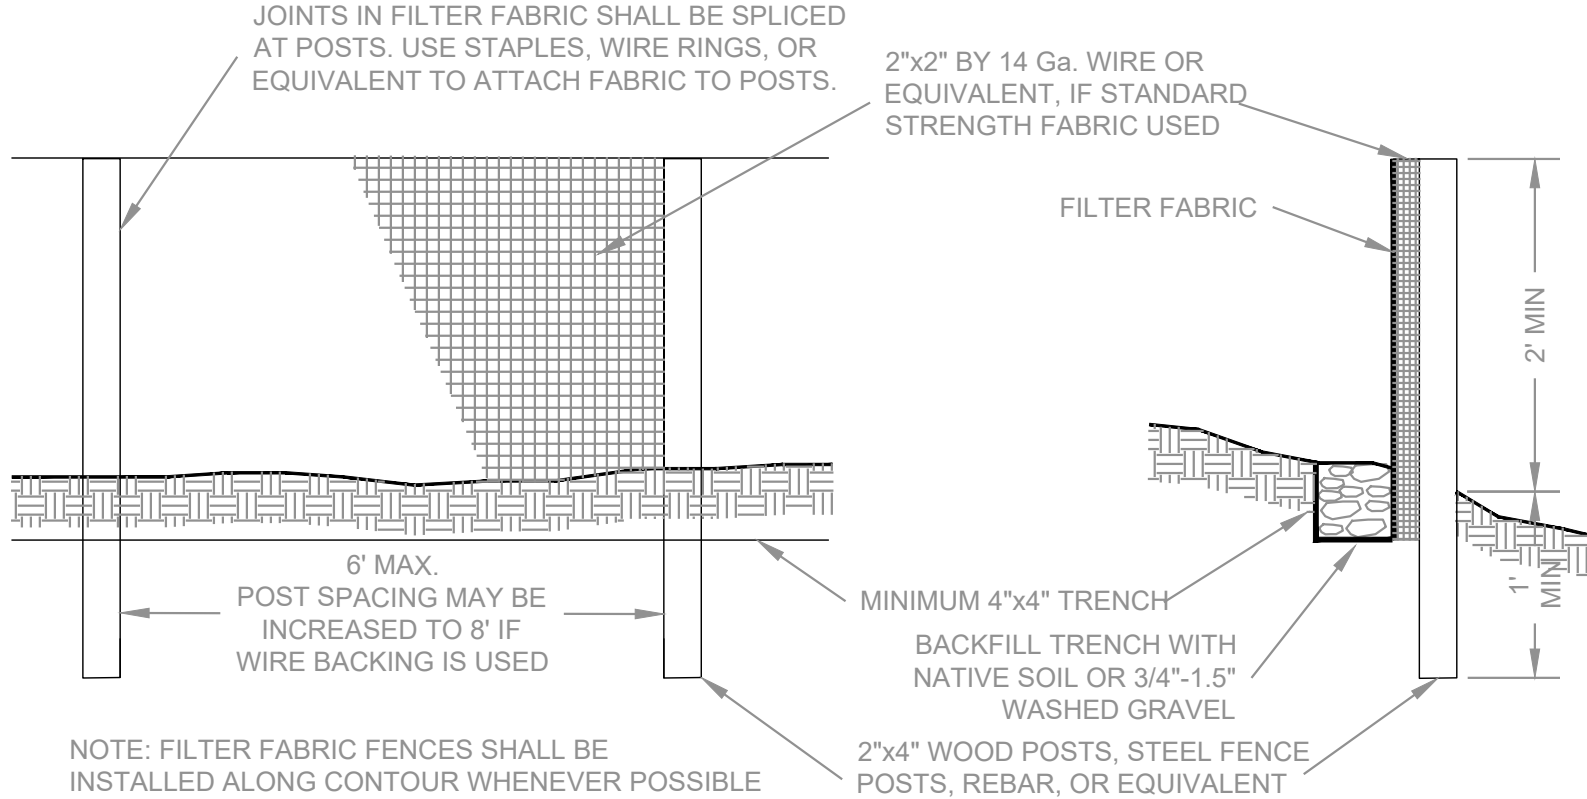
B  
C03

FILTER FABRIC SILT FENCE  
PER D.O.E. FIG. 4.20  
NOT TO SCALE

FILTER FABRIC SILT FENCE  
PER D.O.E. FIG. 4.20  
NOT TO SCALE

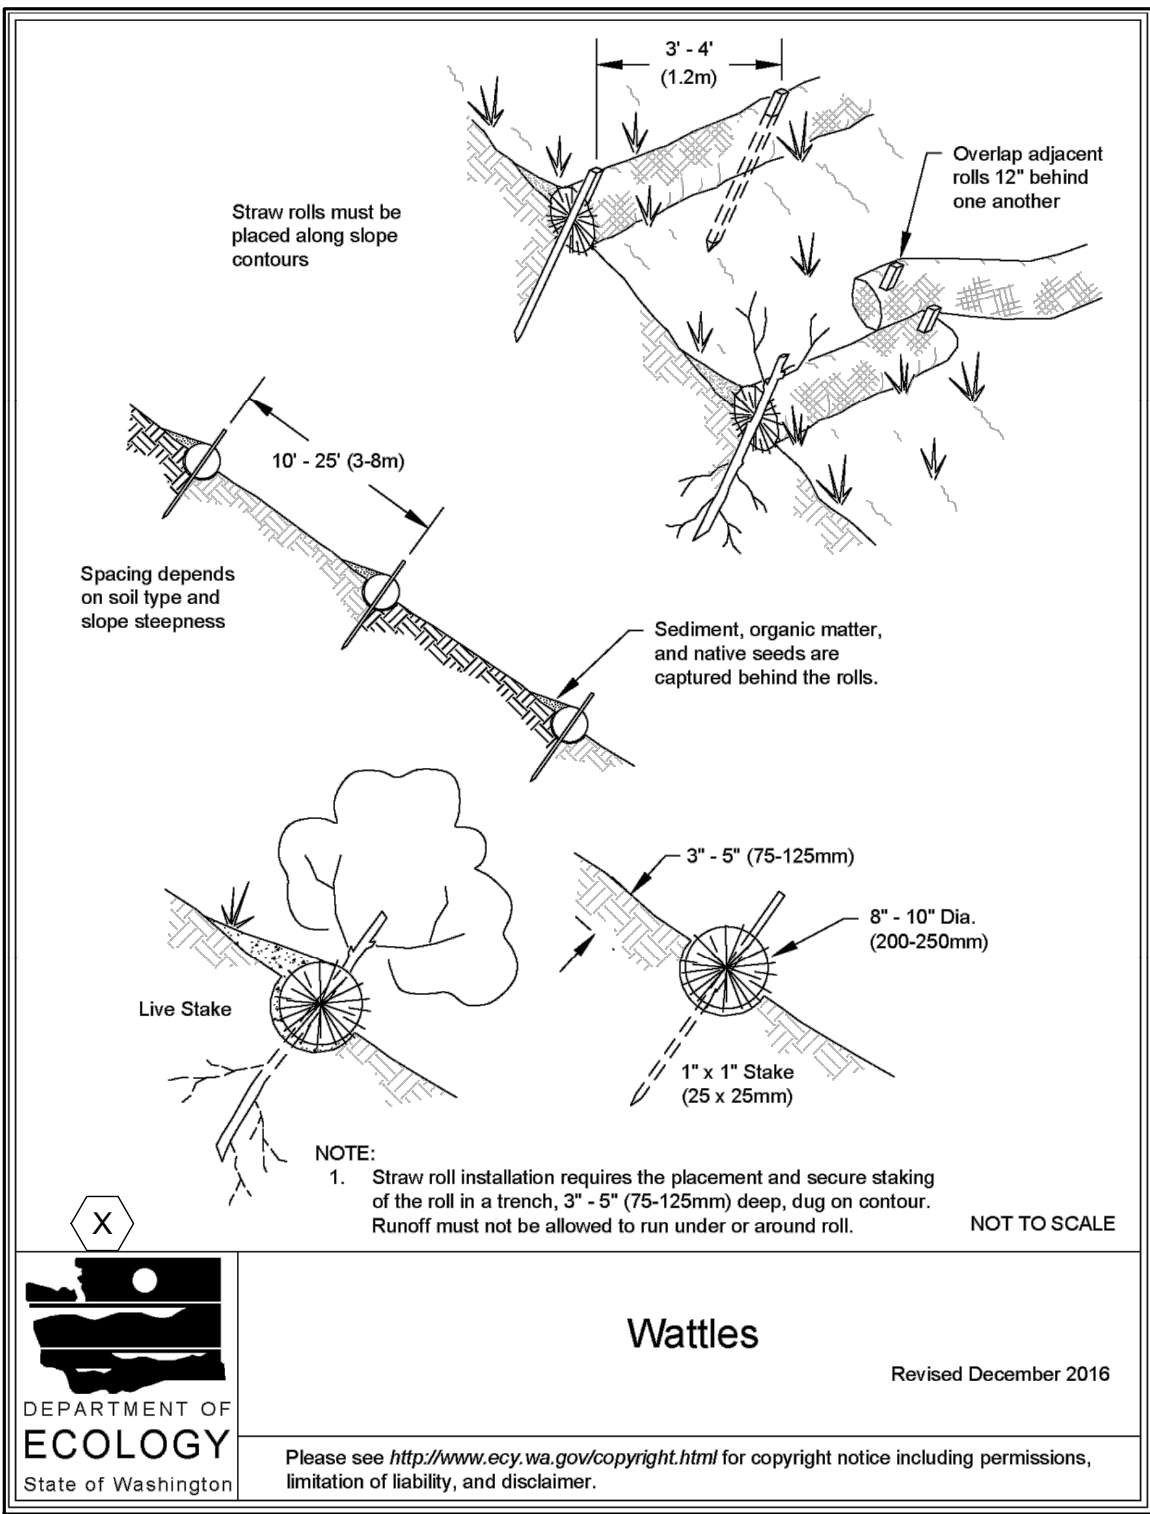
C  
C03

STRAW WATTLES  
PER D.O.E. FIG. 3.24  
NOT TO SCALE

STRAW WATTLES  
PER D.O.E. FIG. 3.24  
NOT TO SCALE

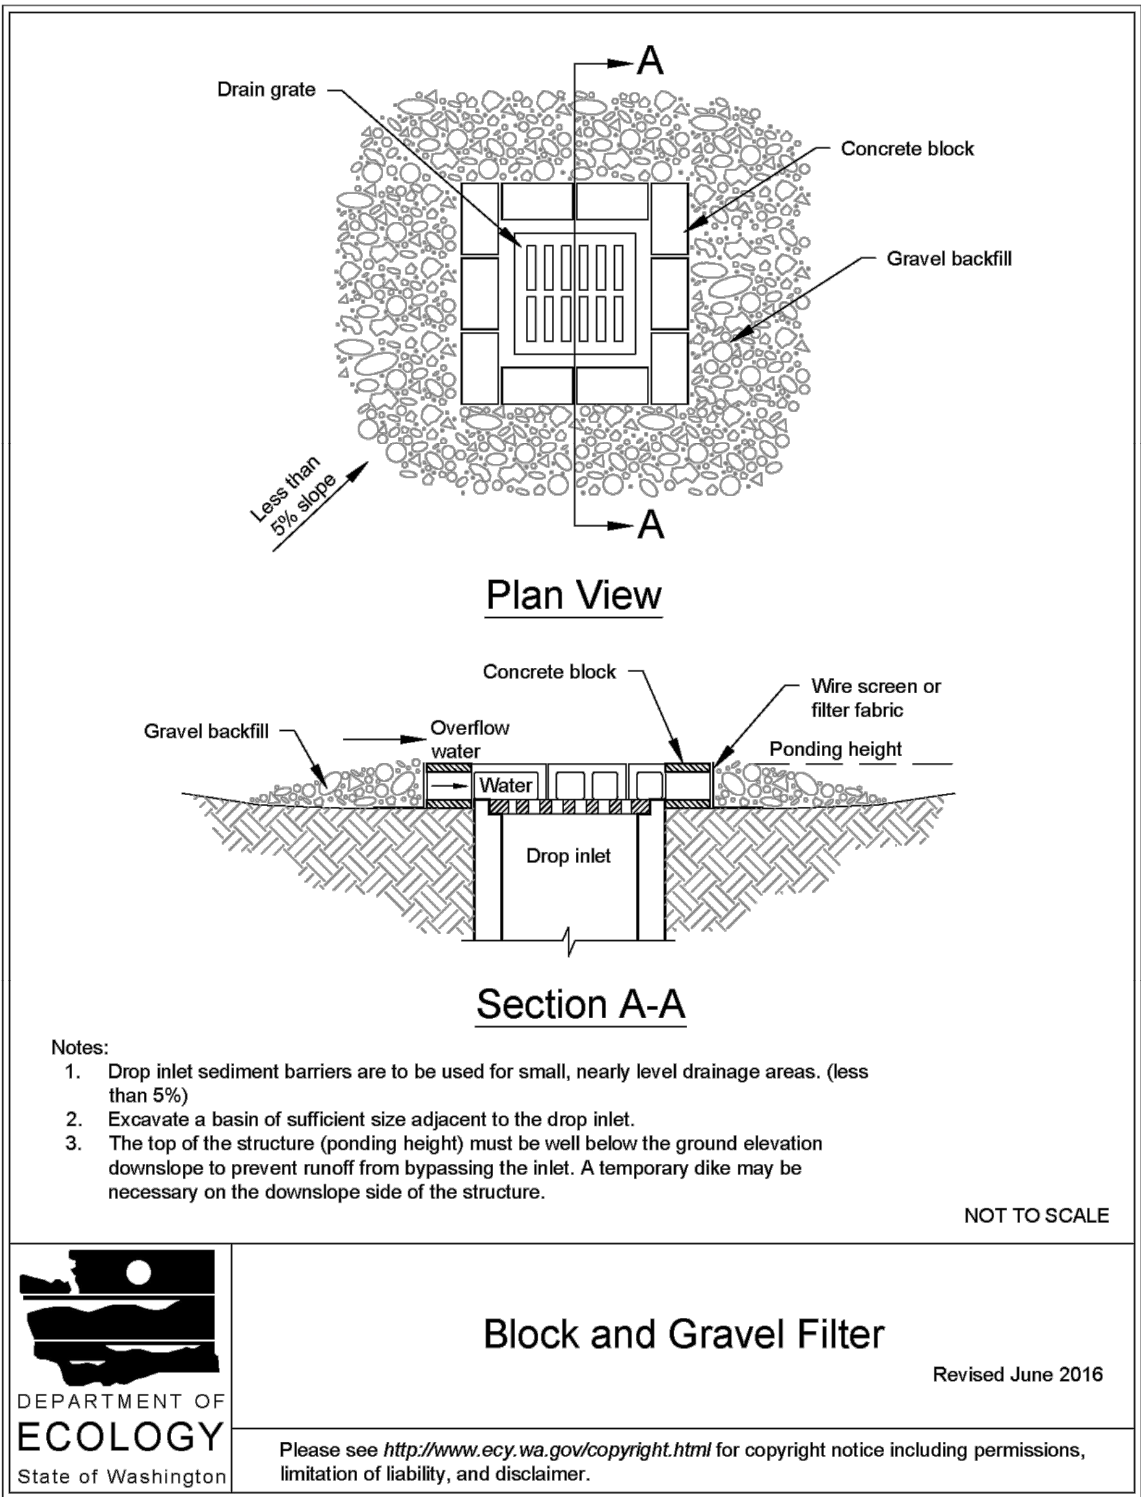
D  
C03

TEMPORARY INLET PROTECTION DETAIL  
PER 2019 D.O.E. FIG. V2.3 PG 359  
NOT TO SCALE

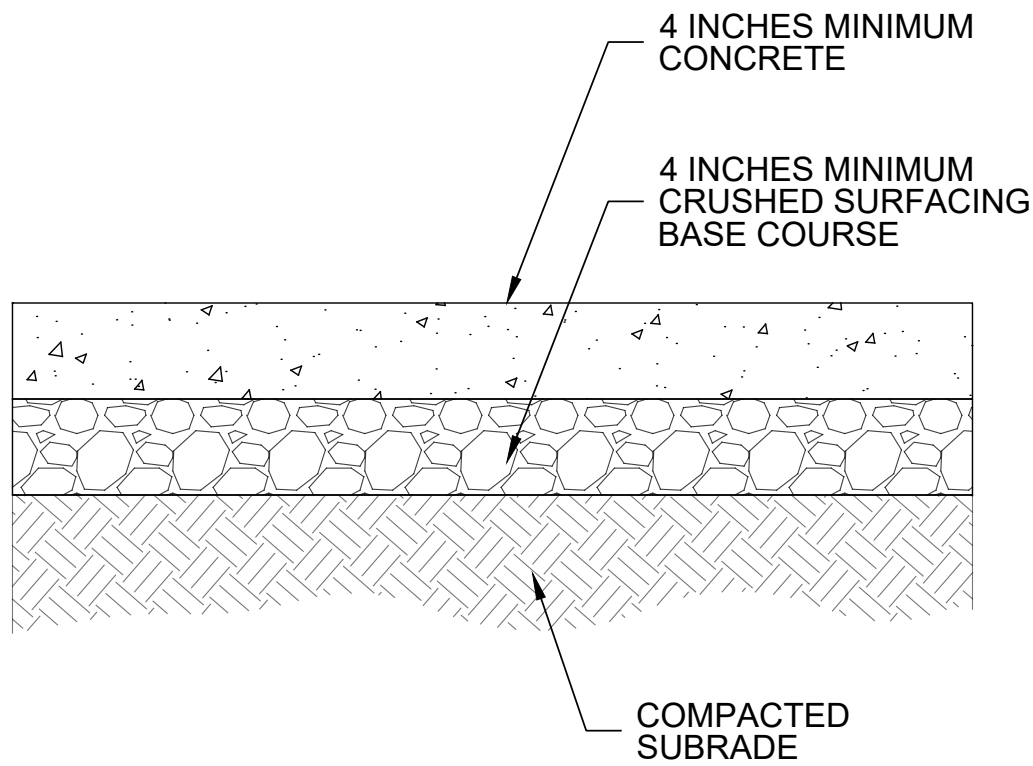
E  
C4

CONCRETE TYPICAL SECTION  
NTS

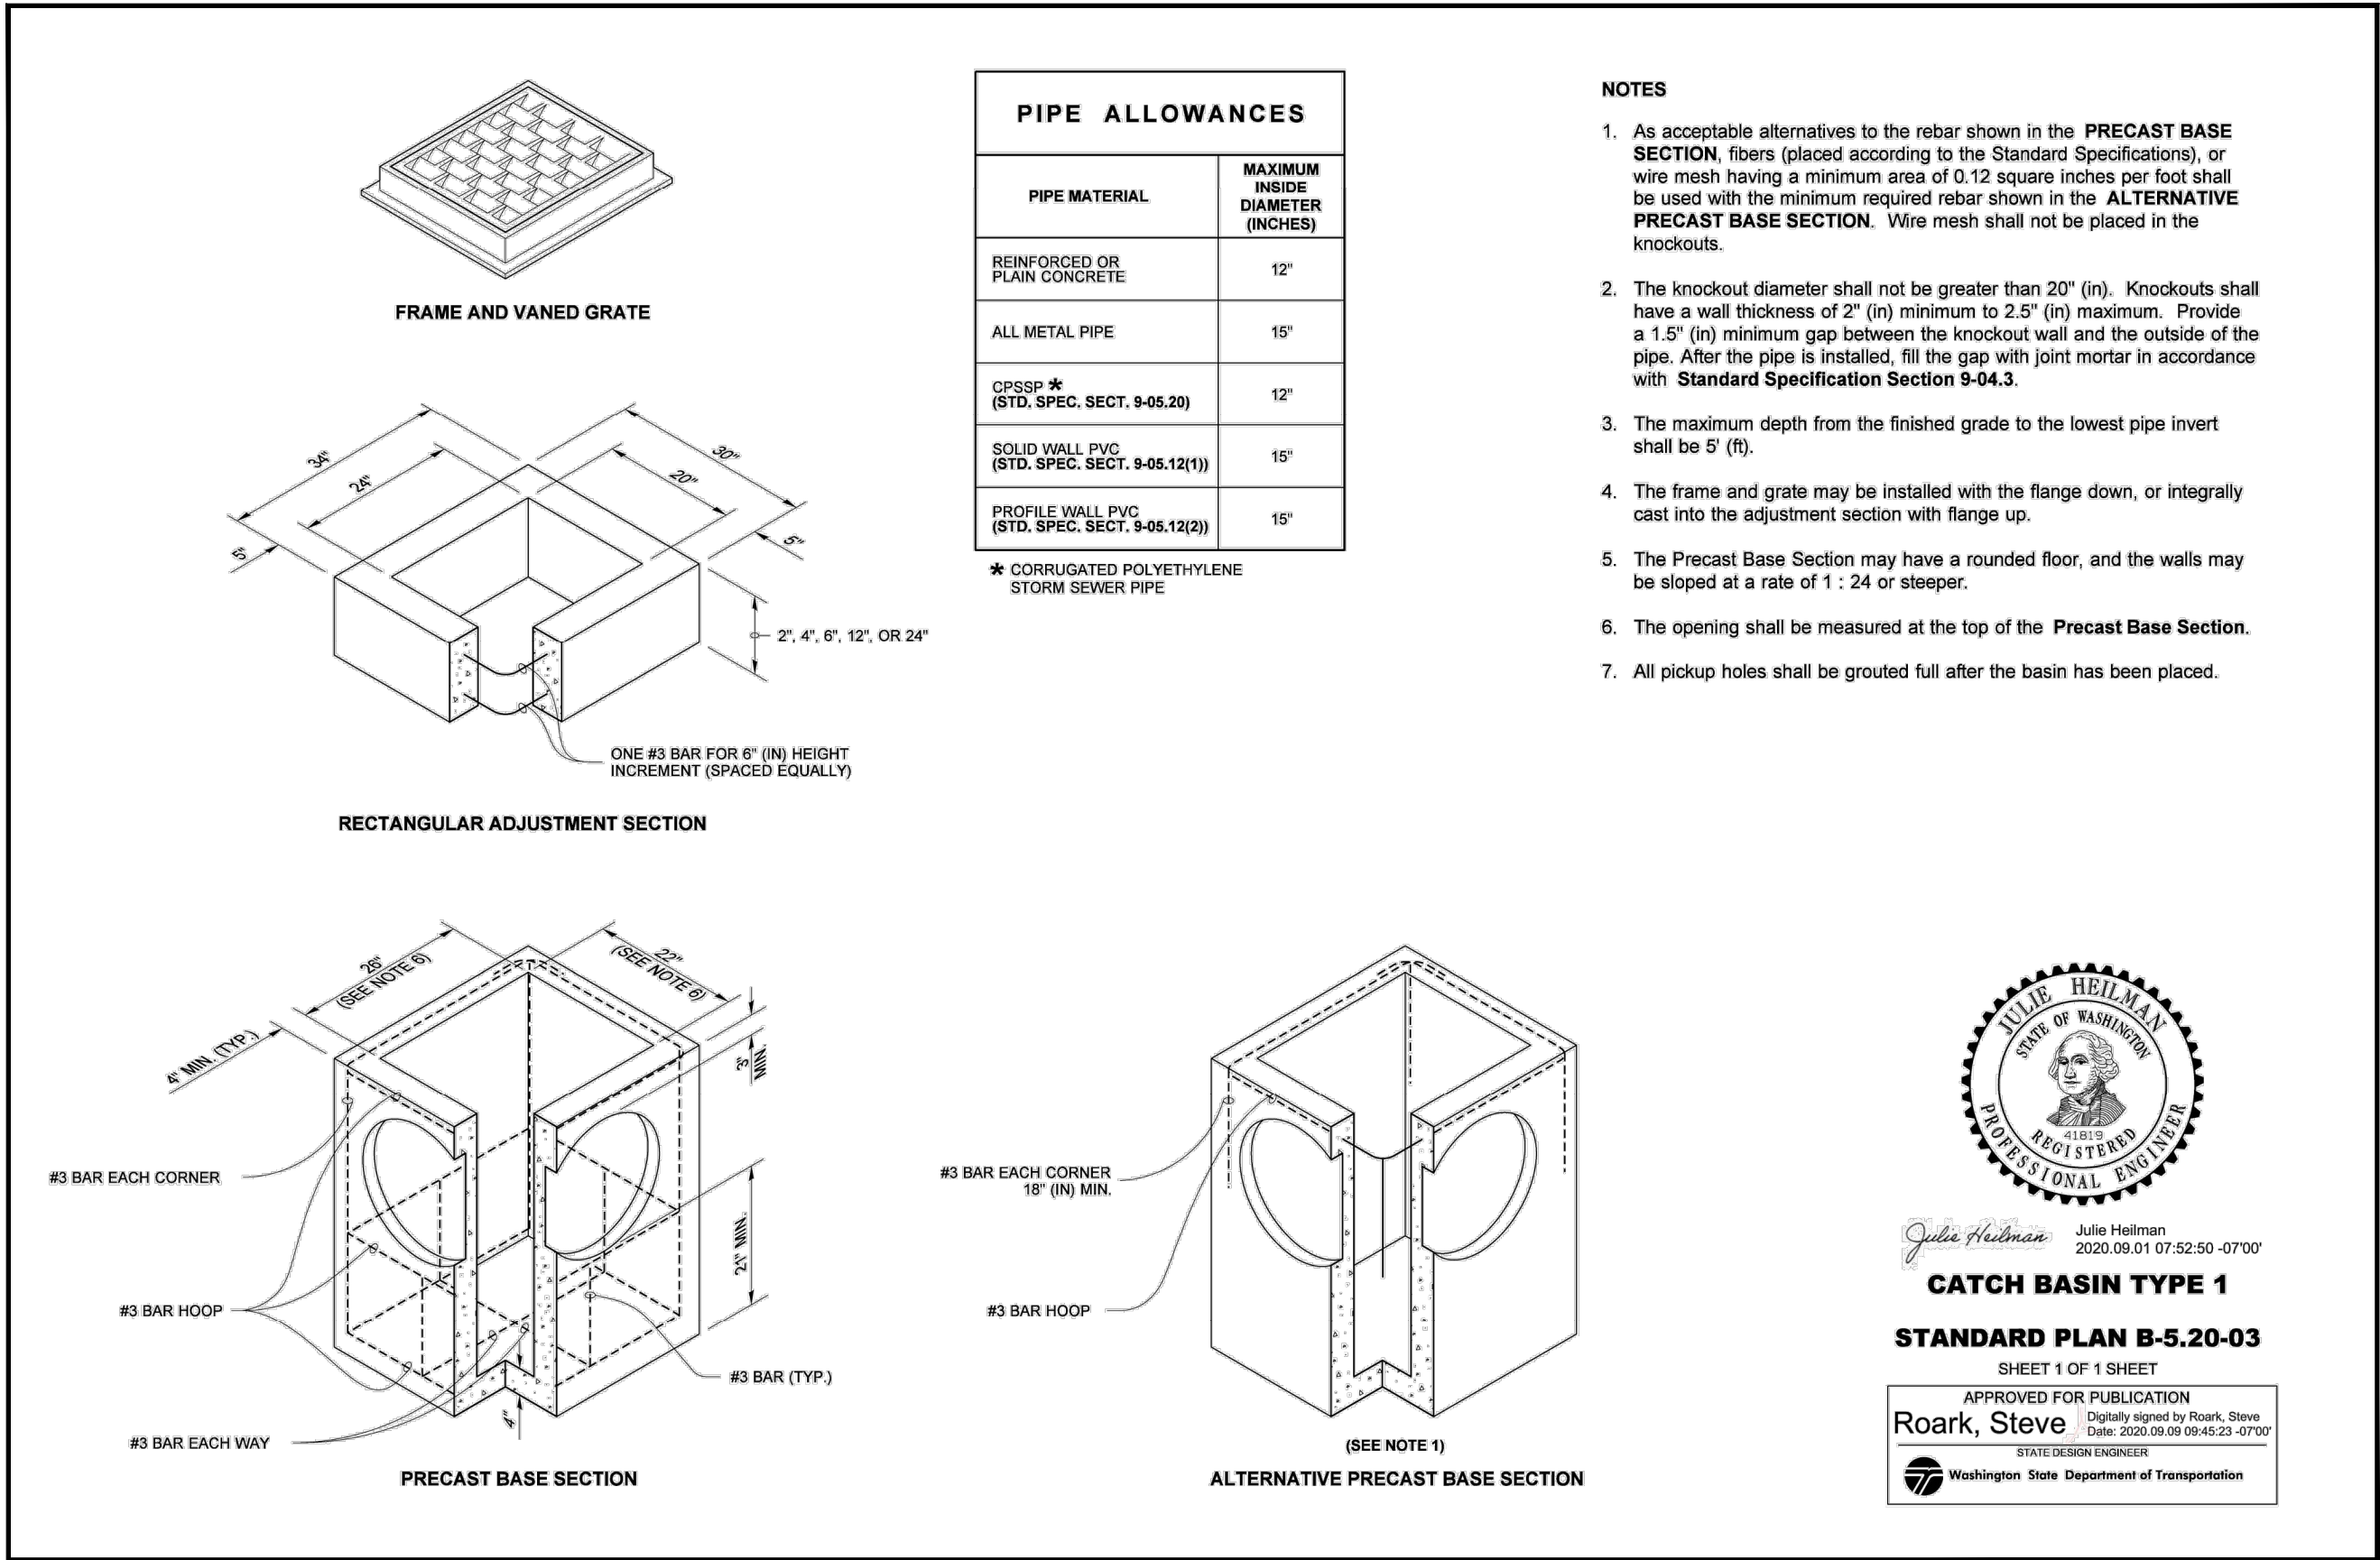
F  
C05

CB TYPE 1 W/ GRATE DETAIL  
WSDOT STD PLAN B-5.20-03  
NOT TO SCALE

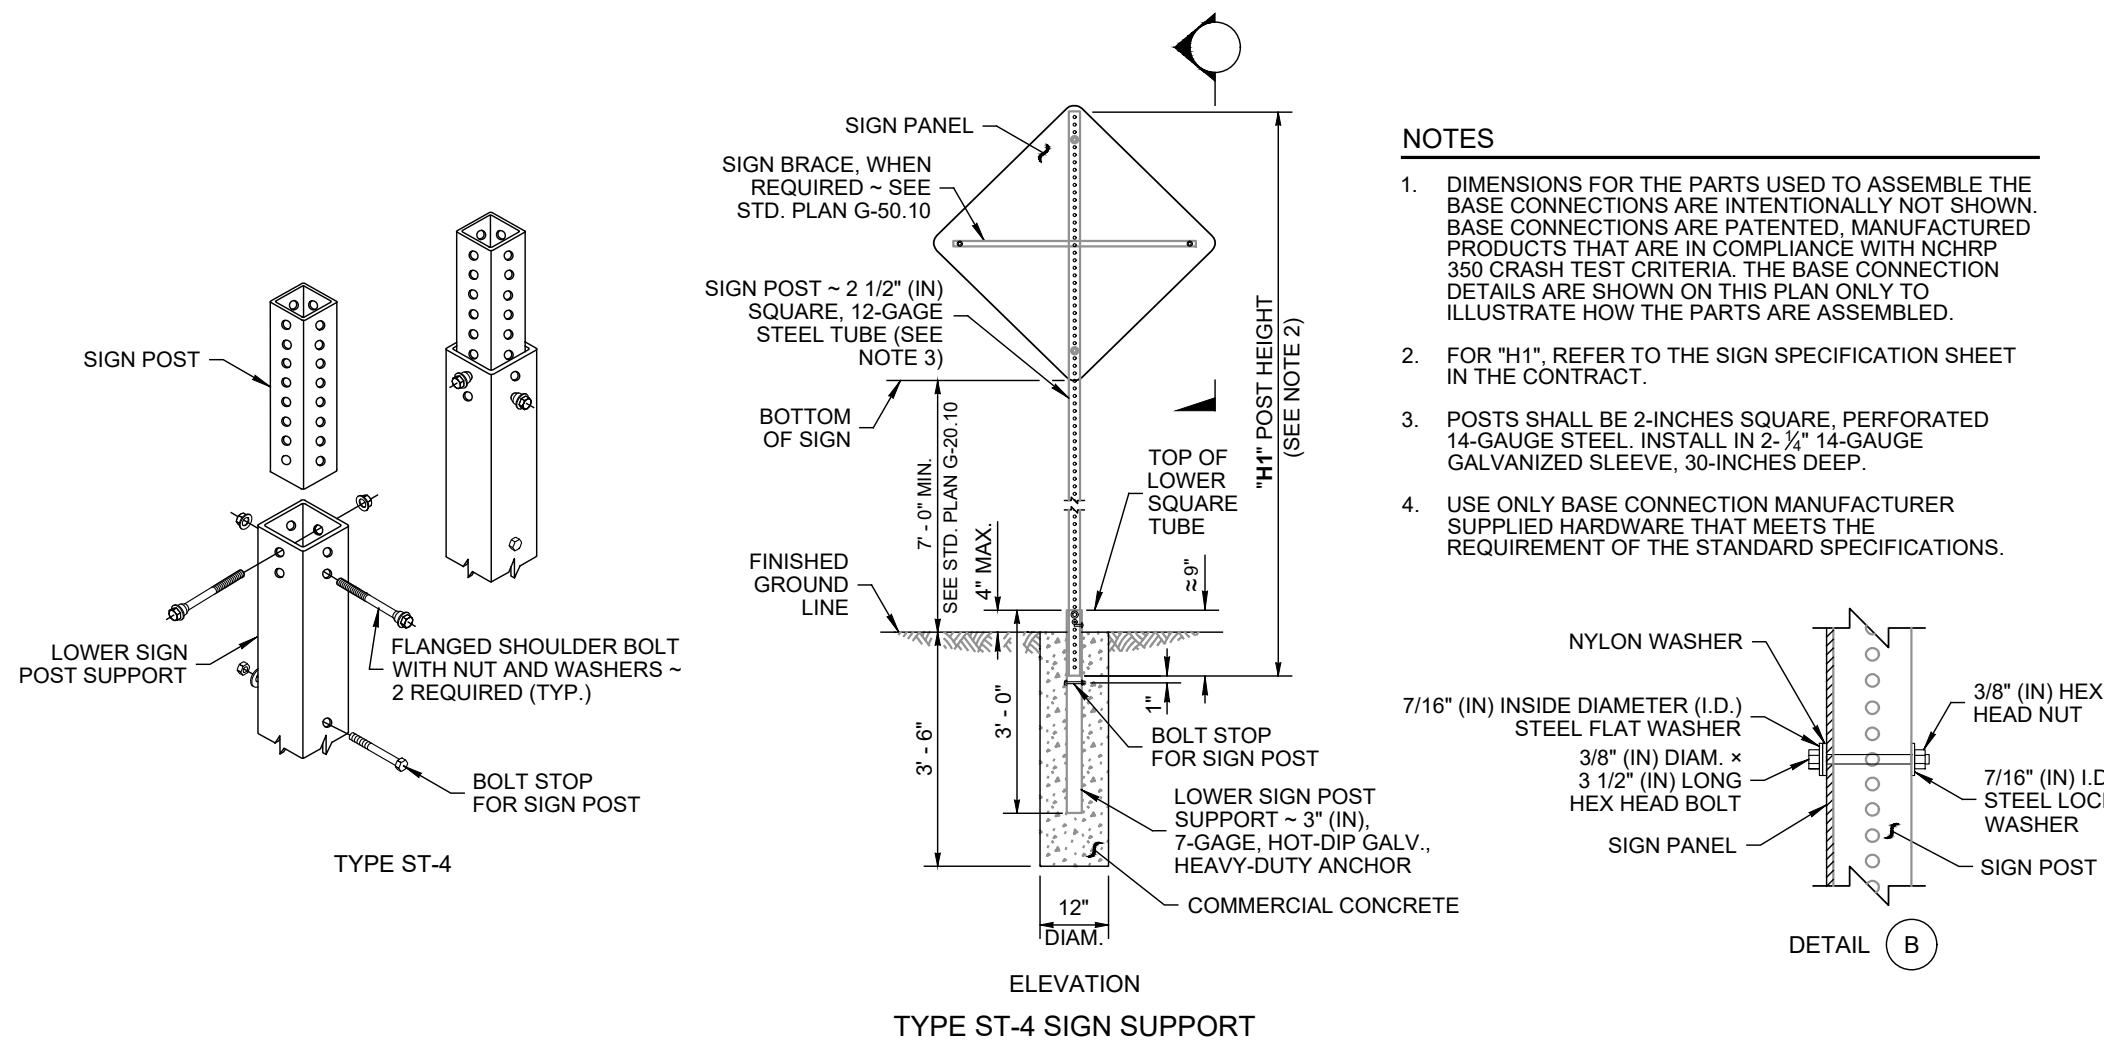
STREET SIGN INSTALLATION DETAIL  
PER WSDOT STD PLAN G-24.50-05  
NTS

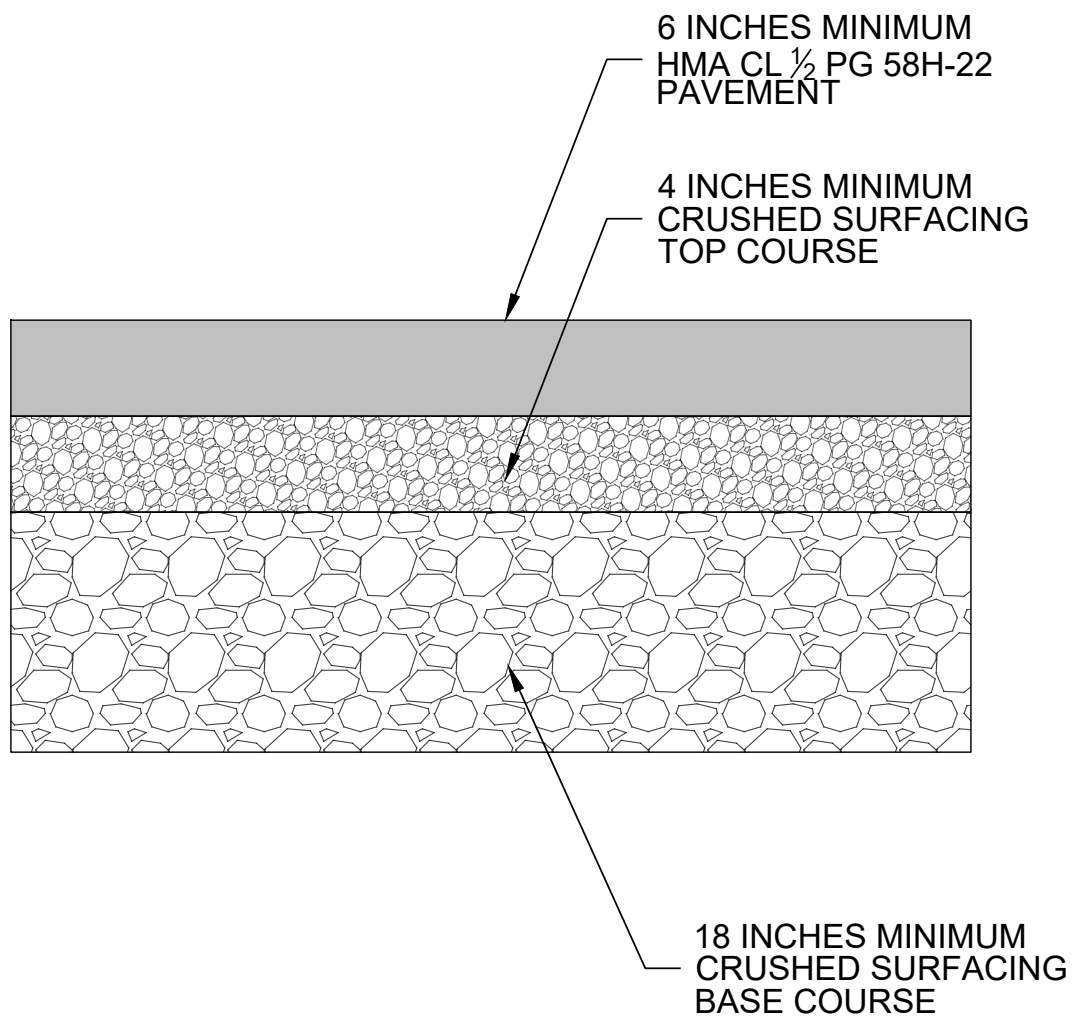
**J**  
C04

ASPHALT TYPICAL SECTION  
NTS

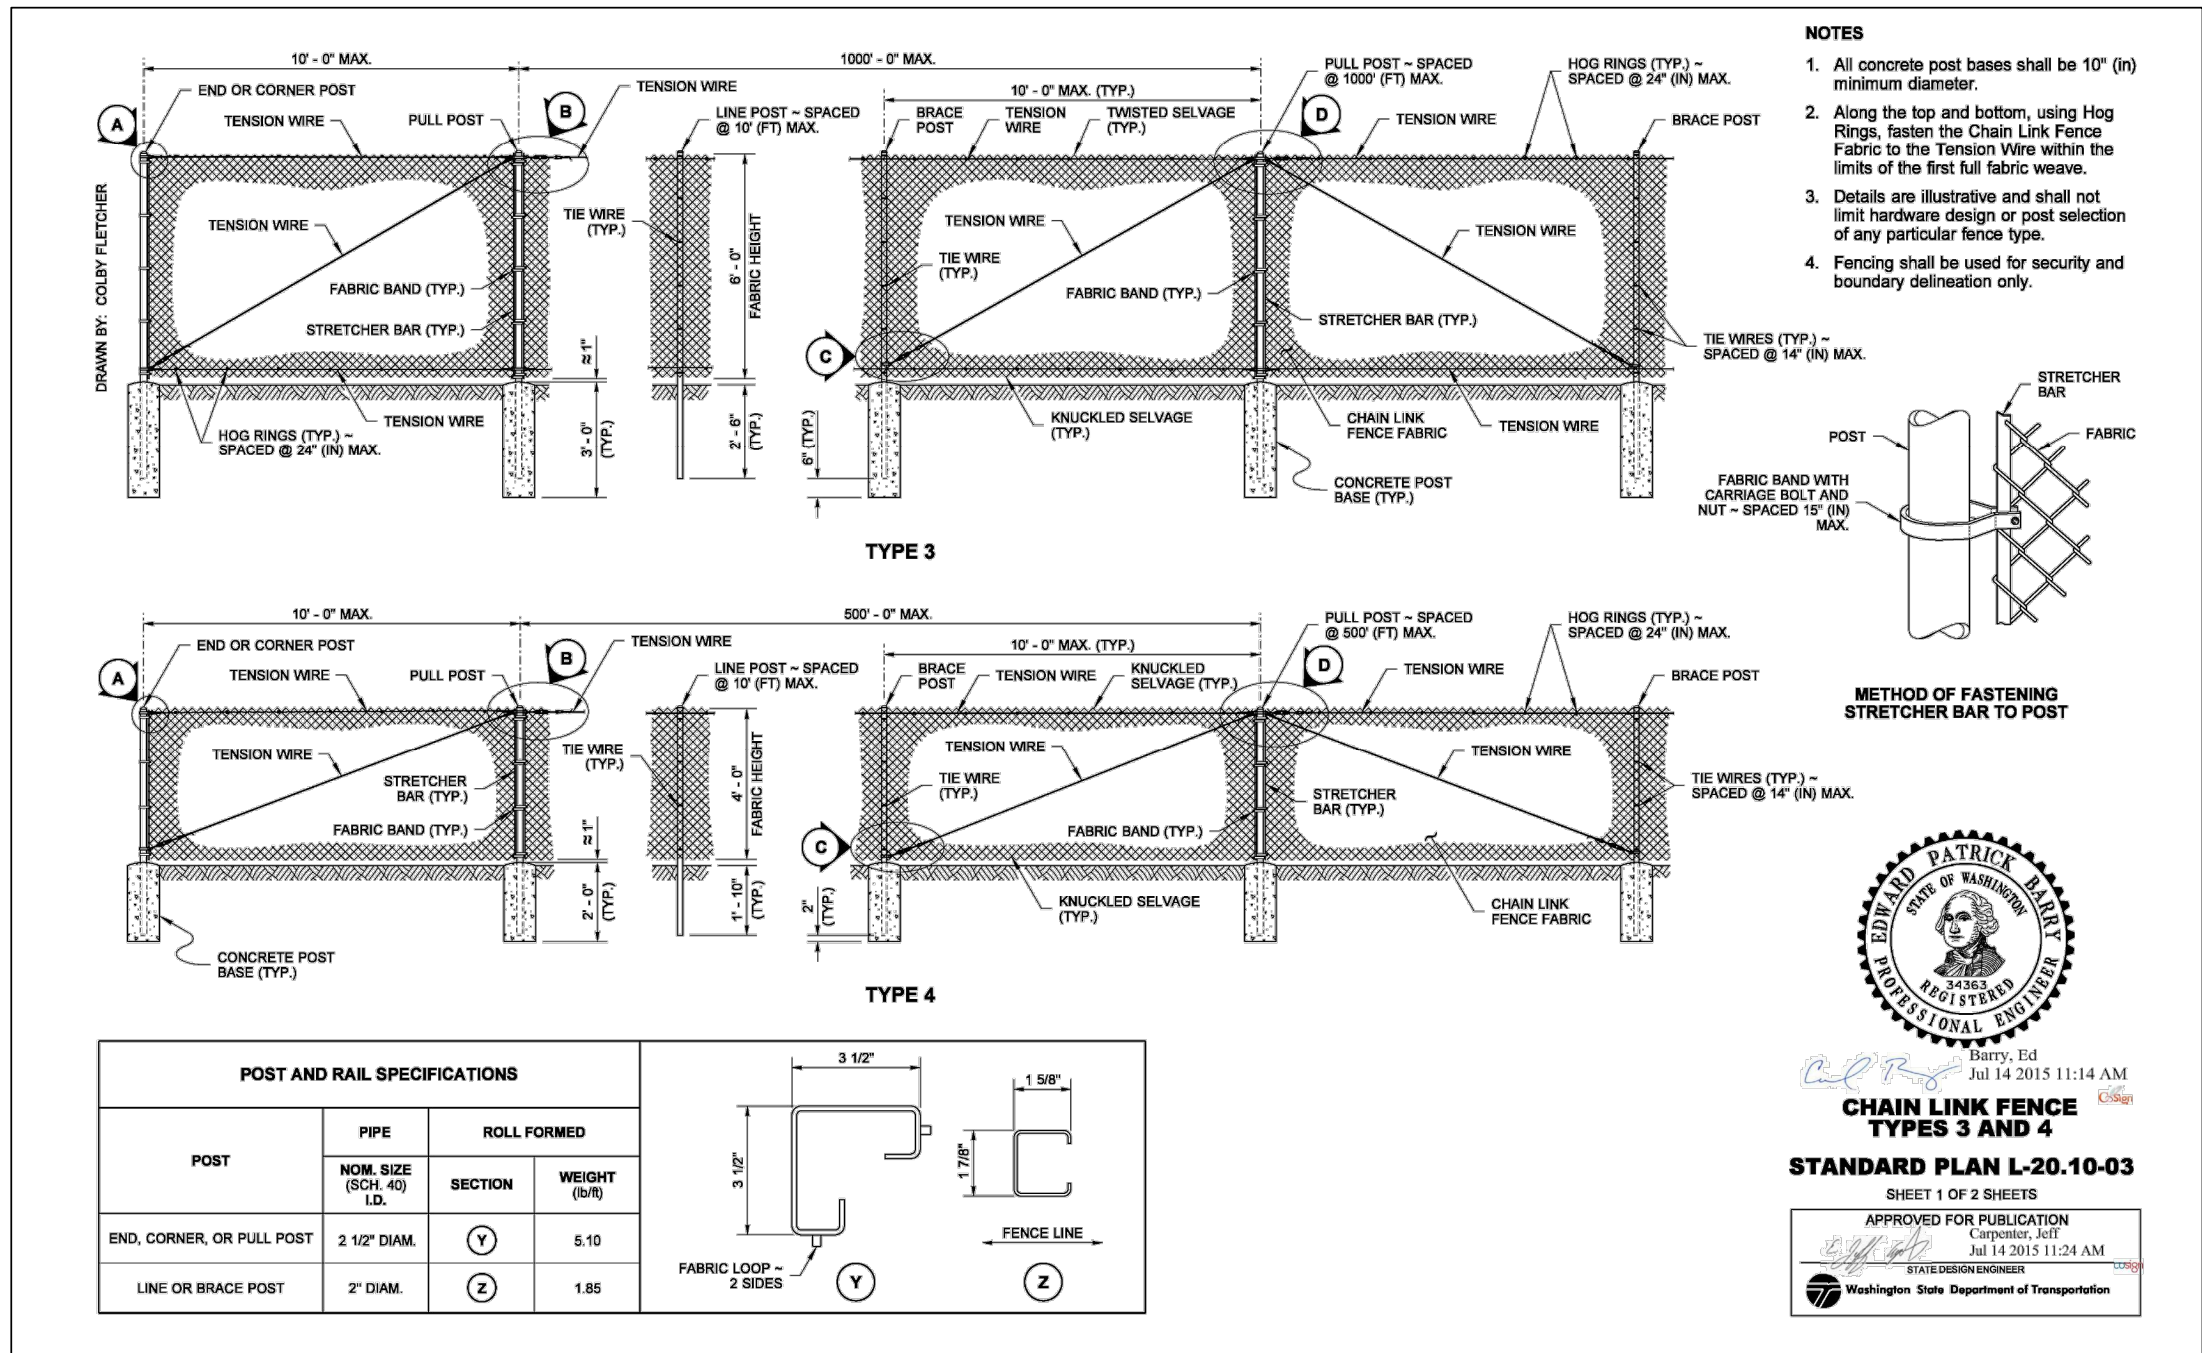
**L**  
C04

CHAINLINK FENCE AND GATE DETAIL  
NTS
