## ANACORTES PLANNING COMMISSION

**May 24, 2023**

### **AGENDA**

- A. Roll Call**
- B. Minutes**
  - 1) Minutes of May 8, 2023
- C. Correspondence**
- D. New Business**
  - 1) Appoint new vice chair.
  - 2) Open Record Public Hearing and Decision for Shoreline Substantial Development Permit SDP-2023-0002 Port of Anacortes 2nd Street and Curtis Wharf project.
- E. Old Business**

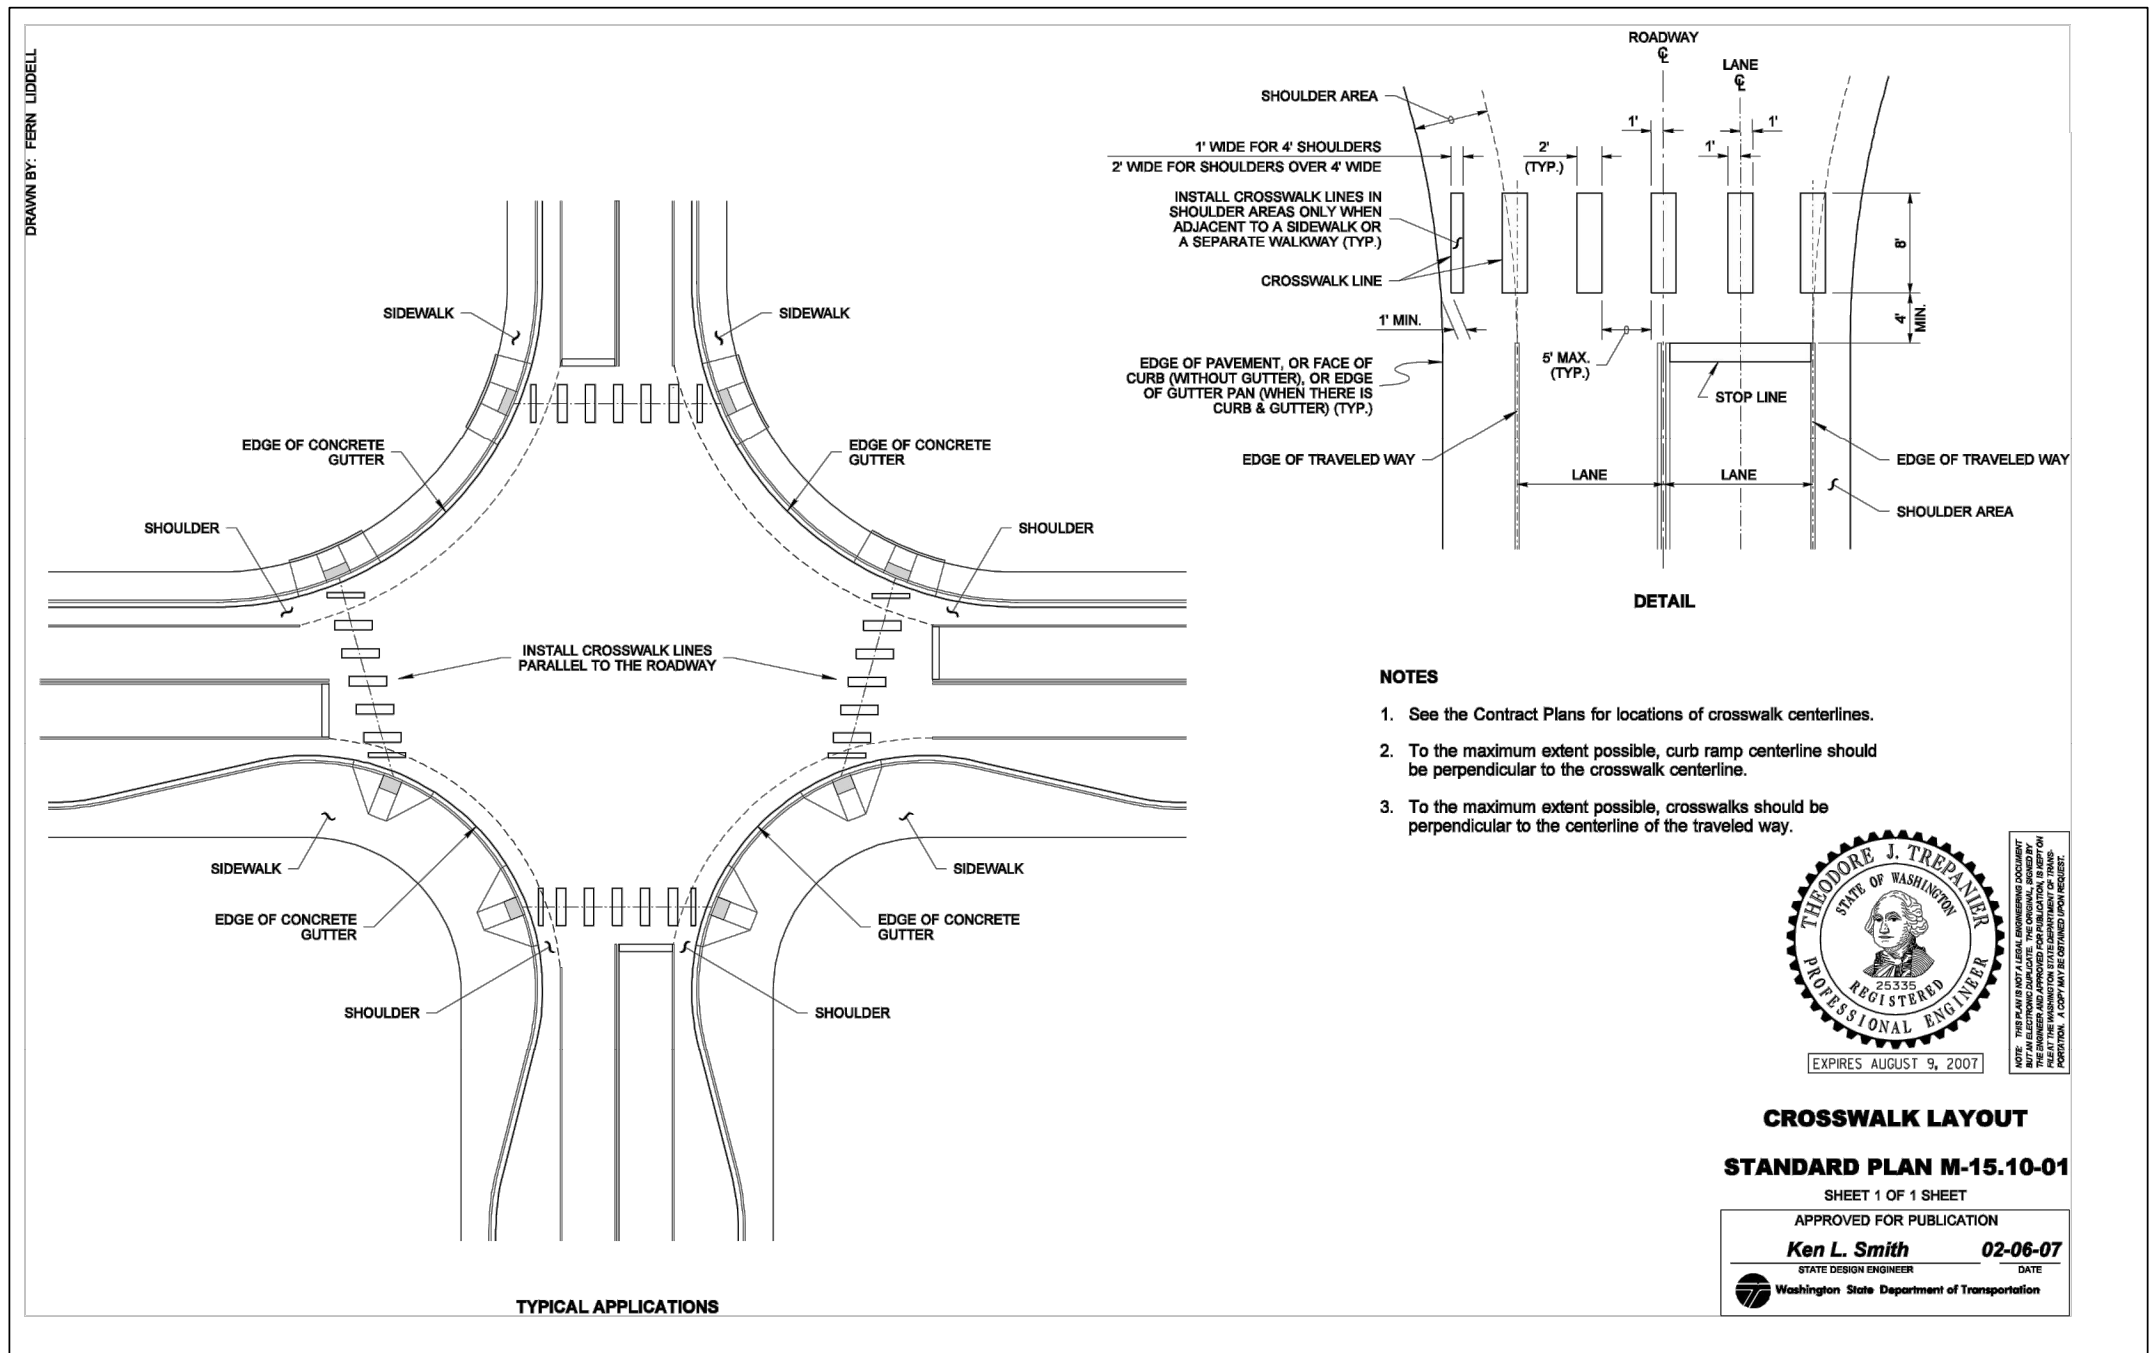
**M**  
C04

CROSSWALK DETAIL  
NTS

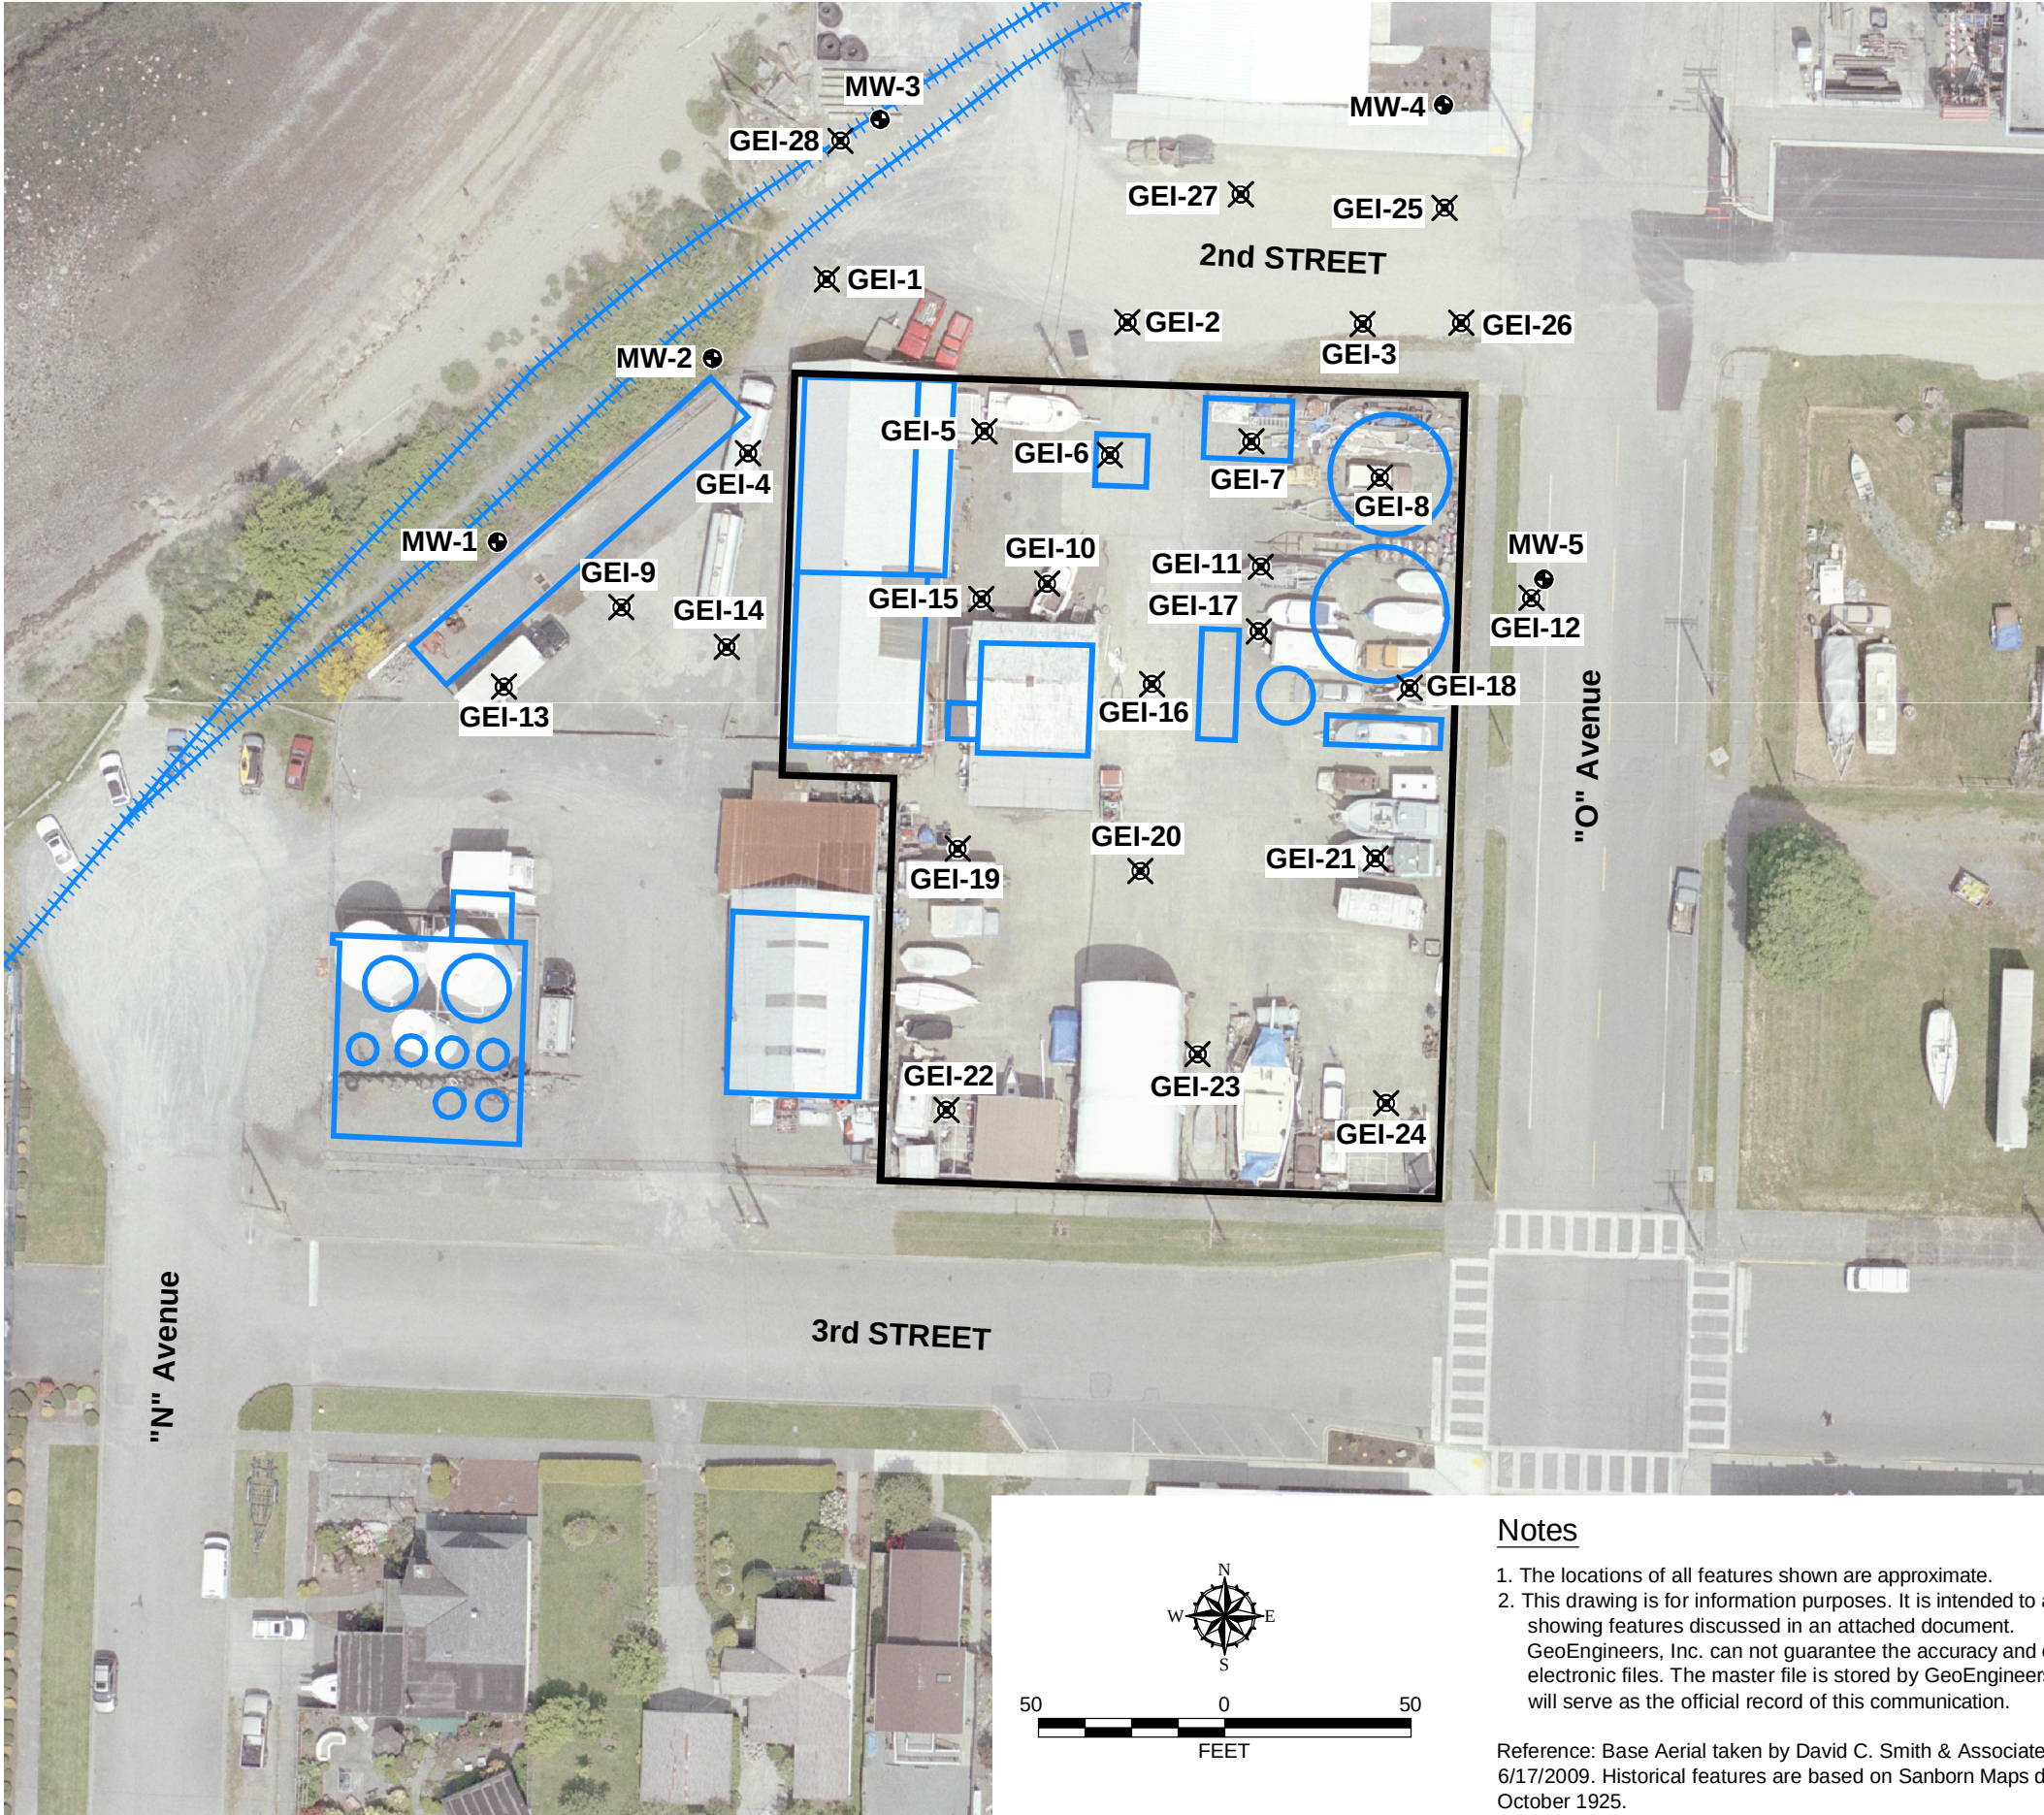
**Figure 1**

- Quiet Cove Property Boundary
- Historical Features
- ⊗ Geoprobe Boring Location
- ⊙ Monitoring Well Location

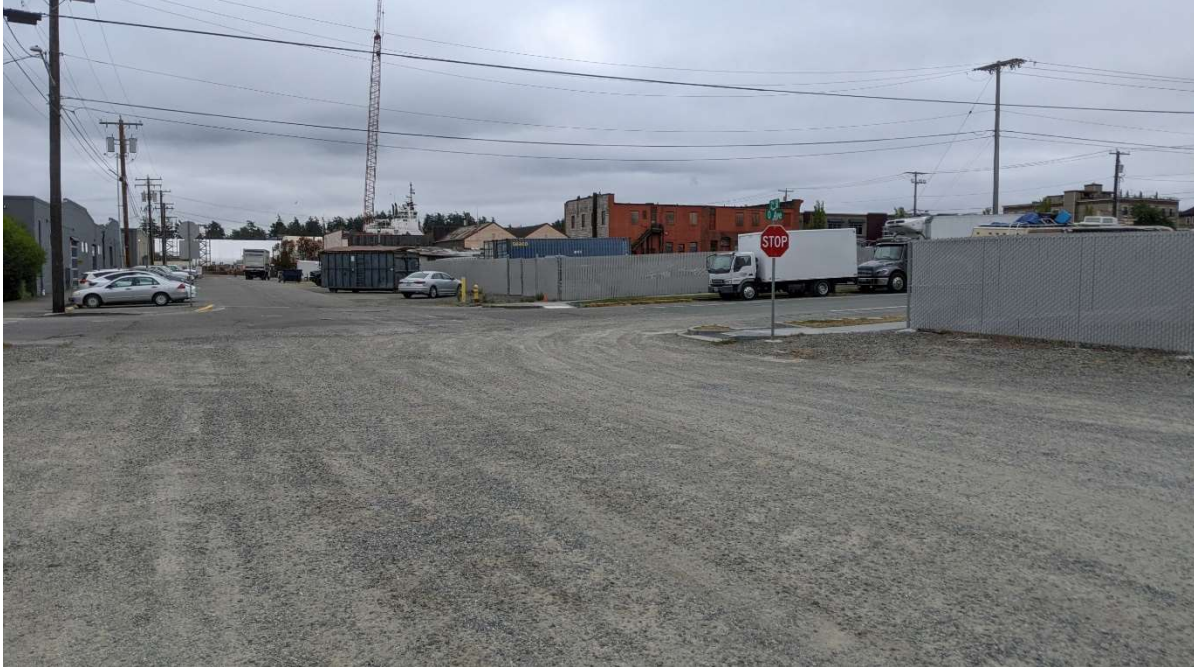
**FIGURE 2    O Avenue & 2<sup>nd</sup> Street Intersection**

See FIGURE 2 for a view of the 2nd Street and O Avenue intersection looking east. The existing gravel roadway edge of 2nd Street can be seen meeting O Avenue. See FIGURE 3 for a view of 2<sup>nd</sup> Street meeting the Curtis Wharf entrance. The existing gravel edge of O Avenue can be seen meeting the Curtis Wharf entrance.

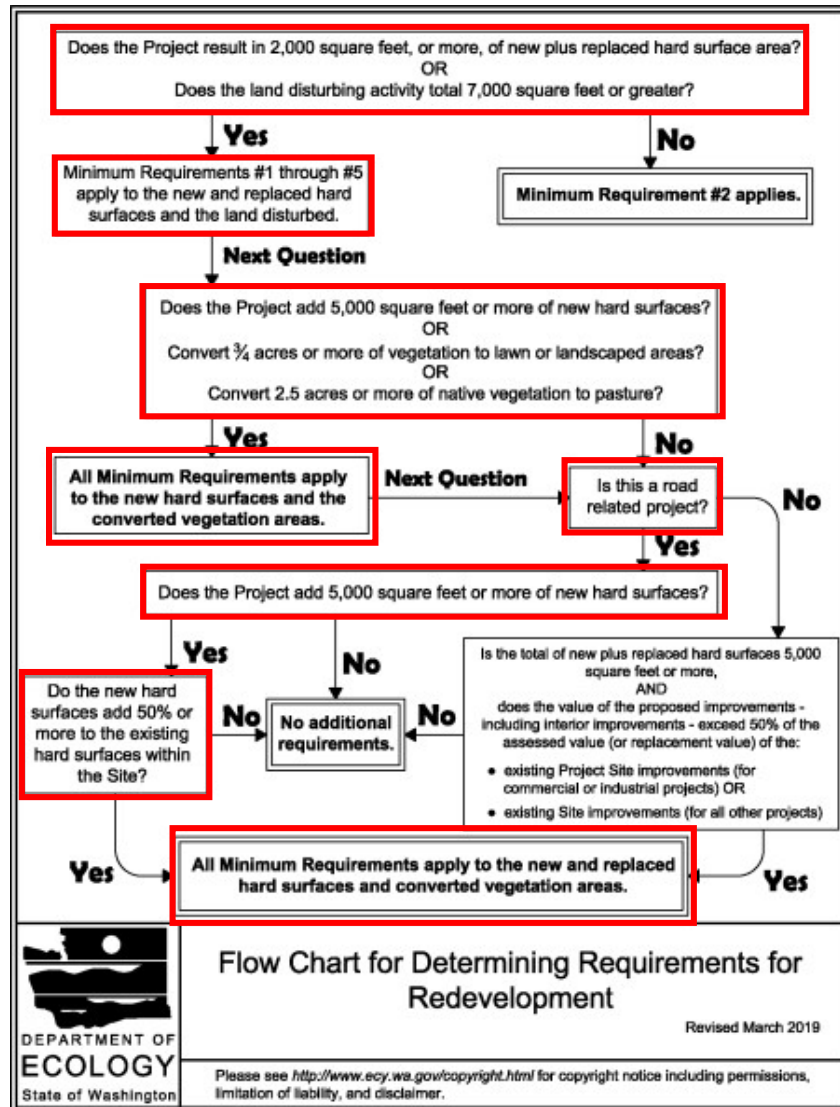
FIGURE 4 Stormwater Management Manual for Western Washington – Volume I – Figure 1-3.2

The City of Anacortes uses the Stormwater Management Manual for Western Washington (SWMMWW) for stormwater guidelines. Volume 1 of the SWMMWW outlines the Minimum Technical Requirements applicable to new development, redevelopment, and road-related projects. Figure 1-3.2 of the SWMMWW is a diagram to aid in the determination of the minimum technical requirements applicable to redevelopment projects. Figure 1-3.2 from the SWMMWW is included below in FIGURE 4.

As shown in FIGURE 4, because the proposed project will install more than 5,000 SF of new plus replaced hard surface area and is road related, all minimum requirements apply to the project.

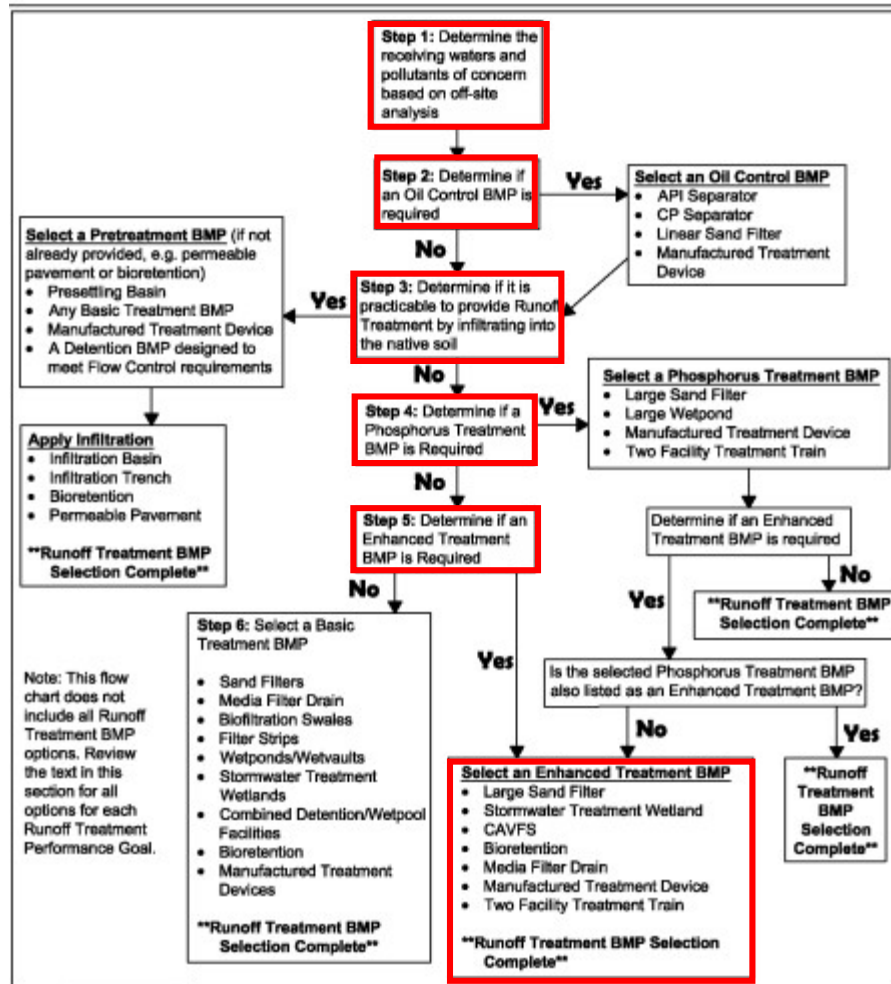
FIGURE 6 Stormwater Management Manual for Western Washington – Volume I – Figure III-1.1

FIGURE 6 above was used to help determine the best treatment facility for all PGHS. The steps were followed in the figure to potential basic treatment facilities that could be used to treat the drive aisle storm water.

Step 3 in determining a treatment facility looks at infiltration for pollutant removal. Characteristics of the native soil are not known to meet the site suitability criteria for treatment.

Step 5 talks about enhanced treatment options and if they are required for the project. In accordance with SWMMWW, enhanced treatment is required for projects that 1) discharge directly to fresh waters or conveyance systems tributary to fresh waters designated for aquatic life use or that have an existing aquatic life use; or 2) use infiltration strictly for flow control – not treatment – and the discharge is within ¼ mile of fresh water designated for aquatic life use or that has an existing aquatic life use. The proposed project directly discharges into the existing storm drain system which directly ties to the Guemes Channel therefore enhanced treatment is required.

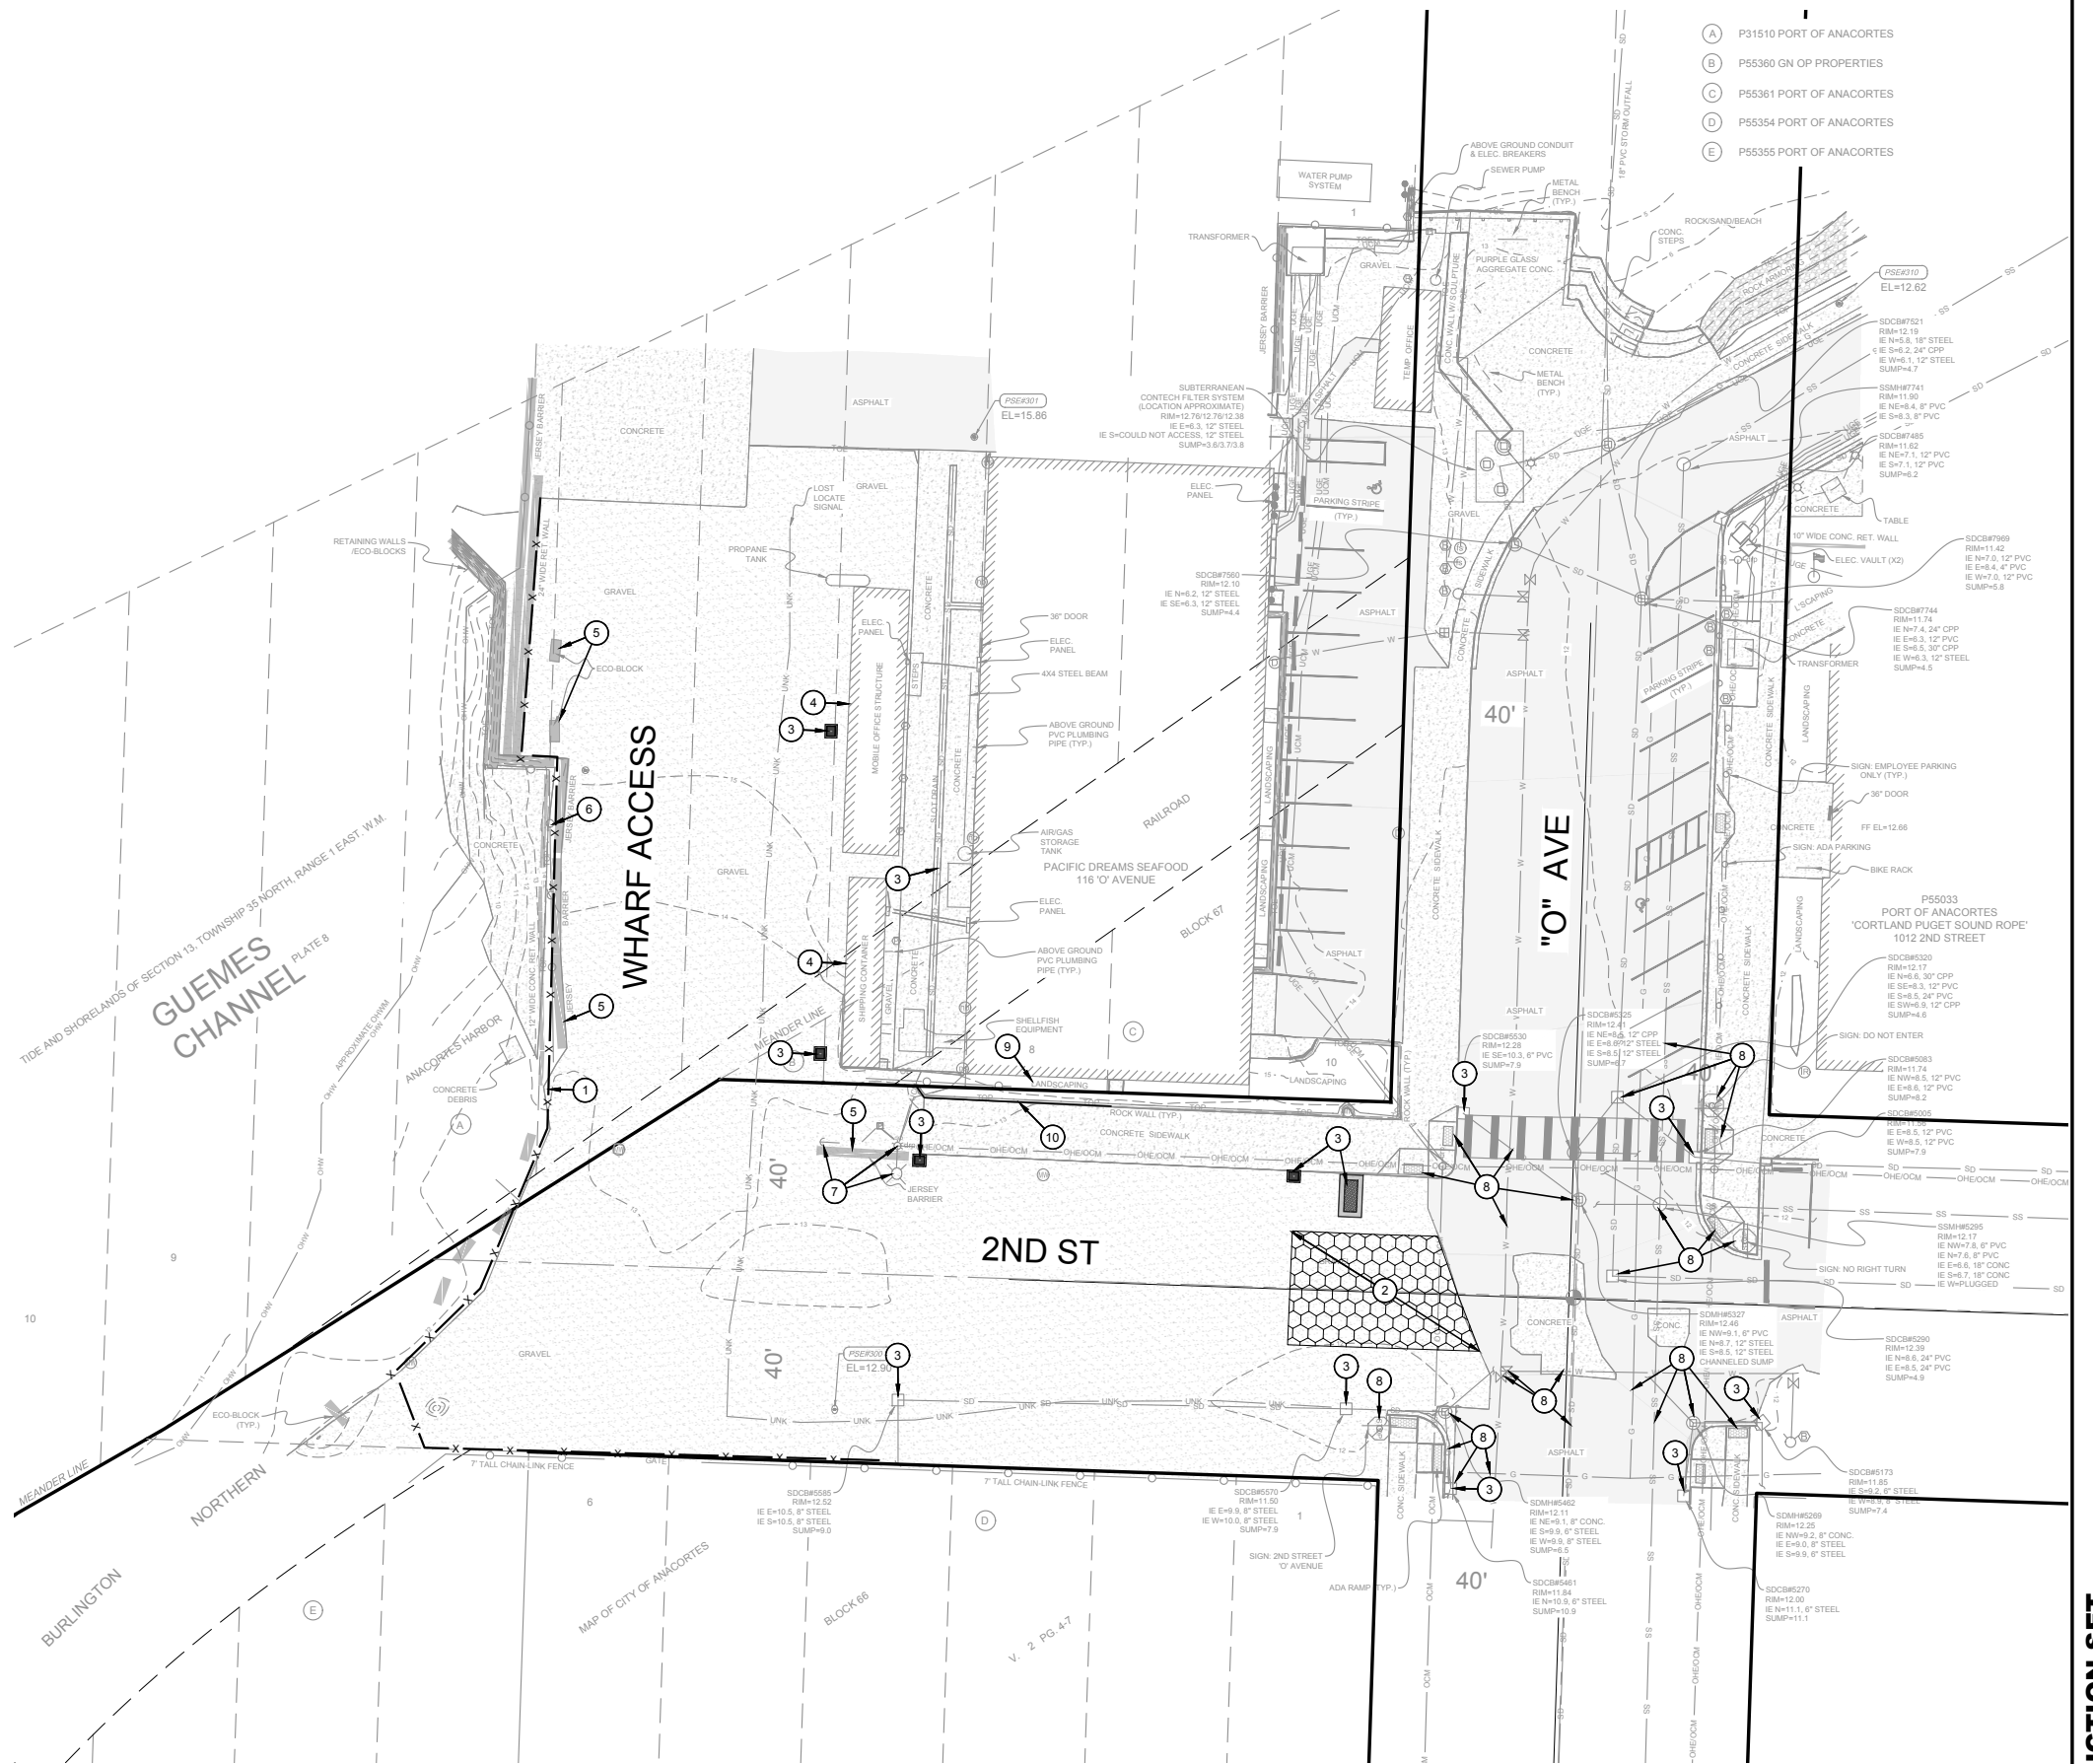
1. REMOVE AND STOCKPILE EX ECOLOGY BLOCKS, JERSEY BARRIERS AN OTHER SURFACE FEATURES AS NEEDED.

EXISTING CONDITIONS, DEMO, & TESC PLAN

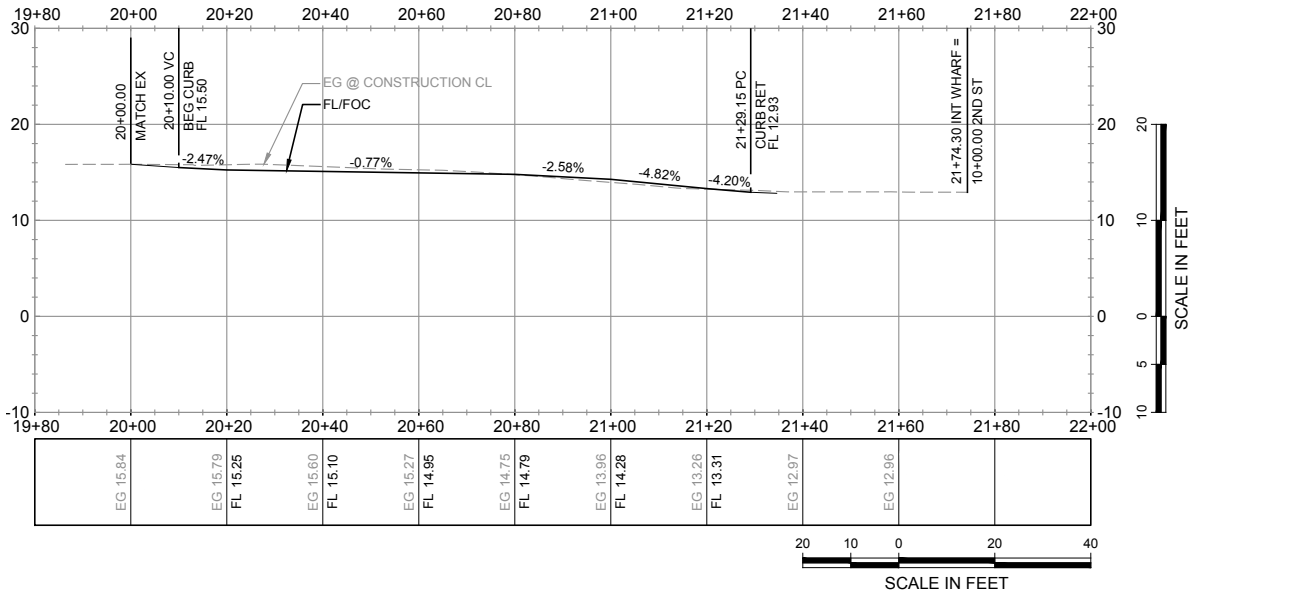
PROPOSED WHARF PROFILE  
SCALE AS SHOWN

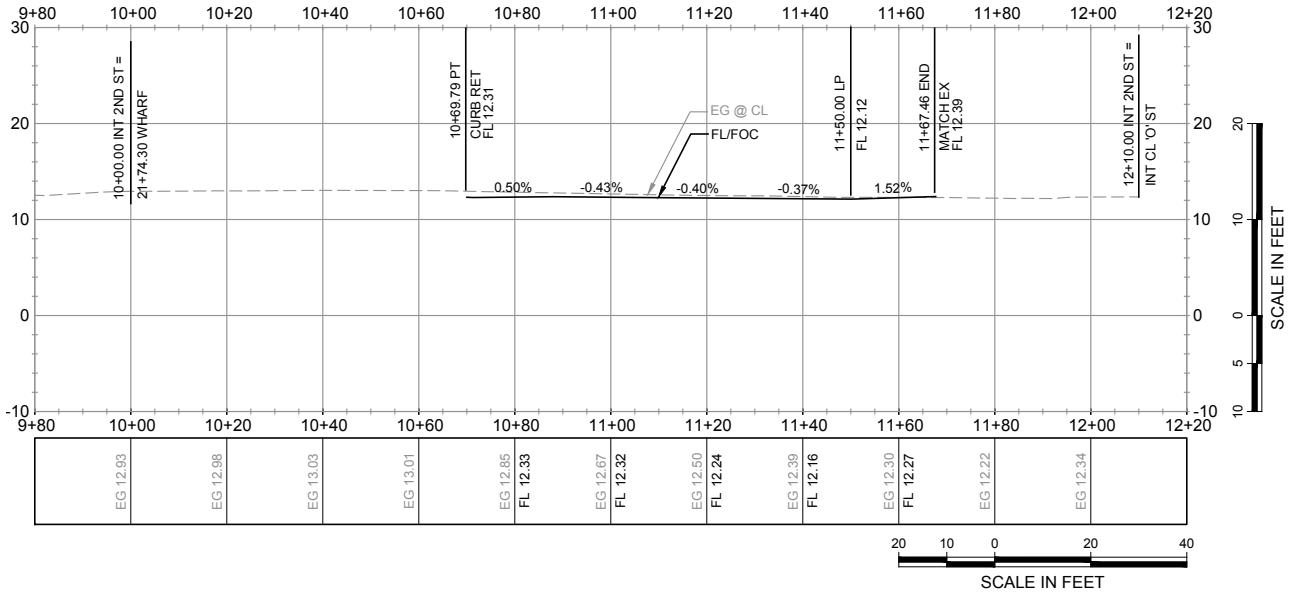
PROPOSED 2ND ST PROFILE  
SCALE AS SHOWN

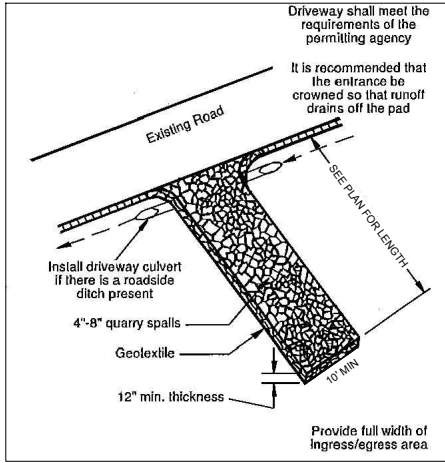
A  
C03

STABILIZED CONSTRUCTION ENTRANCE  
PER D.O.E. FIG. 4.2  
NOT TO SCALE

STABILIZED CONSTRUCTION ENTRANCE  
PER D.O.E. FIG. 4.2  
NOT TO SCALE

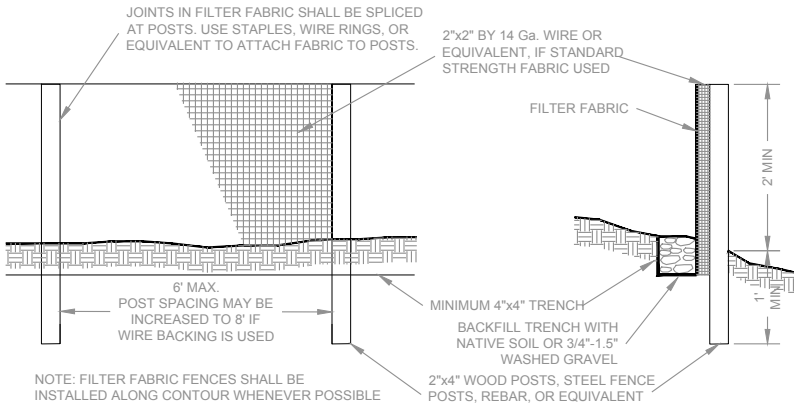
B  
C03

FILTER FABRIC SILT FENCE  
PER D.O.E. FIG. 4.20  
NOT TO SCALE

FILTER FABRIC SILT FENCE  
PER D.O.E. FIG. 4.20  
NOT TO SCALE

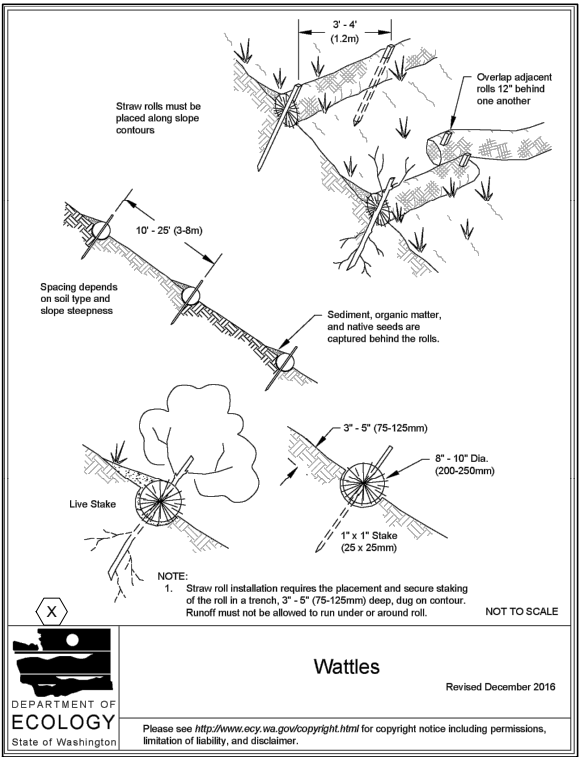
C  
C03

STRAW WATTLES  
PER D.O.E. FIG. 3.24  
NOT TO SCALE

STRAW WATTLES  
PER D.O.E. FIG. 3.24  
NOT TO SCALE

| | <b>ESC Measure</b> | <b>Comment</b> |
|---|---|---|
| 4 | Install Straw Wattles | Install straw wattles around disturbed areas where sediment could be transported off-site. Adjust straw wattles as required by site conditions and construction sequencing. |

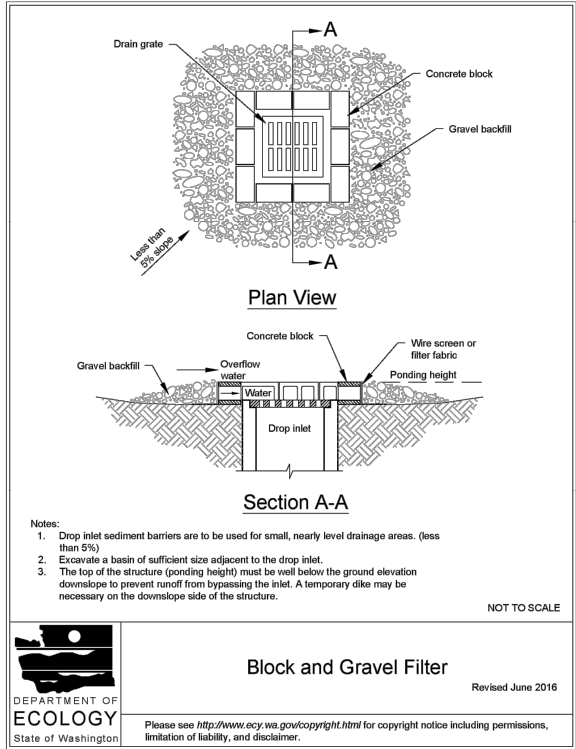
D  
C03

TEMPORARY INLET PROTECTION DETAIL  
PER 2019 D.O.E. FIG. V2.3 PG 359  
NOT TO SCALE

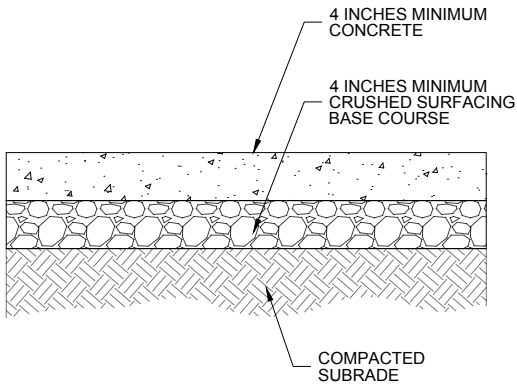
E  
C04

CONCRETE TYPICAL SECTION  
NOT TO SCALE

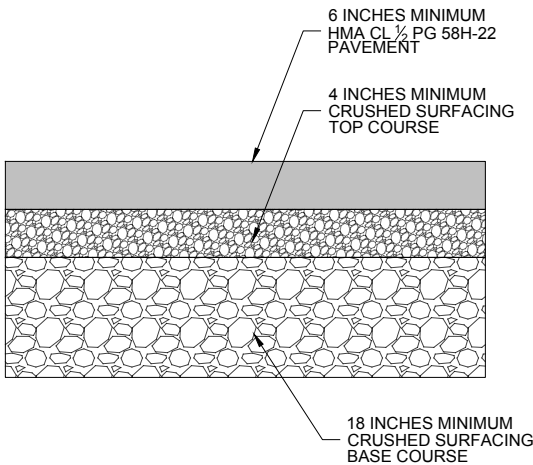
F  
C04

ASPHALT TYPICAL SECTION  
NOT TO SCALE

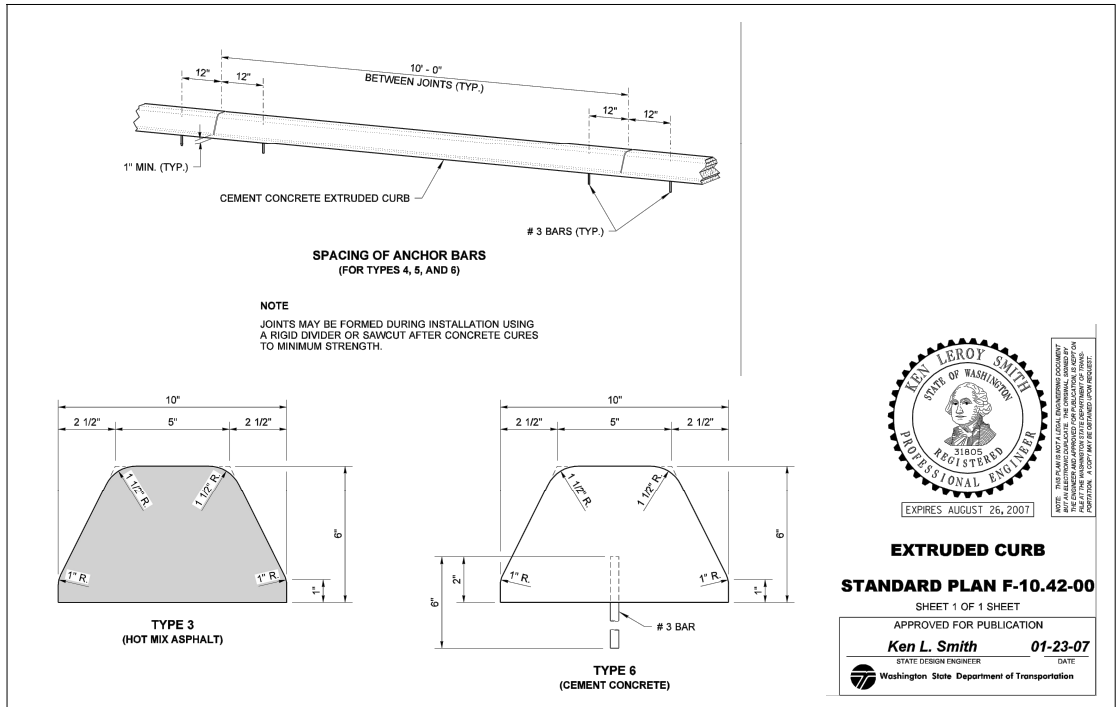
G  
C04

EXTRUDED CONCRETE CURB DETAIL  
STD PLAN F-10.42-00  
NOT TO SCALE

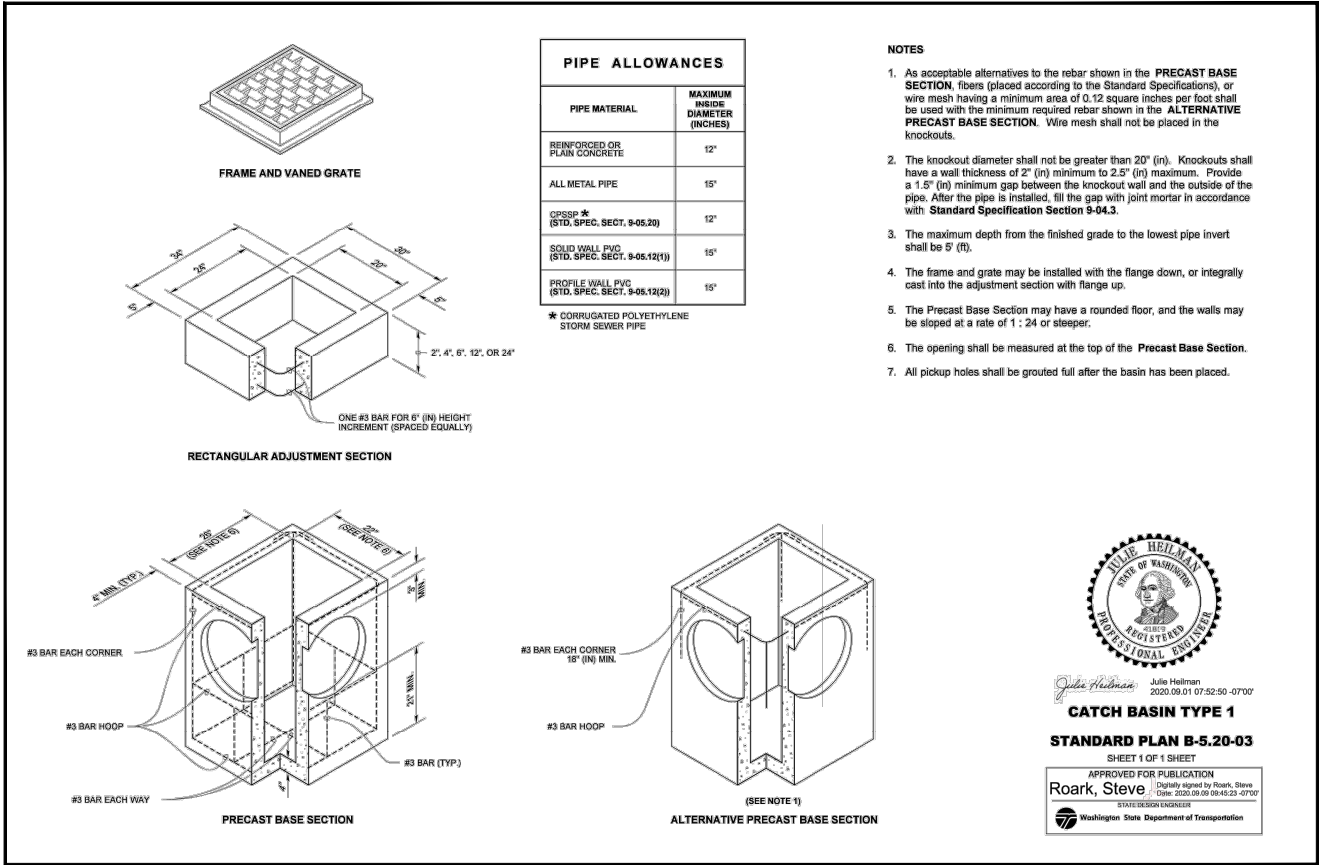
H  
C05

CB TYPE 1 W/ GRATE DETAIL  
WSDOT STD PLAN B-5.20-03  
NOT TO SCALE

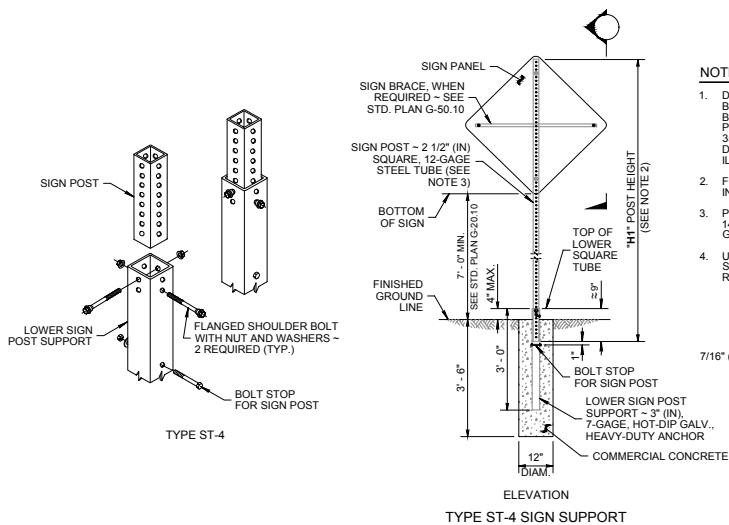
J  
C04

STREET SIGN INSTALLATION DETAIL  
PER WSDOT STD PLAN G-24.50-05  
NOT TO SCALE

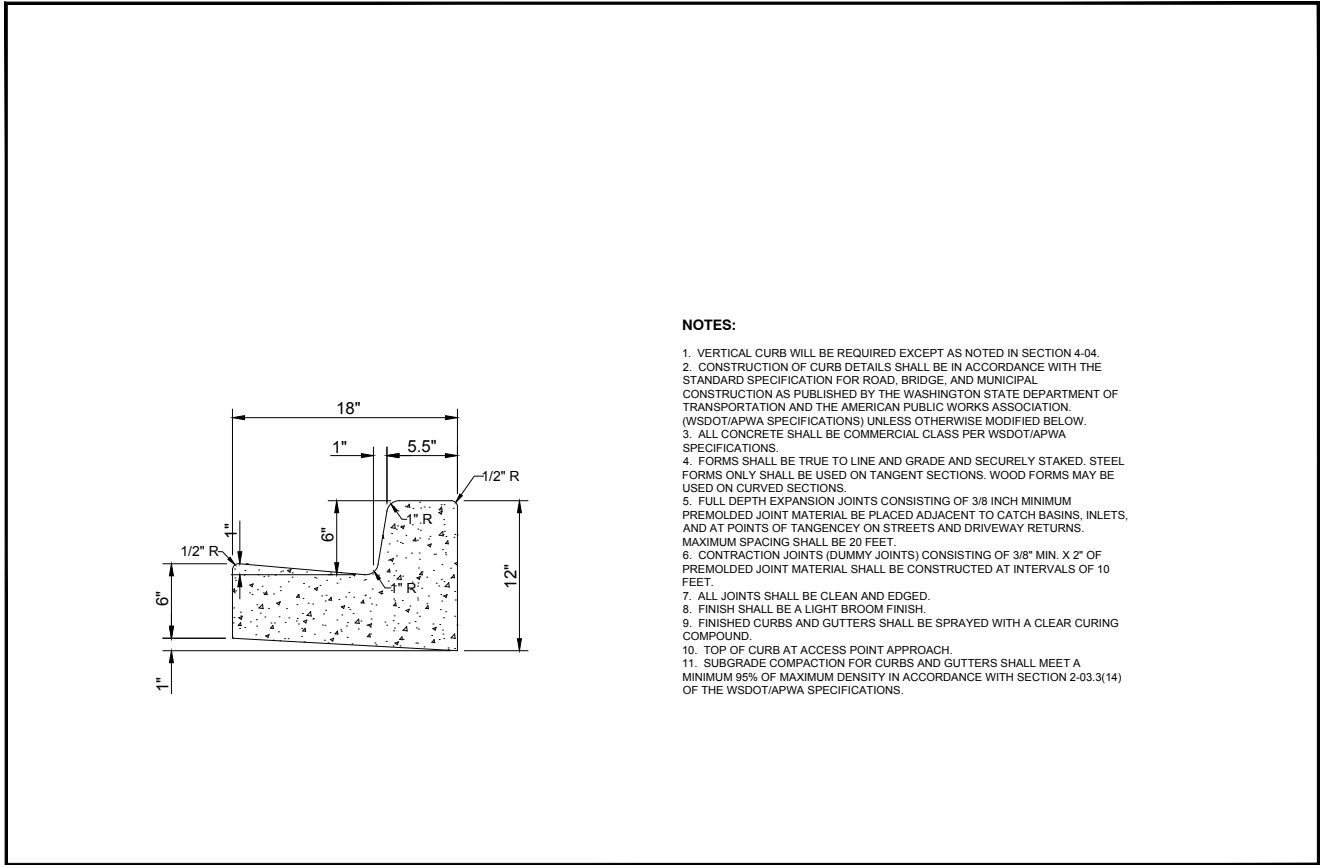
I  
C04

CONCRETE VERTICAL CURB DETAIL  
NOT TO SCALE

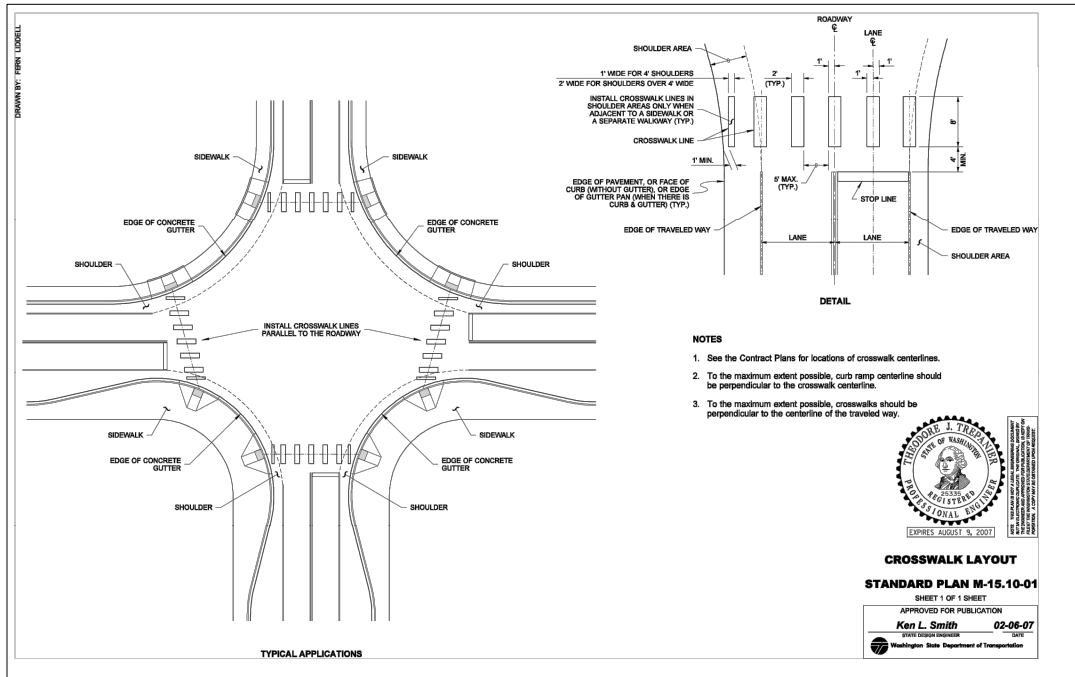
K  
C04

CROSSWALK DETAIL  
NOT TO SCALE

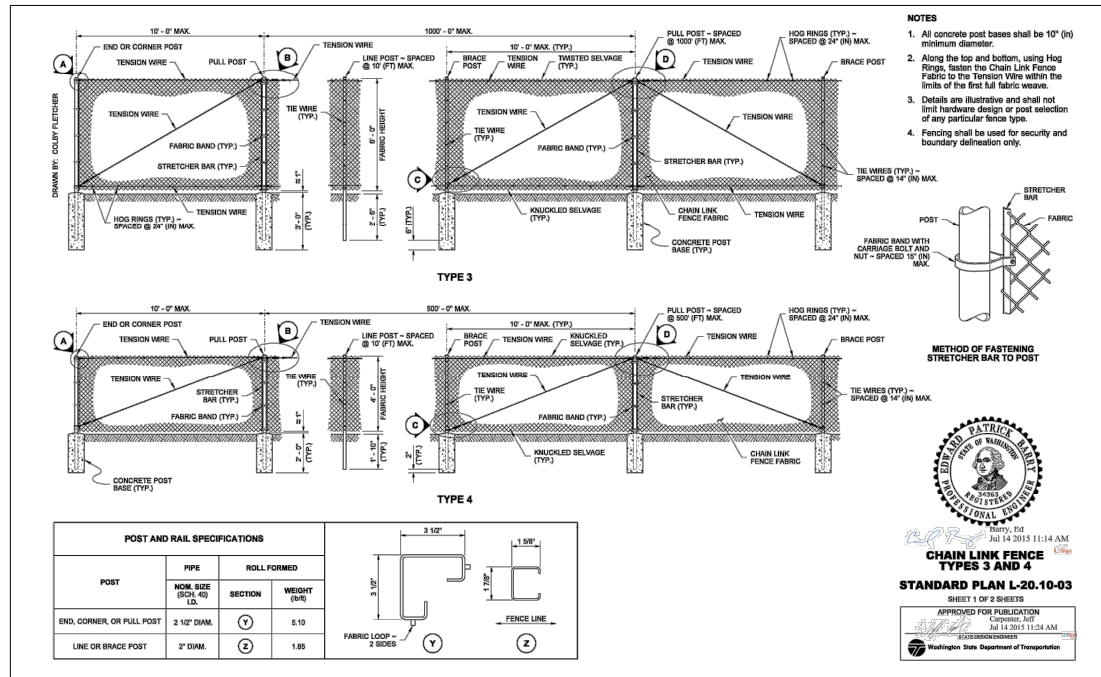
M  
C04

### CHAIN LINK FENCE DETAIL

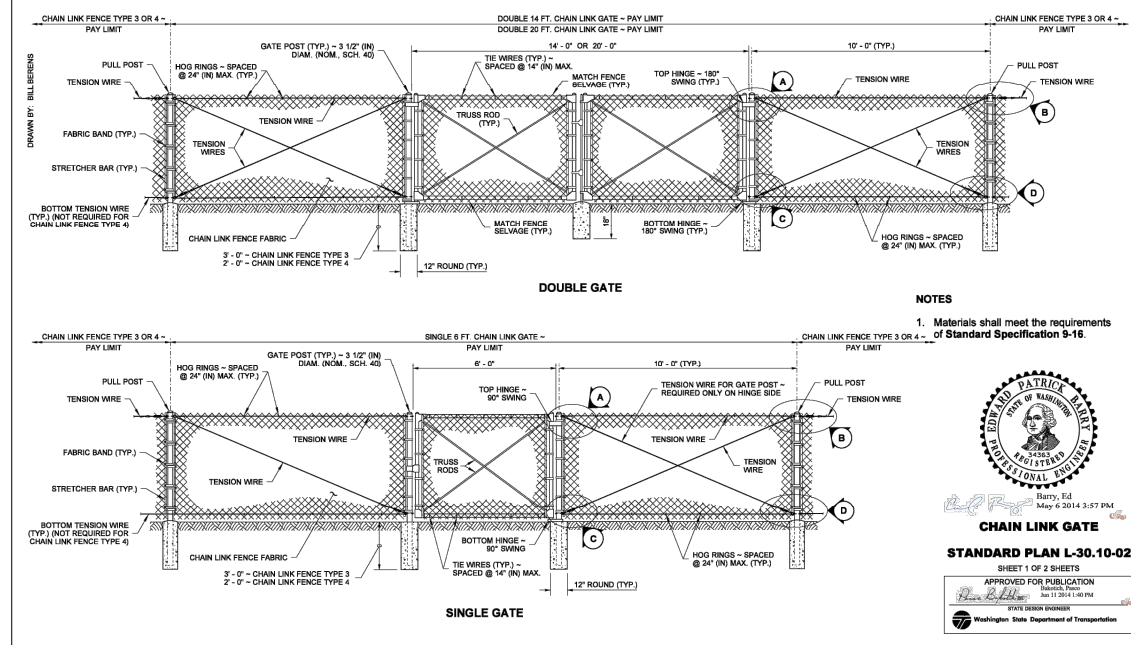
### CHAN LINK GATE DETAIL
