## ANACORTES PLANNING COMMISSION

**May 24, 2023**

### **AGENDA**

- A. Roll Call**
- B. Minutes**
  - 1) Minutes of May 8, 2023
- C. Correspondence**
- D. New Business**
  - 1) Appoint new vice chair.
  - 2) Open Record Public Hearing and Decision for Shoreline Substantial Development Permit SDP-2023-0002 Port of Anacortes 2nd Street and Curtis Wharf project.
- E. Old Business**

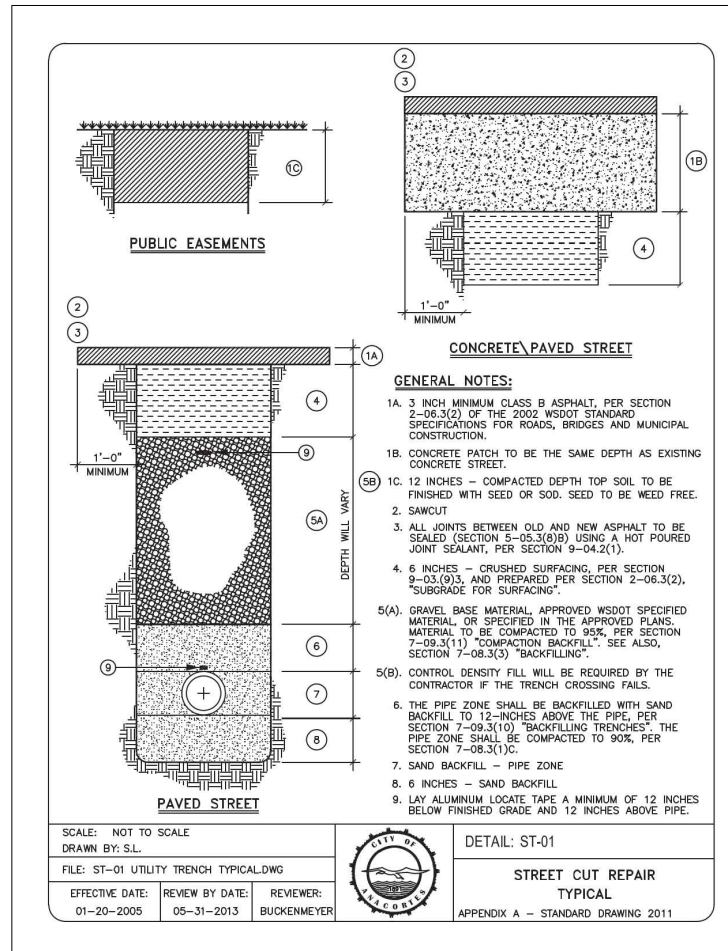
### STREET REPAIR DETAIL

PER ANACORTES STD DETAIL ST-01  
NOT TO SCALE

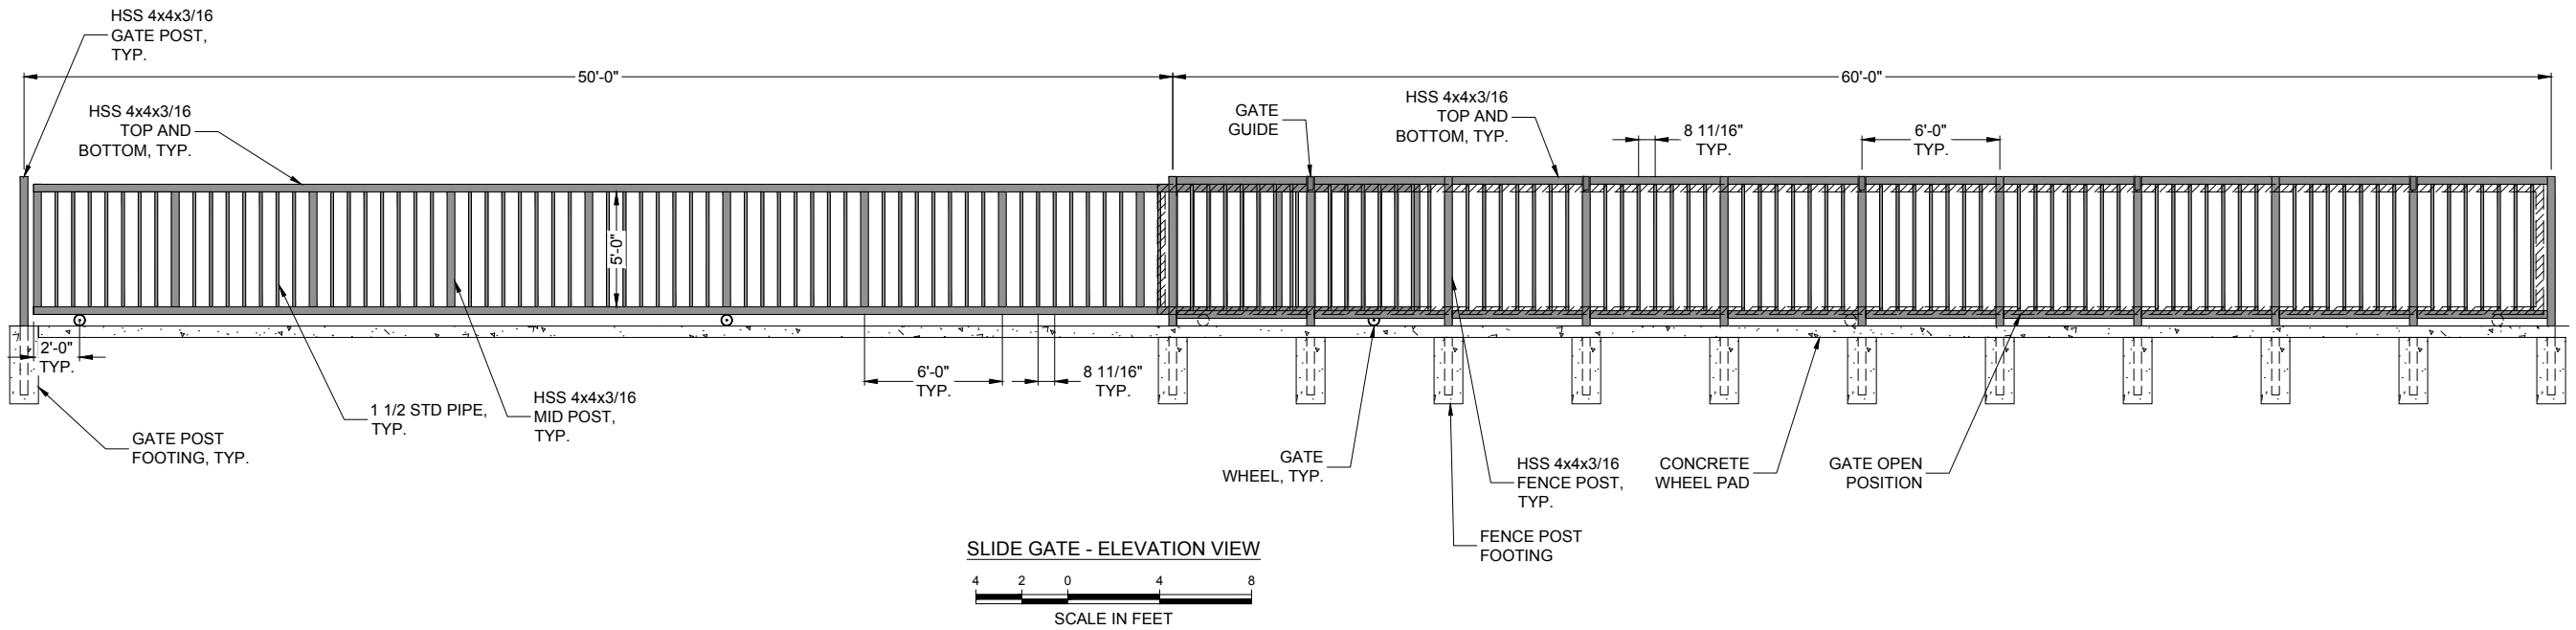
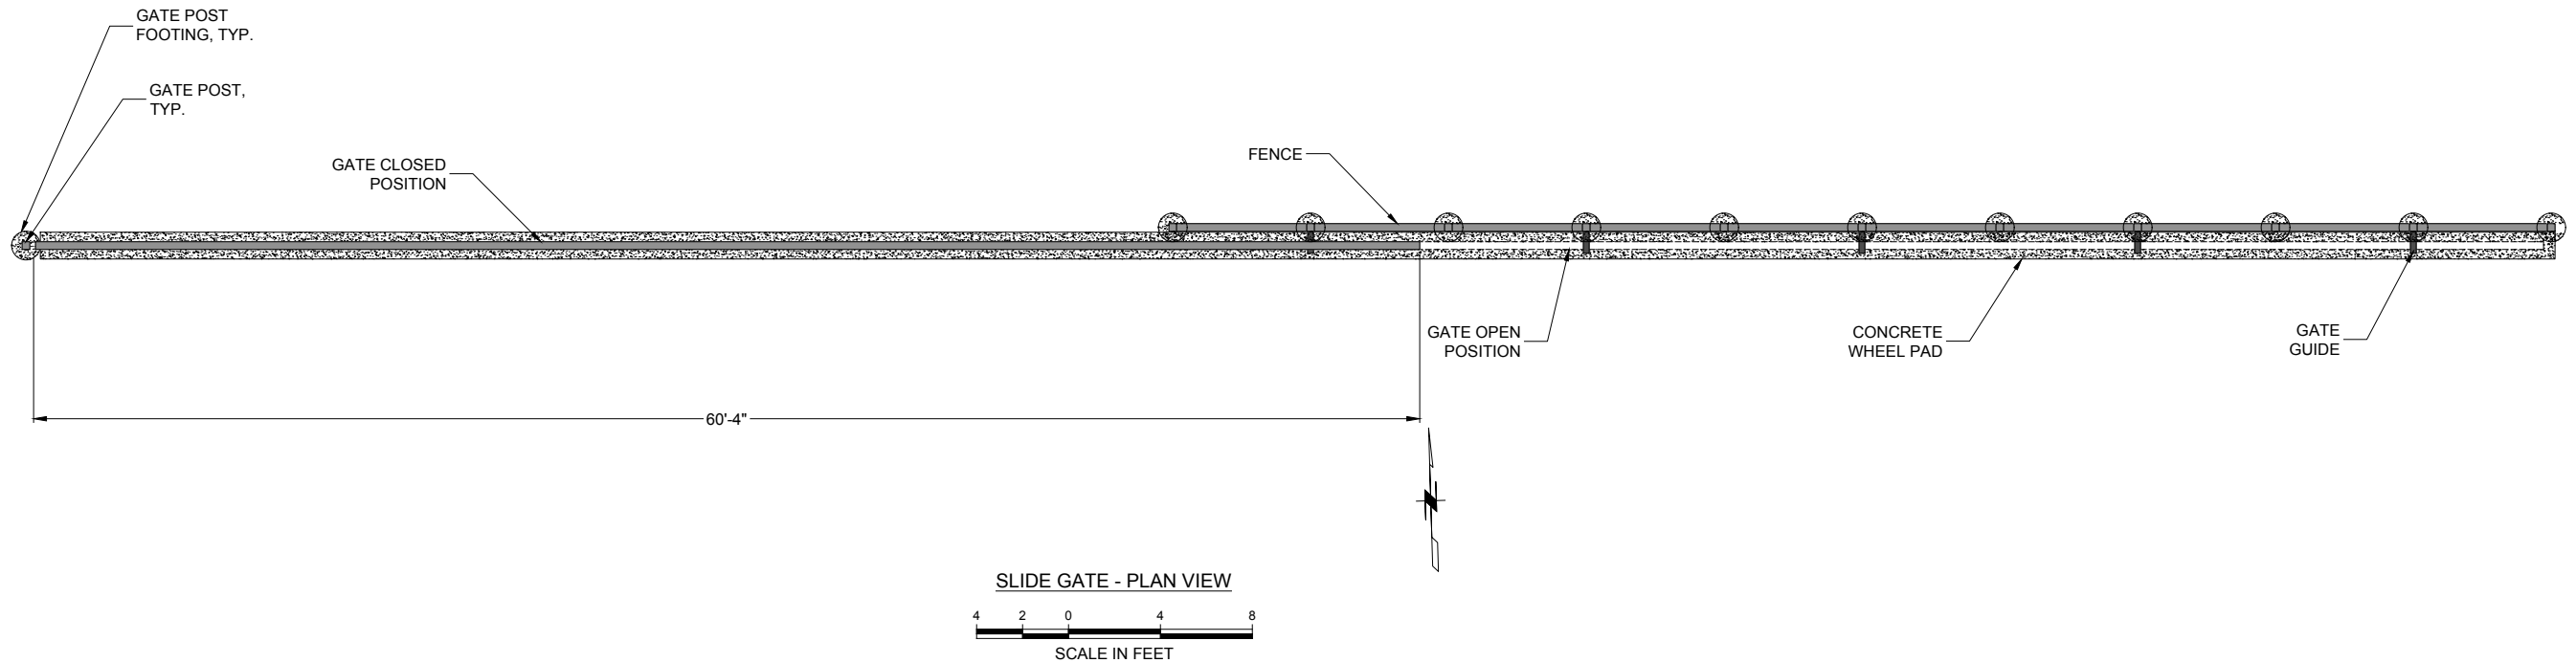
P  
C04

SLIDING GATE DETAIL  
NOT TO SCALE

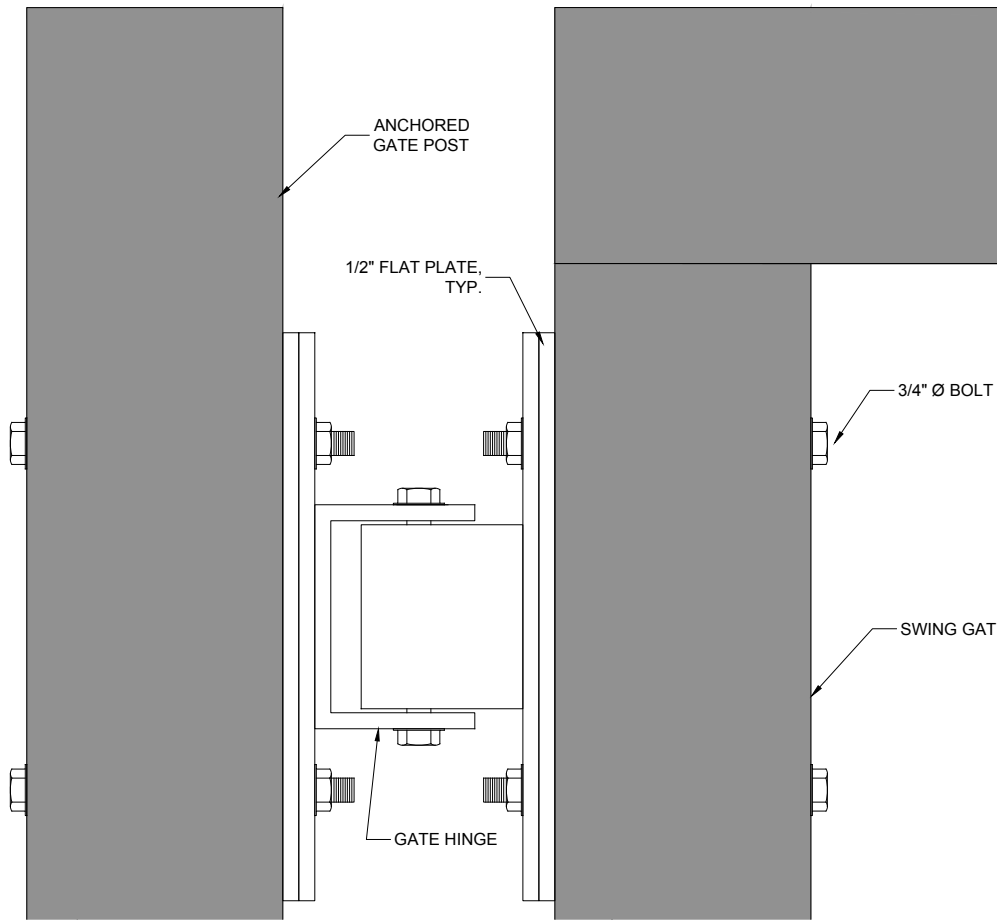
GATE A HINGE DETAIL  
NOT TO SCALE

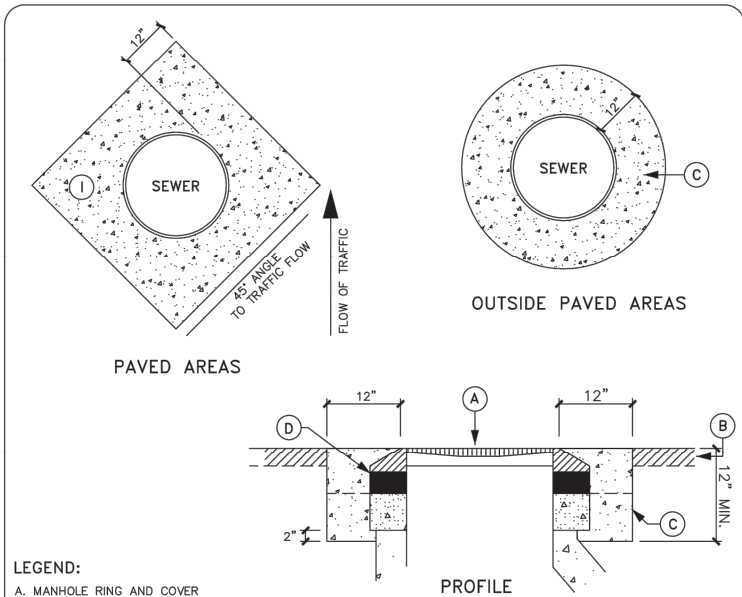
| SCALE: NOT TO SCALE | | DETAIL: ST-02 |

- LEGEND:**
- A. MANHOLE RING AND COVER
  - B. EXISTING SURFACE
  - C. 3000 P.S.I. CEMENT CONCRETE PERIMETER SEAL
  - D. INSTALL PRECAST ADJUSTMENT RINGS OR CONCRETE BLOCKS AS NECESSARY TO MATCH FINAL GRADE.
- NOTES:**
1. THE CONCRETE SHALL CONFORMING TO THE CURRENT WSDOT 9-03.1(4) AND BE 5.5 SACK MIX. (MINIMUM 3000-PSI 28-DAY STRENGTH).
  2. WHERE DEPTH OF NECK EXCEEDS 24 INCHES, ADJUST MANHOLE TO GRADE BY INSERTING A NEW MANHOLE BARREL SECTION BETWEEN THE CONE AND EXISTING BARREL.
  3. ADJUSTMENT RINGS/BLOCK SHALL BE SET IN 3/4\"/>

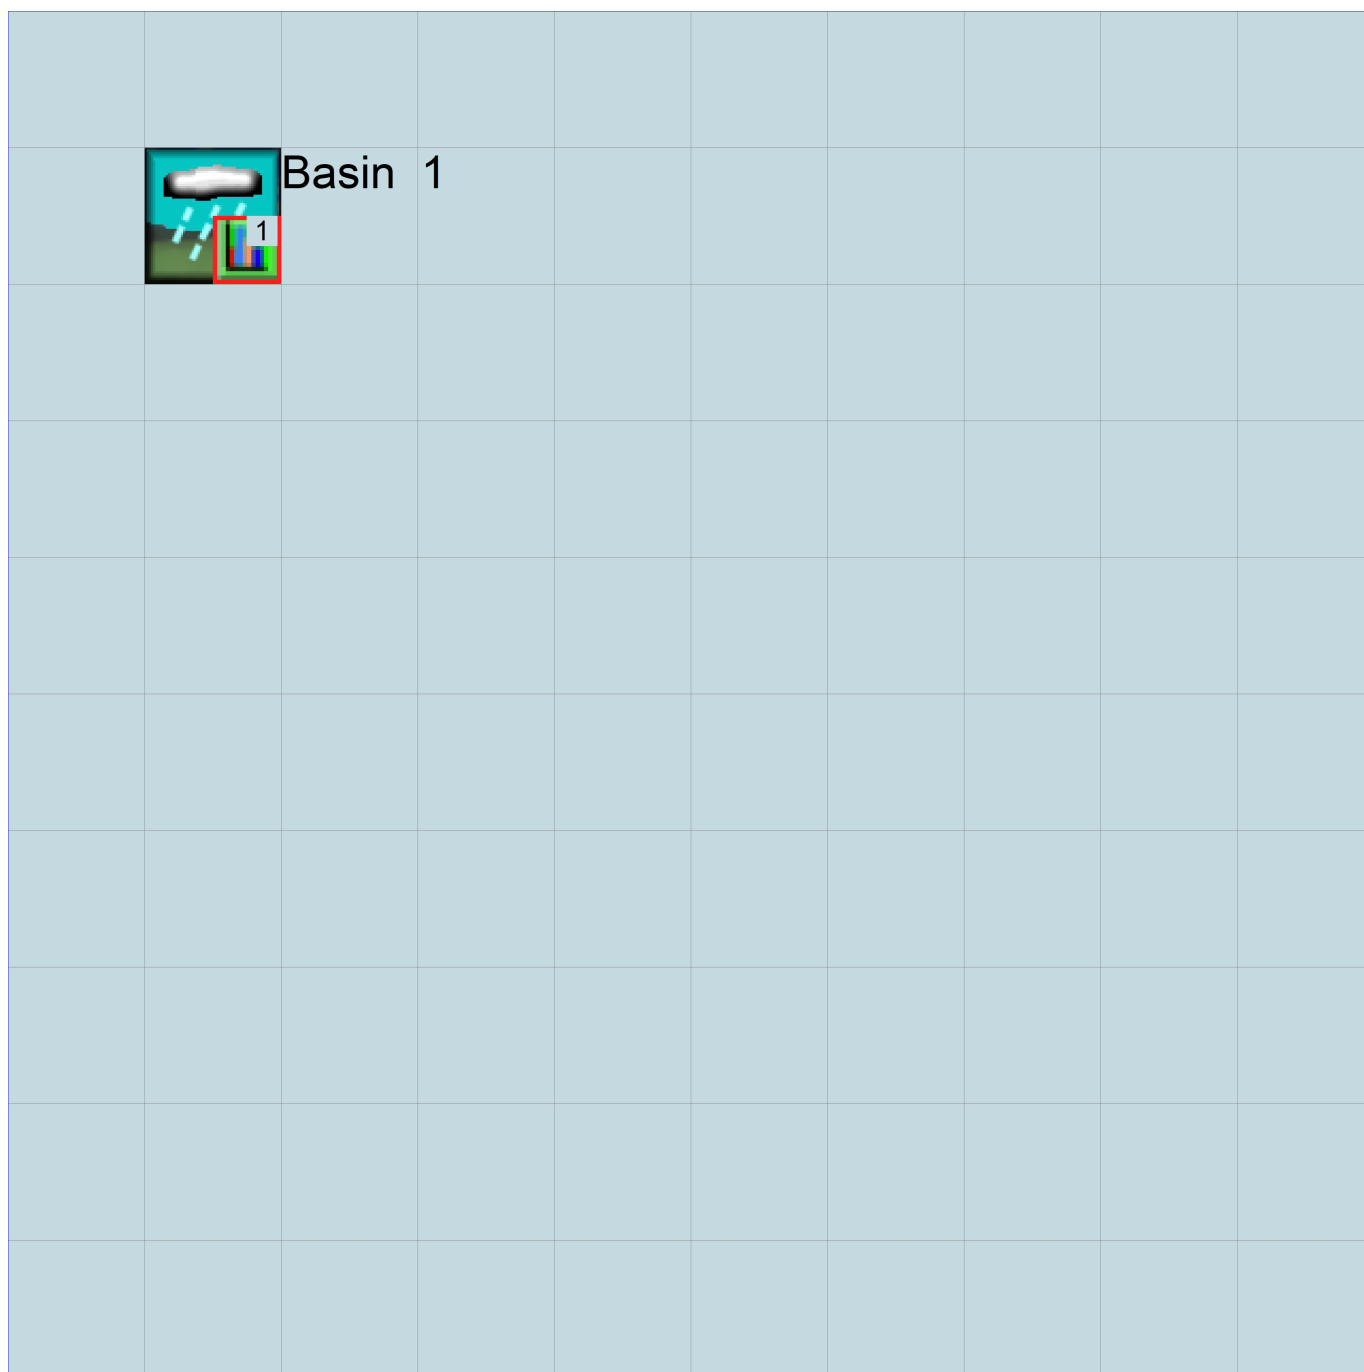
## Mitigated Schematic

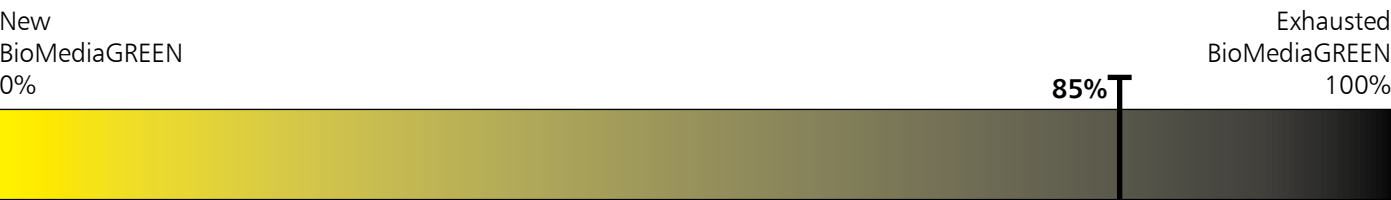
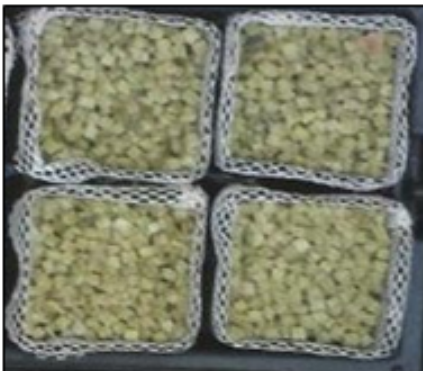
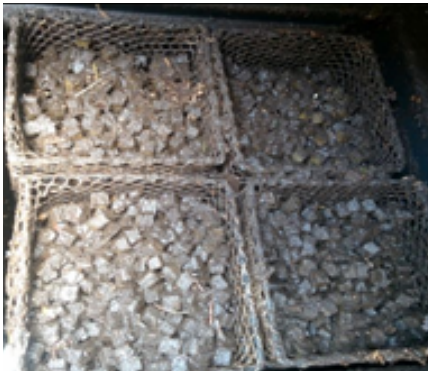
5. Through visual observation, inspect the condition of the pre-filter cartridges. Look for excessive build-up of sediment on the cartridges, any build-up on the tops of the cartridges, or clogging of the holes. Record this information on the inspection form. The prefilter cartridges can be further inspected by removing the cartridge tops and assessing the color of the BioMediaGREEN filter cubes (requires entry into pre-treatment chamber - see notes previous notes regarding confined space entry). Record the color of the material. New material is a light green color. As the media becomes clogged, it will turn darker in color, eventually becoming dark brown or black. The closer to black the media is the higher percentage that the media is exhausted and is in need of replacement.

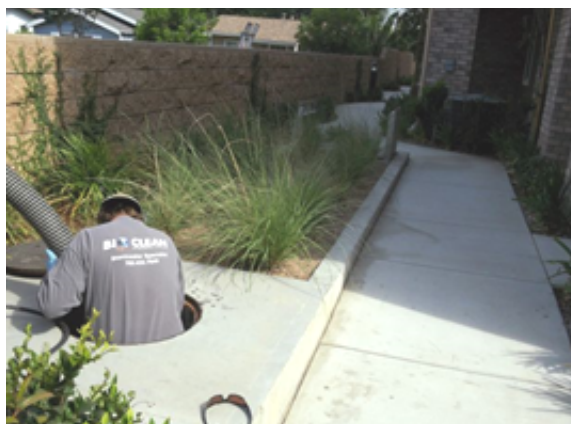
7. Place the vacuum hose over each individual media filter to suck out filter media.

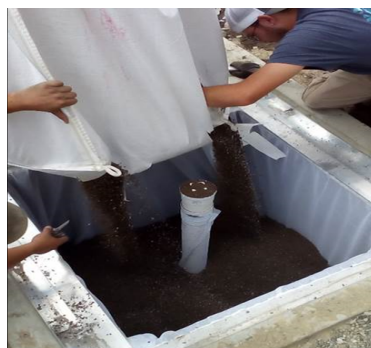
14. Contact one of Contech's Maintenance Team members at <https://www.conteches.com/maintenance> to order new WetlandMedia. The quantity of media needed can be determined by providing the model number and unit depth. Media will be provided in super sacks for easy installation. Each sack will weigh between 1000 and 2000 lbs. A lifting apparatus (backhoe, boom truck, or other) is recommended to position the super sack over the biofiltration chamber. Fill the media cages up to the same level as the old media. Replant with vegetation.

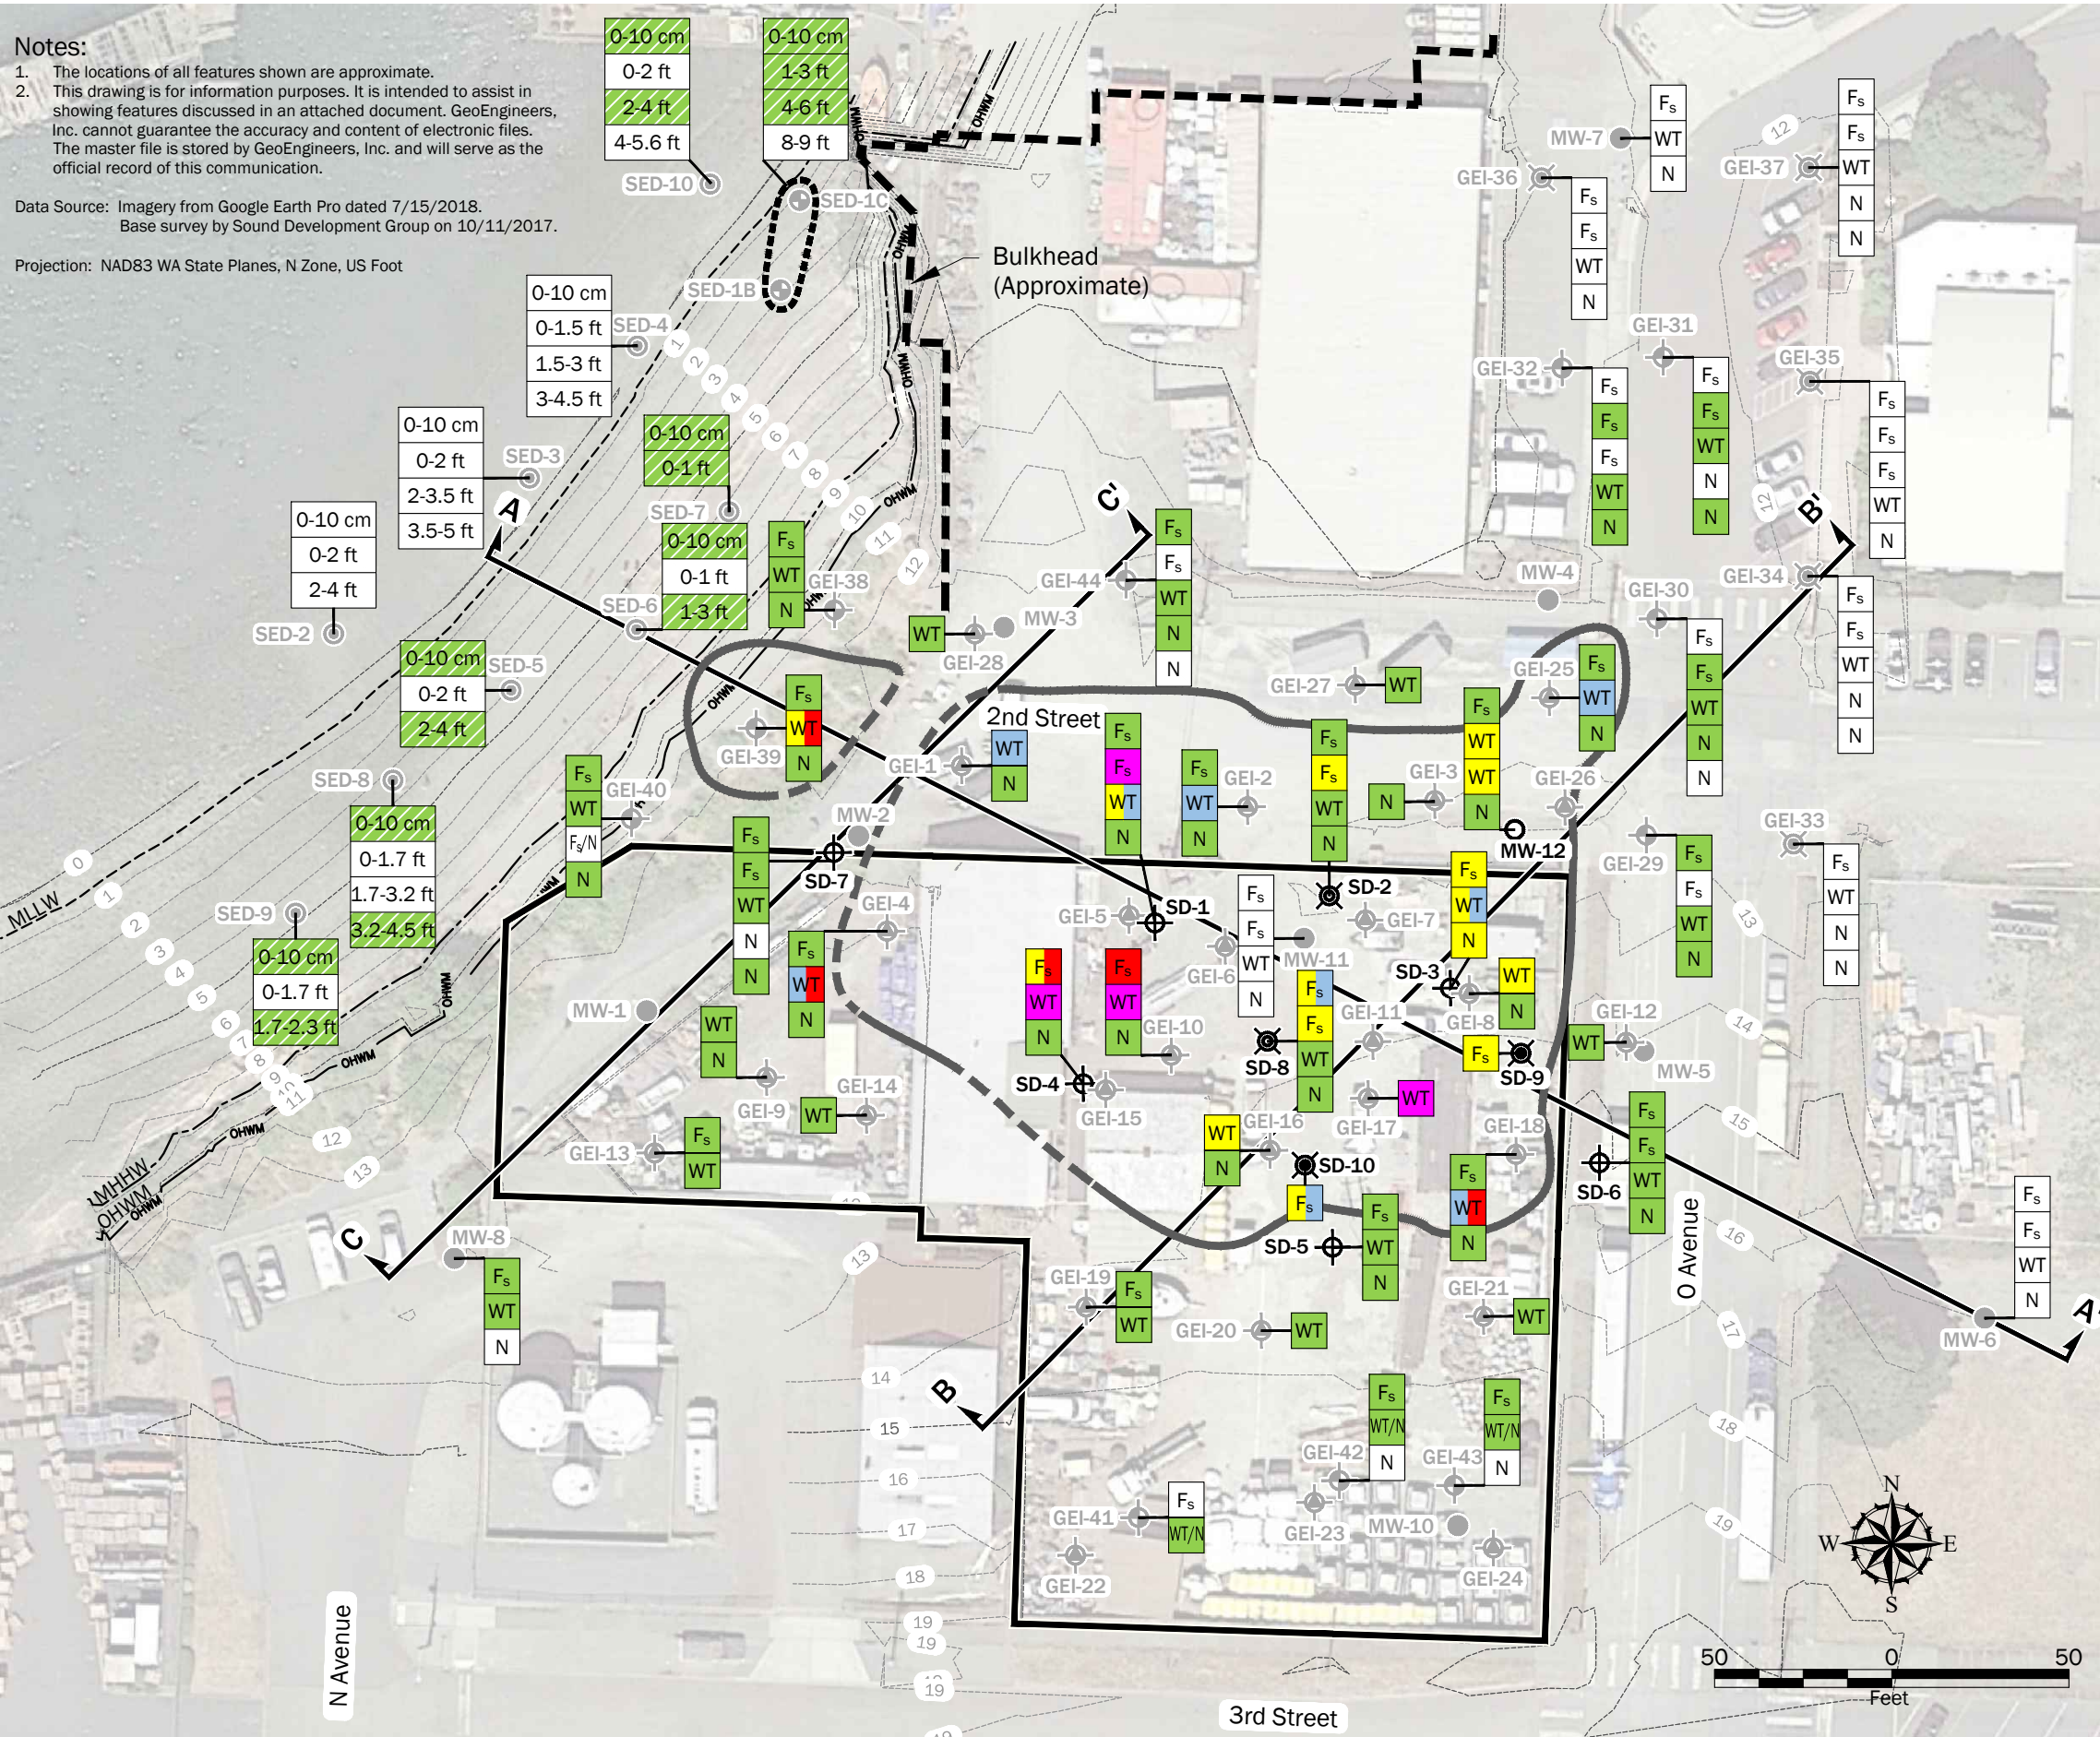
Figure 5

## Approximate Extent of Petroleum Contamination in Soil

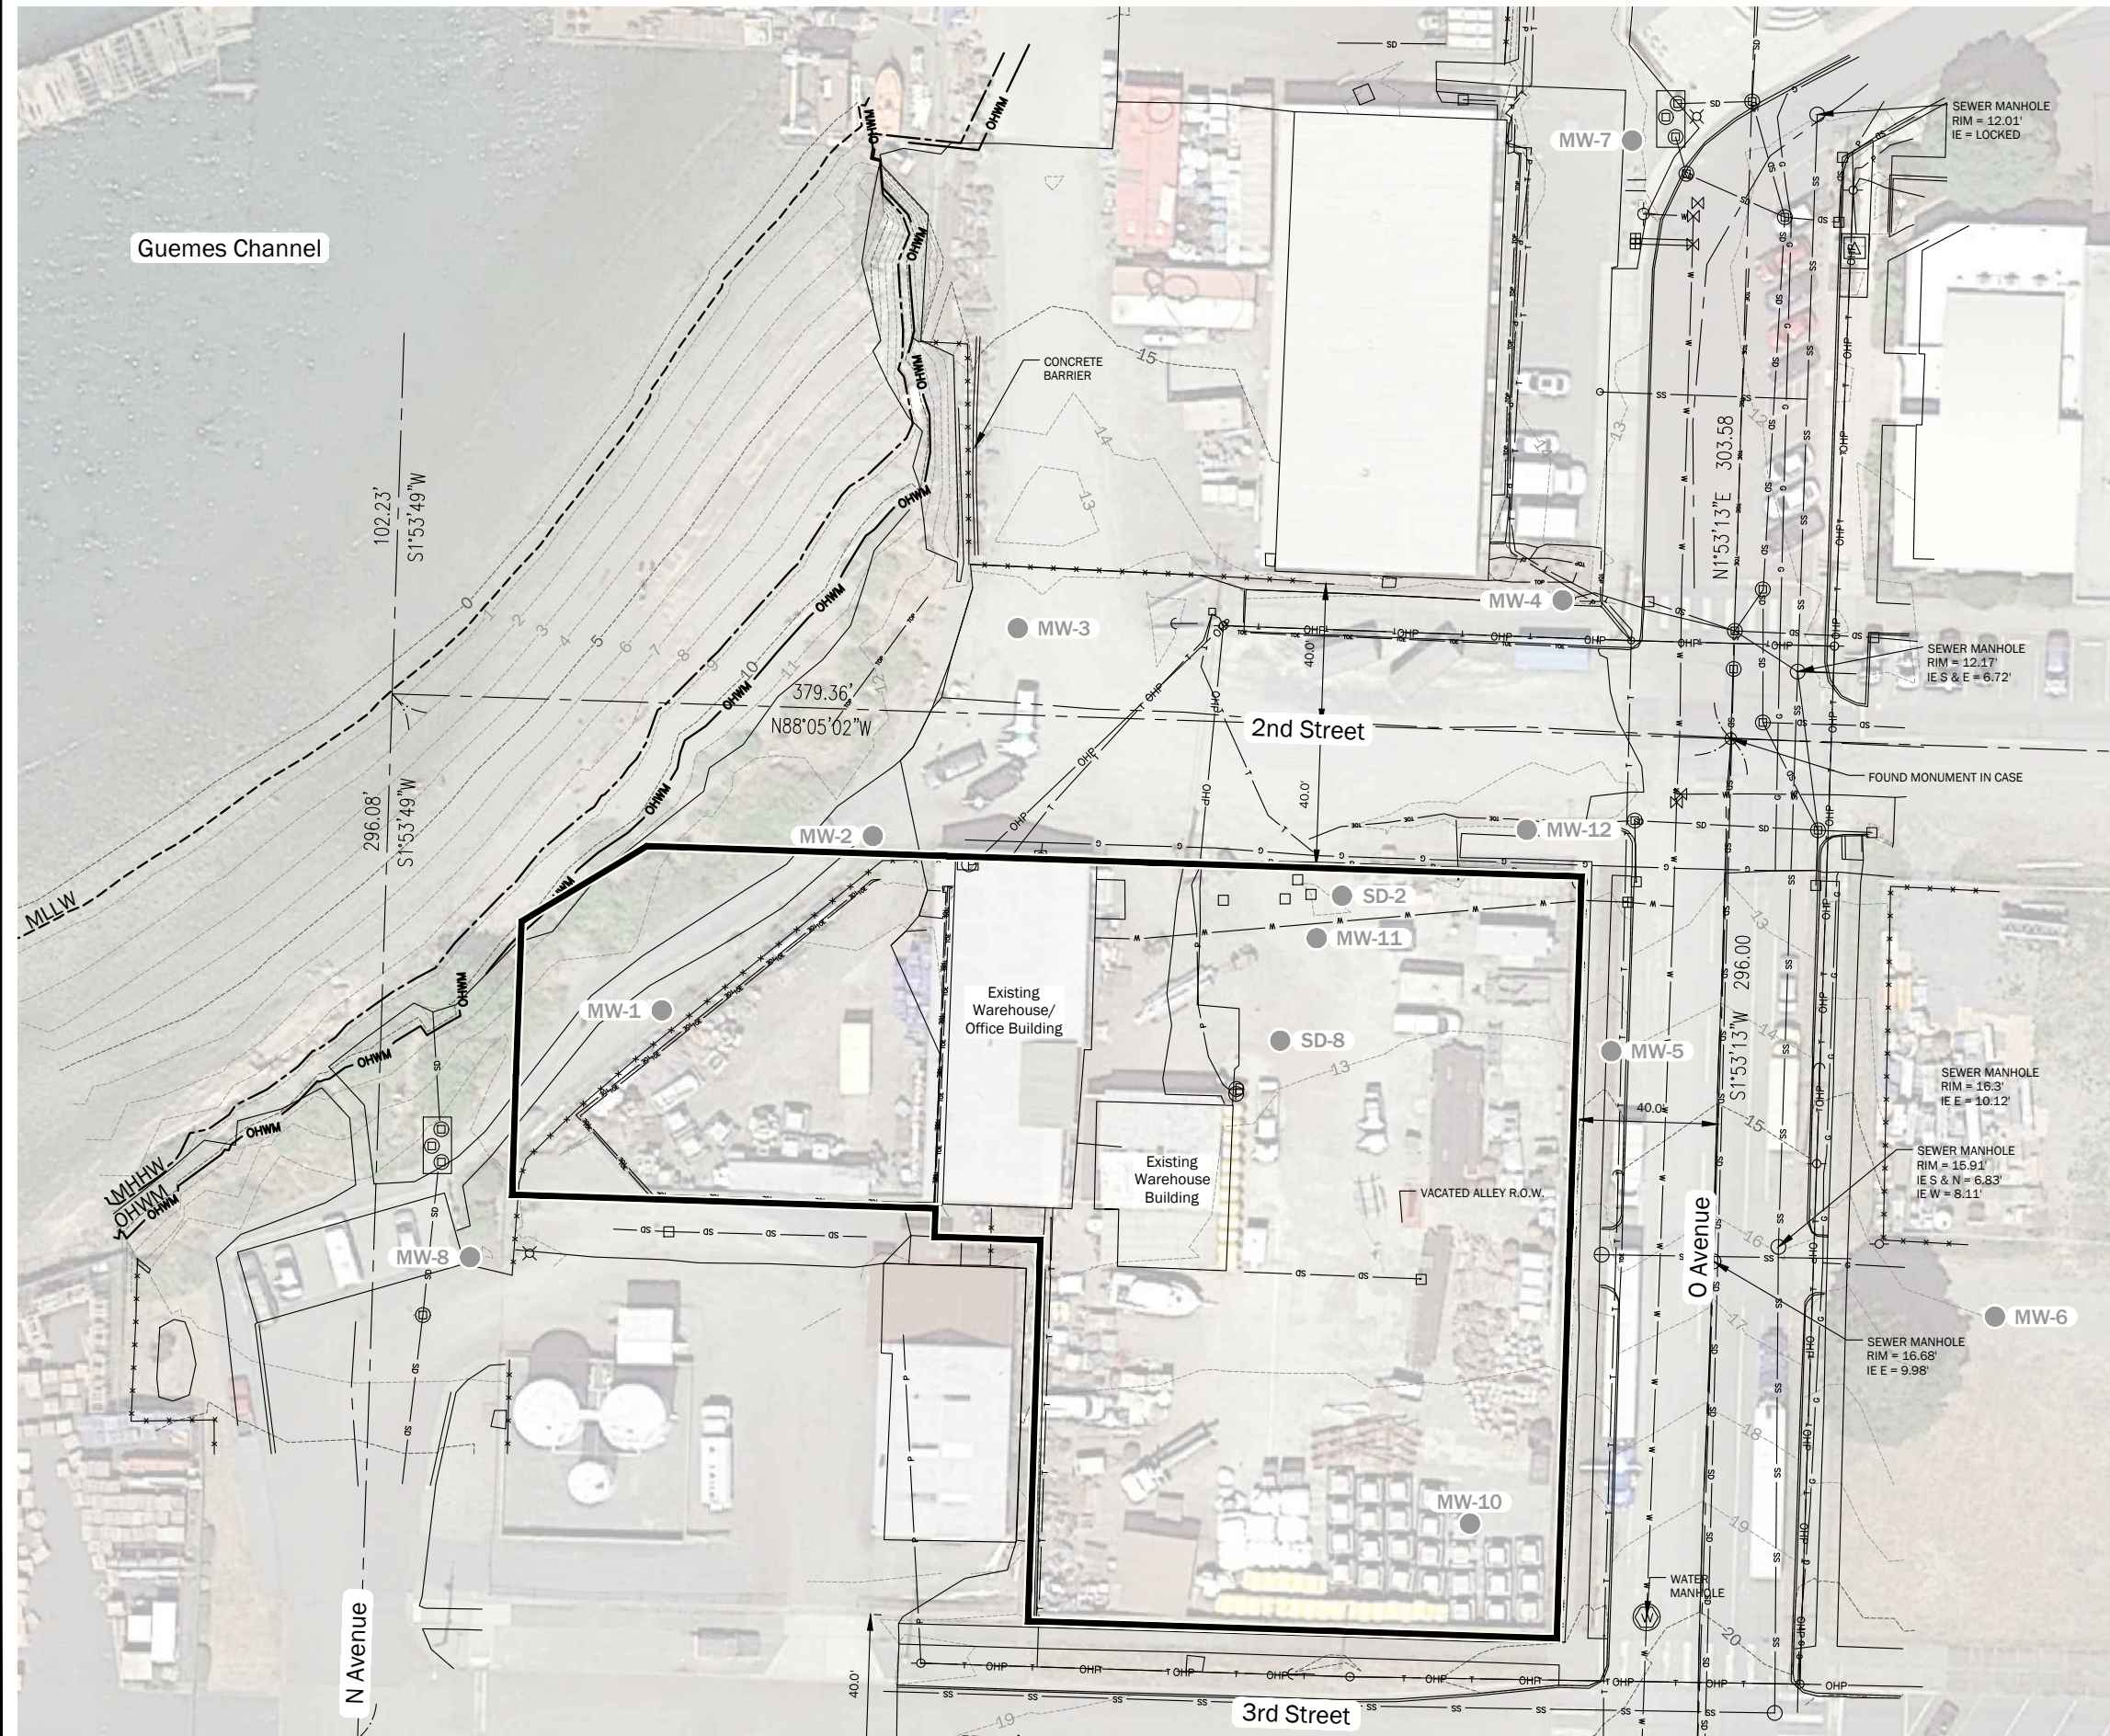
Figure 9

### Existing Site Conditions

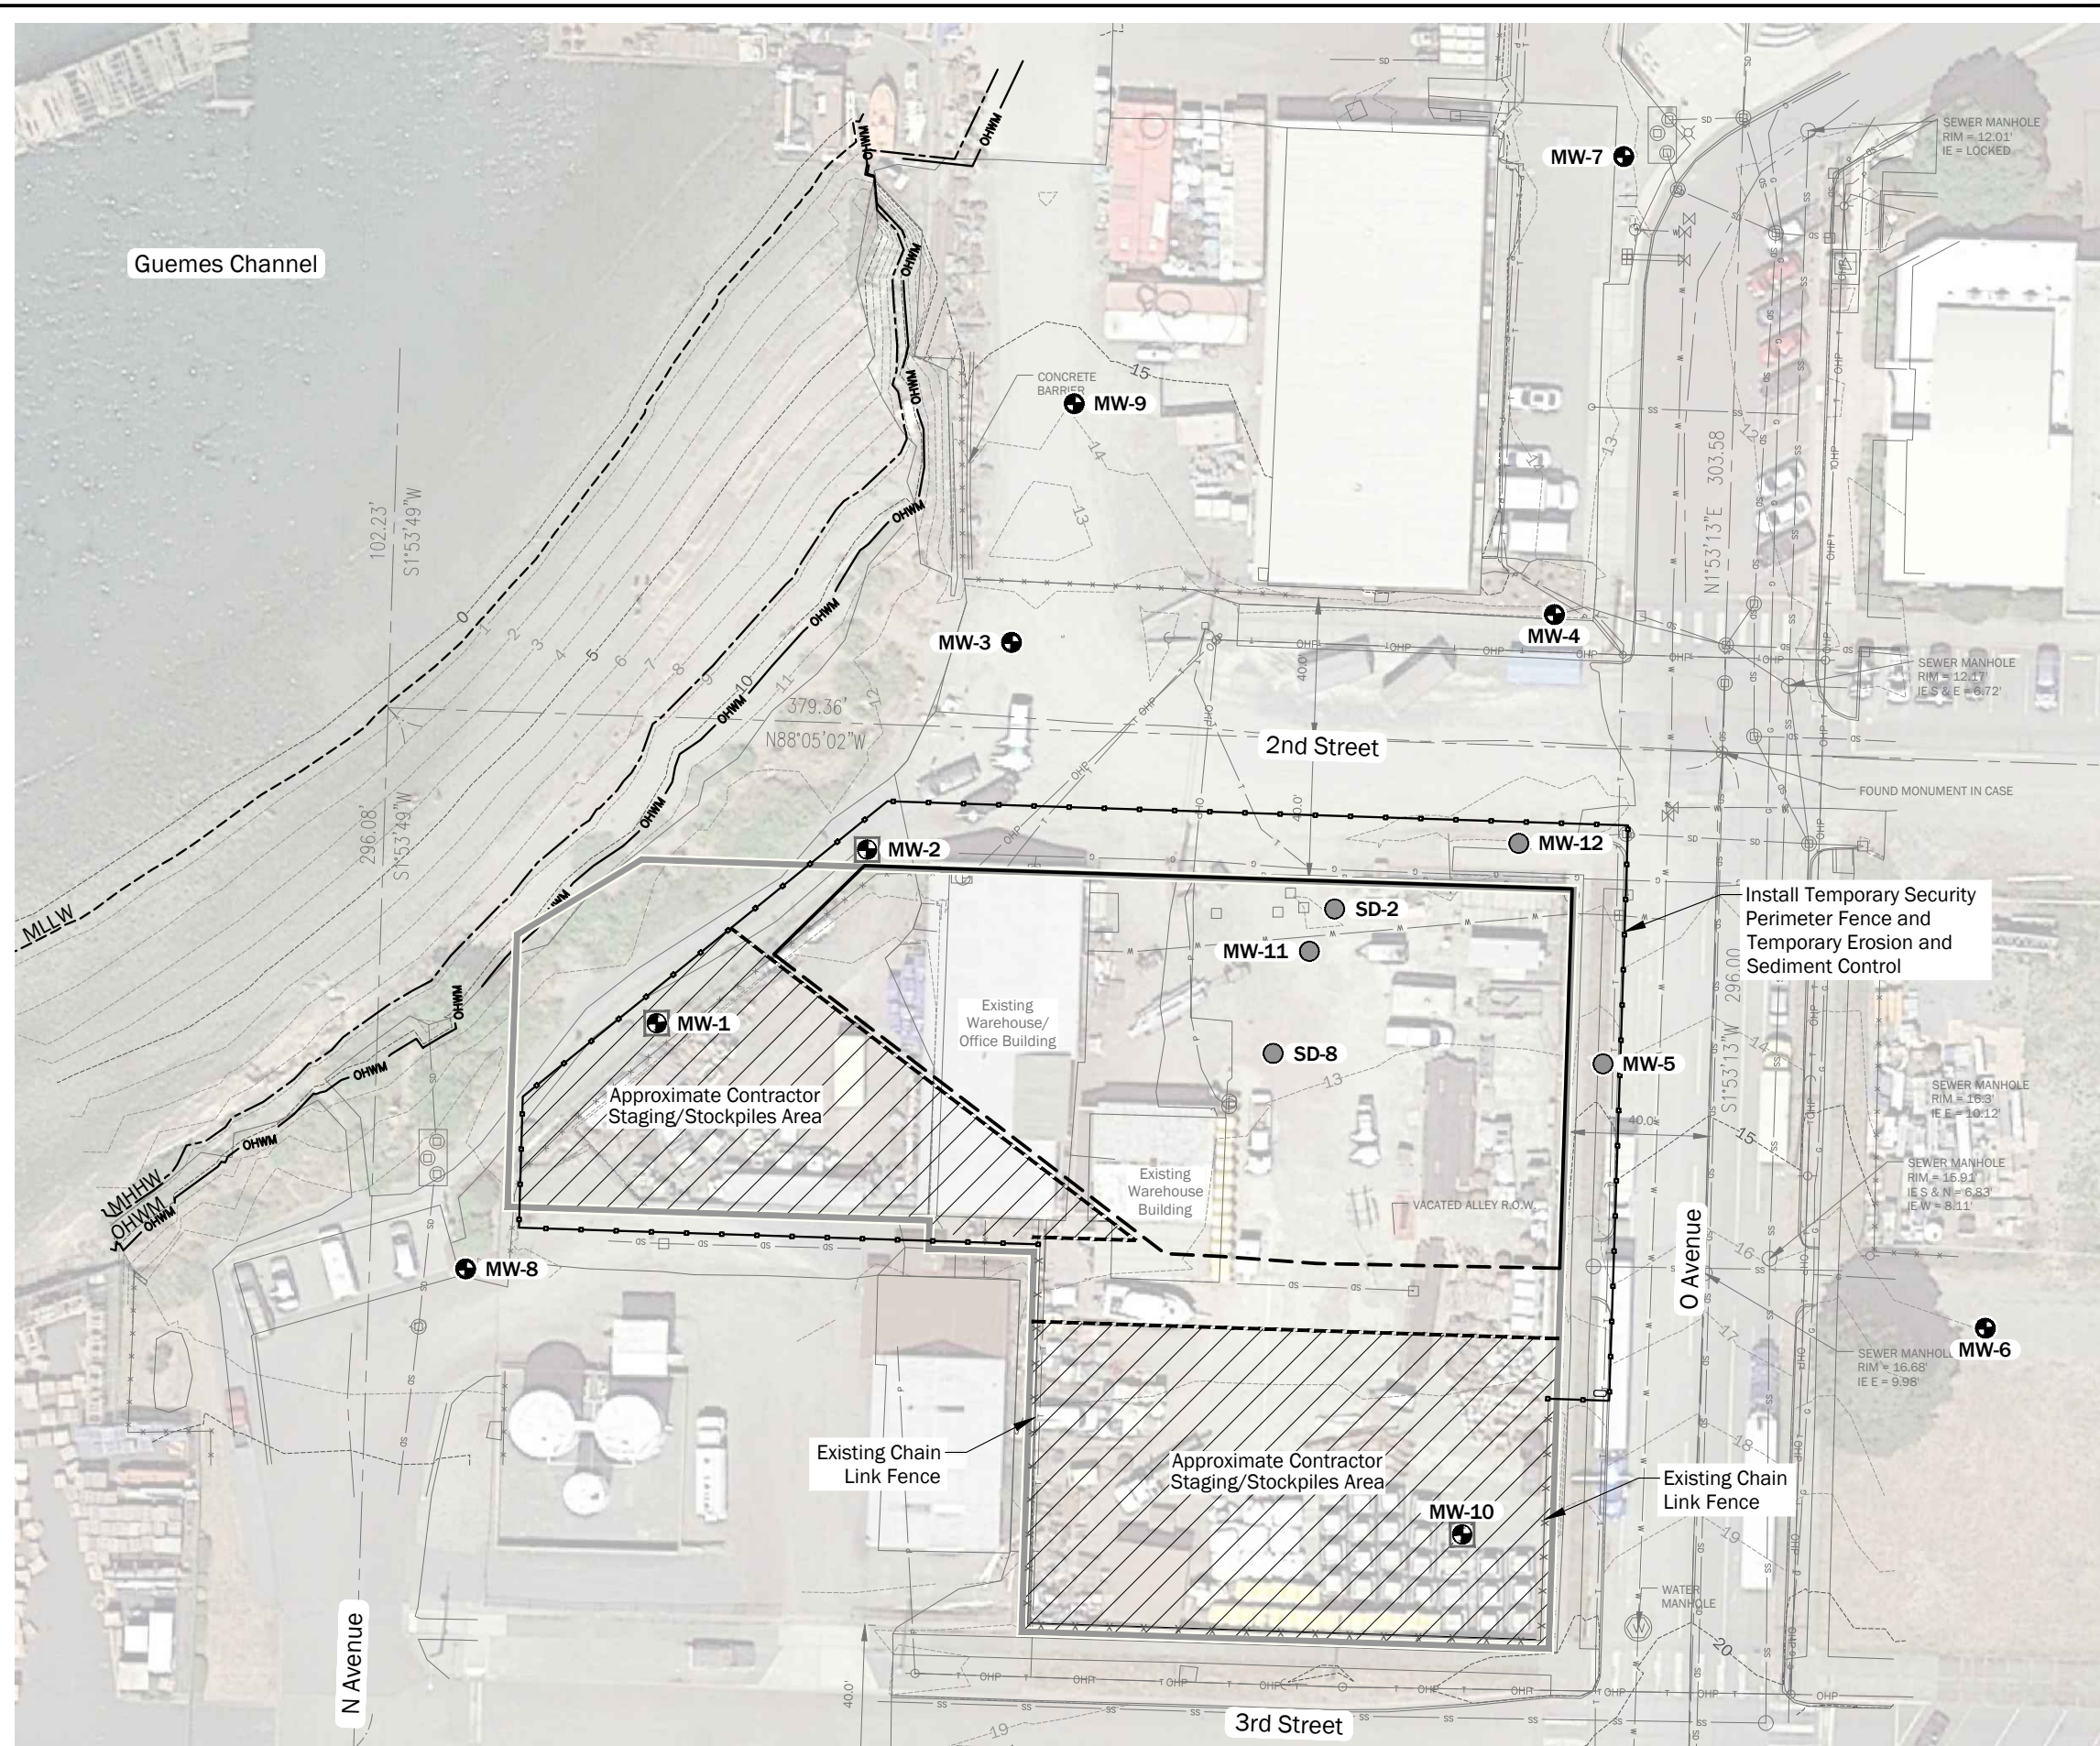
Figure 10

### Temporary Site Controls and Contractor Staging Plan

The southern portion of the Site, where contamination is not present will be available to the contractor for staging as shown on Figure 10. The contractor may propose a different location for staging for Port's approval. The contractor will be responsible for protecting existing surfaces, including existing monitoring wells, used for the staging areas.

The southern portion of the Property will be available for temporary stockpiling as shown on Figure 10. The contractor may use this area or propose a different area for temporarily stockpiling excavated material for Port's approval.

Eleven groundwater monitoring wells including MW-1 through MW-8 and MW-10 through MW-12 are currently located at/near the Site as shown on Figure 10. Monitoring wells located within the excavation limits and equipment operation area will be decommissioned prior to performing excavation activities. Five monitoring wells including MW-2, MW-11, MW-12, SD-02 and SD-08 are located within or immediately adjacent to the limits of excavation and therefore are planned to be decommissioned. The other existing monitoring wells will be protected in place to the extent possible.
