## ANACORTES PLANNING COMMISSION

**May 24, 2023**

### **AGENDA**

- A. Roll Call**
- B. Minutes**
  - 1) Minutes of May 8, 2023
- C. Correspondence**
- D. New Business**
  - 1) Appoint new vice chair.
  - 2) Open Record Public Hearing and Decision for Shoreline Substantial Development Permit SDP-2023-0002 Port of Anacortes 2nd Street and Curtis Wharf project.
- E. Old Business**

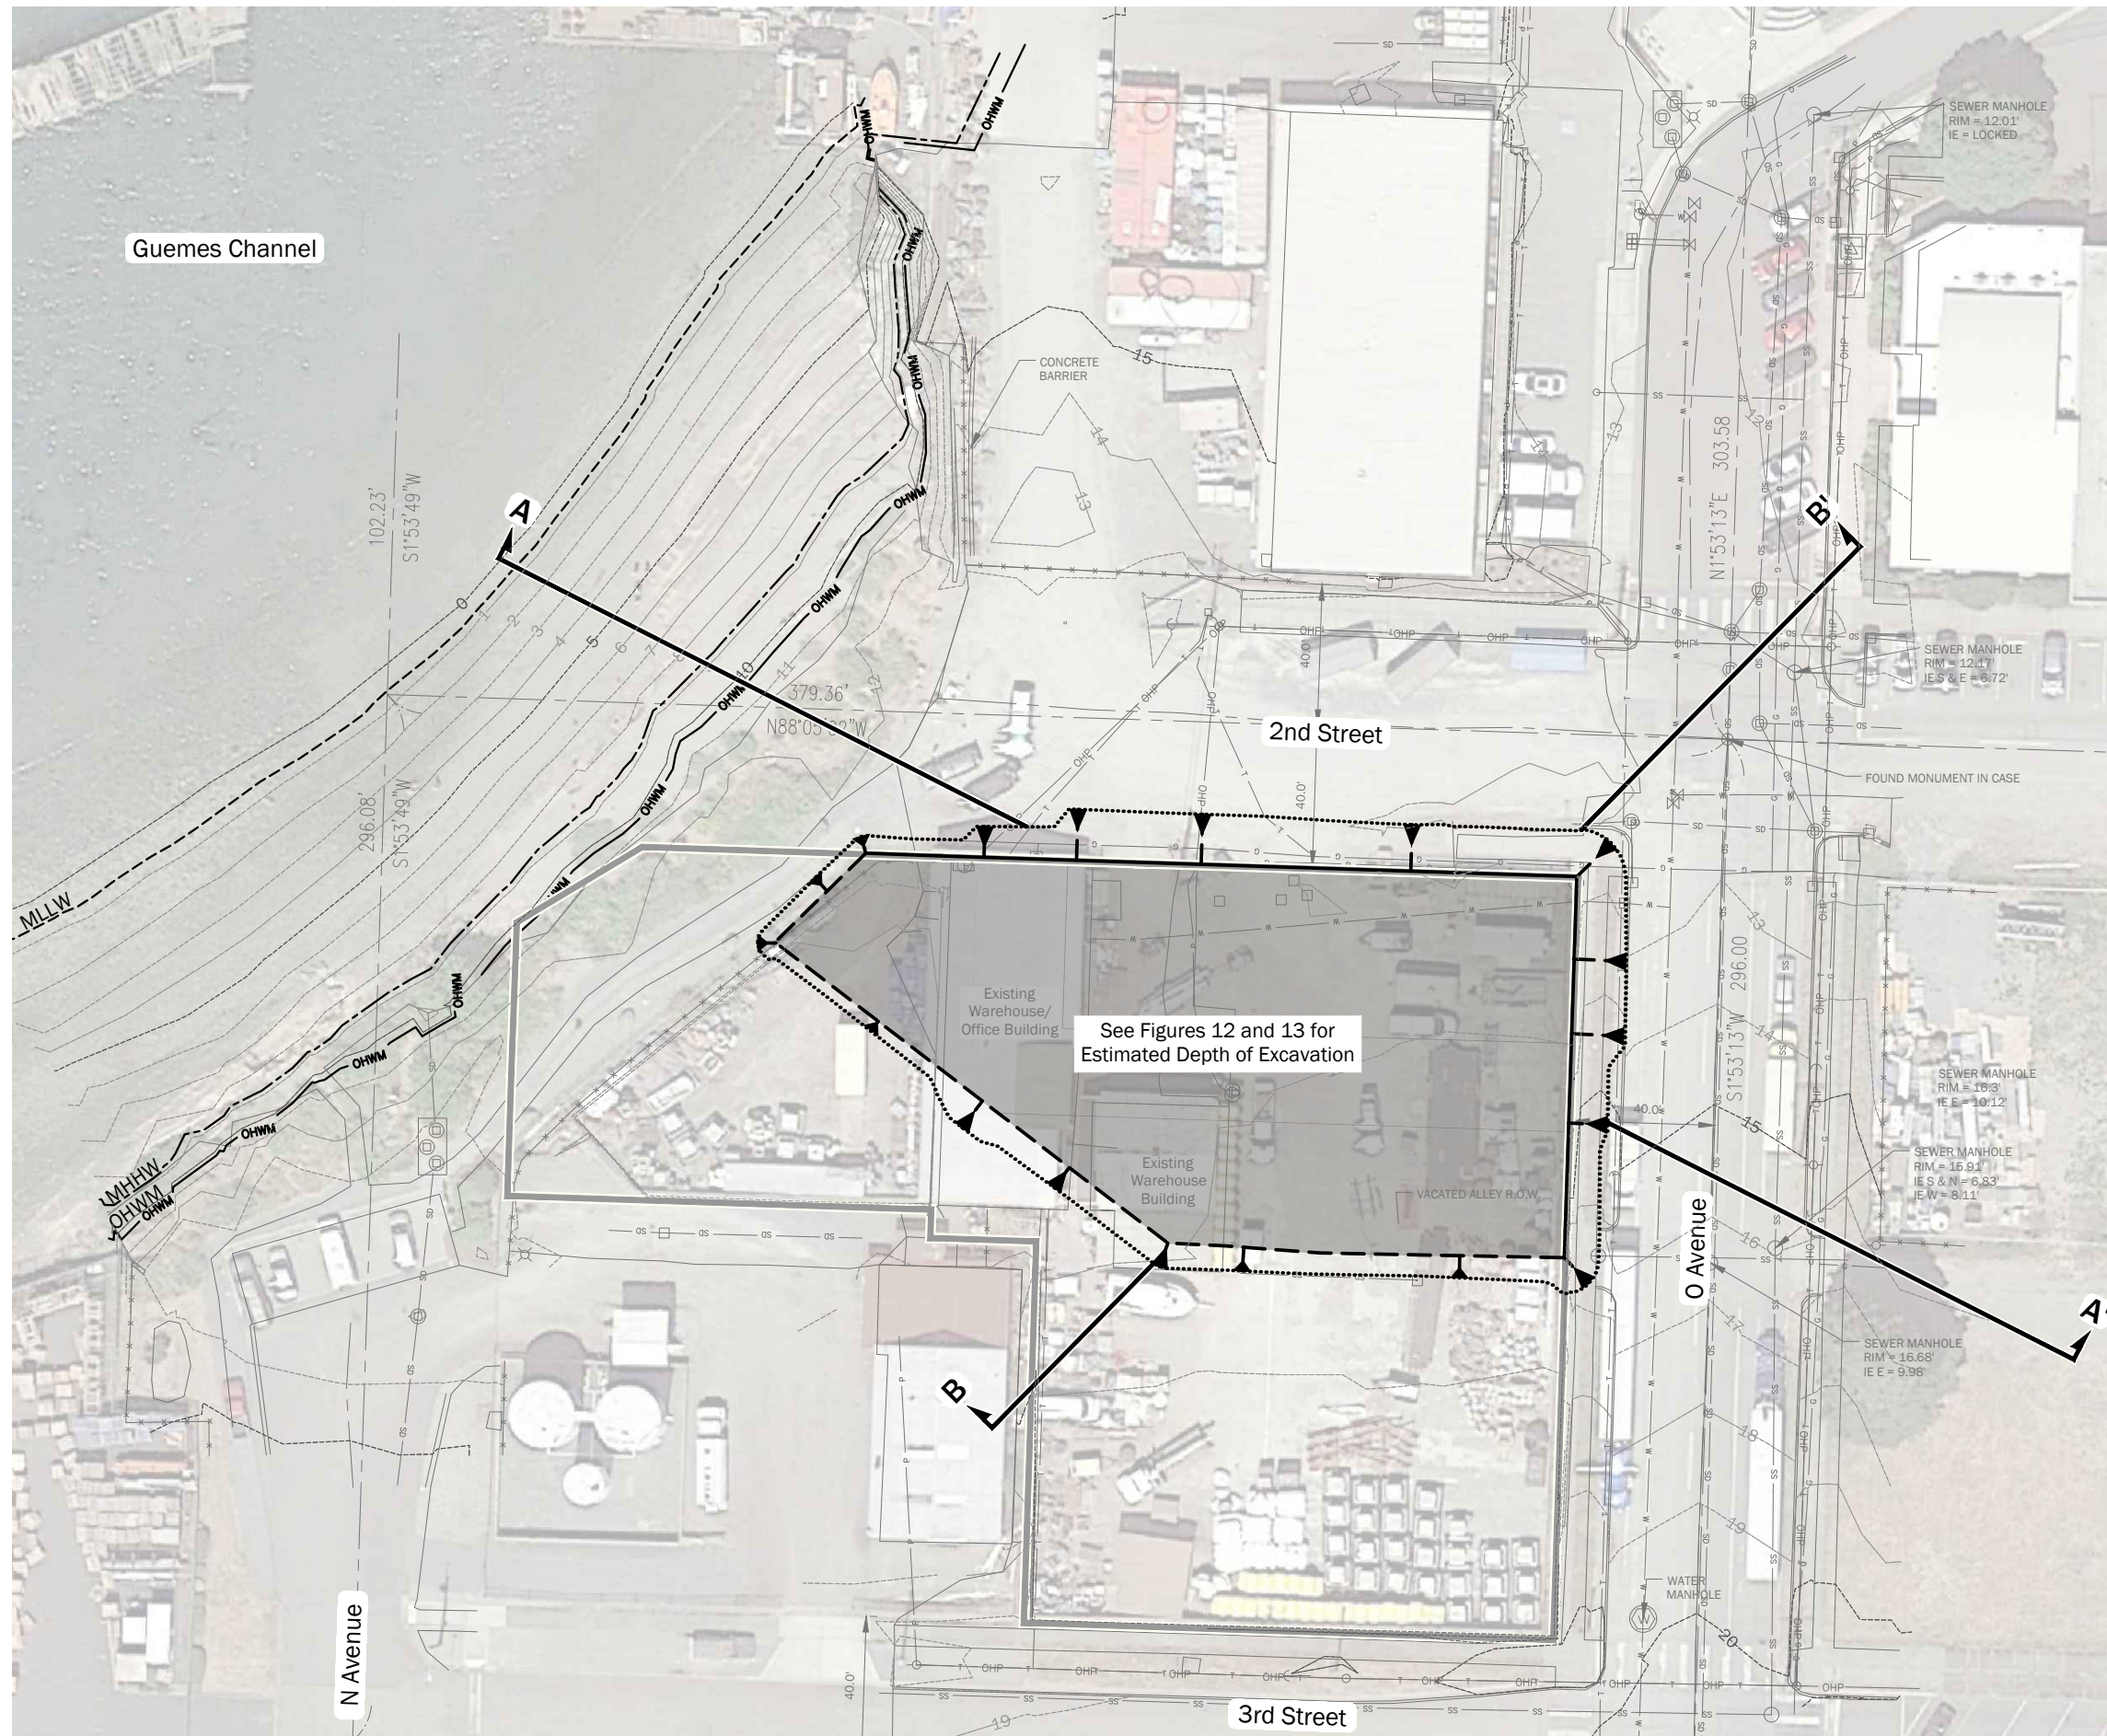
Figure 11

#### Remedial Excavation Plan

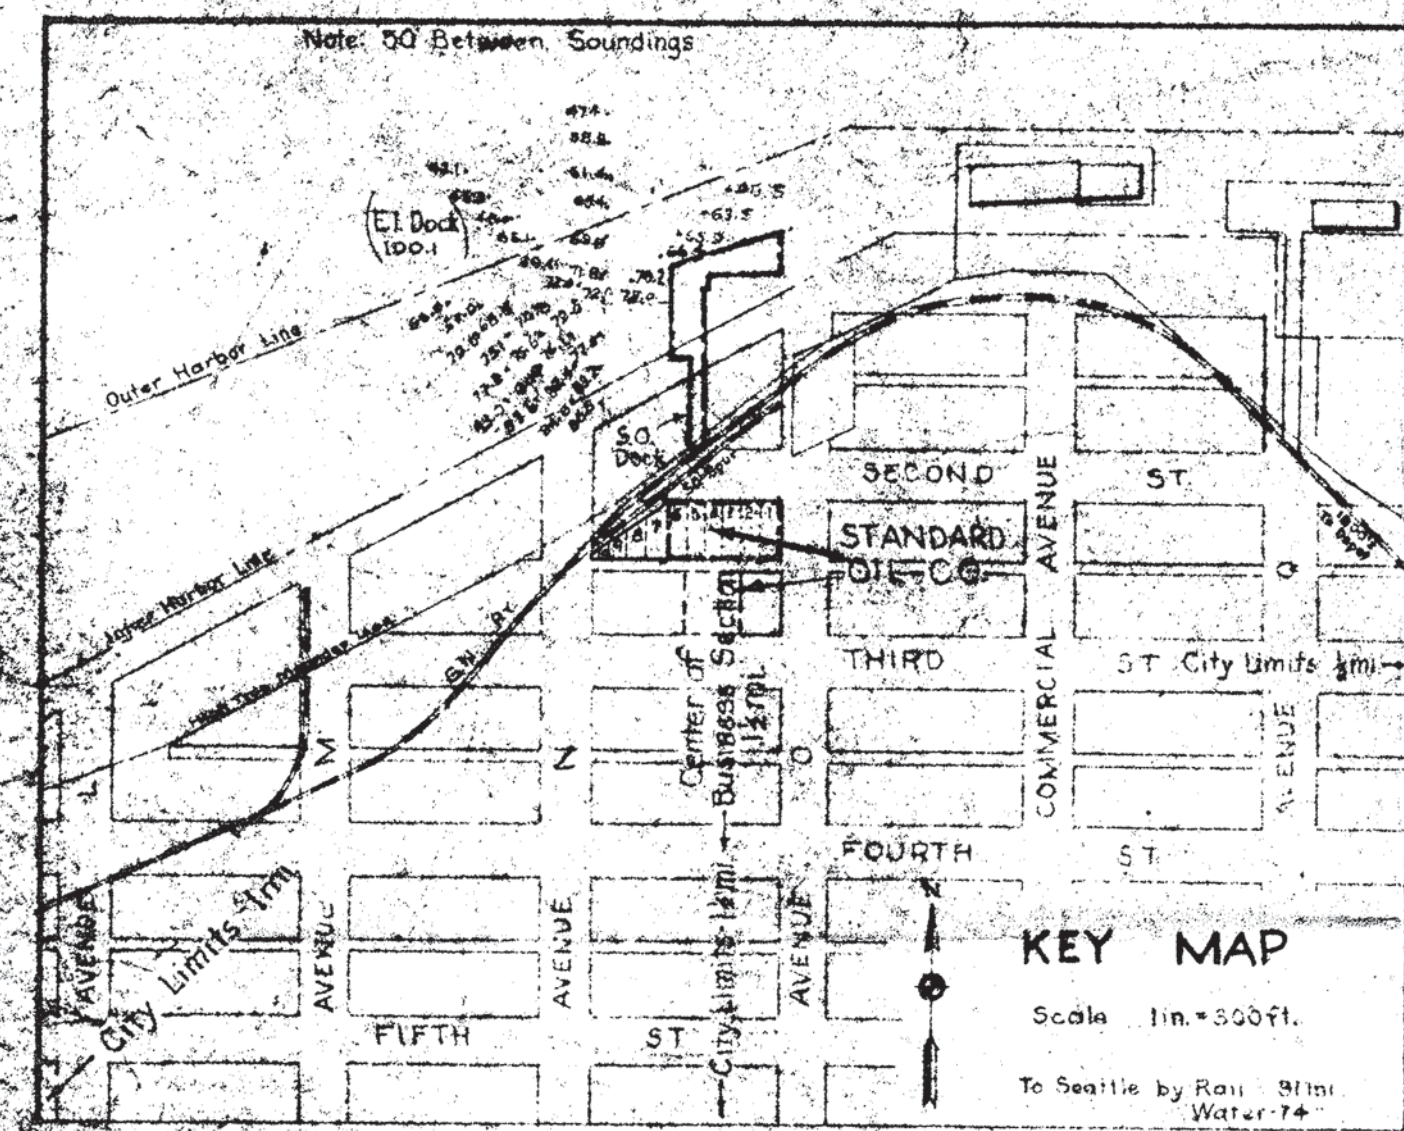
### **Standard Oil Bulk Fuel Terminal Layout**

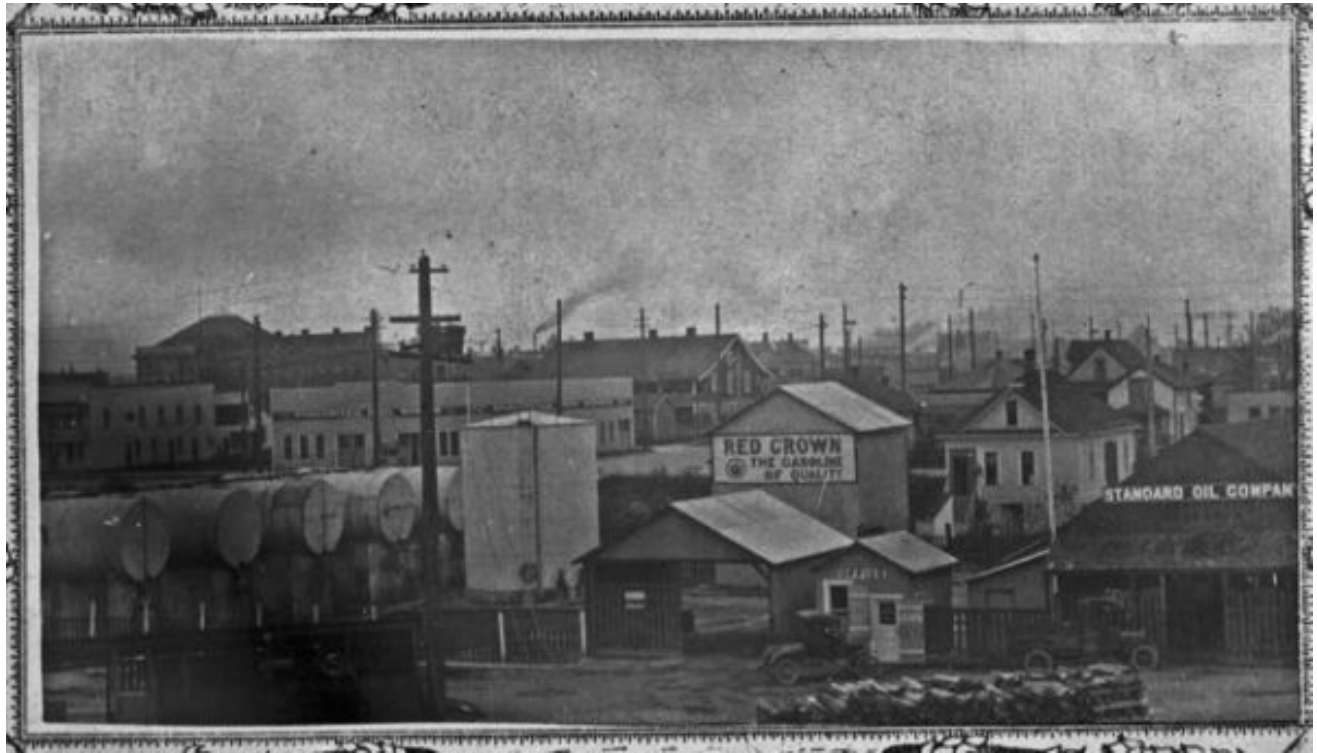
Photocopy of photograph (Original print, Anacortes Museum.) The Standard Oil complex is forefront in this image with tanks, a Red Crown gasoline facility (part of Standard Oil) and Standard Oil Company offices in the lower right. Anacortes Iron Works (1019 3rd Street) is located behind the tanks at 3rd Street and O Avenue.

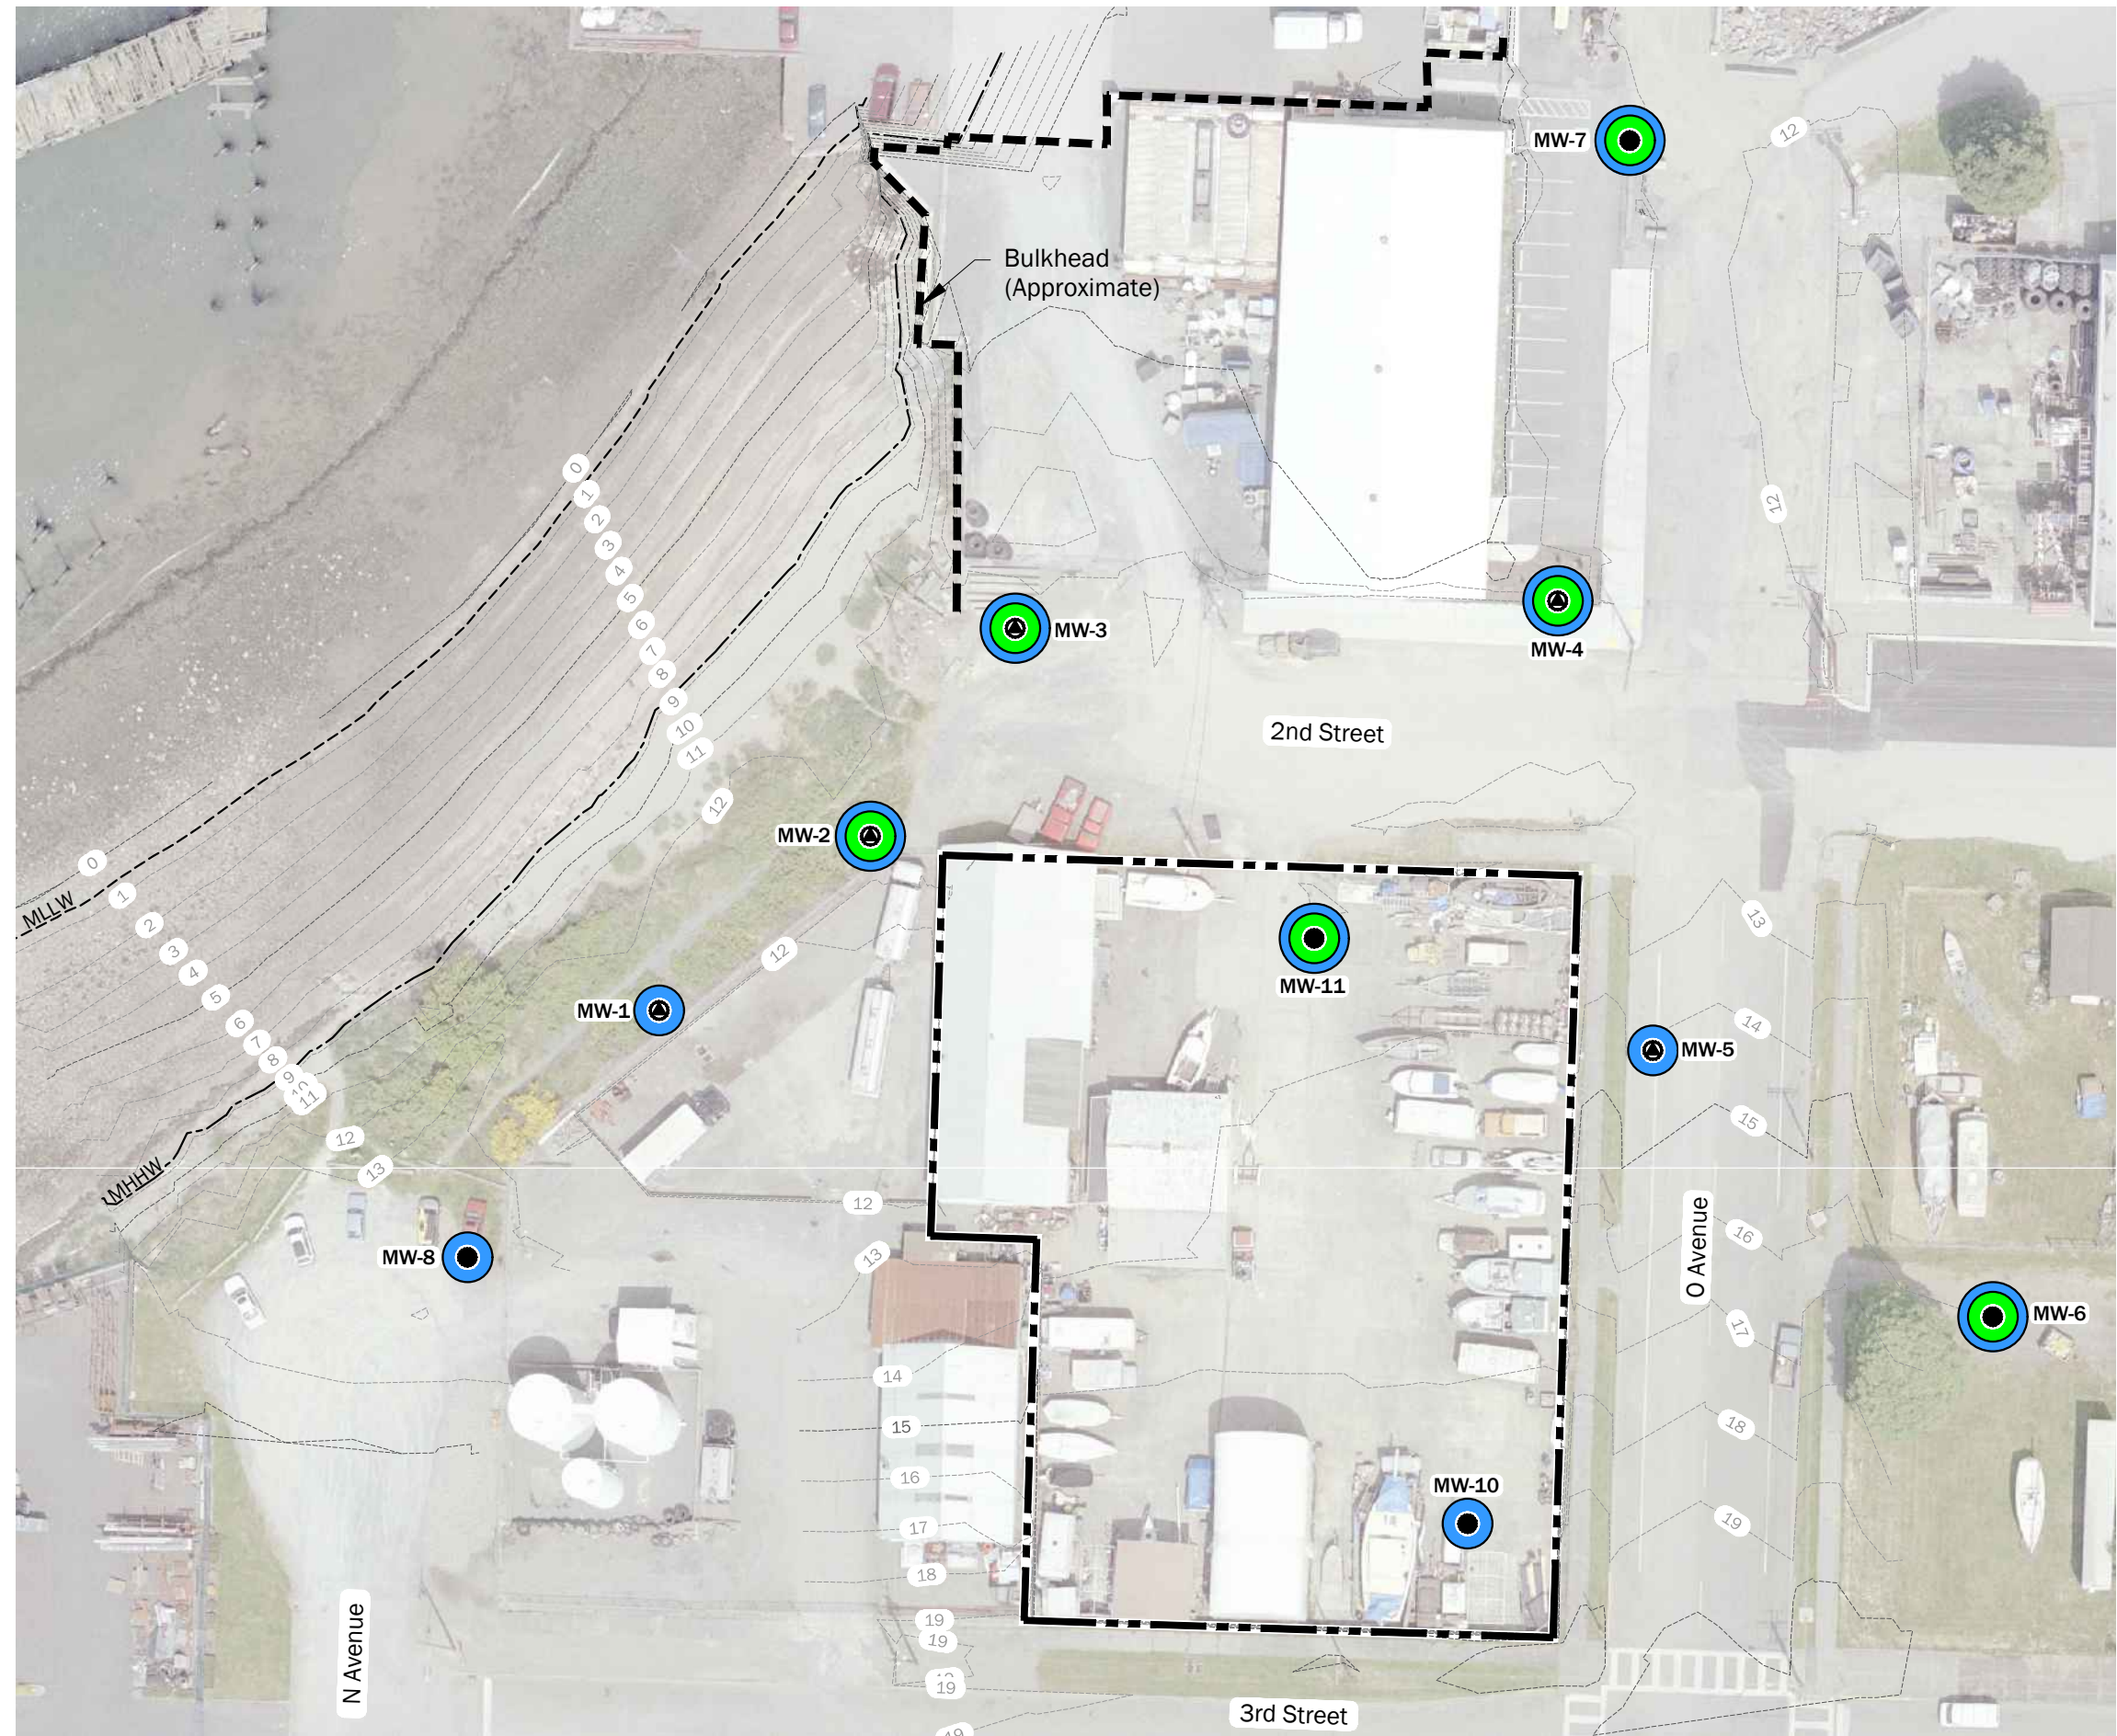
**Figure 3**

- Quiet Cove Property Boundary
- 10--- Contour (Feet, NAVD 88)
- MW-6 ● RI Monitoring Well
- MW-1 ● Focused Site Investigation Monitoring Well
- Slug Test Location
- 72-Hour Tidal Study Location

The hydraulic conductivity for the aquifer was estimated using the results of slug testing in six monitoring wells (MW-2, MW-3, MW-4, MW-6, MW-7, and MW-11) as shown on Figure 4. Diffusivity could not be used to estimate the hydraulic parameters due to the unproportional timing and degree of the observed tidal influence. Based on the slug test results, hydraulic conductivity for the aquifer ranges between 0.02 and 4.11 feet/day with a mean value of 1.25 feet/day. Attachment 4 has additional details on how the hydraulic conductivity was calculated.

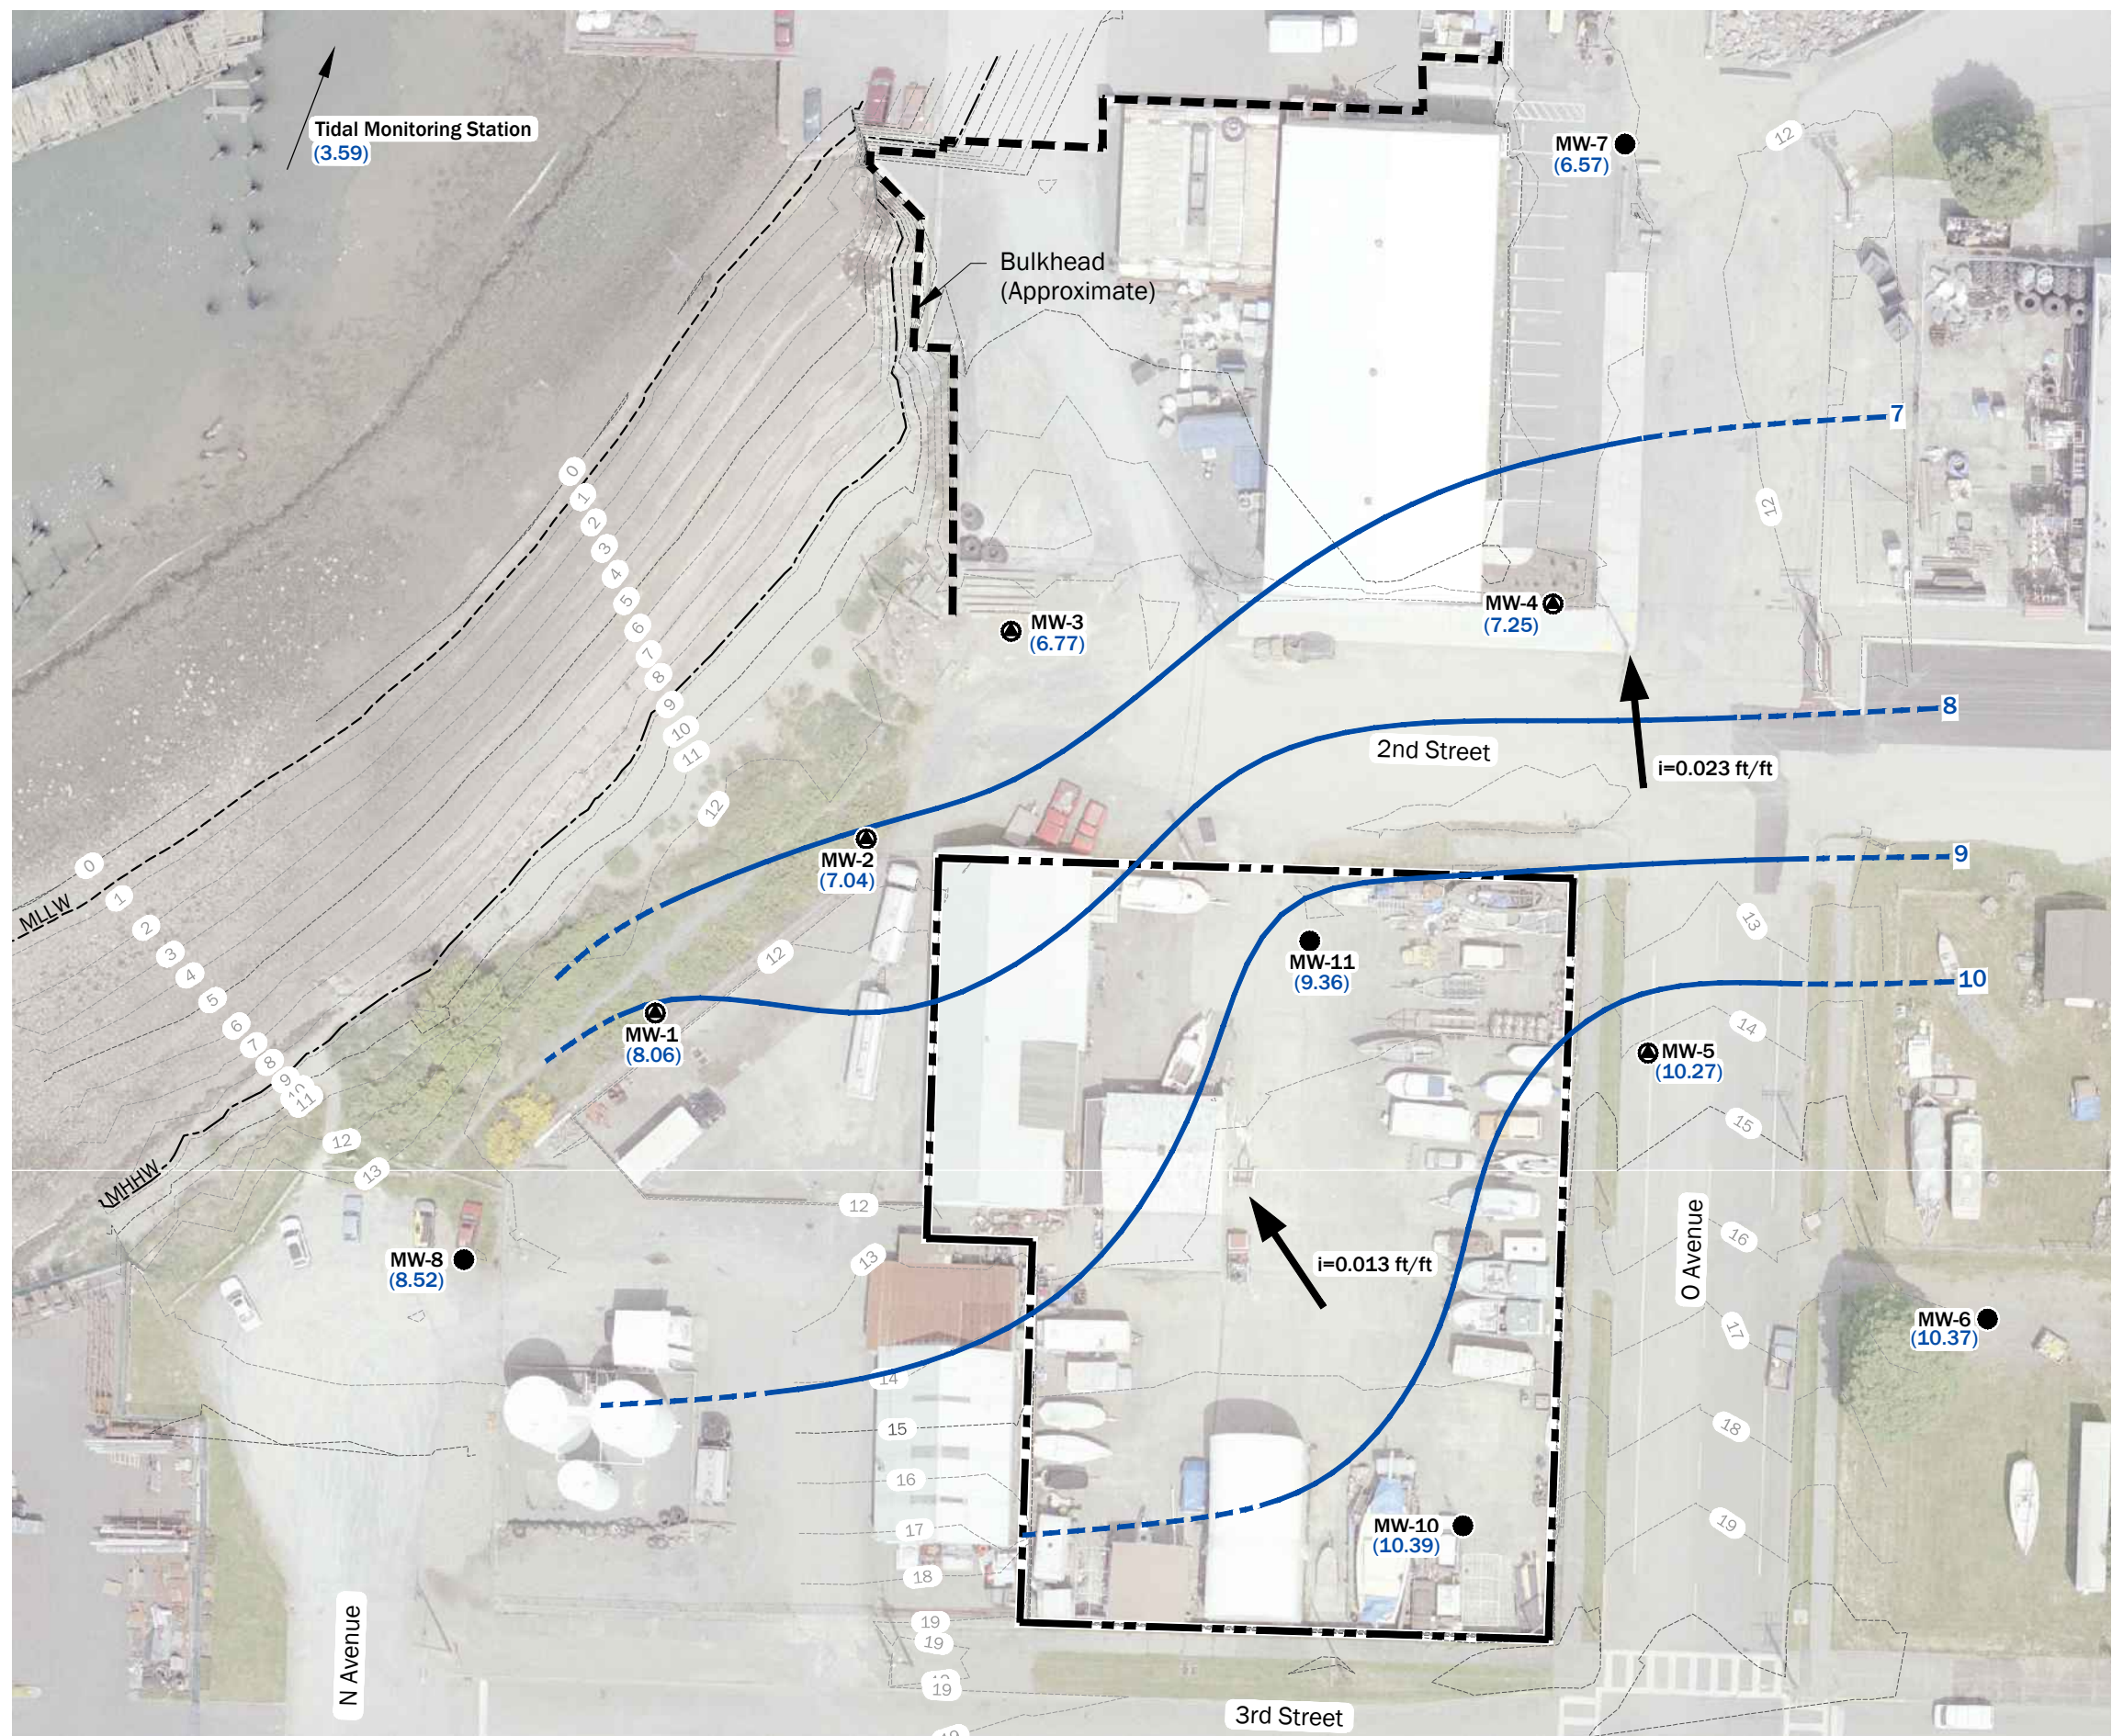
**Figure 4**

- Legend**
- Quiet Cove Property Boundary
  - 10----- Contour (Feet, NAVD 88)
  - MW-6 ● RI Monitoring Well
  - MW-1 ● Focused Site Investigation Monitoring Well
  - (10.39) Mean Groundwater Elevation (Feet, NAVD 88), 72-Hour Tidal Study
  - Groundwater Elevation Contour (Feet, NAVD 88), Mean Elevations 72-Hour Tidal Study. Dashed Where Inferred.
  - Inferred groundwater flow direction and groundwater gradient in feet per foot calculated between monitoring wells MW-10 and MW-2, and between monitoring wells MW-5 and MW-4

| <b>Mean Groundwater and Tidal Elevations,<br/>72-Hour Tidal Study</b> | |

Figure 4 shows the monitoring wells that were used for the tidal study. In general the tidal study indicated a relatively low degree of tidal influence on the monitoring wells at the Site. The three monitoring wells observed to be the most tidal influence during the 72-hour tidal study are MW-6, MW-7 and MW-10. The remaining monitoring wells used, including monitoring wells MW-1, MW-2, and MW-3 indicated less tidal influence. Further detail on the tidal study results are presented in Hydrogeologic Investigation (Attachment 4).

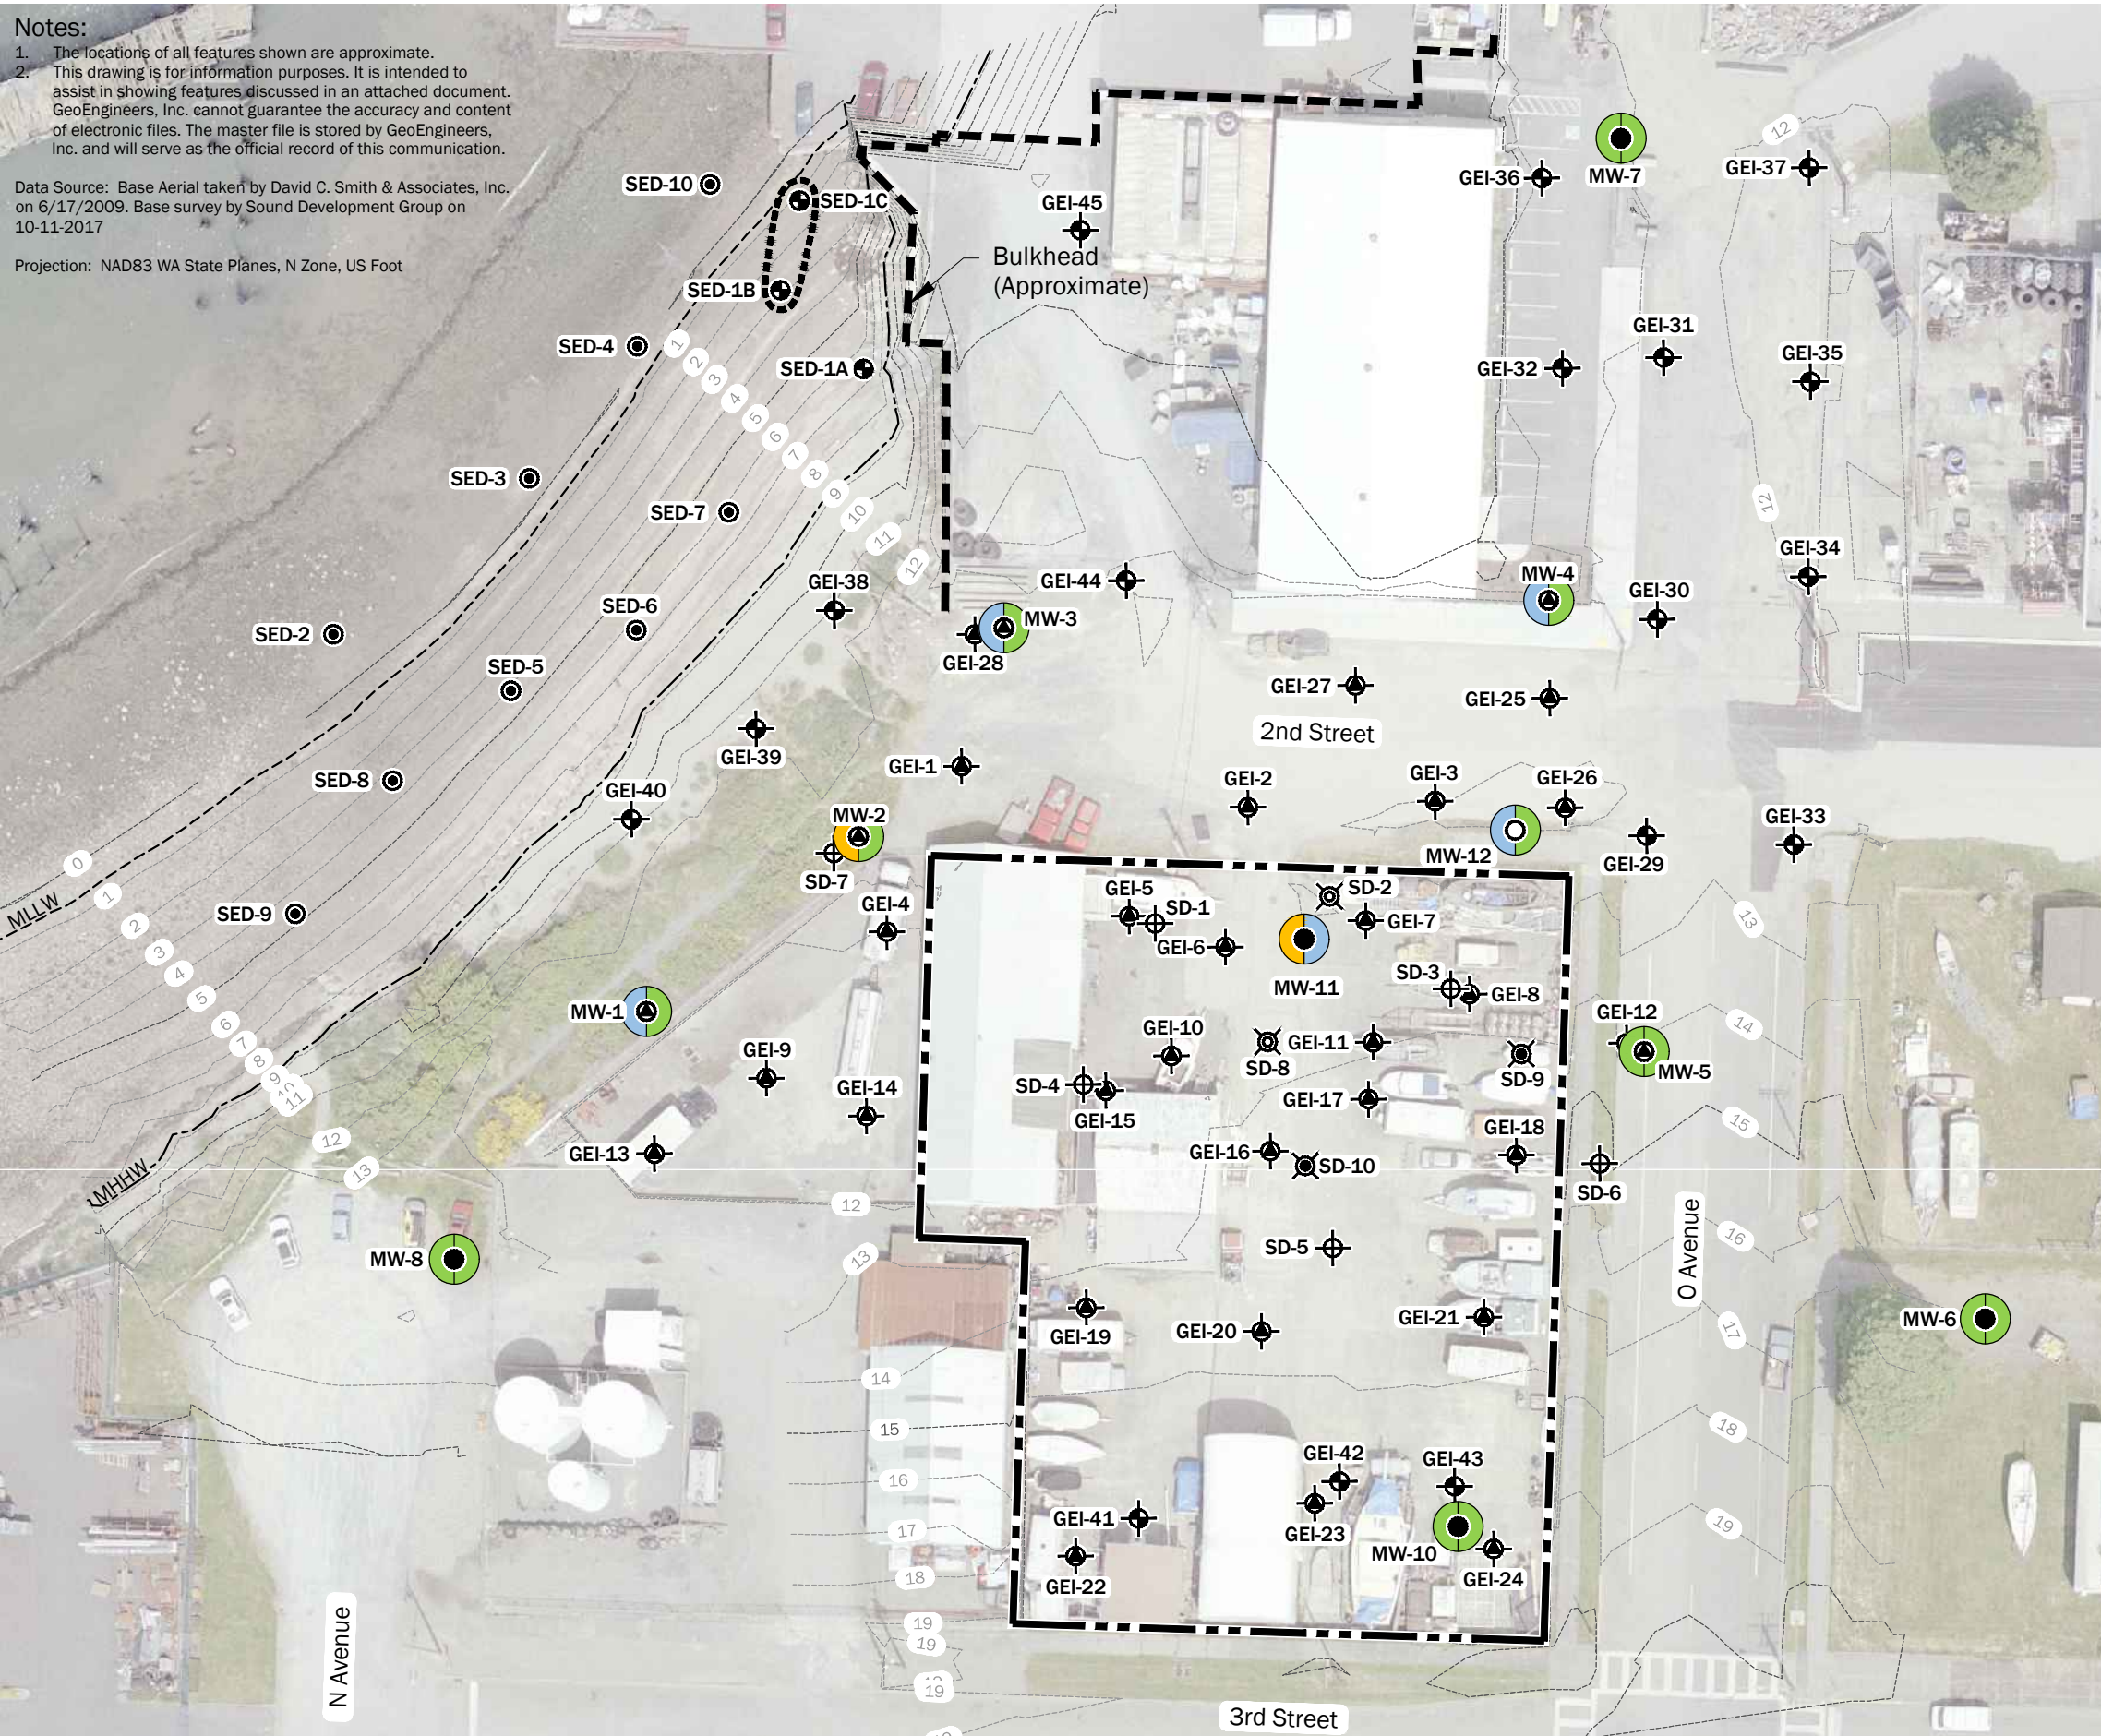
- Quiet Cove Property Boundary
- 10 ----- Contour (Feet, NAVD 88)
- SD-1 Supplemental RI Soil Boring Location
- SD-2 Supplemental RI Soil Boring Location and Temporary Well Screen
- SD-9 Supplemental RI Shallow Soil Boring Location
- MW-12 Supplemental RI Monitoring Well
- GEI-31 RI Soil Boring Location
- SED-1A RI Tier 1 Sediment Sample
- SED-2 RI Tier 2 Sediment Sample
- MW-6 RI Monitoring Well
- GEI-1 Focused Site Investigation Soil Boring Location
- MW-1 Focused Site Investigation Monitoring Well
- Composite Sediment Sample Grab Area (SED-1)
- Groundwater Monitoring Event
- TPH-D without Silica Gel Cleanup
- TPH-D with Silica Gel Cleanup

As previously noted the Supplemental Investigation groundwater was analyzed for diesel- and heavy-oil TPH with and without the silica gel cleanup preparation method. Figure 16 presents these analytical results for diesel- and heavy oil-range TPH side by side. The results indicate that without the silica gel cleanup diesel-range hydrocarbons are present above screening levels throughout the source area and downgradient wells consistent with results from the RI groundwater monitoring. With the silica cleanup gel procedure the only exceedance for diesel- and/or heavy-oil range TPH is at MW-11. The results indicate

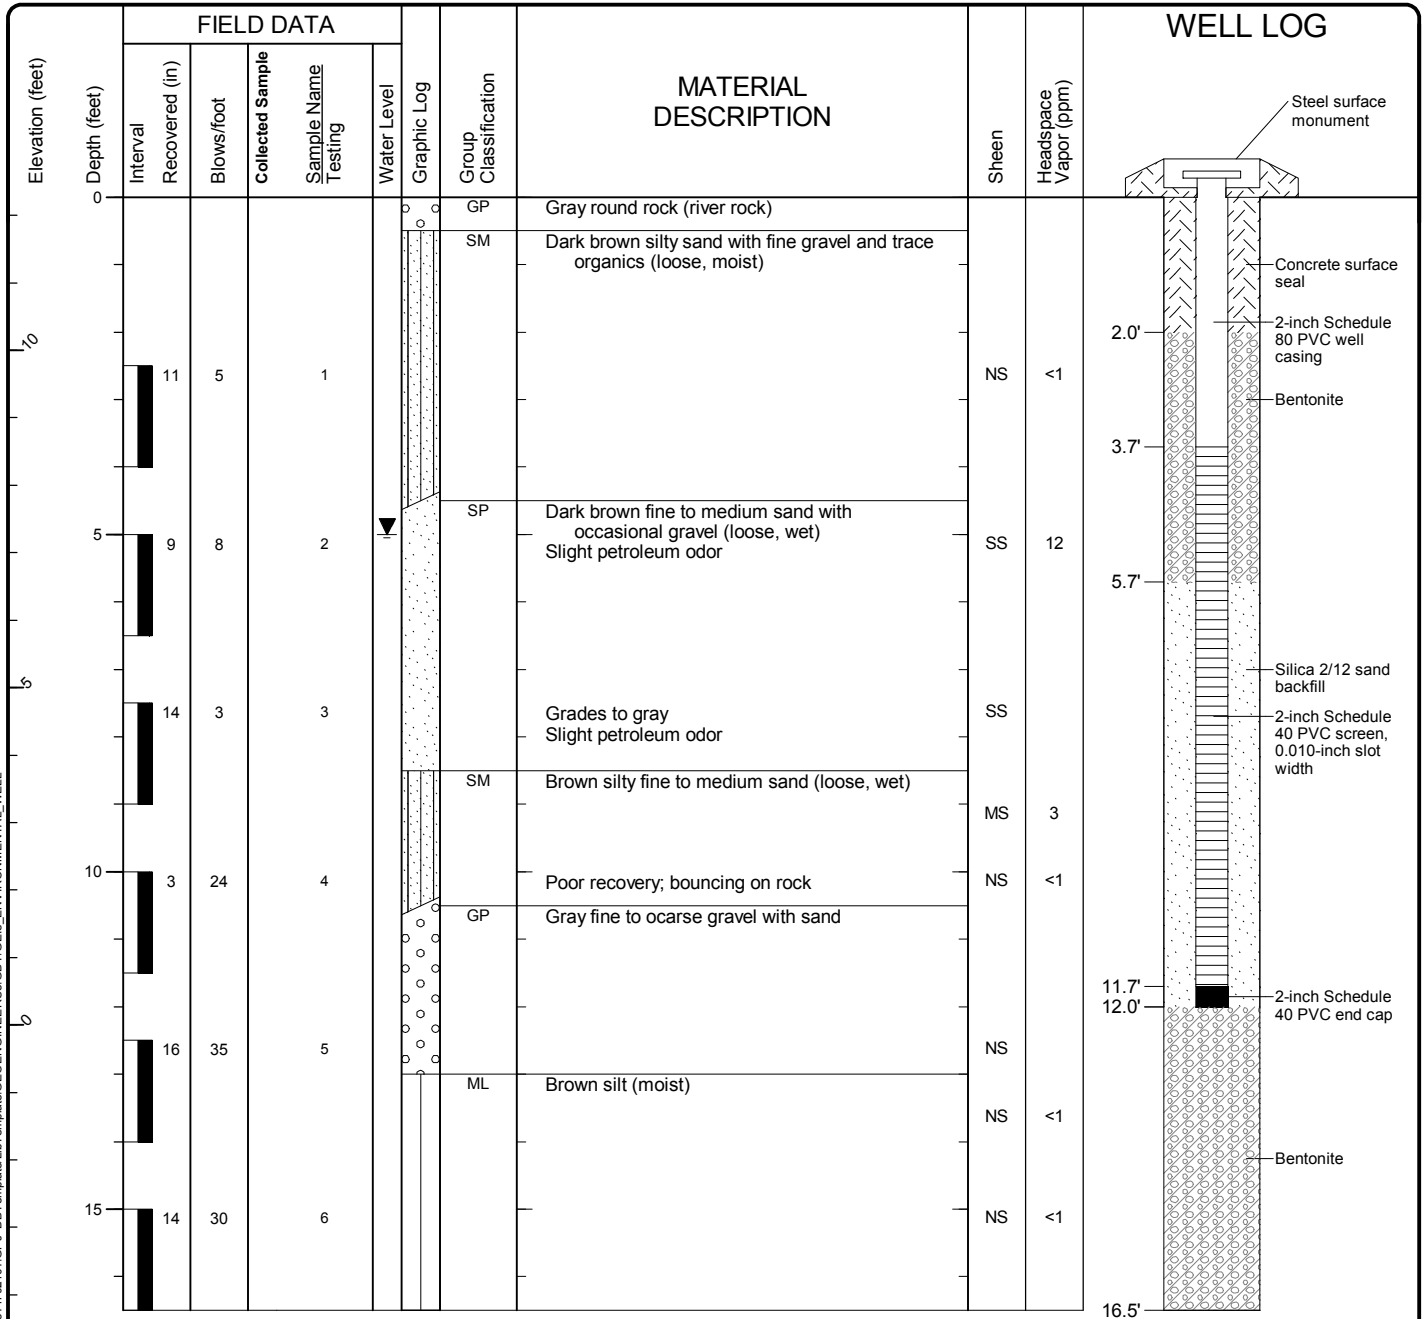
### Log of Monitoring Well MW-1

| Easting (X)<br>Northing (Y)<br>559643.3137<br>1208598.405 | | Horizontal<br>Datum<br>NAD83 | | Depth to<br>Water (ft)<br>5.0<br>Elevation (ft)<br>7.3 | |

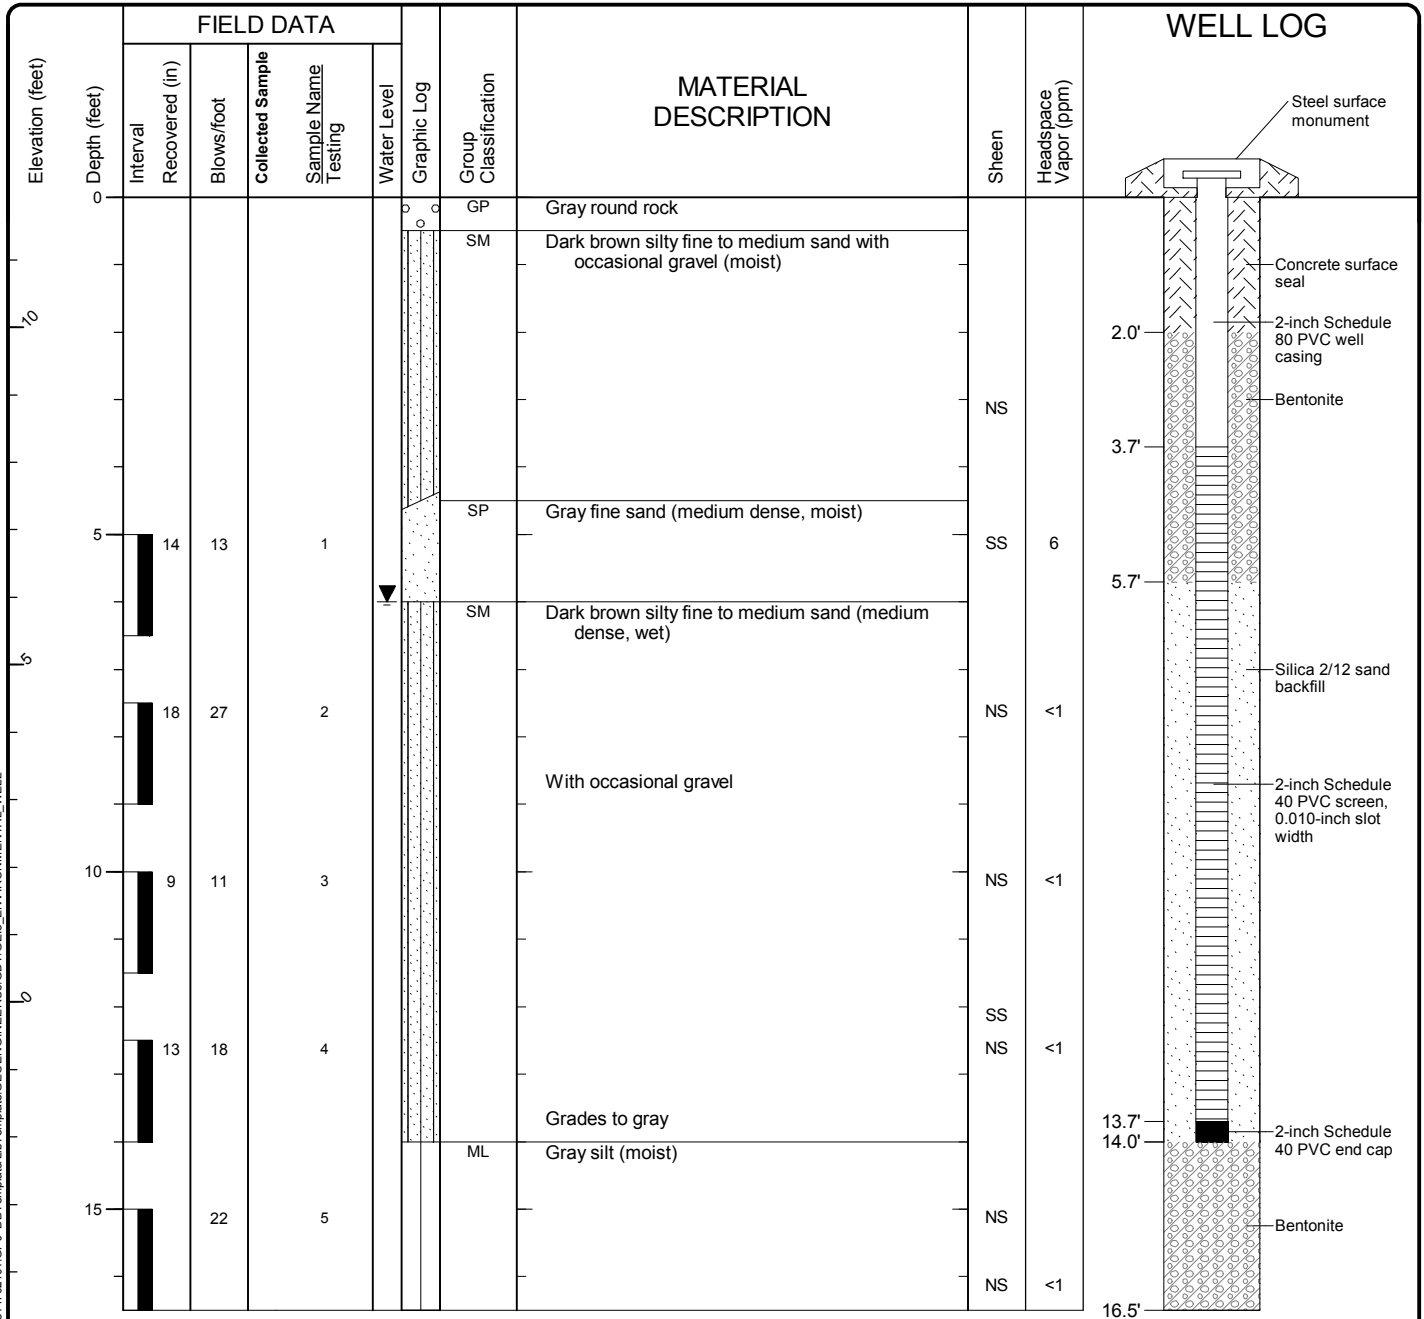
### Log of Monitoring Well MW-2

| Easting (X)<br>Northing (Y) 559692.5327<br>1208656.1166 | | Horizontal<br>Datum NAD83 | | | |
