## ANACORTES PLANNING COMMISSION

**May 24, 2023**

### **AGENDA**

- A. Roll Call**
- B. Minutes**
  - 1) Minutes of May 8, 2023
- C. Correspondence**
- D. New Business**
  - 1) Appoint new vice chair.
  - 2) Open Record Public Hearing and Decision for Shoreline Substantial Development Permit SDP-2023-0002 Port of Anacortes 2nd Street and Curtis Wharf project.
- E. Old Business**

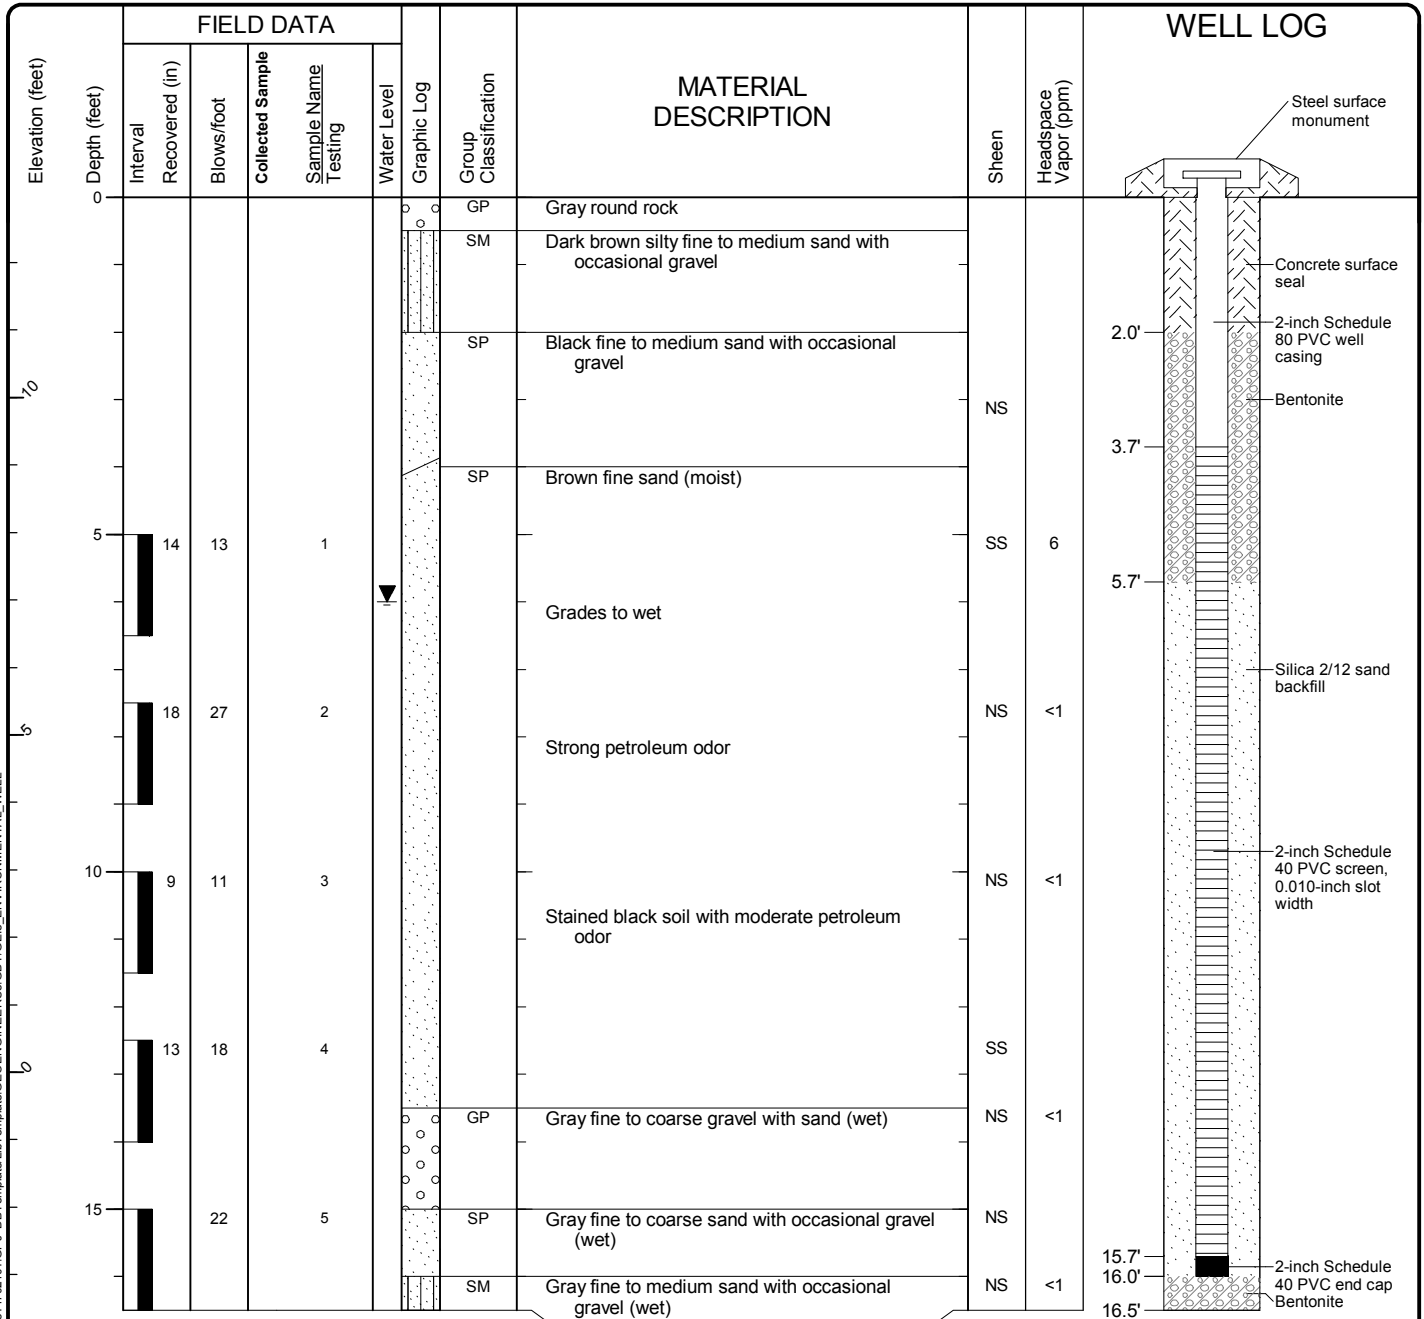
### Log of Monitoring Well MW-3

| Easting (X)<br>Northing (Y) 559756.678468316<br>1208701.08910405 | | Horizontal<br>Datum NAD83 | | Depth to<br>Water (ft) 6.0<br>Elevation (ft) 7.0 | |

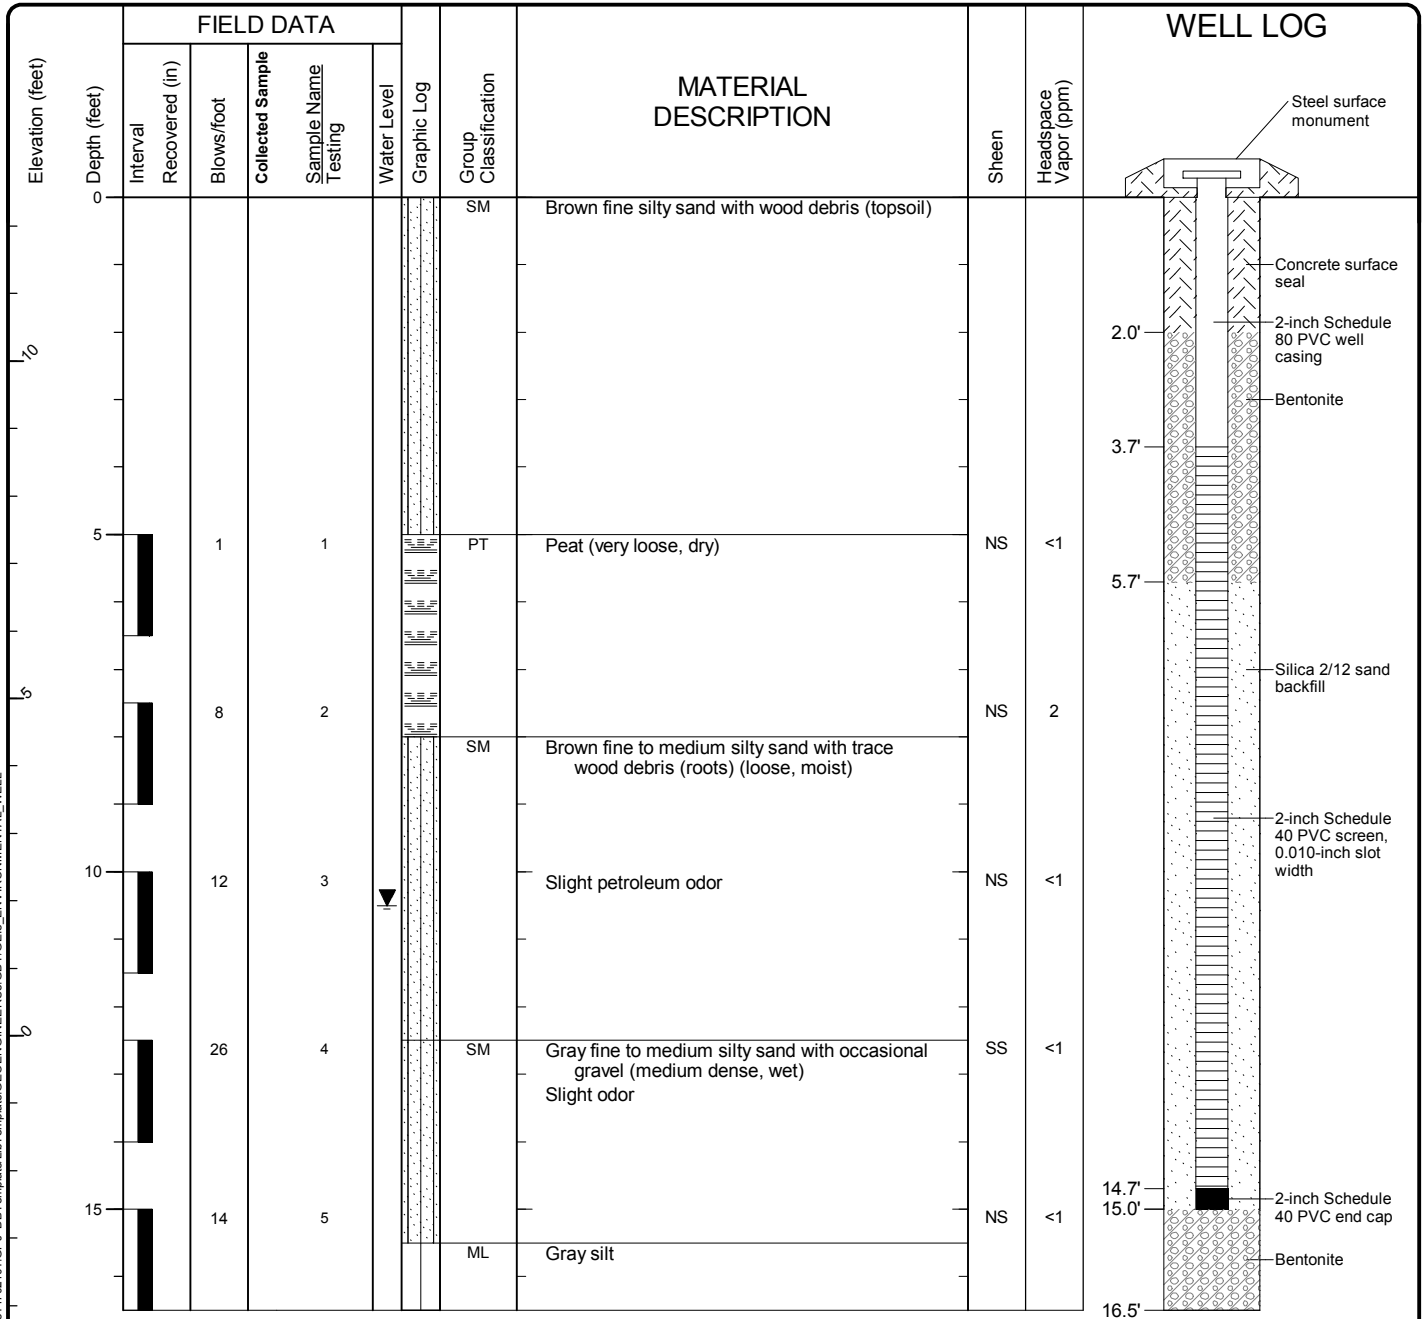
### Log of Monitoring Well MW-4

| Easting (X)<br>Northing (Y) 559760.5958<br>1208852.2931 | | Horizontal<br>Datum NAD83 | | Depth to<br>Water (ft) 10.5<br>Elevation (ft) 1.9 | |

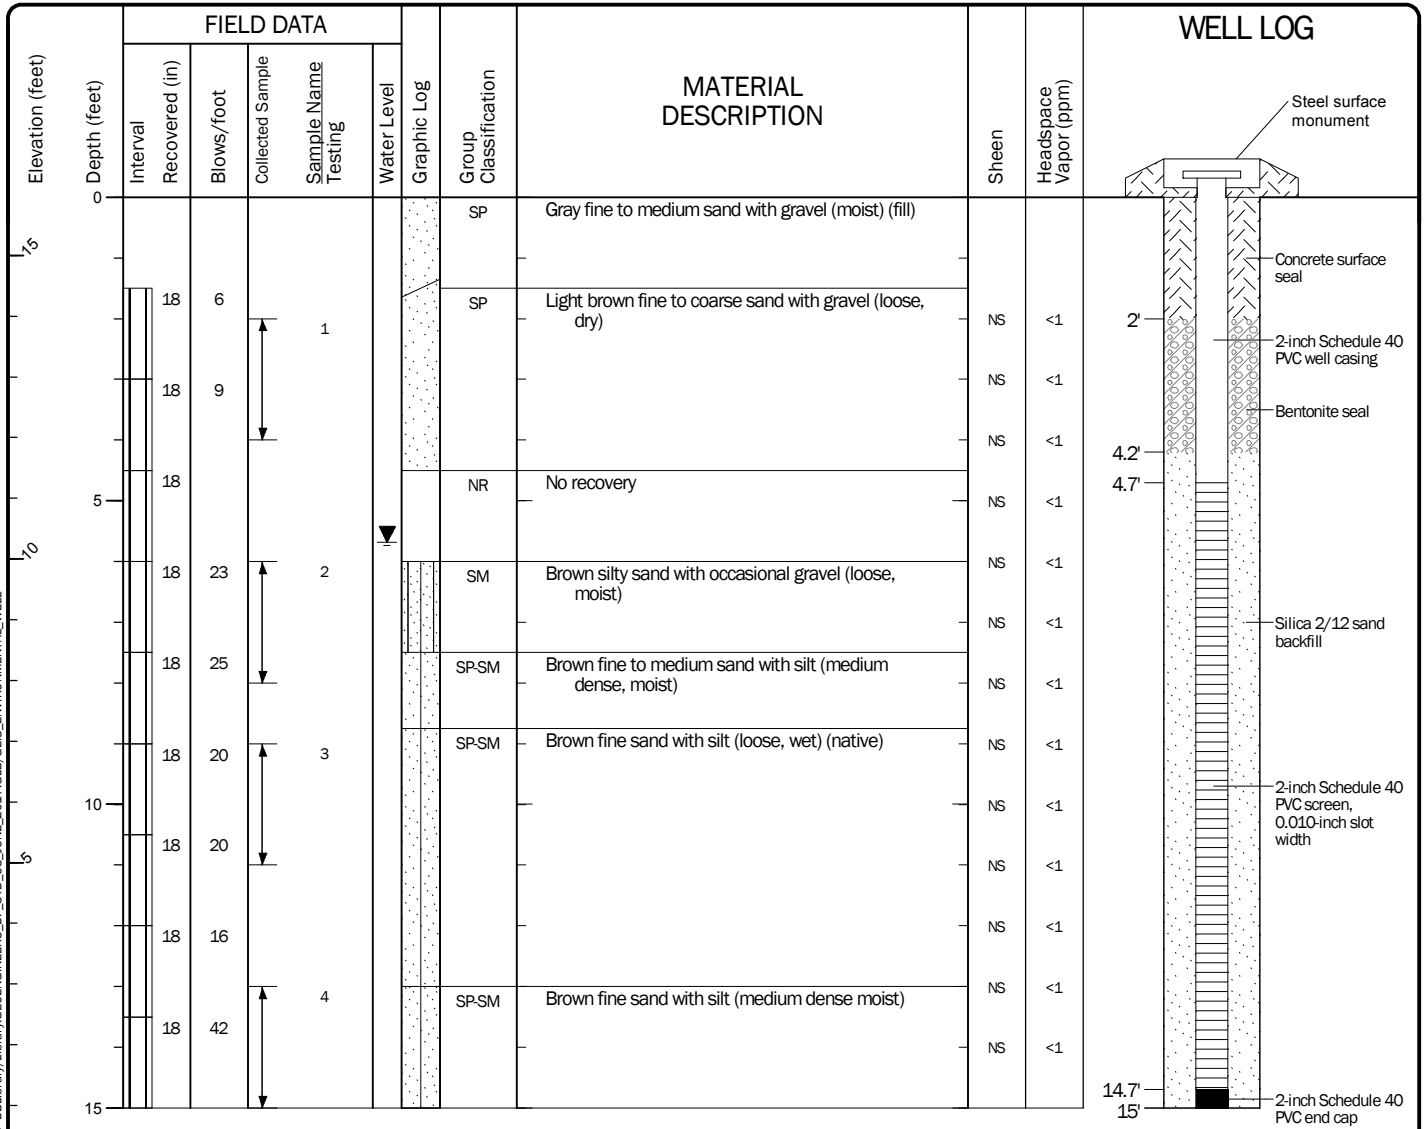
### Log of Monitoring Well MW-6

| Easting (X)<br>Northing (Y) | | 1208975.42<br>559557.88 | Horizontal<br>Datum WA State Plane North<br>NAD83 (feet) | | Depth to<br>Water (ft) 5.68<br>Elevation (ft) 9.75 |

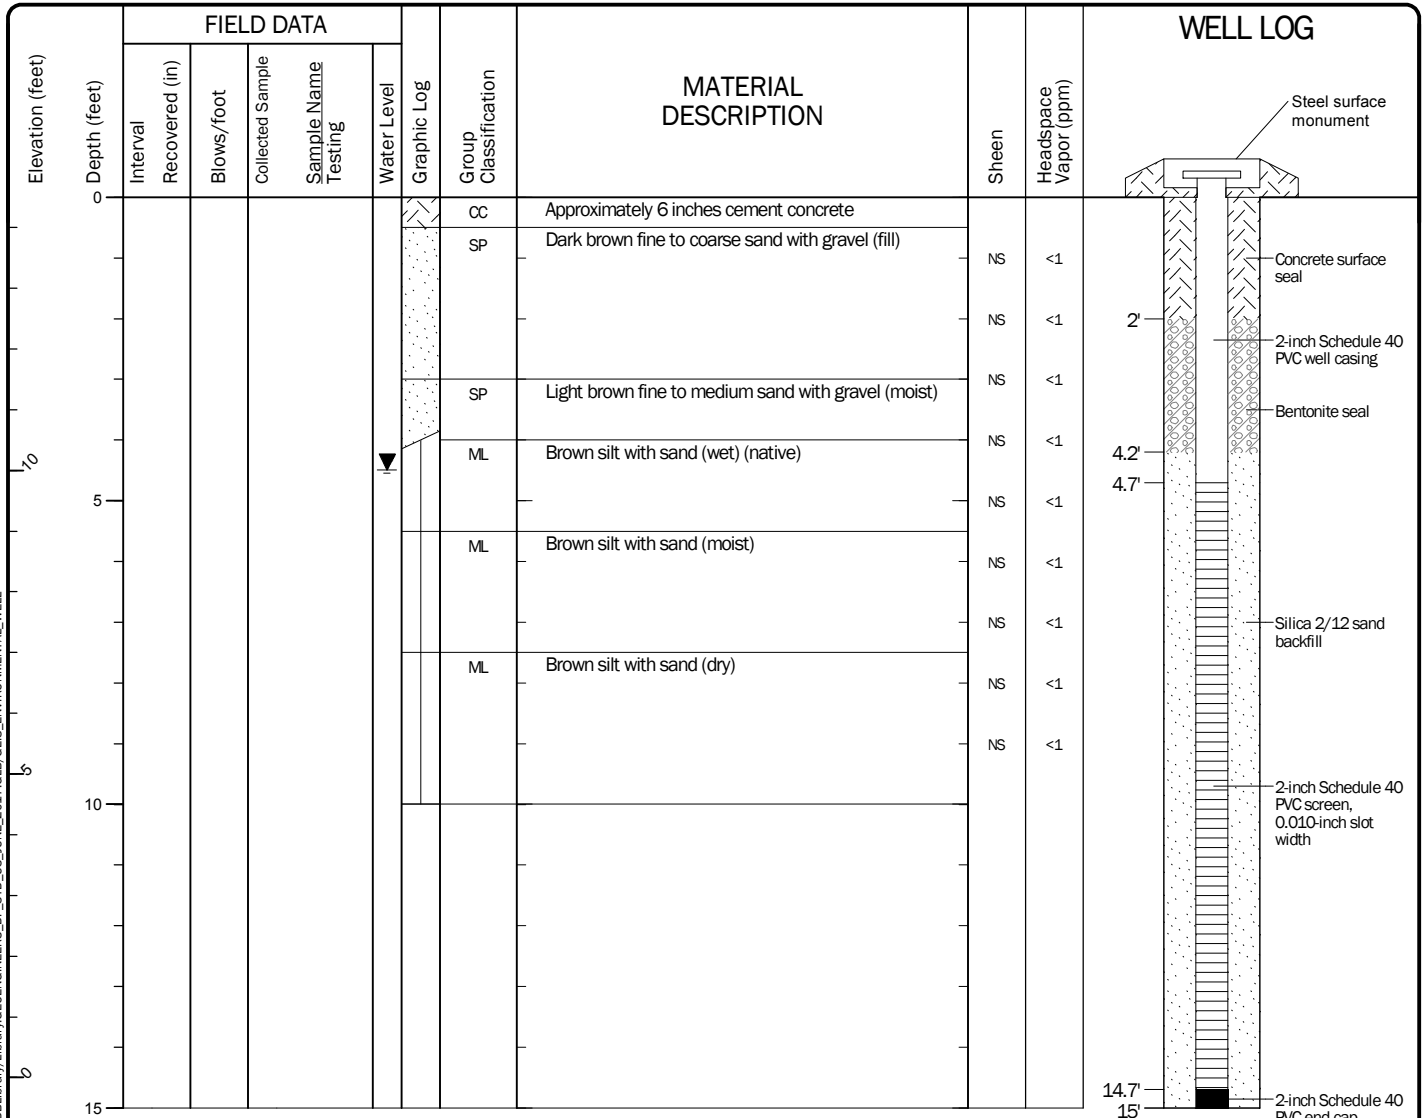
### Log of Monitoring Well MW-10

| Easting (X)<br>Northing (Y)<br>1208826.27<br>559499.27 | | Horizontal<br>Datum<br>WA State Plane North<br>NAD83 (feet) | | Depth to<br>Water (ft)<br>4.49 | Elevation (ft)<br>9.68 |
| Notes: Soil descriptions referenced from exploration log GEI-43 | | | | | |

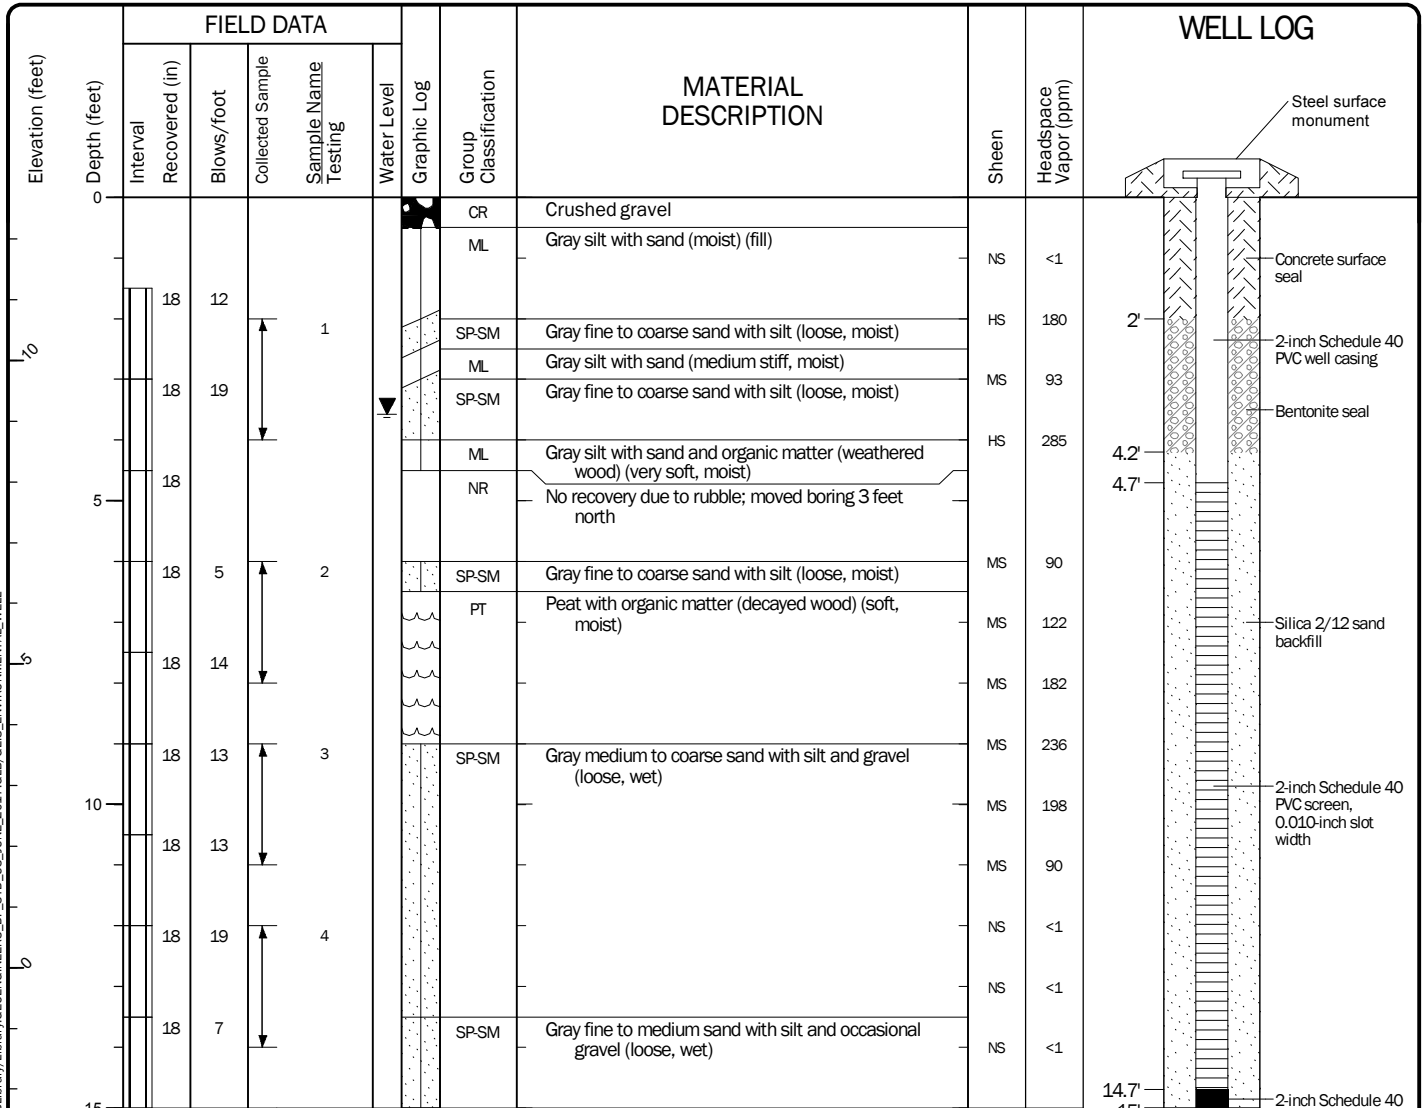
### Log of Monitoring Well MW-11

| Easting (X)<br>Northing (Y) | | 1208783.3<br>559665.06 | Horizontal<br>Datum WA State Plane North<br>NAD83 (feet) | | Depth to<br>Water (ft) 3.58<br>Elevation (ft) 8.70 |

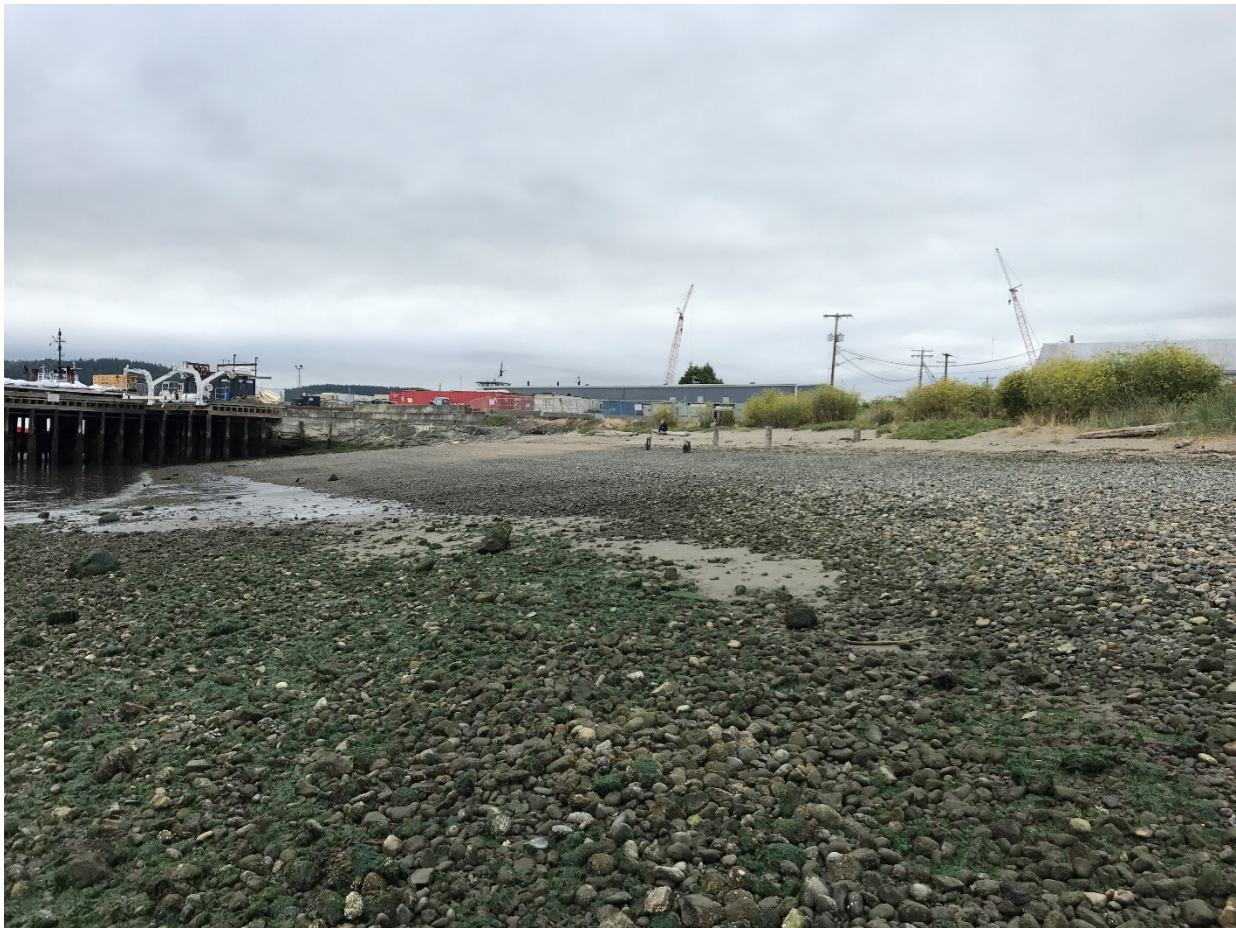
**Figure 2-1**

**View of the lower beach from N Avenue looking northeast.**

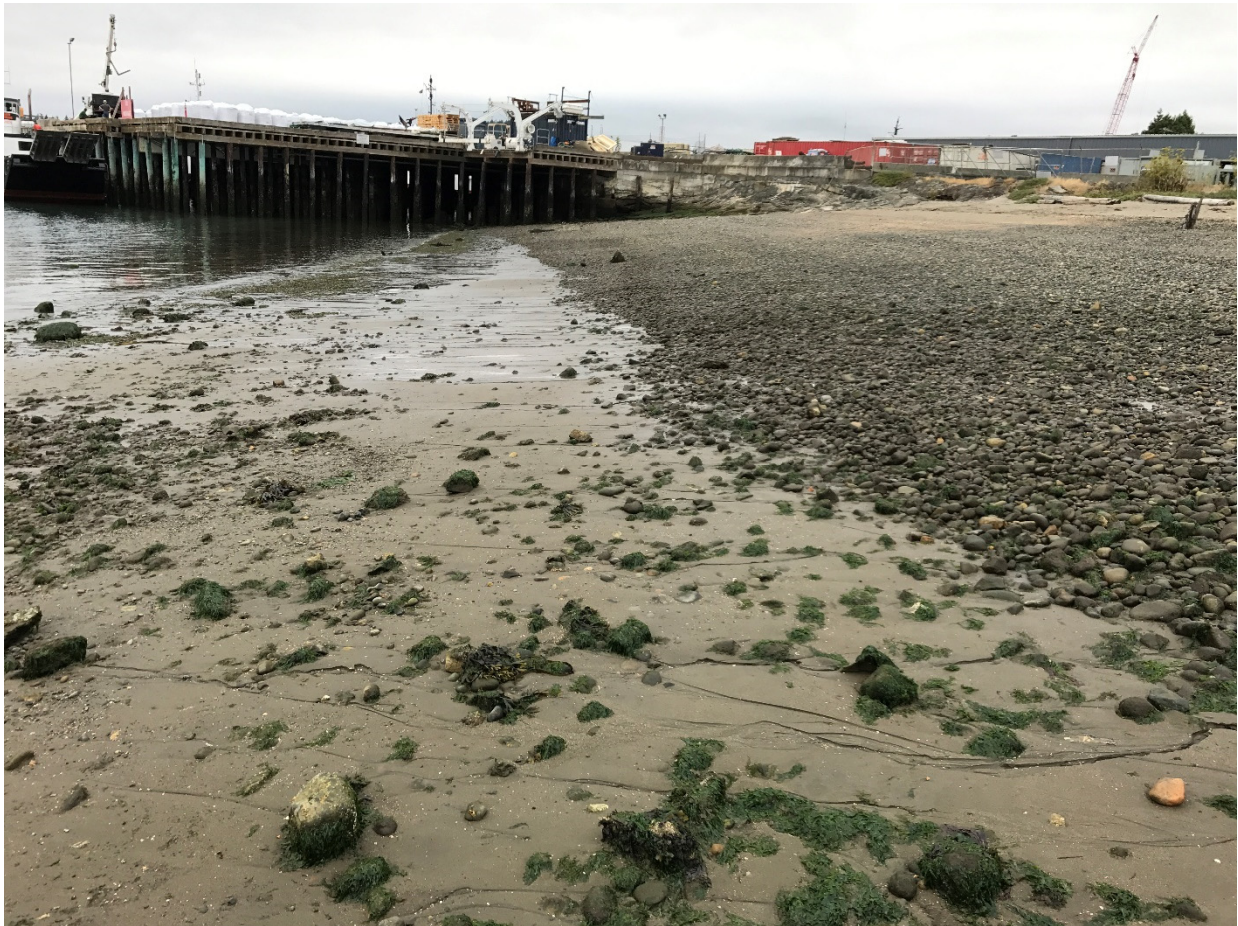
**Figure 2-2**

**View of the lower beach from adjacent to Quiet Cove Site looking northeast.**

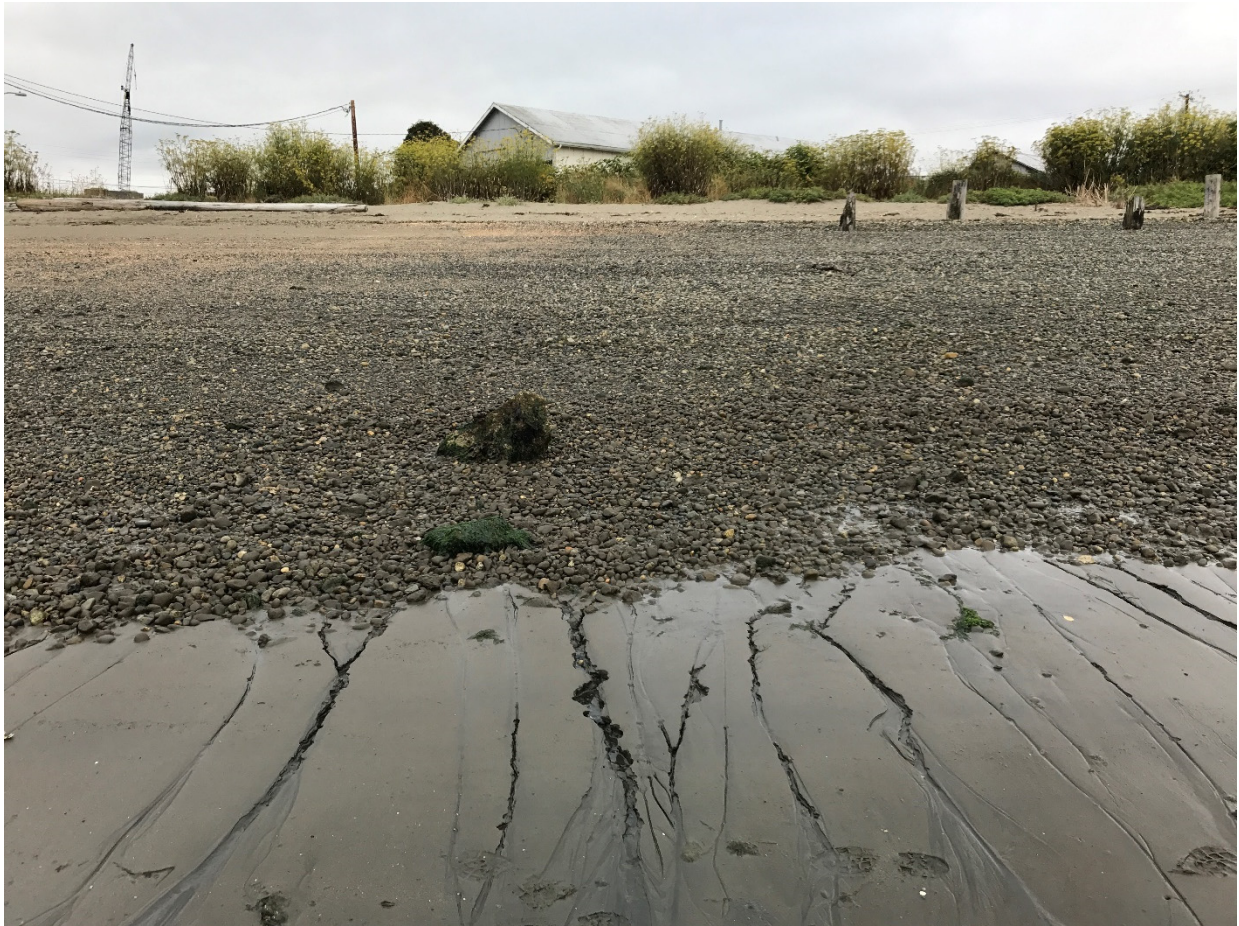
**Figure 2-3**

**View from the lower beach looking east at the Quiet Cove Site (building is the office/maintenance building).**

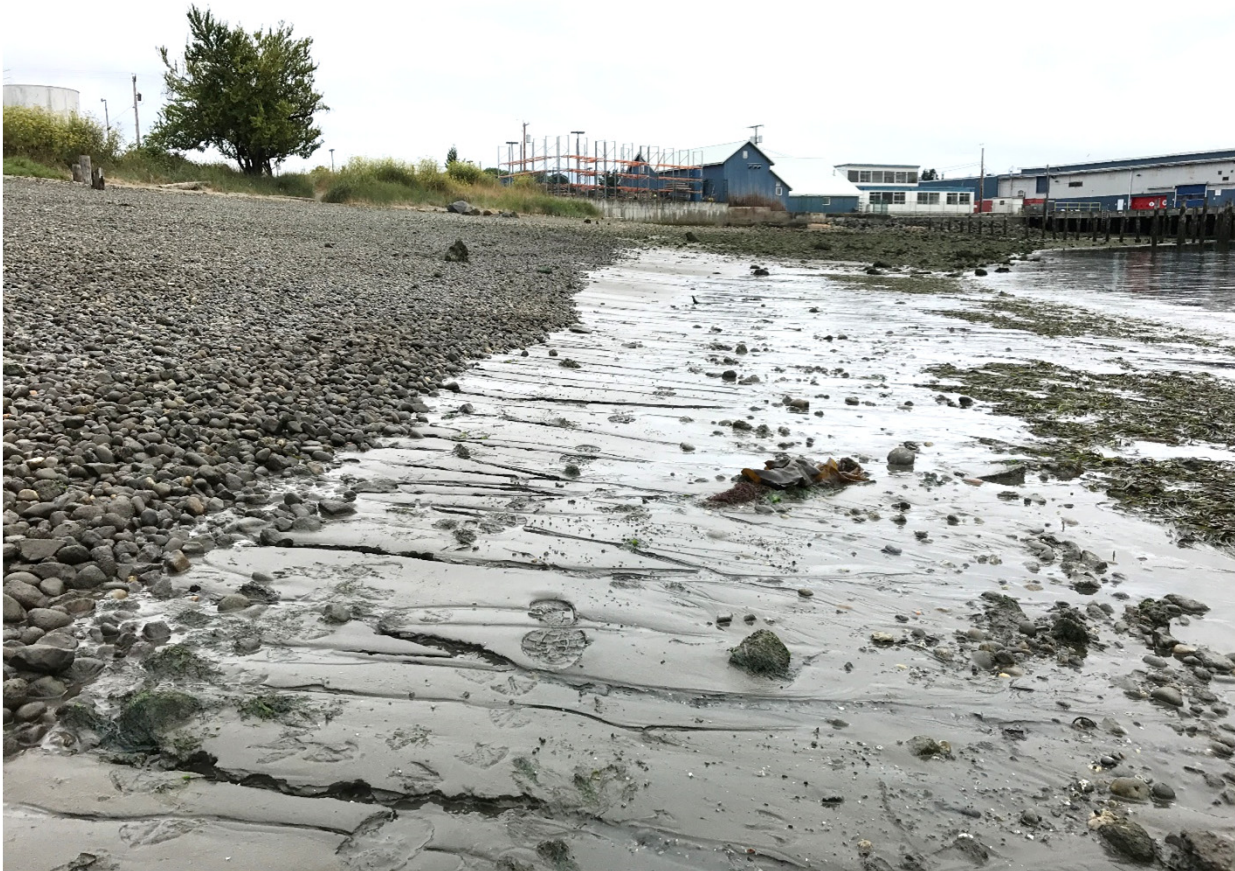
**Figure 2-4**

**View of the lower beach from adjacent to the Quiet Cove Site looking southwest.**

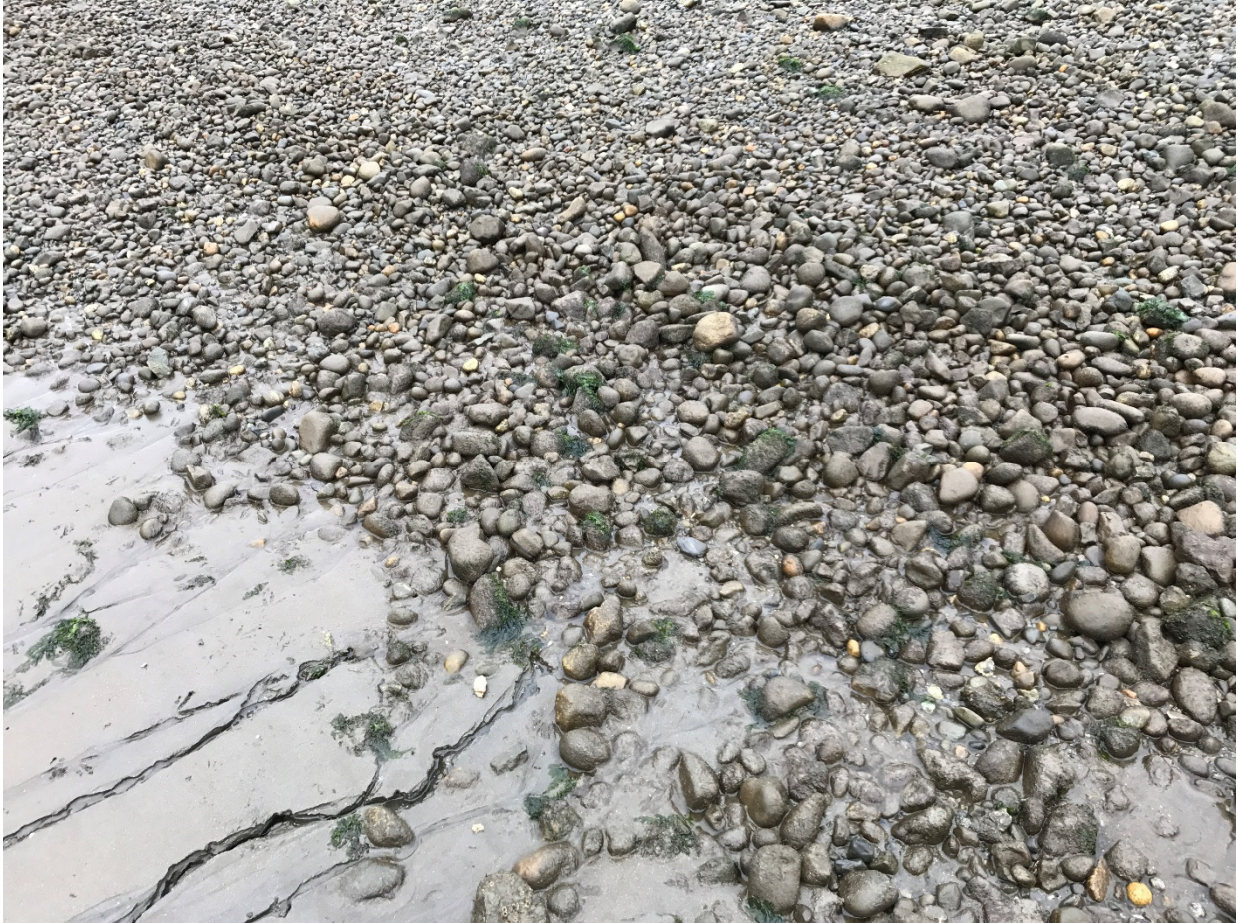
**Figure 2-5**

**Close-up of beach substrate at elevation around 0 feet MLLW.**

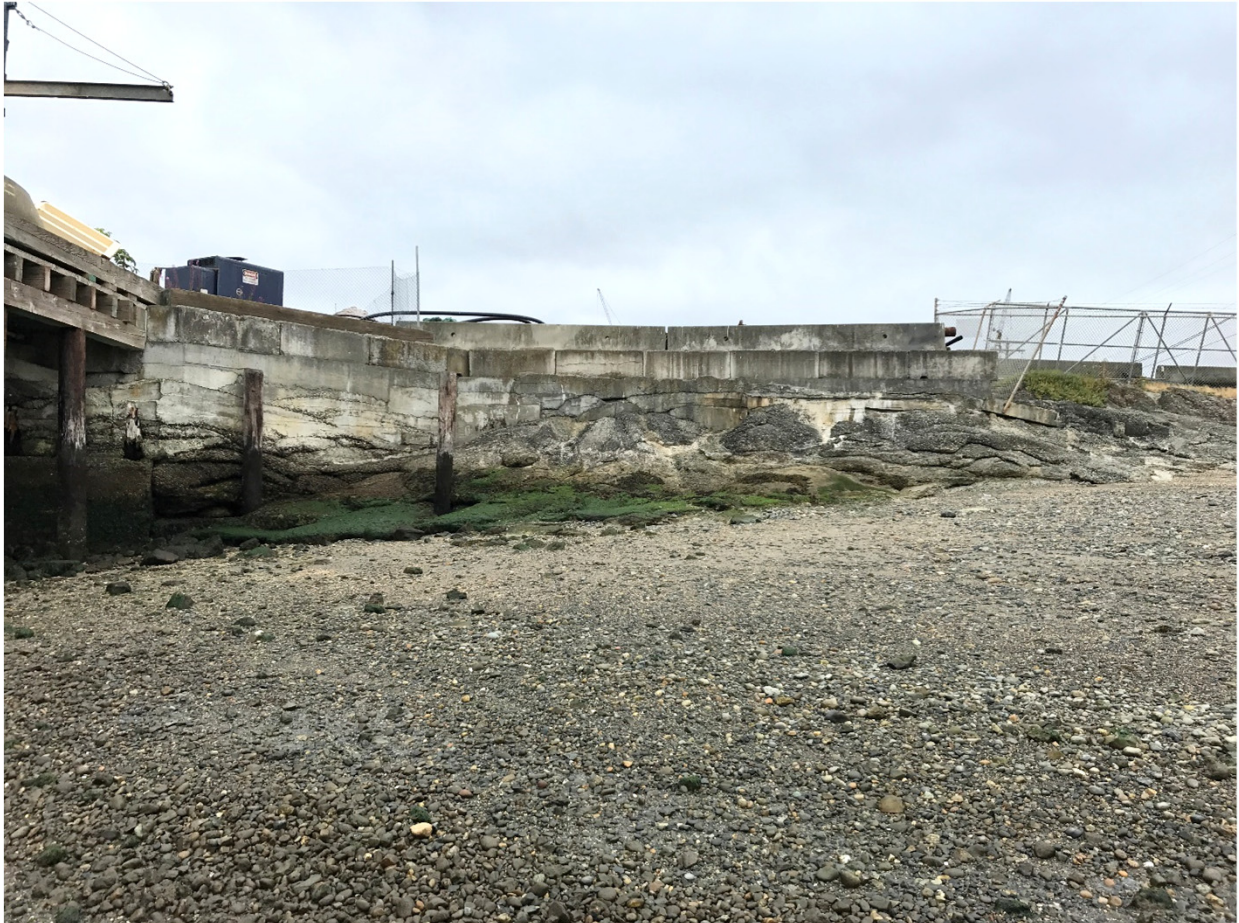
**Figure 2-6**

**View of the south end of Curtis Wharf looking east from the lower beach.**

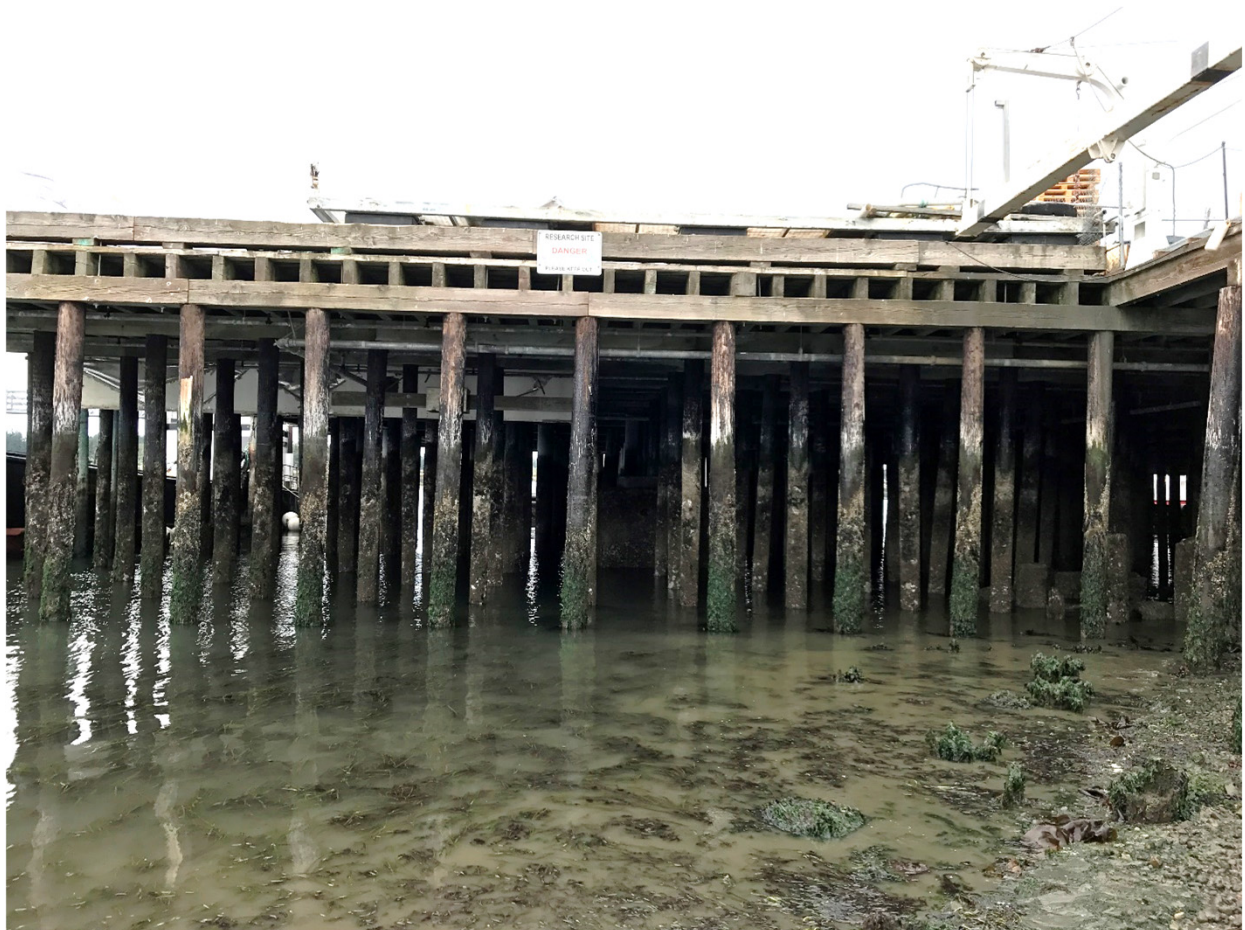
Figure 2-7

View of the southwest section of Curtis Wharf from the lower beach.

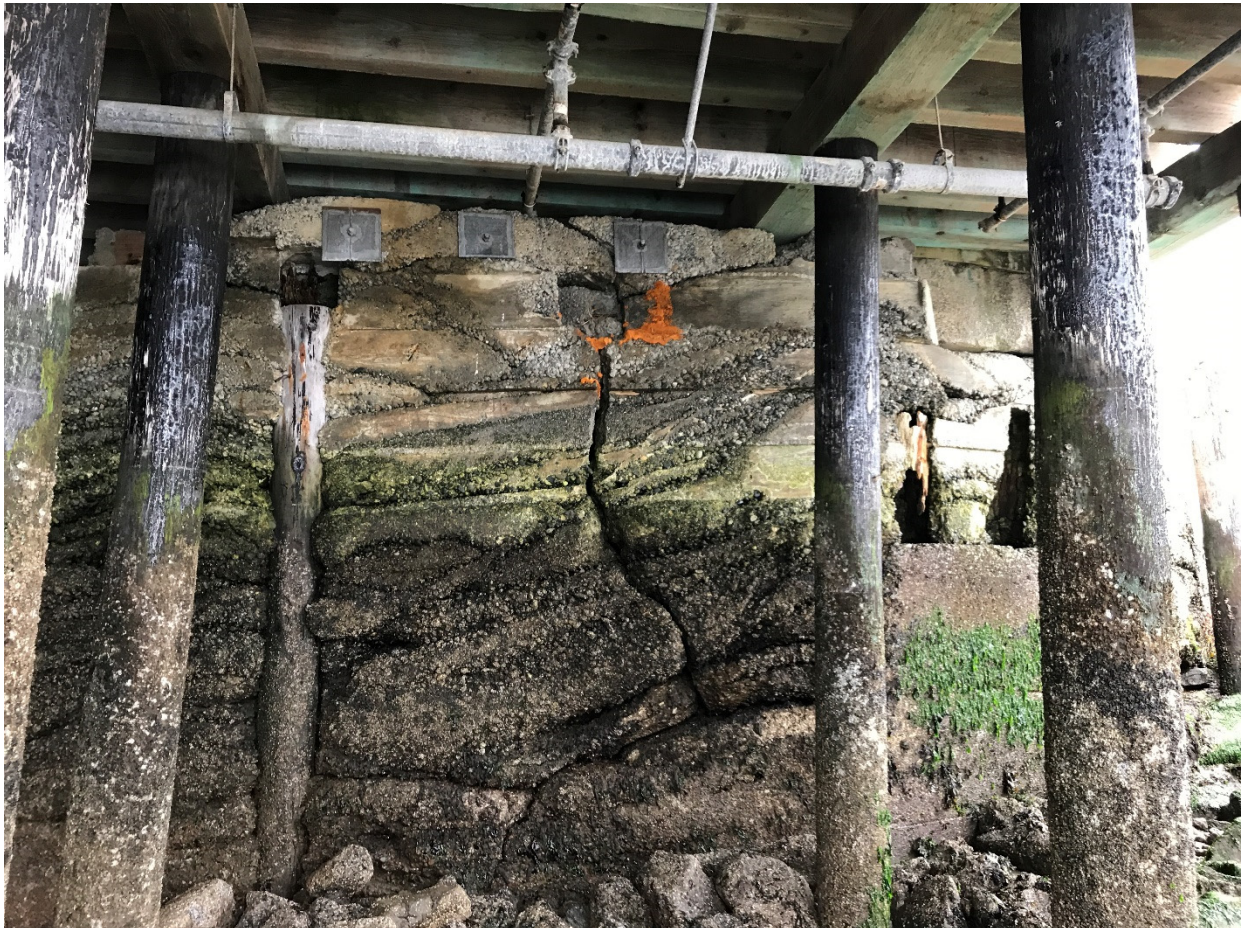
**Figure 2-8**

**Under-wharf view of the southwest bulkhead on Curtis Wharf. Pipe is for fire suppression system. No evidence of historical product lines coming through the bulkhead.**

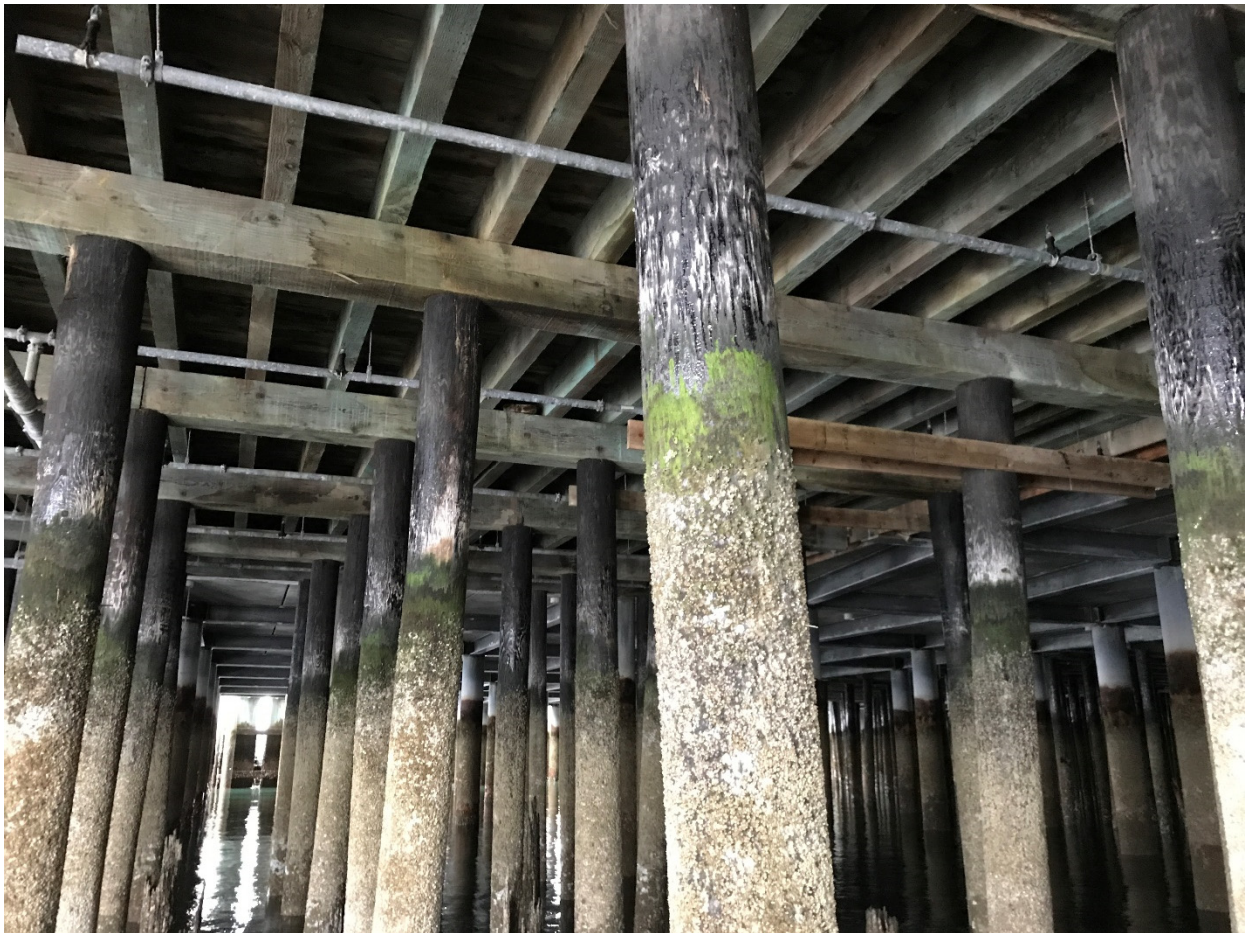
**Figure 2-9**

**Under-wharf view from the bulkhead looking north. Pipe is for fire suppression system.**

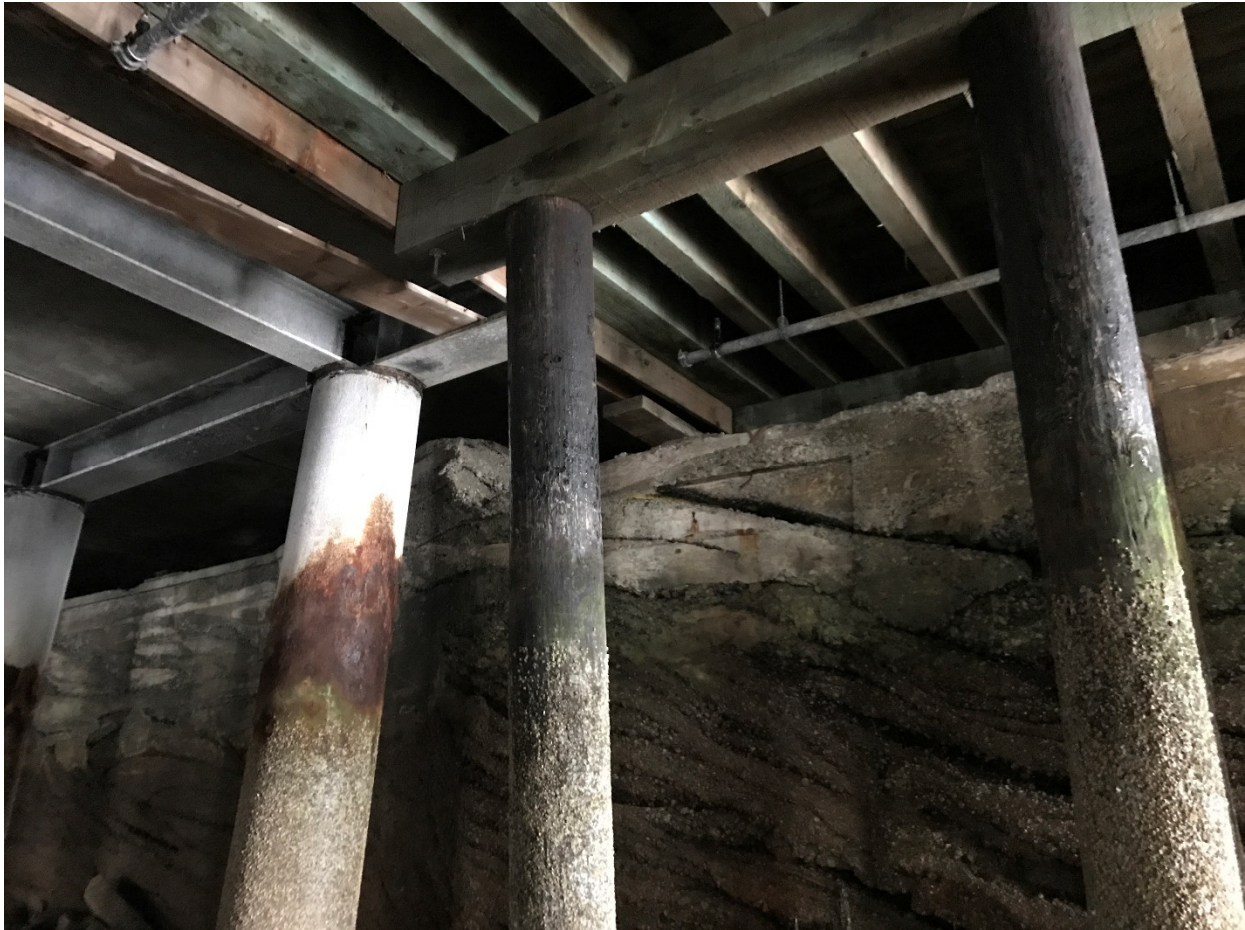
**Under-wharf view close up of bulkhead and wharf interface near the west end of the wharf.**
