## ANACORTES PLANNING COMMISSION

**May 24, 2023**

### **AGENDA**

- A. Roll Call**
- B. Minutes**
  - 1) Minutes of May 8, 2023
- C. Correspondence**
- D. New Business**
  - 1) Appoint new vice chair.
  - 2) Open Record Public Hearing and Decision for Shoreline Substantial Development Permit SDP-2023-0002 Port of Anacortes 2nd Street and Curtis Wharf project.
- E. Old Business**

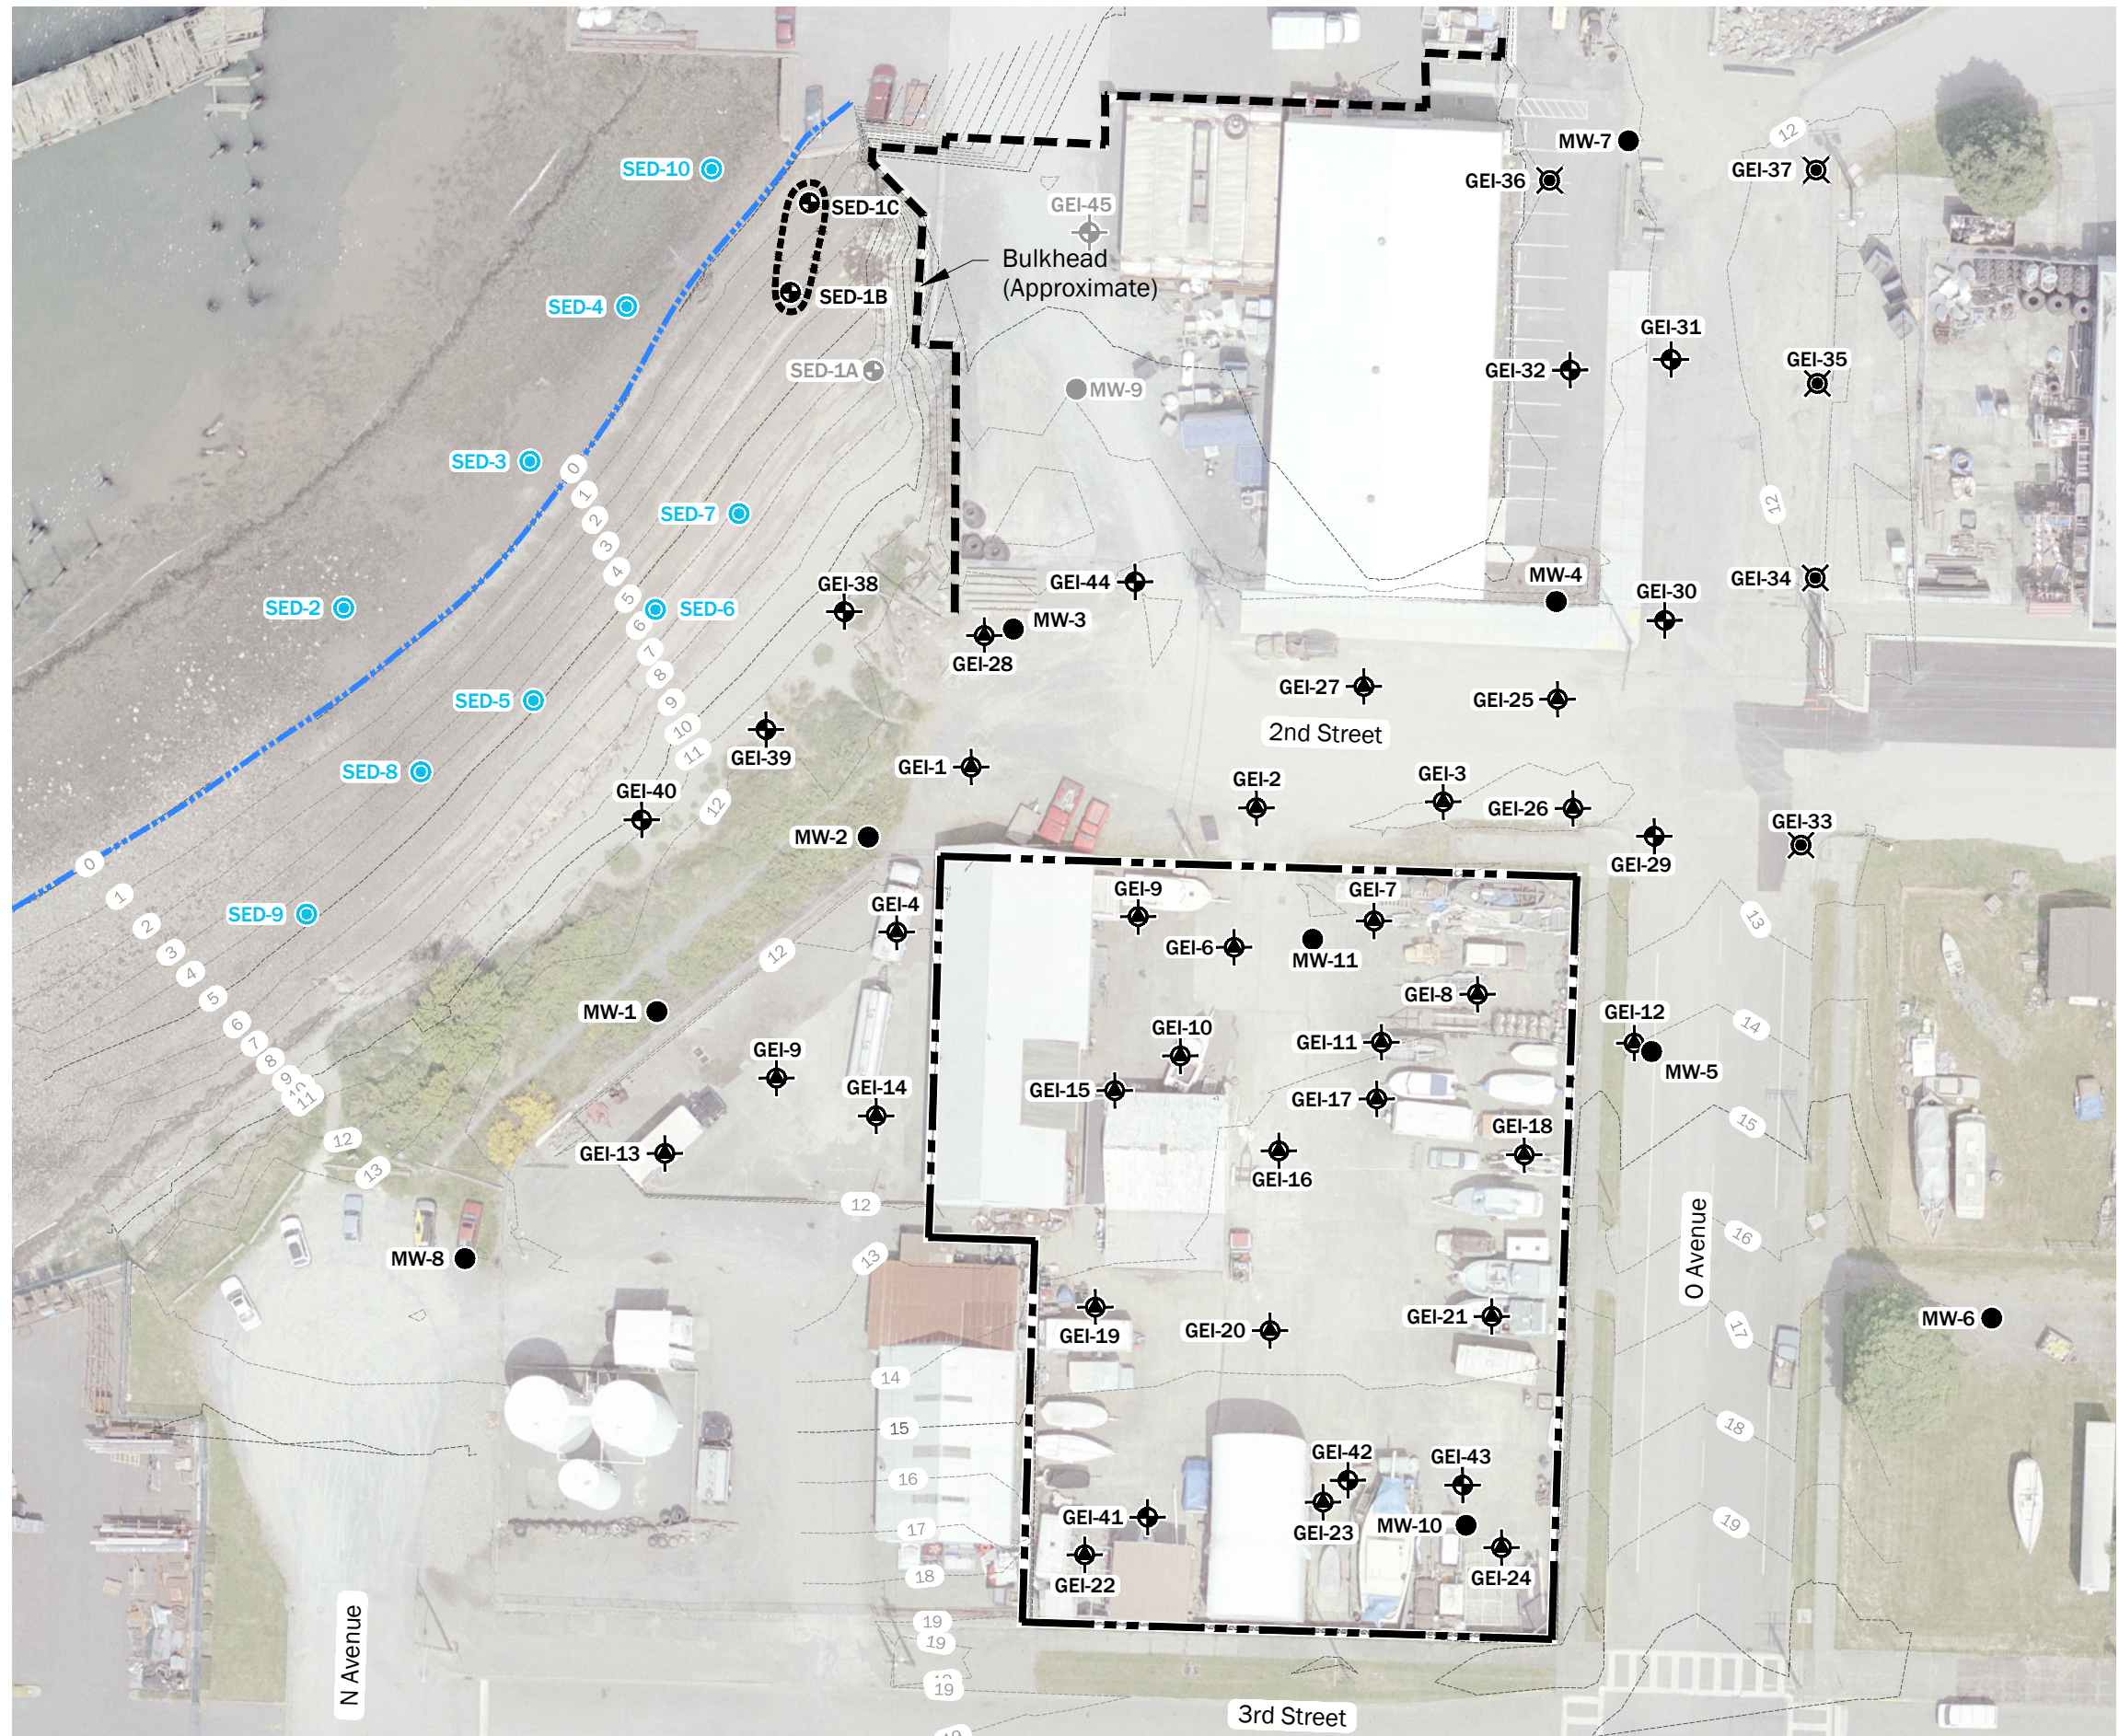
Revised Tier 2 Sampling Locations

Surface and subsurface sediment samples would be collected at the nine locations shown in the attached figure (SED-2 to -10). Subsurface samples would extend a minimum of 2-feet into the native geologic layer. The following analyses are proposed for these sediment samples based on the observed contamination in the adjacent upland:

- Additional analysis of archived samples would only be triggered if exceedances are found in SED-5 through -10 and weight of evidence indicates contamination has passed into the marine environment. These additional analyses would be determined in consultation with Ecology.

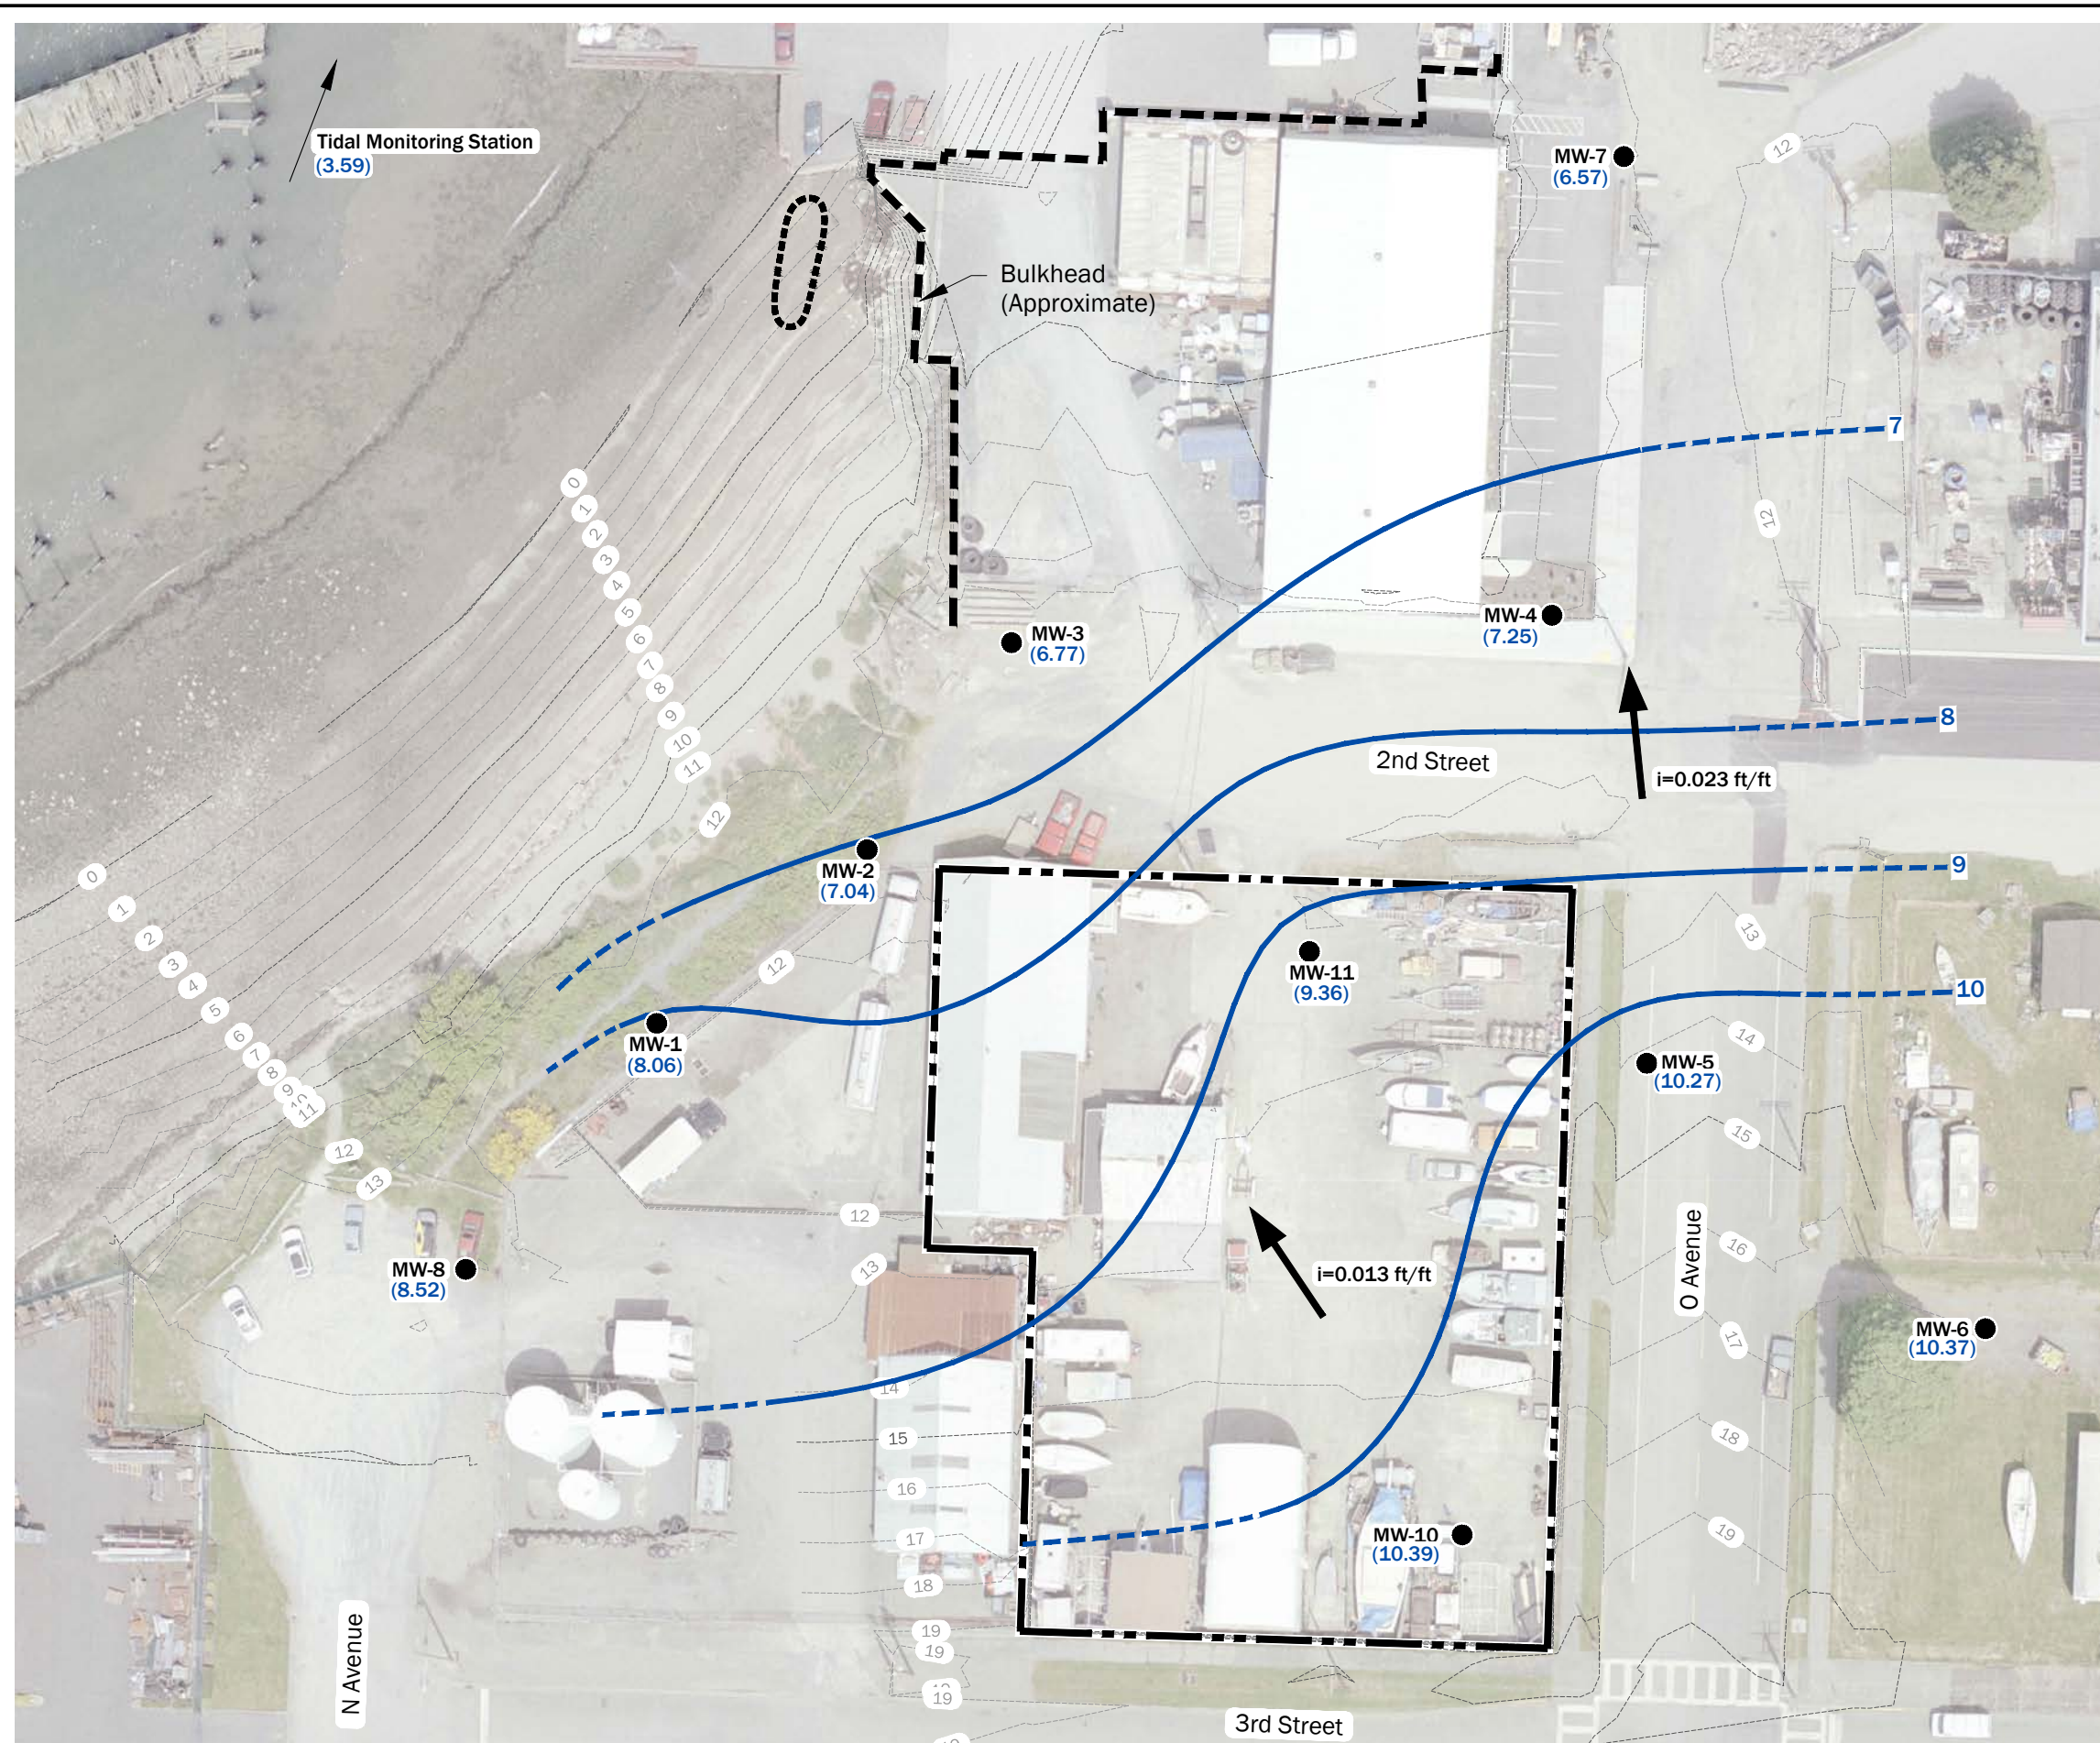
**Figure 2**

- Site Boundary
- MW-10 (10.39) ● Monitoring Well and Mean Groundwater Elevation, 72-Hour Tidal Study
- Composite Sediment Sample Grab Area (SED-1)
- 10--- Ground Surface Elevation Contour (Feet, NAVD 88)
- Groundwater Elevation Contour, Mean Elevations 72-Hour Tidal Study. Dashed Where Inferred.
- Inferred groundwater flow direction and groundwater gradient in feet per foot calculated between monitoring wells MW-10 and MW-2, and between monitoring wells MW-5 and MW-4

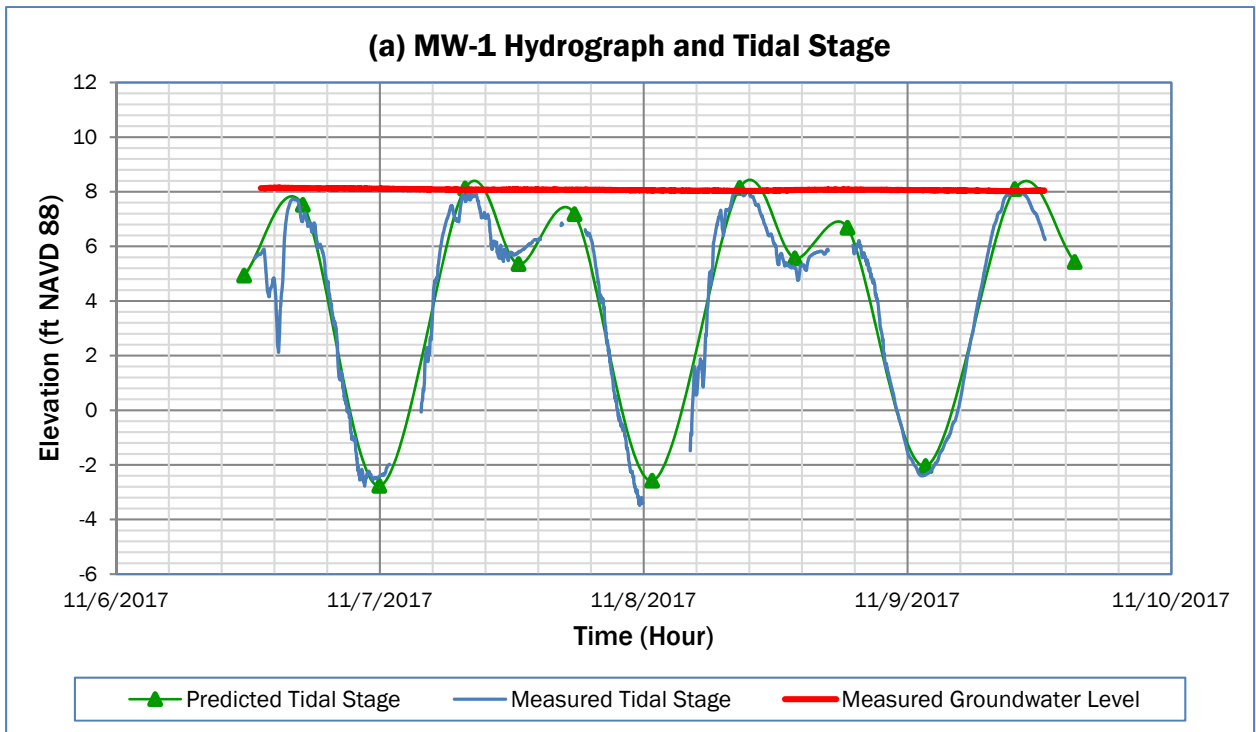
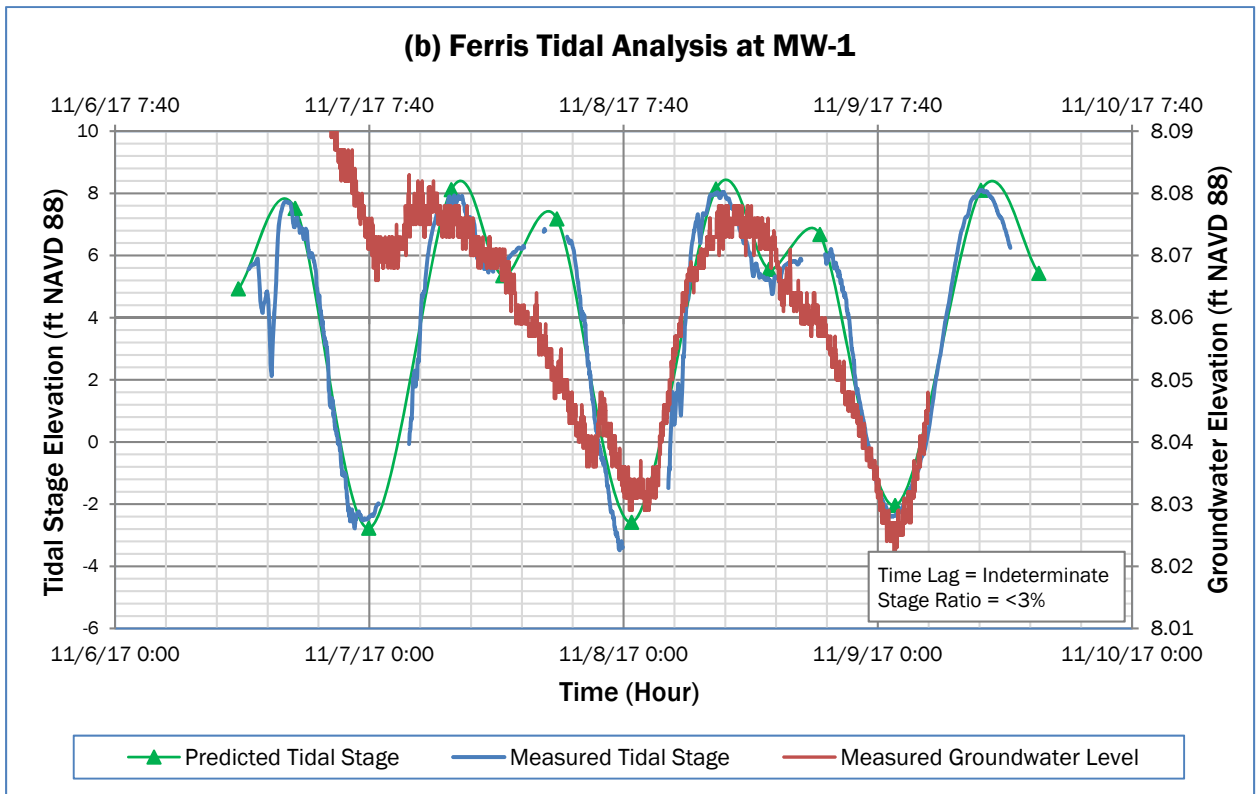
1. Method based on Ferris (1951).
2. Distance to Shoreline: 35 feet
3. This drawing is for information purposes. It is intended to assist in showing features discussed in an attached document. GeoEngineers, Inc. cannot guarantee the accuracy and content of electronic files. The master file is stored by GeoEngineers, Inc. and will serve as the official record of this communication.

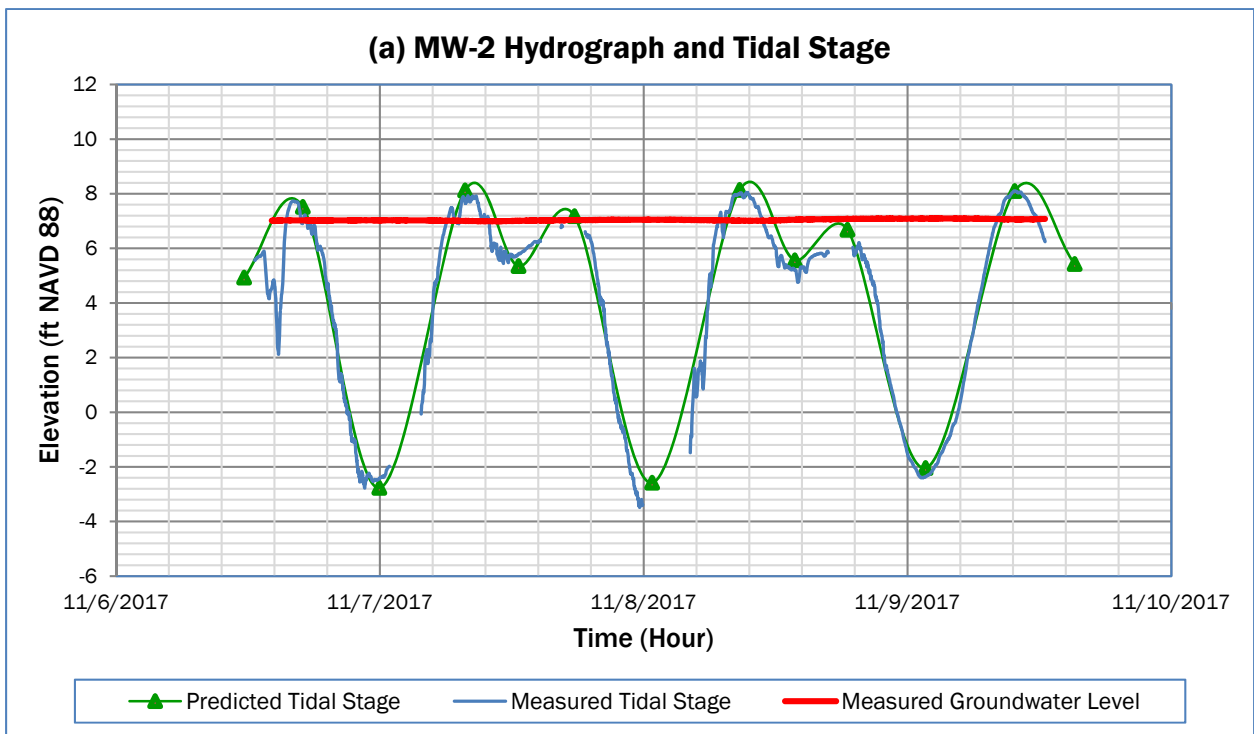
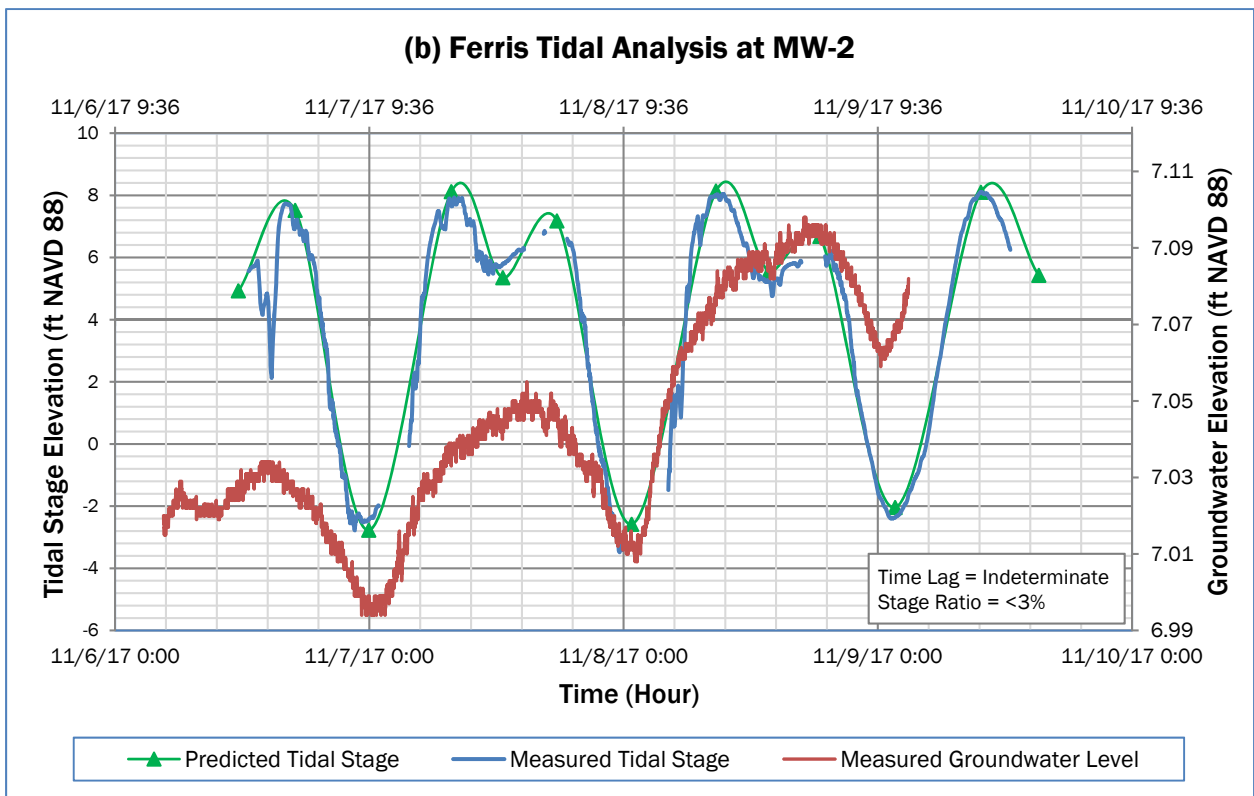
| | <b>Figure 14</b> |

1. Method based on Ferris (1951).
2. Distance to Shoreline: 40 feet
3. This drawing is for information purposes. It is intended to assist in showing features discussed in an attached document. GeoEngineers, Inc. cannot guarantee the accuracy and content of electronic files. The master file is stored by GeoEngineers, Inc. and will serve as the official record of this communication.

The time lag and stage ratio for each tidal study monitoring well was determined over a period of two full tidal cycles (Figures 14 through 23). The observed tidal effects on monitoring locations used for the tidal study are presented in Table 2. Tidal study data for the monitoring wells indicating the most tidal influence are summarized in the table below and are organized by shortest to longest time lag in hours.

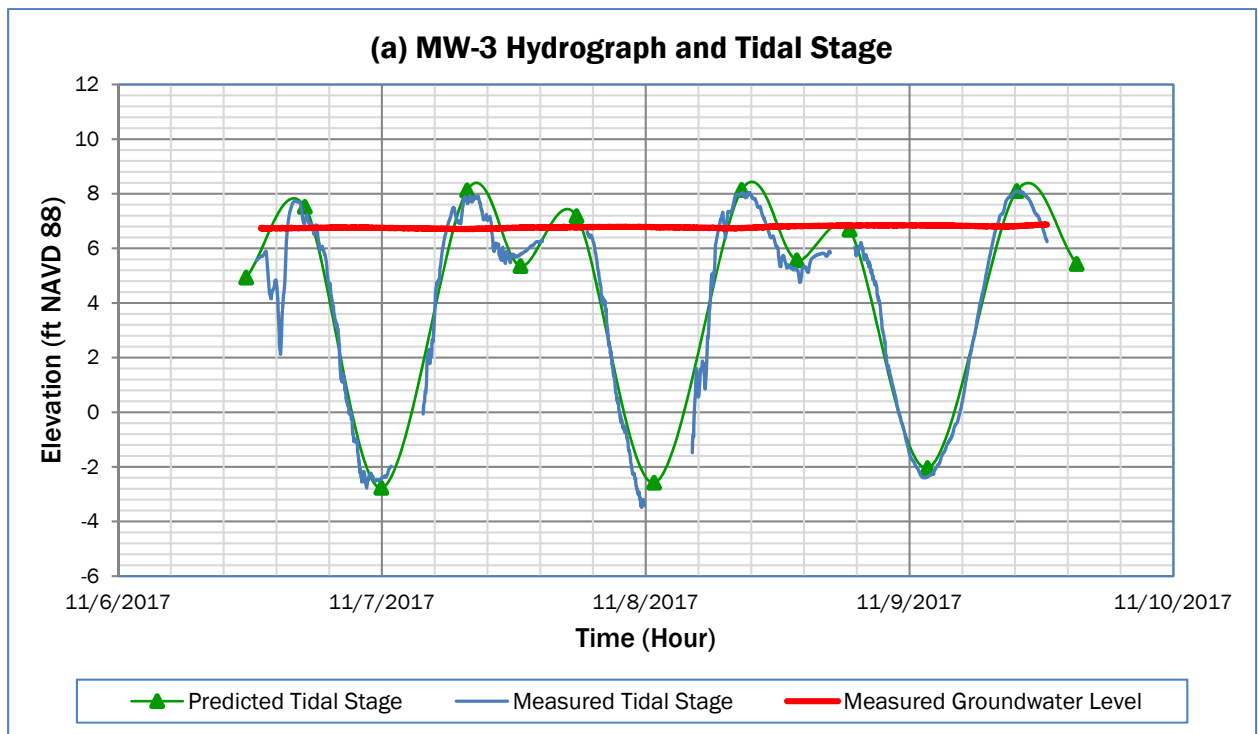
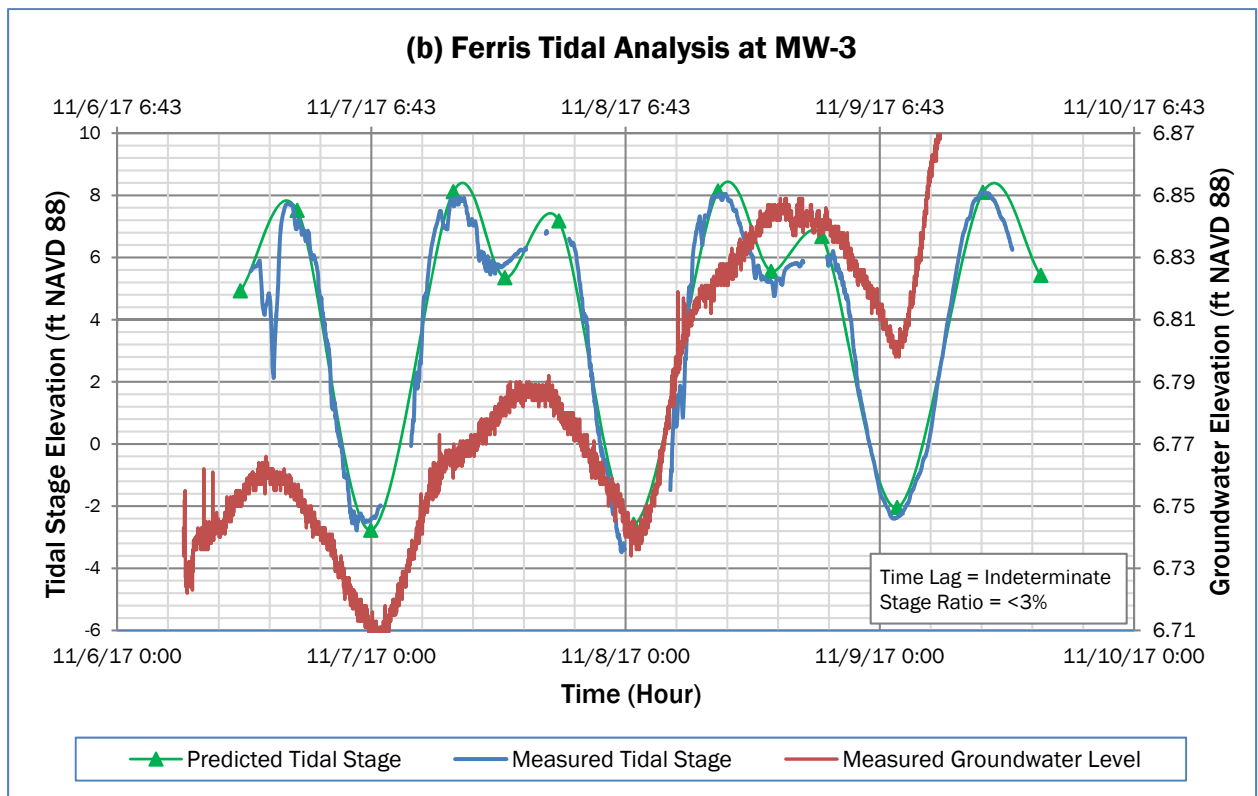
| | <b>Figure 15</b> |

1. Method based on Ferris (1951).
2. Distance to Shoreline: 45 feet
3. This drawing is for information purposes. It is intended to assist in showing features discussed in an attached document. GeoEngineers, Inc. cannot guarantee the accuracy and content of electronic files. The master file is stored by GeoEngineers, Inc. and will serve as the official record of this communication.

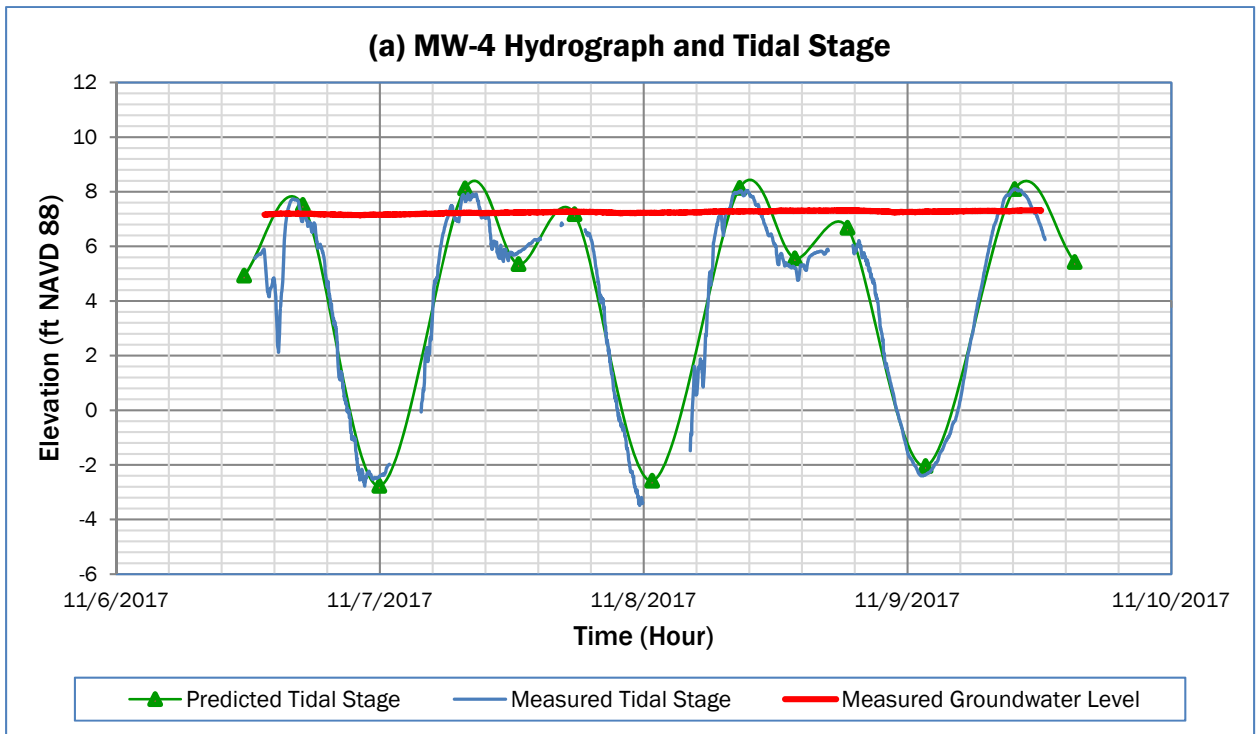
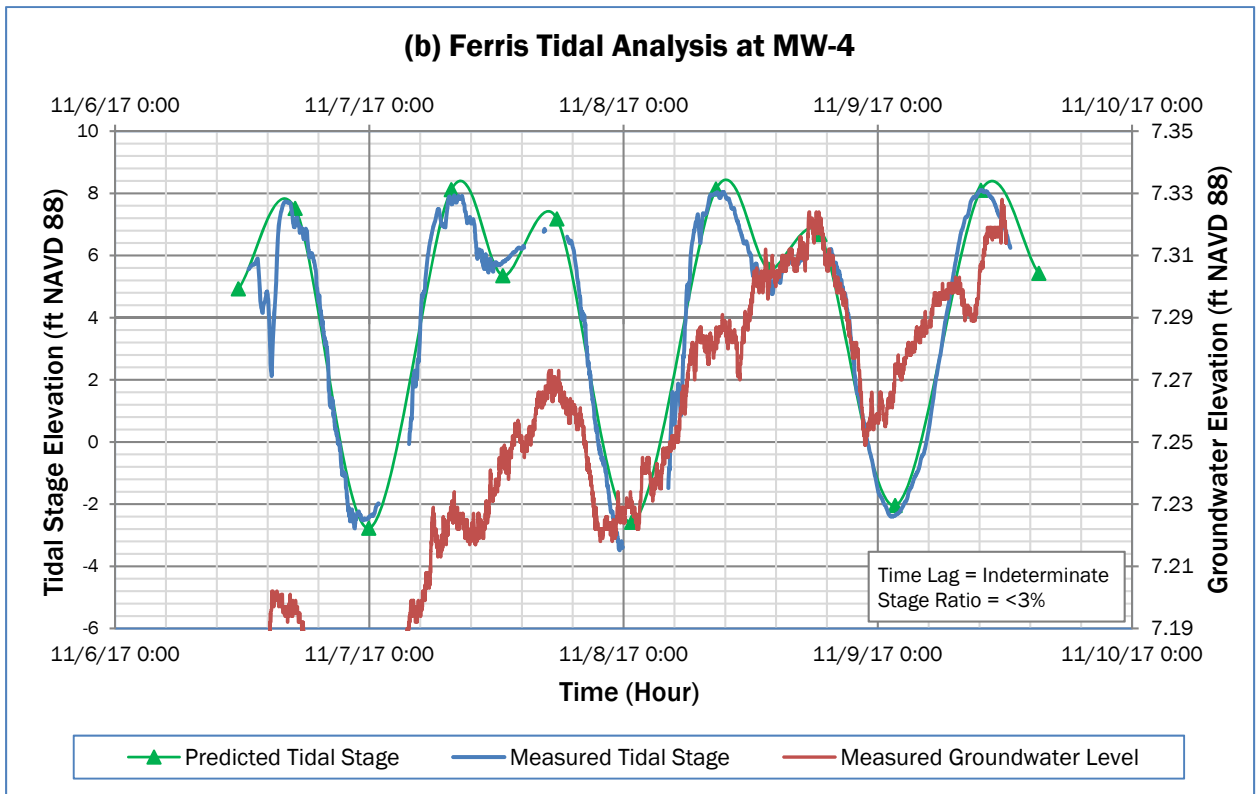
| | <b>Figure 16</b> |

1. Method based on Ferris (1951).
2. Distance to Shoreline: 190 feet
3. This drawing is for information purposes. It is intended to assist in showing features discussed in an attached document. GeoEngineers, Inc. cannot guarantee the accuracy and content of electronic files. The master file is stored by GeoEngineers, Inc. and will serve as the official record of this communication.

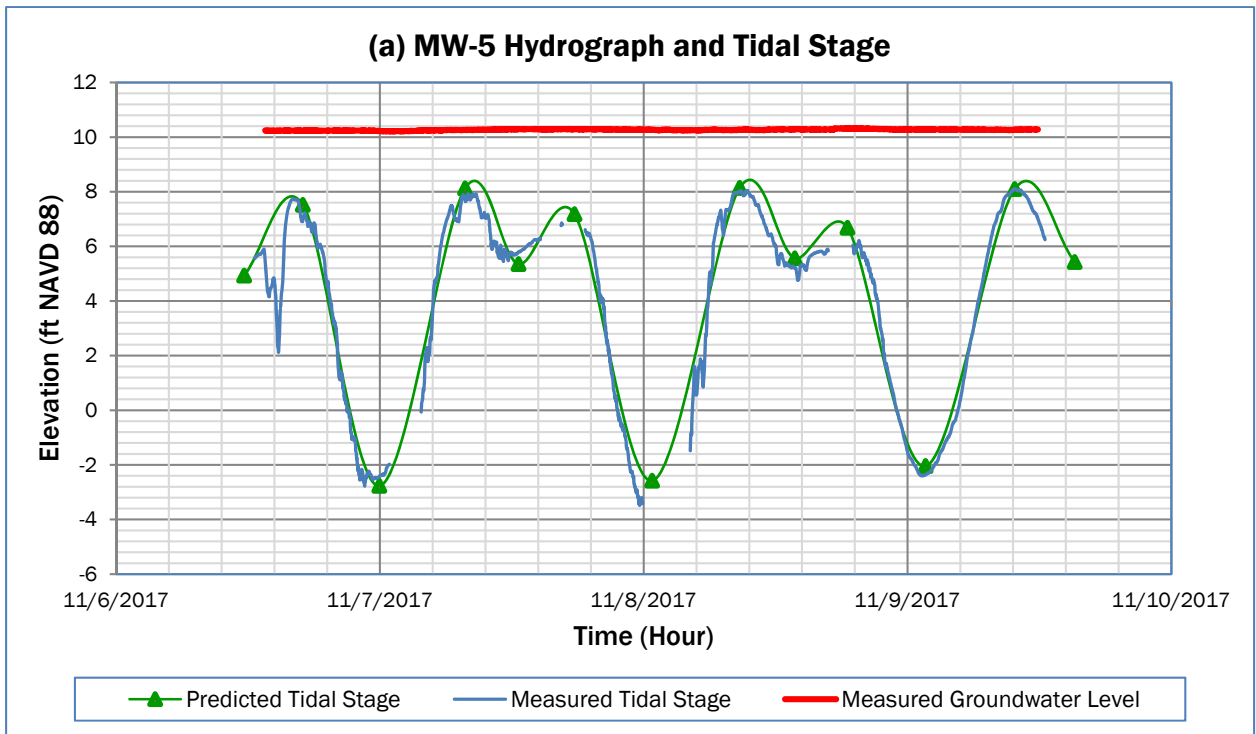
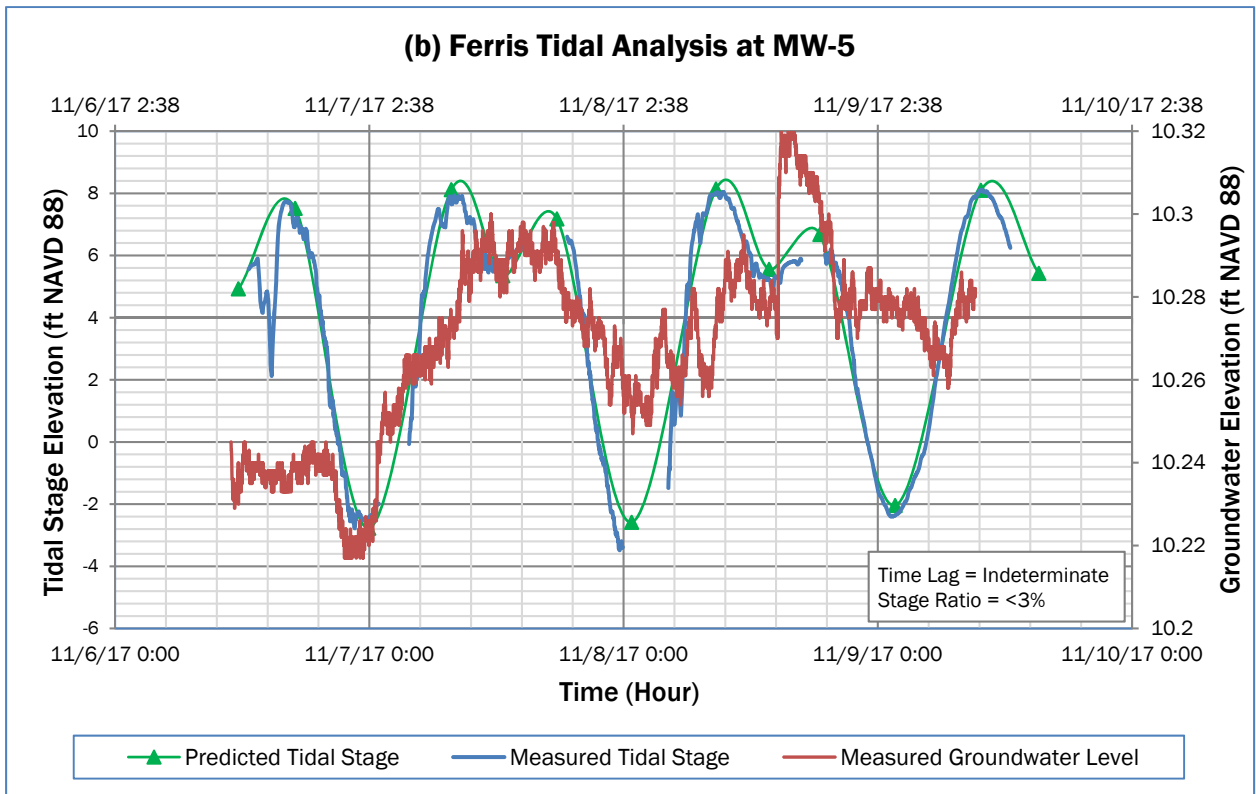
| | <b>Figure 17</b> |

1. Method based on Ferris (1951).
2. Distance to Shoreline: 260 feet
3. This drawing is for information purposes. It is intended to assist in showing features discussed in an attached document. GeoEngineers, Inc. cannot guarantee the accuracy and content of electronic files. The master file is stored by GeoEngineers, Inc. and will serve as the official record of this communication.

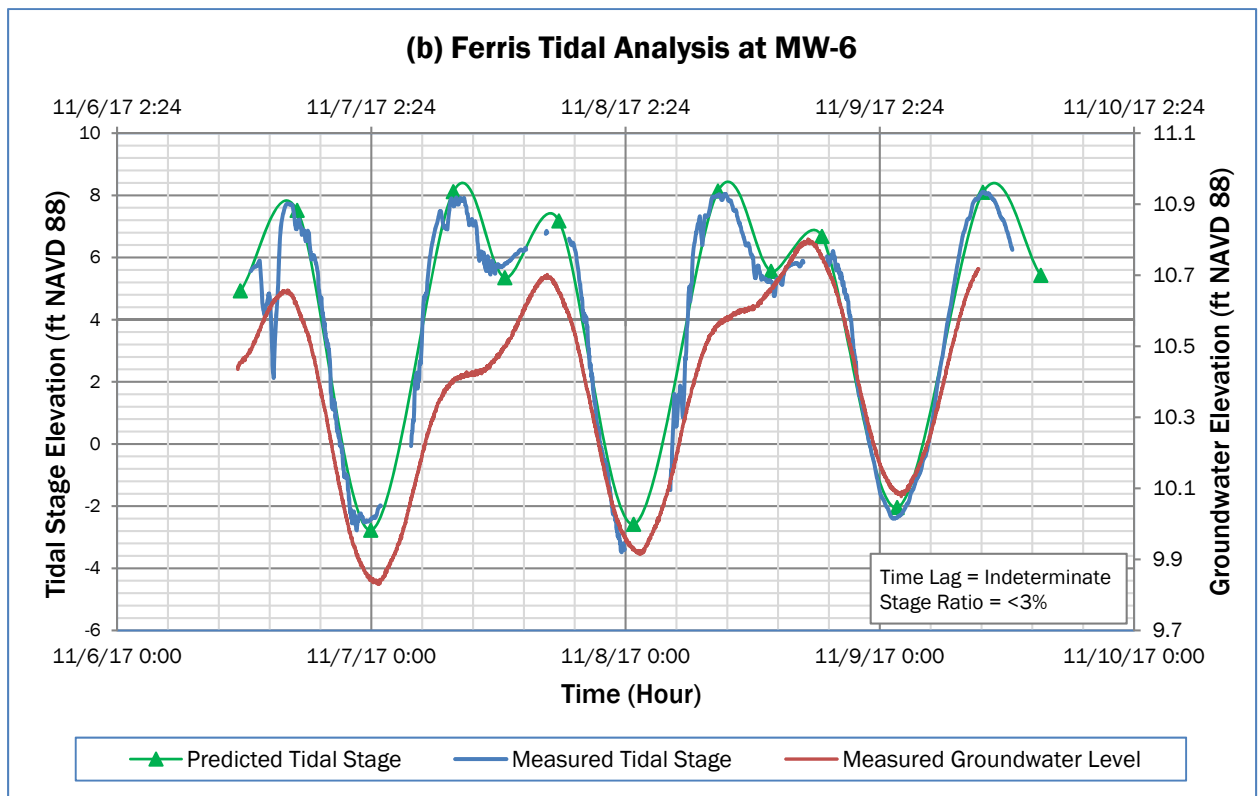
| | <b>Figure 18</b> |

1. Method based on Ferris (1951).
2. Distance to Shoreline: 380 feet
3. This drawing is for information purposes. It is intended to assist in showing features discussed in an attached document. GeoEngineers, Inc. cannot guarantee the accuracy and content of electronic files. The master file is stored by GeoEngineers, Inc. and will serve as the official record of this communication.

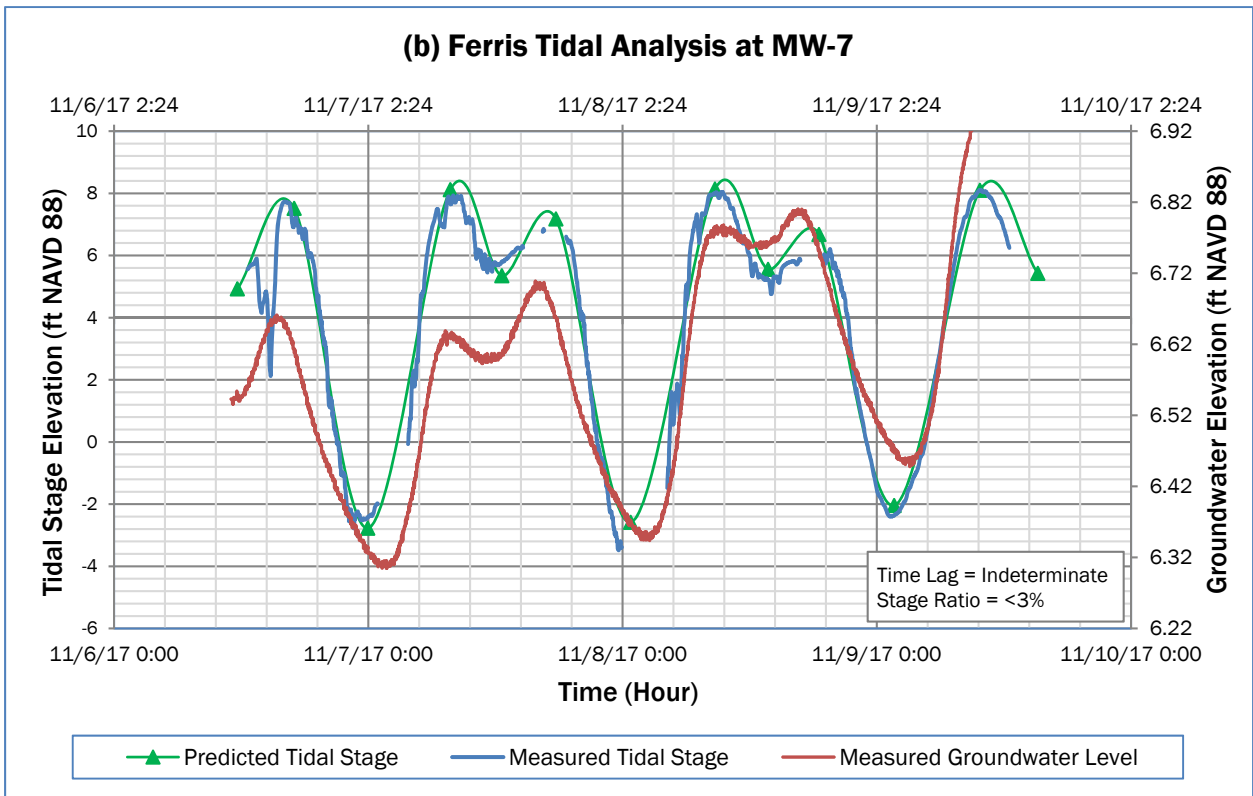
| | <b>Figure 19</b> |

1. Method based on Ferris (1951).
2. Distance to Shoreline: 240 feet
3. This drawing is for information purposes. It is intended to assist in showing features discussed in an attached document. GeoEngineers, Inc. cannot guarantee the accuracy and content of electronic files. The master file is stored by GeoEngineers, Inc. and will serve as the official record of this communication.

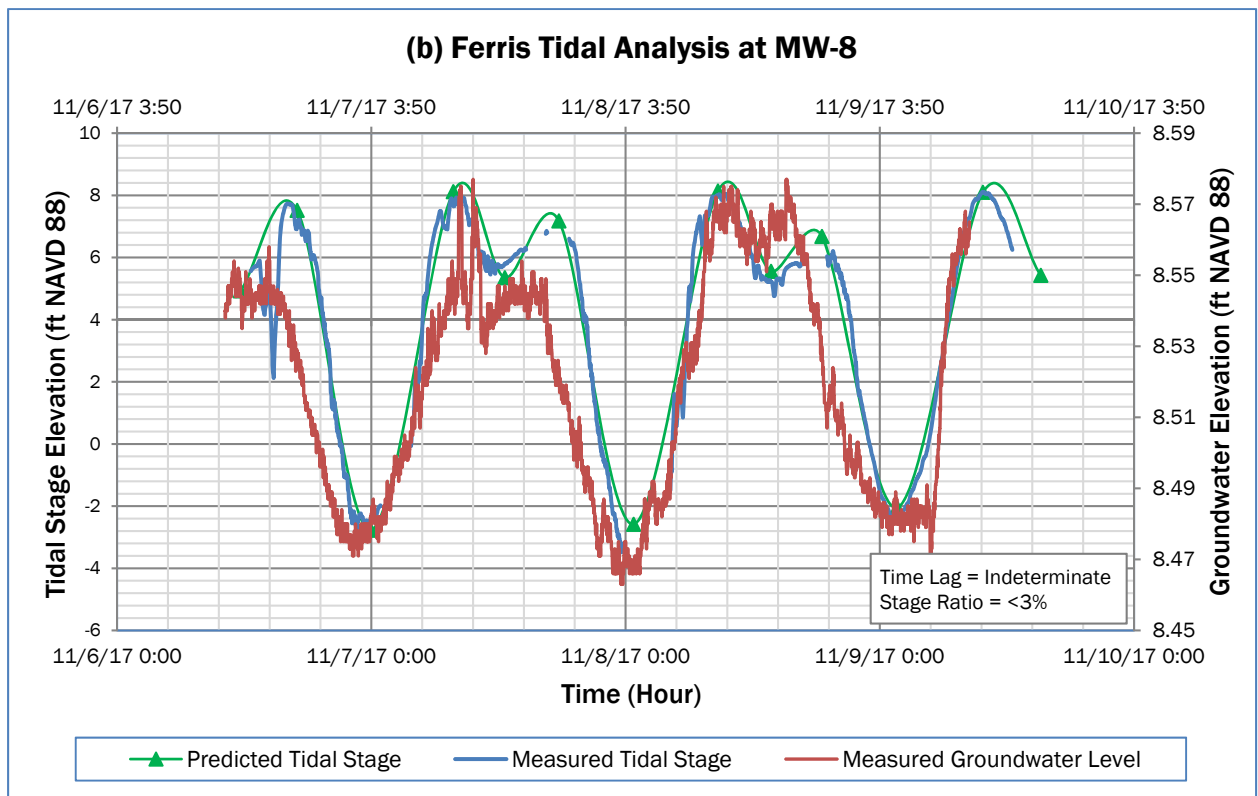
| | <b>Figure 20</b> |

1. Method based on Ferris (1951).
2. Distance to Shoreline: 80 feet
3. This drawing is for information purposes. It is intended to assist in showing features discussed in an attached document. GeoEngineers, Inc. cannot guarantee the accuracy and content of electronic files. The master file is stored by GeoEngineers, Inc. and will serve as the official record of this communication.
