## ANACORTES PLANNING COMMISSION

**May 24, 2023**

### **AGENDA**

- A. Roll Call**
- B. Minutes**
  - 1) Minutes of May 8, 2023
- C. Correspondence**
- D. New Business**
  - 1) Appoint new vice chair.
  - 2) Open Record Public Hearing and Decision for Shoreline Substantial Development Permit SDP-2023-0002 Port of Anacortes 2nd Street and Curtis Wharf project.
- E. Old Business**

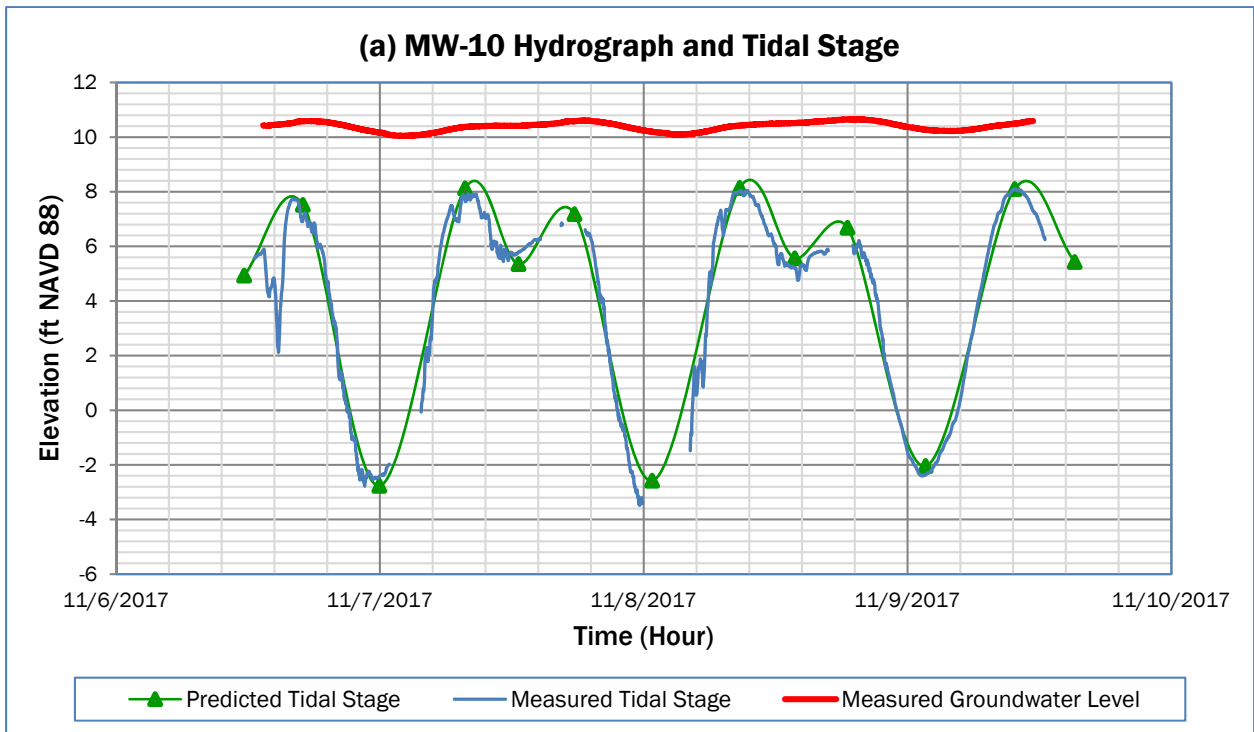
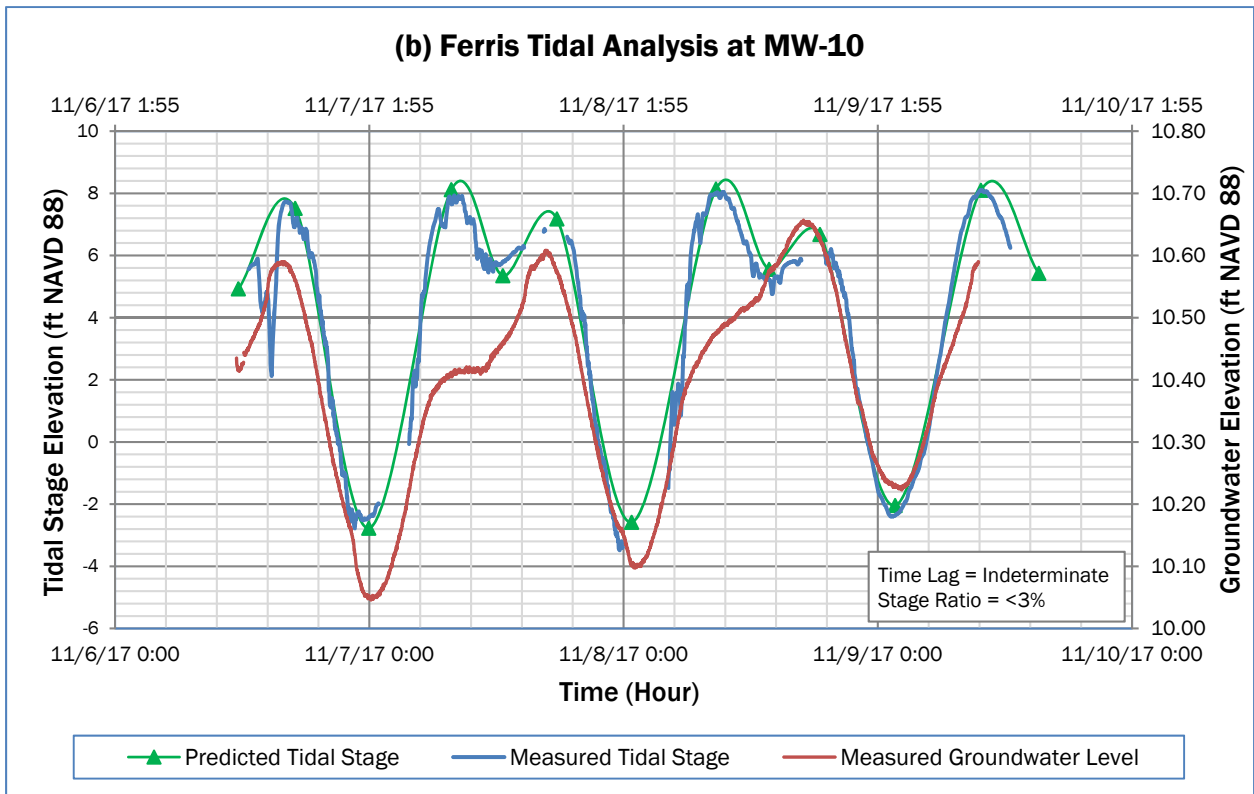
| | <b>Figure 21</b> |

1. Method based on Ferris (1951).
2. Distance to Shoreline: 300 feet
3. This drawing is for information purposes. It is intended to assist in showing features discussed in an attached document. GeoEngineers, Inc. cannot guarantee the accuracy and content of electronic files. The master file is stored by GeoEngineers, Inc. and will serve as the official record of this communication.

The time lag and stage ratio for each tidal study monitoring well was determined over a period of two full tidal cycles (Figures 14 through 23). The observed tidal effects on monitoring locations used for the tidal study are presented in Table 2. Tidal study data for the monitoring wells indicating the most tidal influence are summarized in the table below and are organized by shortest to longest time lag in hours.

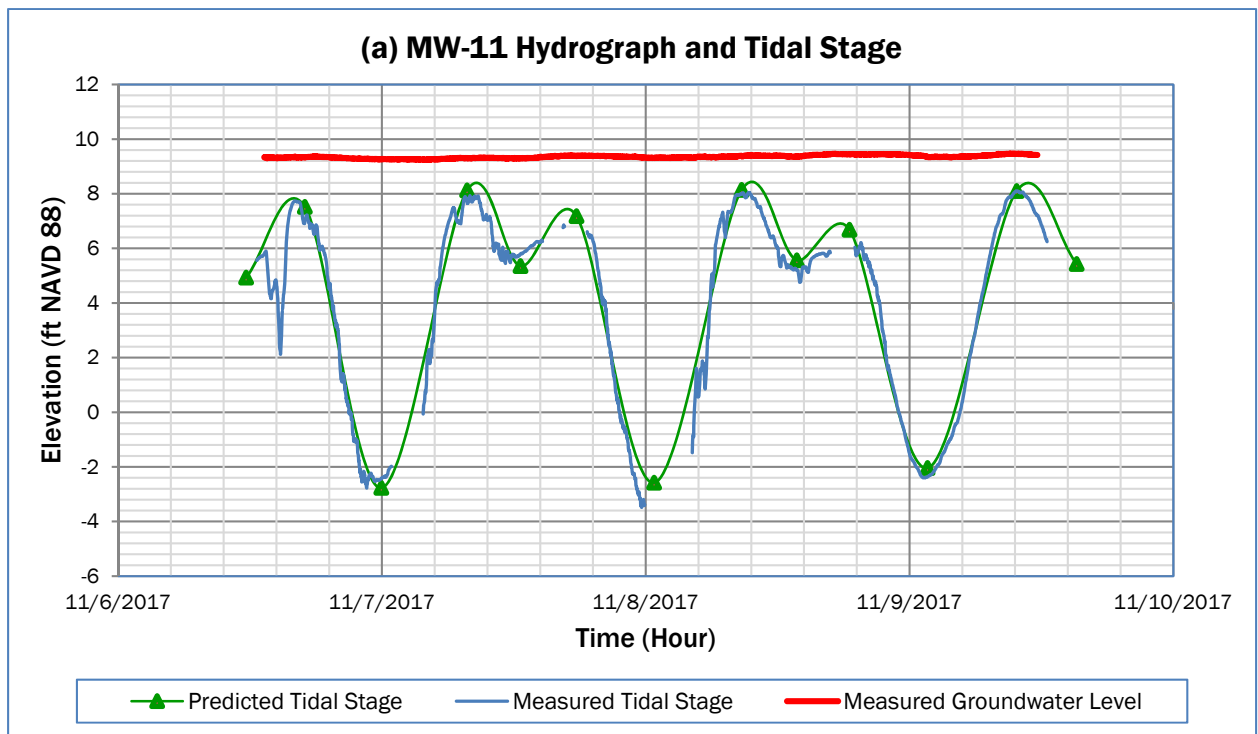
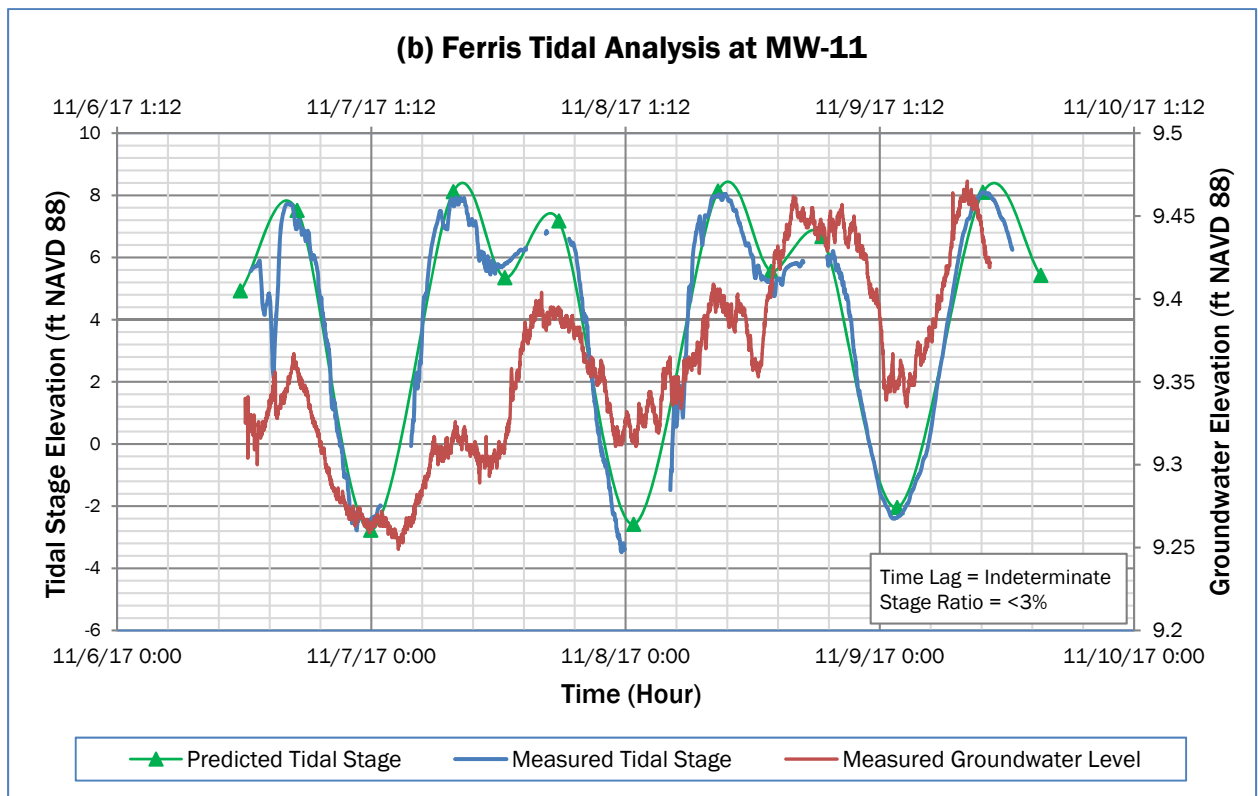
**Figure 22**

1. Method based on Ferris (1951).
2. Distance to Shoreline: 160 feet
3. This drawing is for information purposes. It is intended to assist in showing features discussed in an attached document. GeoEngineers, Inc. cannot guarantee the accuracy and content of electronic files. The master file is stored by GeoEngineers, Inc. and will serve as the official record of this communication.

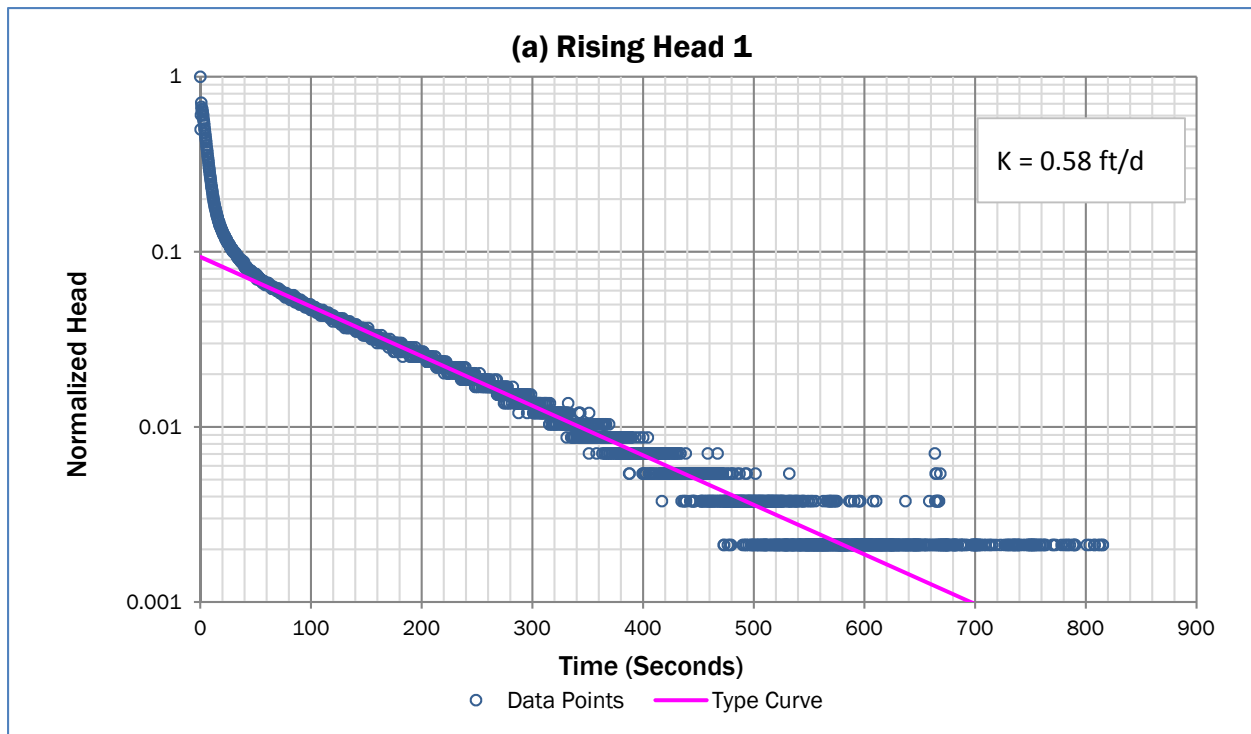
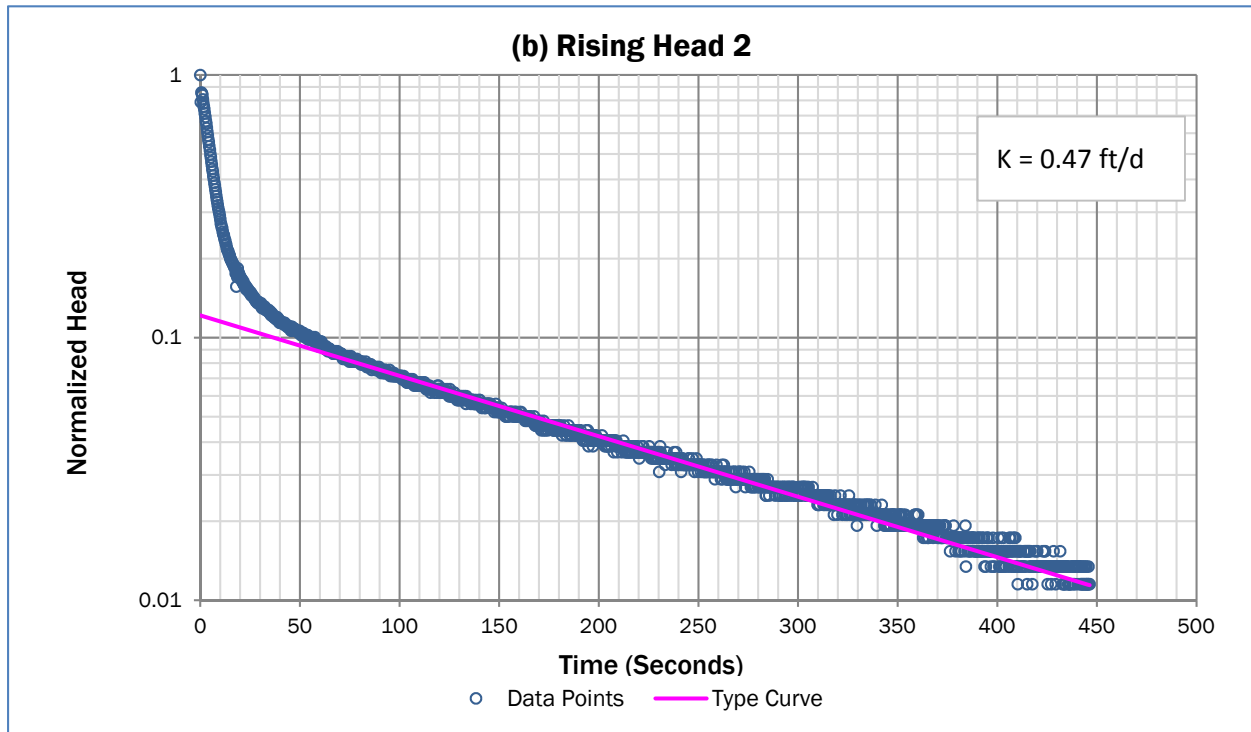
**Figure 23**

1. Water level response was measured with an unvented 0-30psi INW PT2X pressure transducer recording 8 times per second.
  2. Well is screened across the water table.
  3. Aquifer is assumed to be unconfined.
  4. Saturated thickness is assumed to be 7.6 feet.
  5. Well is screened from 3.7 to 11.7 feet below ground surface.
  6. Static water level was 6.37 feet below ground surface.
  7. This drawing is for information purposes. It is intended to assist in showing features discussed in an attached document. GeoEngineers, Inc. cannot guarantee the accuracy and content of electronic files. The master file is stored by GeoEngineers, Inc. and will serve as the official record of this communication.
- Data Source: project.GeoEngineers.com/Technical Analysis/Tidal Study and Slug Testing/Slug Tests/MW-2\_BouwerRice1976.xls

Hydraulic conductivity testing that included slug testing was performed on selected monitoring locations at the Site on November 16, 2017. The purpose of the slug testing was to use the data, in combination with data gathered during the tidal study, to estimate hydraulic conductivity ( $K$ ) within the aquifer in the vicinity of the test locations. Slug testing was performed at monitoring well locations MW-2, MW-3, MW-4, MW-6, MW-7, and MW-11. Field procedures, as well as the procedure for data analysis from the slug testing are described below. The locations selected for slug testing are shown on Figure 2. Plots of the slug test results are presented on Figures 24 through 29.

The hydraulic conductivity for the aquifer was estimated using the results of slug testing in six monitoring wells (MW-2, MW-3, MW-4, MW-6, MW-7, and MW-11). As stated above, diffusivity could not be used to estimate the hydraulic parameters due to the unproportional timing and degree of the observed tidal influence. Based on the slug test results, hydraulic conductivity for the aquifer ranges between 0.02 and 4.11 feet/day with a mean value of 1.25 feet/day. Slug test results and calculated hydraulic conductivities for each monitoring well are shown on Figures 24 through 29.

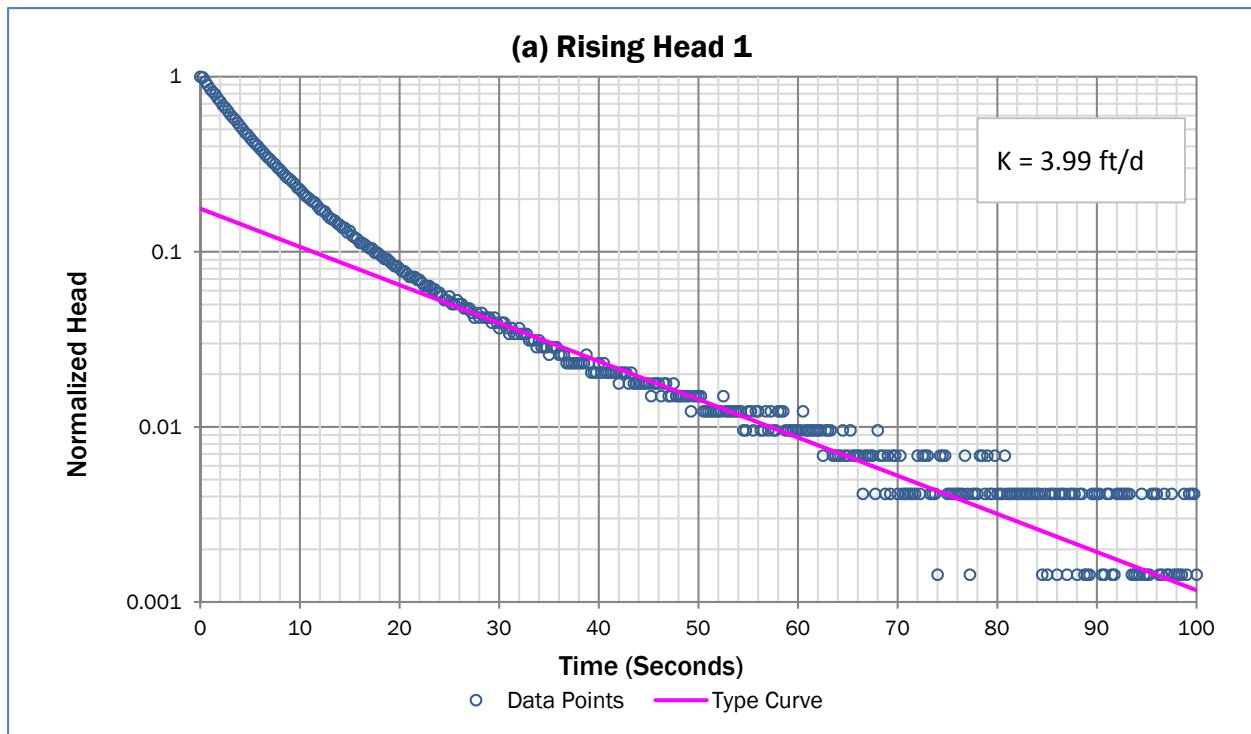
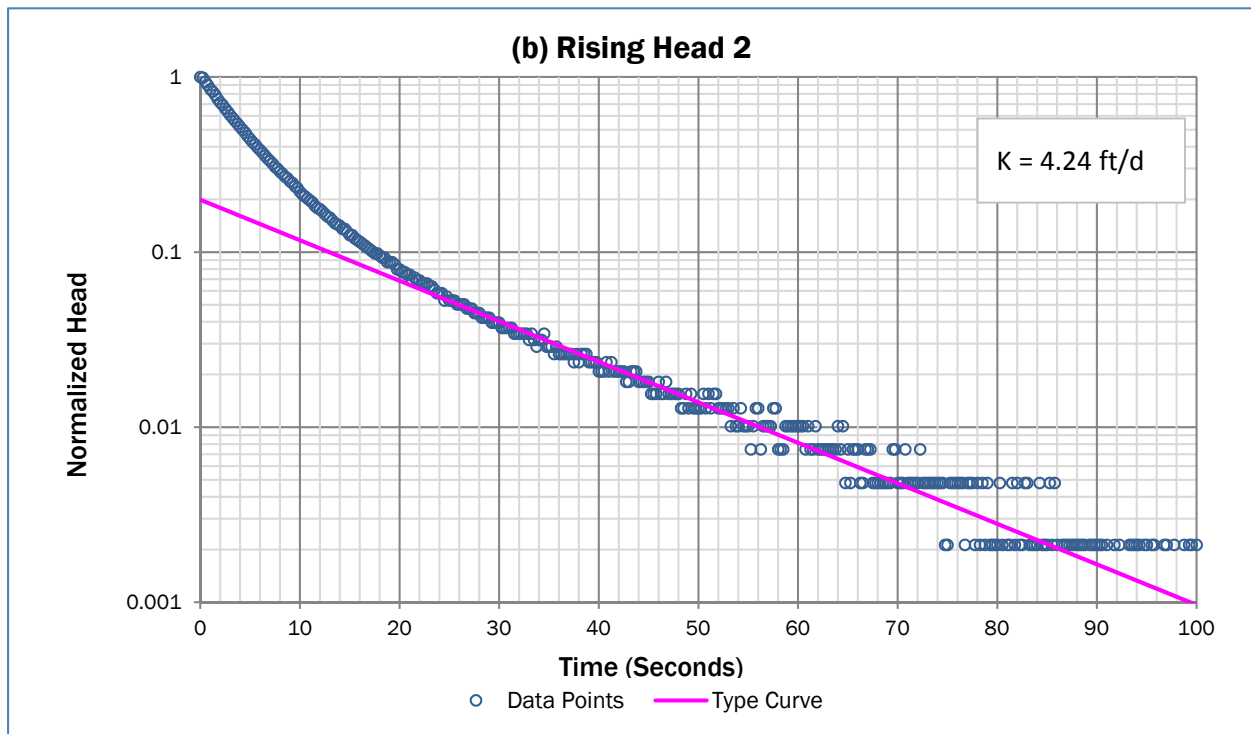
**Figure 24**

1. Water level response was measured with an unvented 0-30psi INW PT2X pressure transducer recording 8 times per second.
  2. Well is screened across the water table.
  3. Aquifer is assumed to be unconfined.
  4. Saturated thickness is assumed to be 7.6 feet.
  5. Well is screened from 3.7 to 15.7 feet below ground surface.
  6. Static water level was 6.86 feet below ground surface.
  7. This drawing is for information purposes. It is intended to assist in showing features discussed in an attached document. GeoEngineers, Inc. cannot guarantee the accuracy and content of electronic files. The master file is stored by GeoEngineers, Inc. and will serve as the official record of this communication.
- Data Source: project.GeoEngineers.com/Technical Analysis/Tidal Study and Slug Testing/Slug Tests/MW-3\_BouwerRice1976.xls

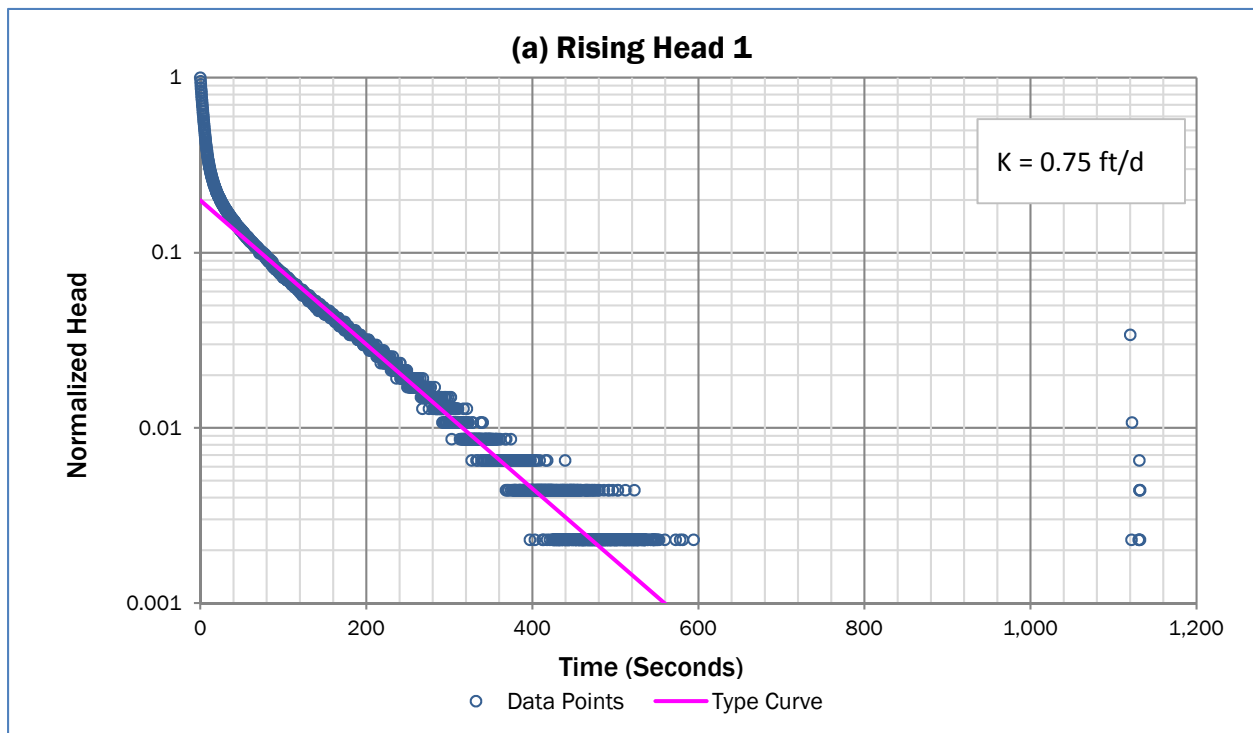
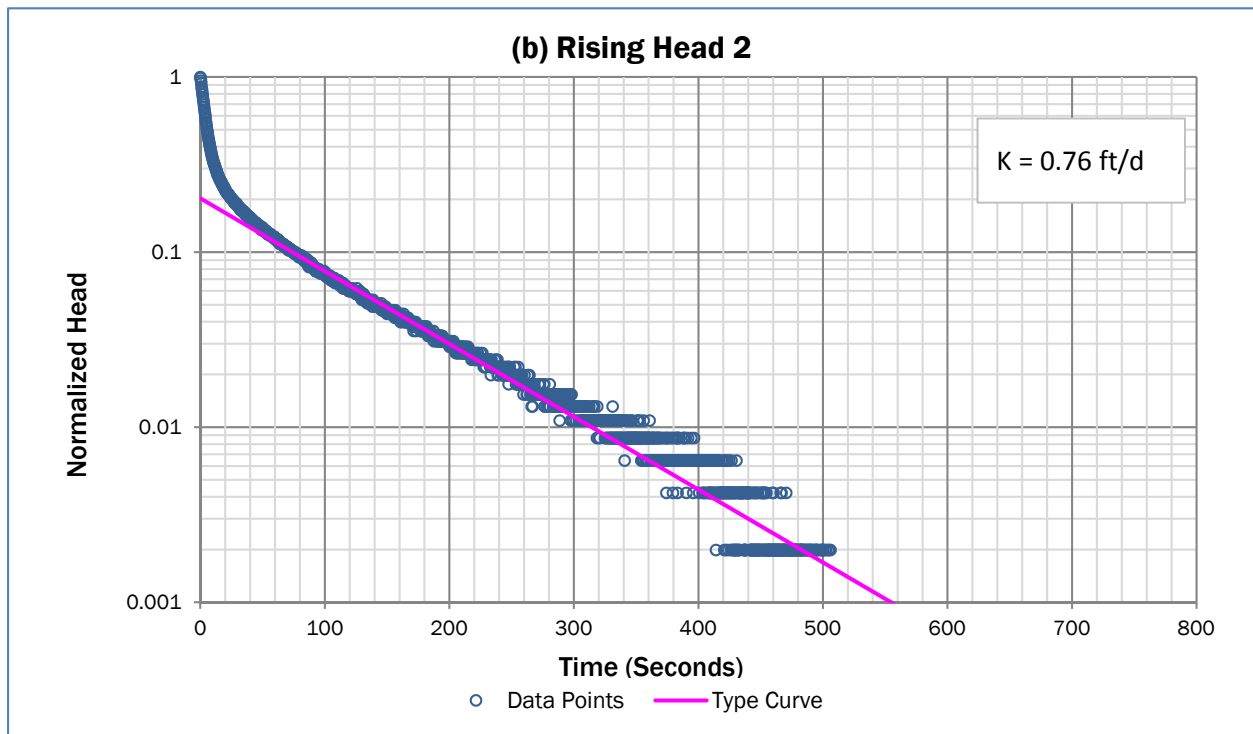
**Figure 25**

1. Water level response was measured with an unvented 0-30psi INW PT2X pressure transducer recording 8 times per second.
  2. Well is screened across the water table.
  3. Aquifer is assumed to be unconfined.
  4. Saturated thickness is assumed to be 9.2 feet.
  5. Well is screened from 3.7 to 14.7 feet below ground surface.
  6. Static water level was 6.3 feet below ground surface.
  7. This drawing is for information purposes. It is intended to assist in showing features discussed in an attached document. GeoEngineers, Inc. cannot guarantee the accuracy and content of electronic files. The master file is stored by GeoEngineers, Inc. and will serve as the official record of this communication.
- Data Source: project.GeoEngineers.com/Technical Analysis/Tidal Study and Slug Testing/Slug Tests/MW-4\_BouwerRice1976.xls

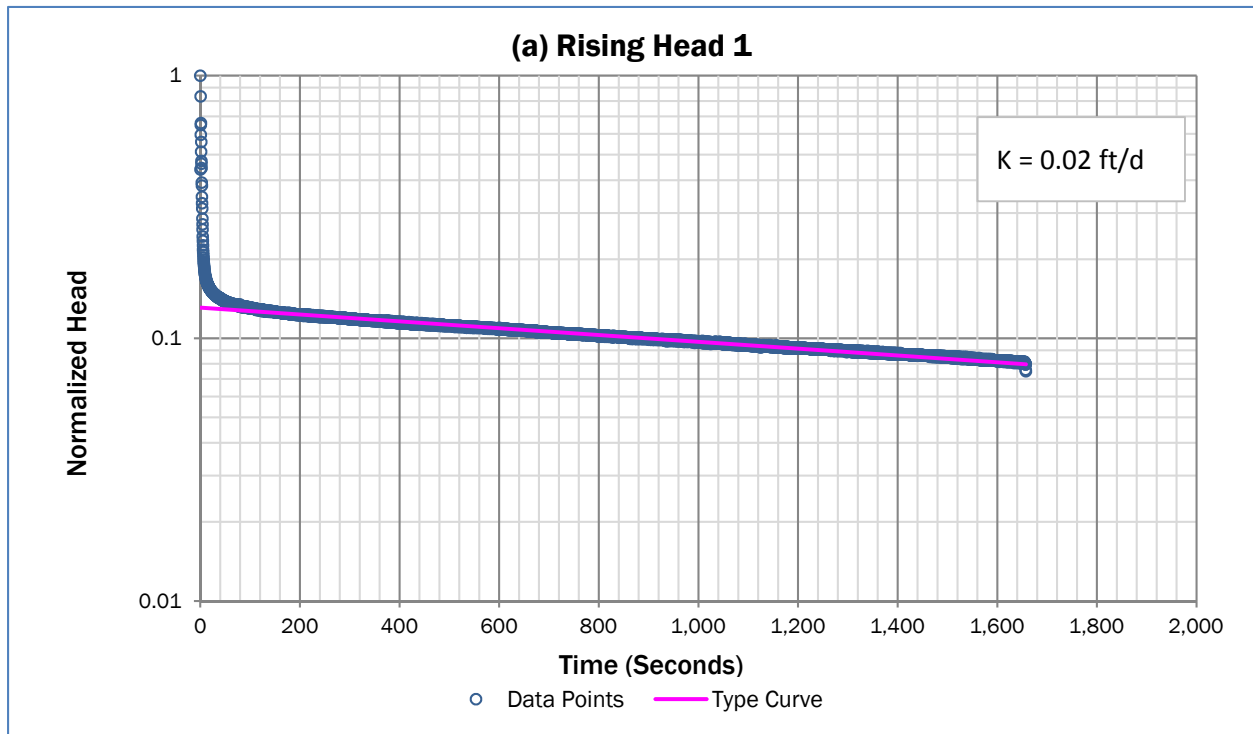
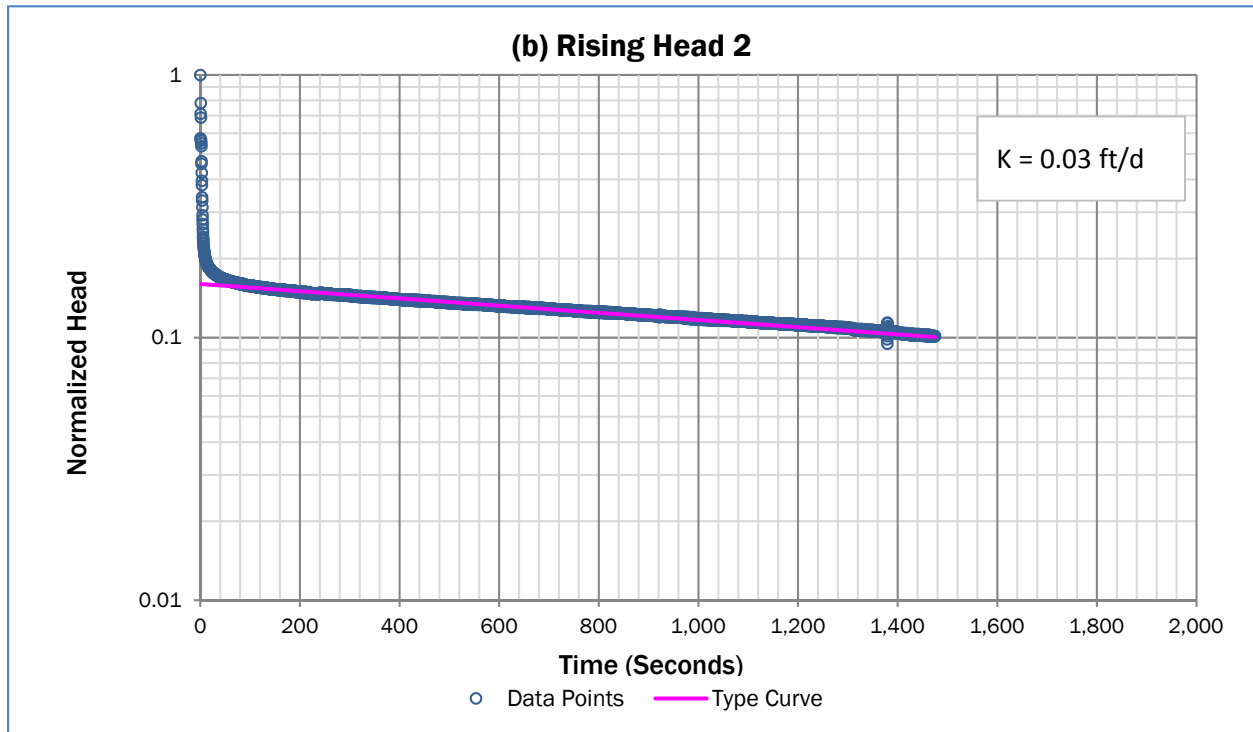
**Figure 26**

1. Water level response was measured with an unvented 0-30psi INW PT2X pressure transducer recording 8 times per second.
2. Well is screened across the water table.
3. Aquifer is assumed to be unconfined.
4. Saturated thickness is assumed to be 9.07 feet.
5. Well is screened from 5 to 15 feet below ground surface.
6. Static water level was 6.43 feet below ground surface.
7. This drawing is for information purposes. It is intended to assist in showing features discussed in an attached document. GeoEngineers, Inc. cannot guarantee the accuracy and content of electronic files. The master file is stored by GeoEngineers, Inc. and will serve as the official record of this communication.

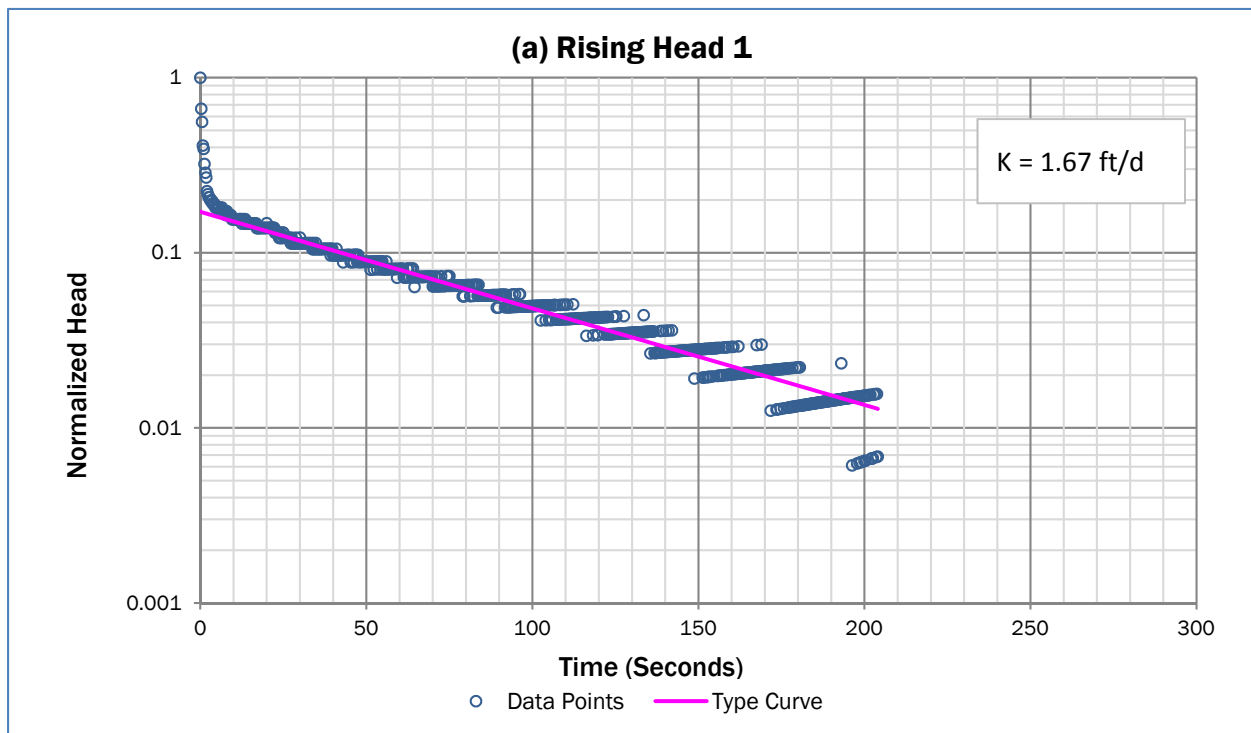
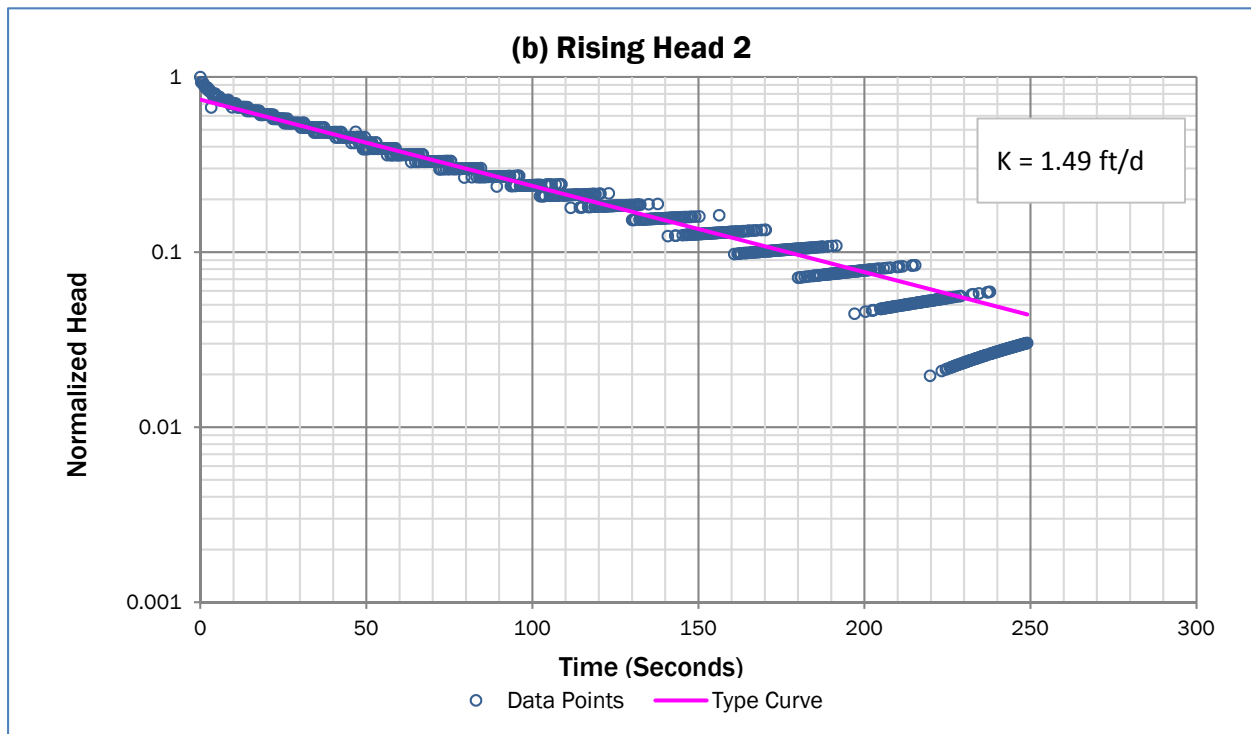
**Figure 27**

1. Water level response was measured with an unvented 0-30psi INW PT2X pressure transducer recording 8 times per second.
2. Well is screened across the water table.
3. Aquifer is assumed to be unconfined.
4. Saturated thickness is assumed to be 8.11 feet.
5. Well is screened from 5 to 10 feet below ground surface.
6. Static water level was 7.39 feet below ground surface.
7. This drawing is for information purposes. It is intended to assist in showing features discussed in an attached document. GeoEngineers, Inc. cannot guarantee the accuracy and content of electronic files. The master file is stored by GeoEngineers, Inc. and will serve as the official record of this communication.

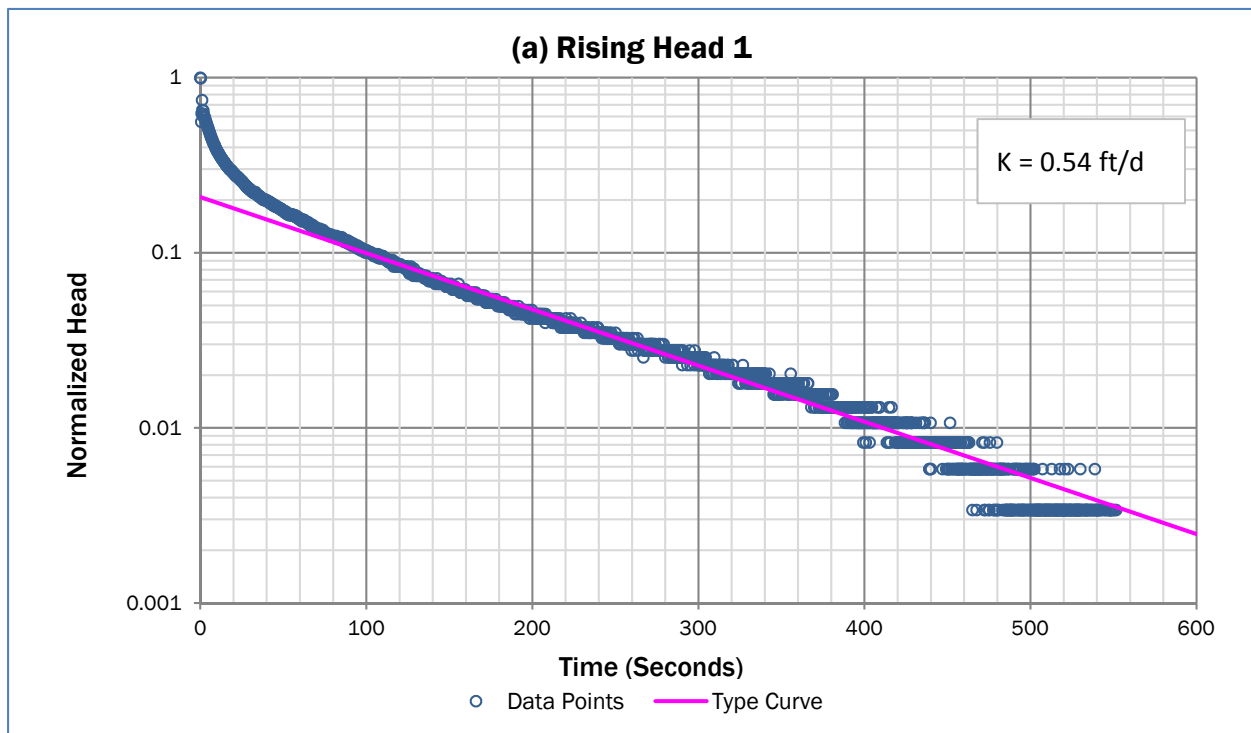
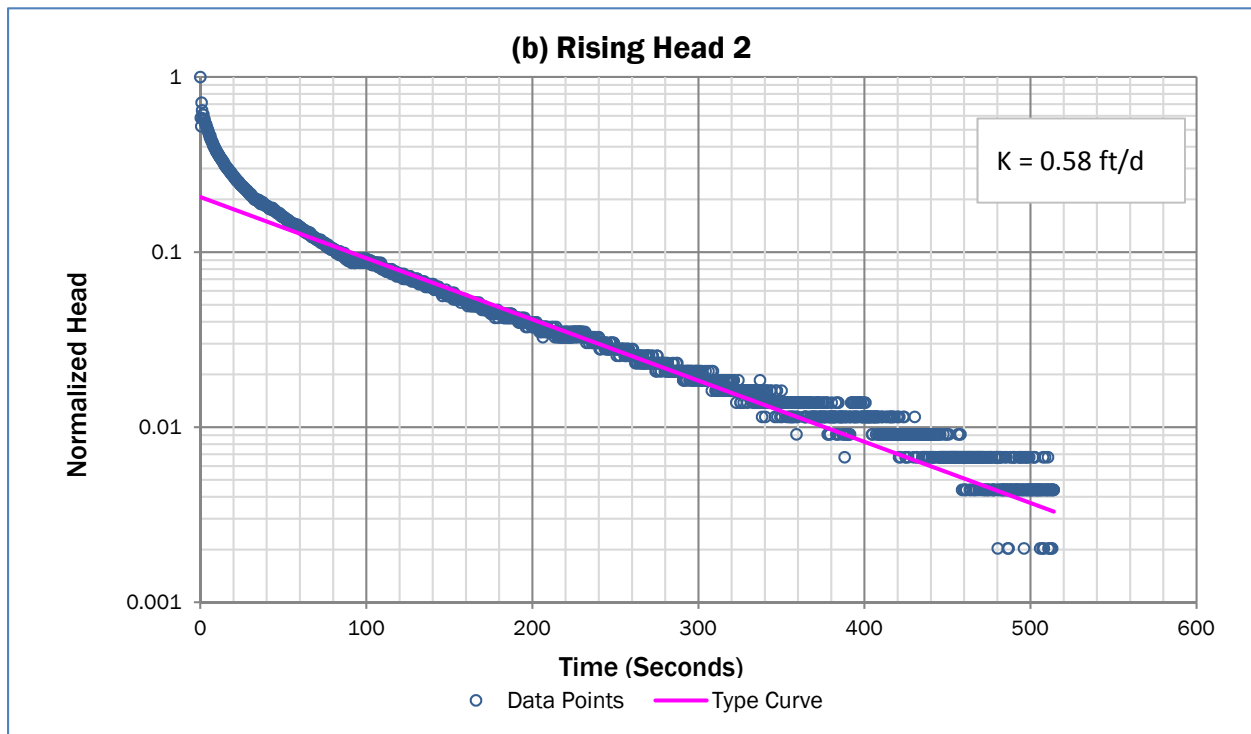
**Figure 28**

1. Water level response was measured with an unvented 0-30psi INW PT2X pressure transducer recording 8 times per second.
2. Well is screened across the water table.
3. Aquifer is assumed to be unconfined.
4. Saturated thickness is assumed to be 10.45 feet.
5. Well is screened from 5 to 15 feet below ground surface.
6. Static water level was 5 feet below ground surface.
7. This drawing is for information purposes. It is intended to assist in showing features discussed in an attached document. GeoEngineers, Inc. cannot guarantee the accuracy and content of electronic files. The master file is stored by GeoEngineers, Inc. and will serve as the official record of this communication.

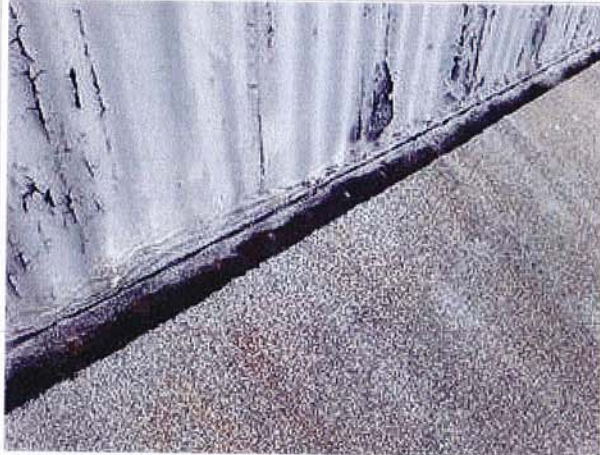
| HM# | AHERA Category | Homogeneous Material Description | Homogeneous Area | Quantity (Approximate) | Sample #s | Asbestos Content |
|---|---|---|---|---|---|---|
| 7 | Misc. | Putty / caulk | Garage 1, at shed roof to corrugated wall penetration. | 30 L.F. | 7 | Chrysotile 7-10% |

| Sample | | | |
|---|---|---|---|
| <b>Quantity</b> | 30 | <b>Unit of Measure</b> | Lineal Feet |
| <b>Asbestos Type/%</b> | <b>Chrysotile 7-10%</b> | | |

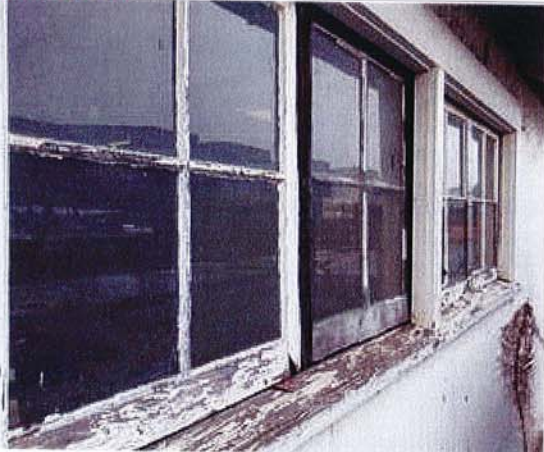
| Sample | | | |
|---|---|---|---|
| <b>Quantity</b> | 8 windows at 2ft x 2ft | <b>Unit of Measure</b> | Each |
| <b>Asbestos Type/%</b> | <b>Tremolite &lt;1%</b> | | |

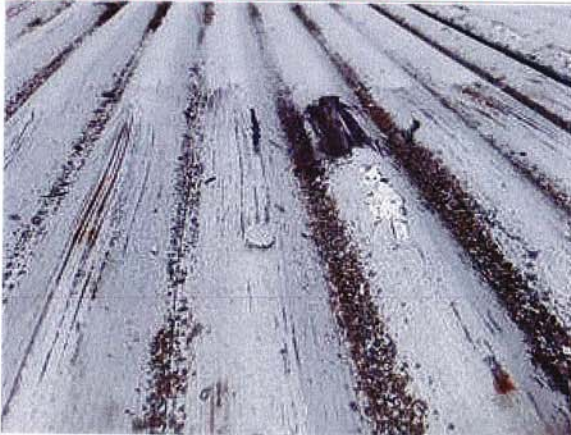
| Sample | | | |
|---|---|---|---|
| <b>Quantity</b> | 7000 | <b>Unit of Measure</b> | Square Feet |
| <b>Asbestos Type/%</b> | <b>Layer 1 (Silver coating): None Detected.</b><br><b>Layer 2 (Black mastic): Chrysotile 10-15%</b> | | |

| Lab Sample Description | Asbestos Type/% | Non-Asbestos Fibers | Non-Fibrous Materials |
|---|---|---|---|
| Layer: 2 Black fibrous tarry roofing mastic | Chrysotile 10-15% | Cellulose <1%<br>Fibrous Glass 3-5% | Binder, Mineral Aggregate |

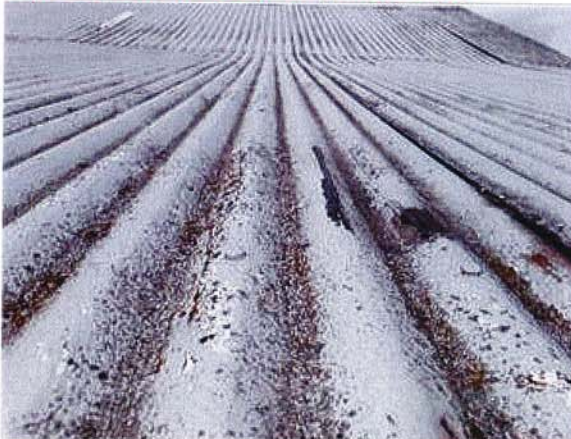
| Sample | | | |
|---|---|---|---|
| <b>Quantity</b> | See sample 19 for total quantity. | <b>Unit of Measure</b> | Square Feet |
| <b>Asbestos Type/%</b> | <b>Layer 1 (Silver coating): None Detected.</b><br><b>Layer 2 (Black mastic): Chrysotile 3-5%</b> | | |

| Lab Sample Description | Asbestos Type/% | Non-Asbestos Fibers | Non-Fibrous Materials |
|---|---|---|---|
| Layer: 2 Black fibrous tarry roofing mastic with white/tan paint | Chrysotile 3-5% | Cellulose <1% | Binder, Mineral Aggregate |

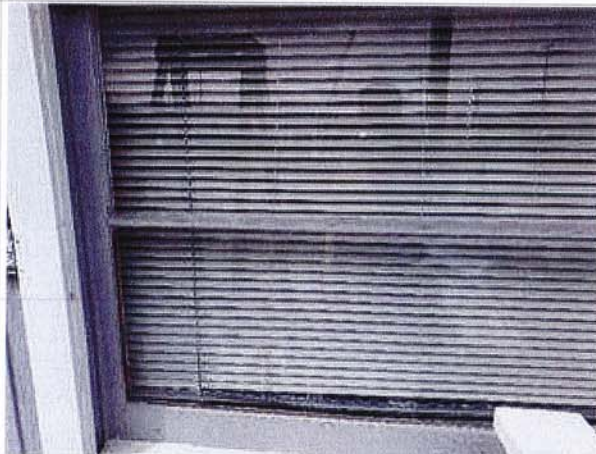
| Sample | | | |
|---|---|---|---|
| <b>Quantity</b> | One window at 4' by 5' | <b>Unit of Measure</b> | Each |
| <b>Asbestos Type/%</b> | <b>Layer 1 (Putty): Tremolite &lt;1%</b><br><b>Layer 2 (Substrate): None Detected.</b> | | |

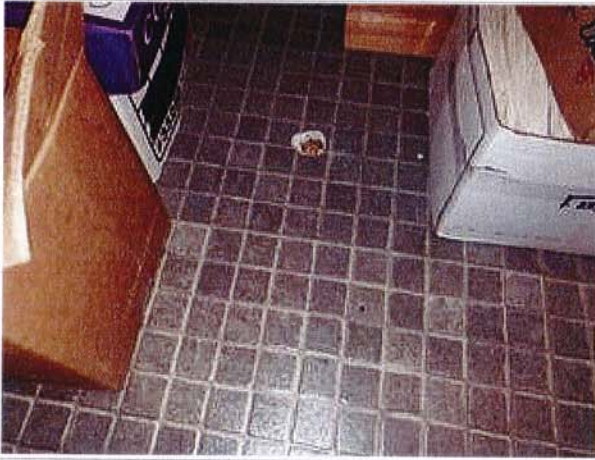
| Sample | | | |
|---|---|---|---|
| <b>Quantity</b> | 160 | <b>Unit of Measure</b> | Square Feet |
| <b>Asbestos Type/%</b> | Layers 1-4: None Detected.<br><b>Layer 5 (White backing): Chrysotile 35-40%</b><br>Layers 6-7: None Detected. | | |

| HM# | AHERA Category | Homogeneous Material Description | Homogeneous Area | Quantity (Approximate) | Sample #s | Asbestos Content |
|---|---|---|---|---|---|---|
| 23 | Misc. | Flooring sheet vinyl, 2 inseparable layers. | Office 2 storage Room floor. | 160 S.F. | 27 | Layers 1-4: None Detected.<br>Layer 5 (White backing): Chrysotile 35-40%<br>Layer 6-7: None Detected. |

Chrysotile 35-40%

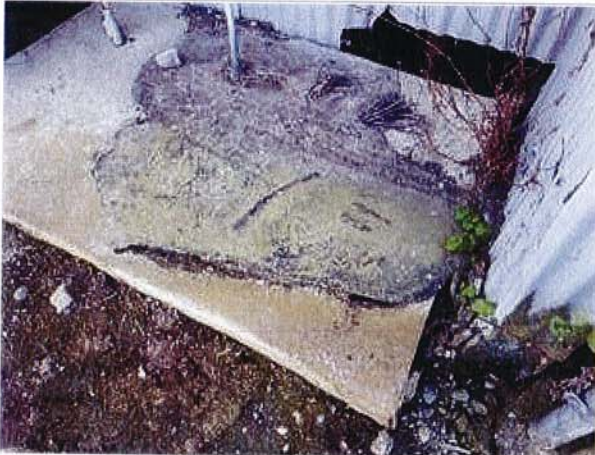
| Sample | | | |
|---|---|---|---|
| <b>Quantity</b> | 16 | <b>Unit of Measure</b> | Square Feet |
| <b>Asbestos Type/%</b> | <b>Chrysotile 1-3%</b> | | |

| HM# | AHERA Category | Homogeneous Material Description | Homogeneous Area | Quantity (Approximate) | Sample #s | Asbestos Content |
|---|---|---|---|---|---|---|
| 25 | Misc. | Roofing tar | At the North West corner of office 2, on cement slab. | 16 S.F. | 29 | Chrysotile 1-3% |

| Lab Sample Description | Asbestos Type/% | Non-Asbestos Fibers | Non-Fibrous Materials |
|---|---|---|---|
| Black fibrous tarry roofing mastic | Chrysotile 1-3% | Cellulose 3-5% | Binder, Mineral Aggregate |

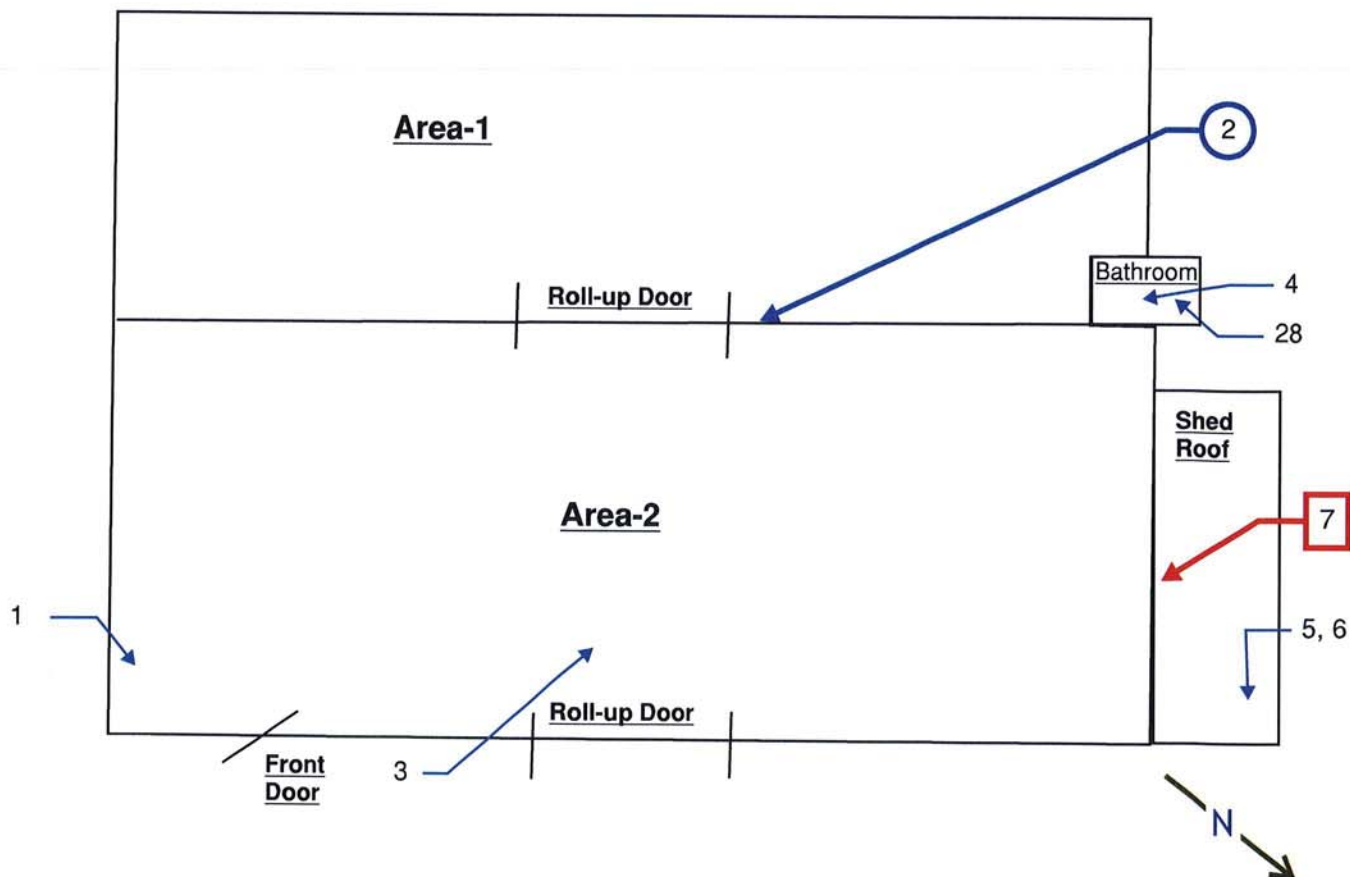
## Garage-1

Visual samples presumed to be asbestos-containing appear in triangles EX: #

Samples less than one percent asbestos appear in circles EX: #

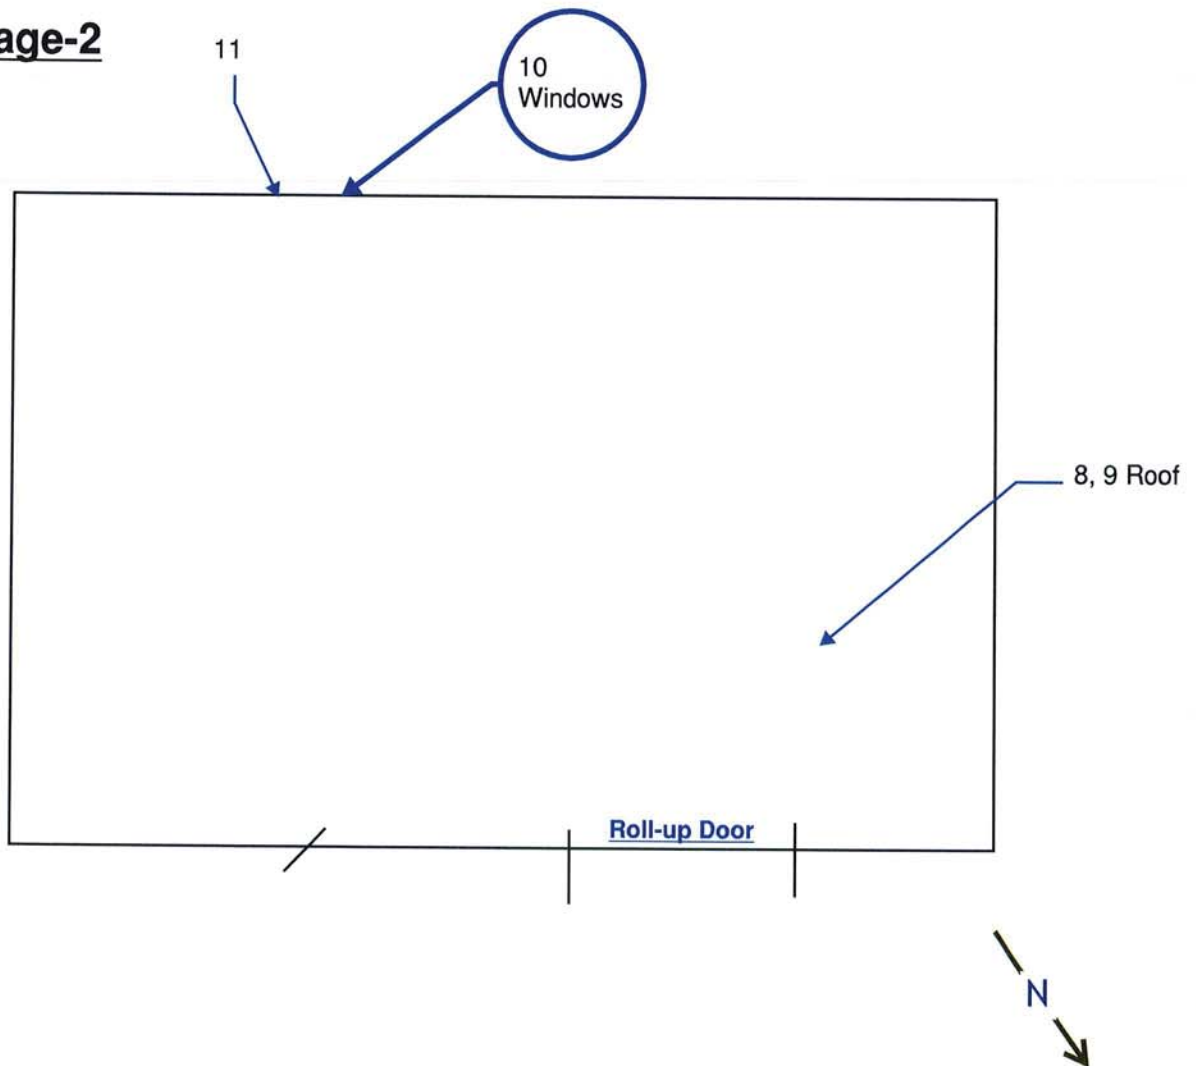
### Garage-2

Visual samples presumed to be asbestos-containing appear in triangles EX: #

Samples less than one percent asbestos appear in circles EX: #
