## ANACORTES PLANNING COMMISSION

**May 24, 2023**

### **AGENDA**

- A. Roll Call**
- B. Minutes**
  - 1) Minutes of May 8, 2023
- C. Correspondence**
- D. New Business**
  - 1) Appoint new vice chair.
  - 2) Open Record Public Hearing and Decision for Shoreline Substantial Development Permit SDP-2023-0002 Port of Anacortes 2nd Street and Curtis Wharf project.
- E. Old Business**

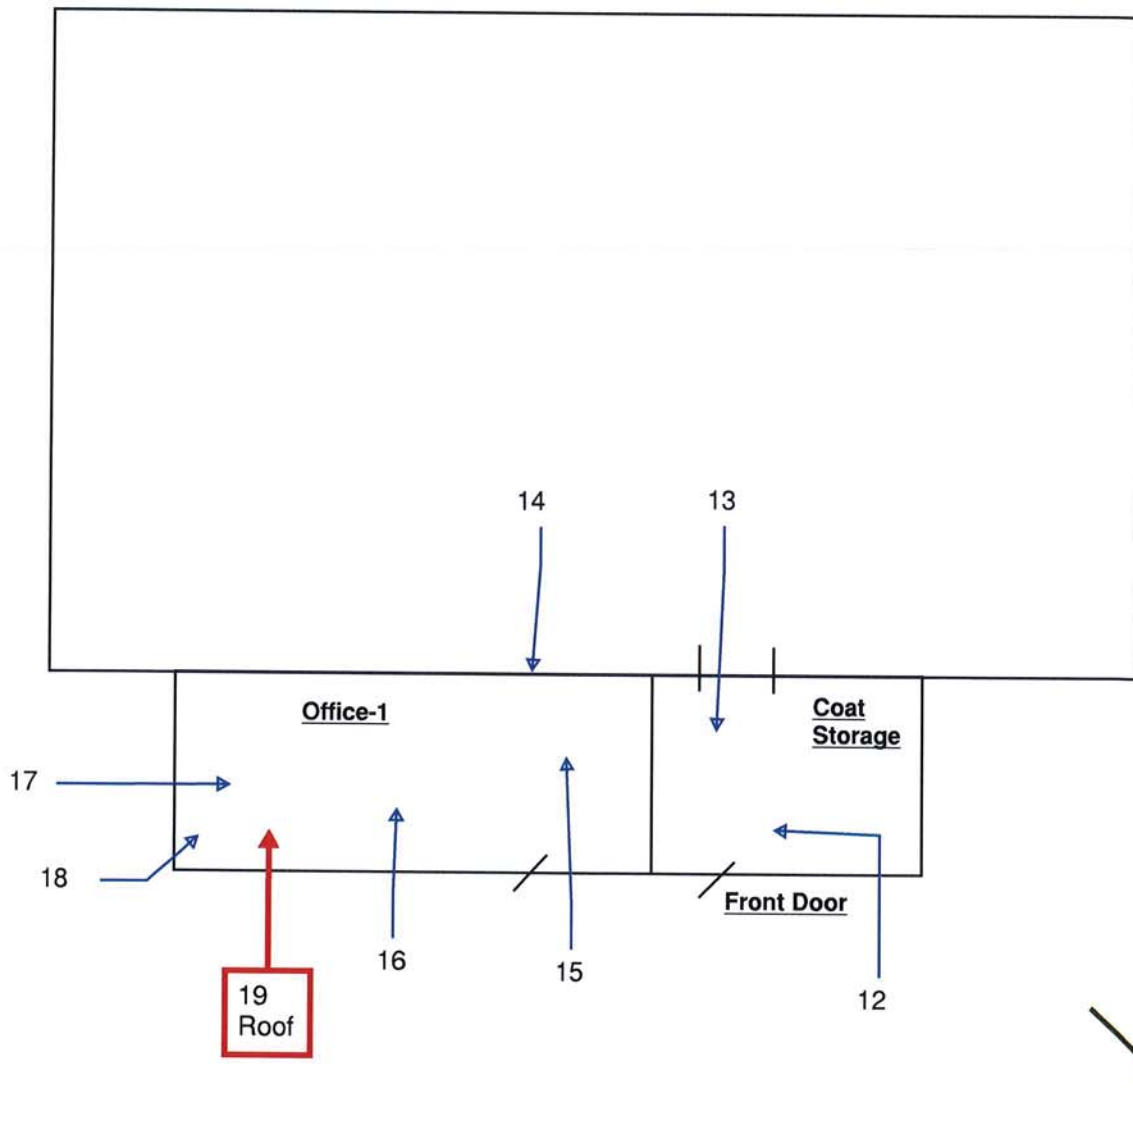
## Garage-3

Samples positive for asbestos appear in squares EX: #  
 Visual samples presumed to be asbestos-containing appear in triangles EX: #  
 Samples less than one percent asbestos appear in circles EX: #

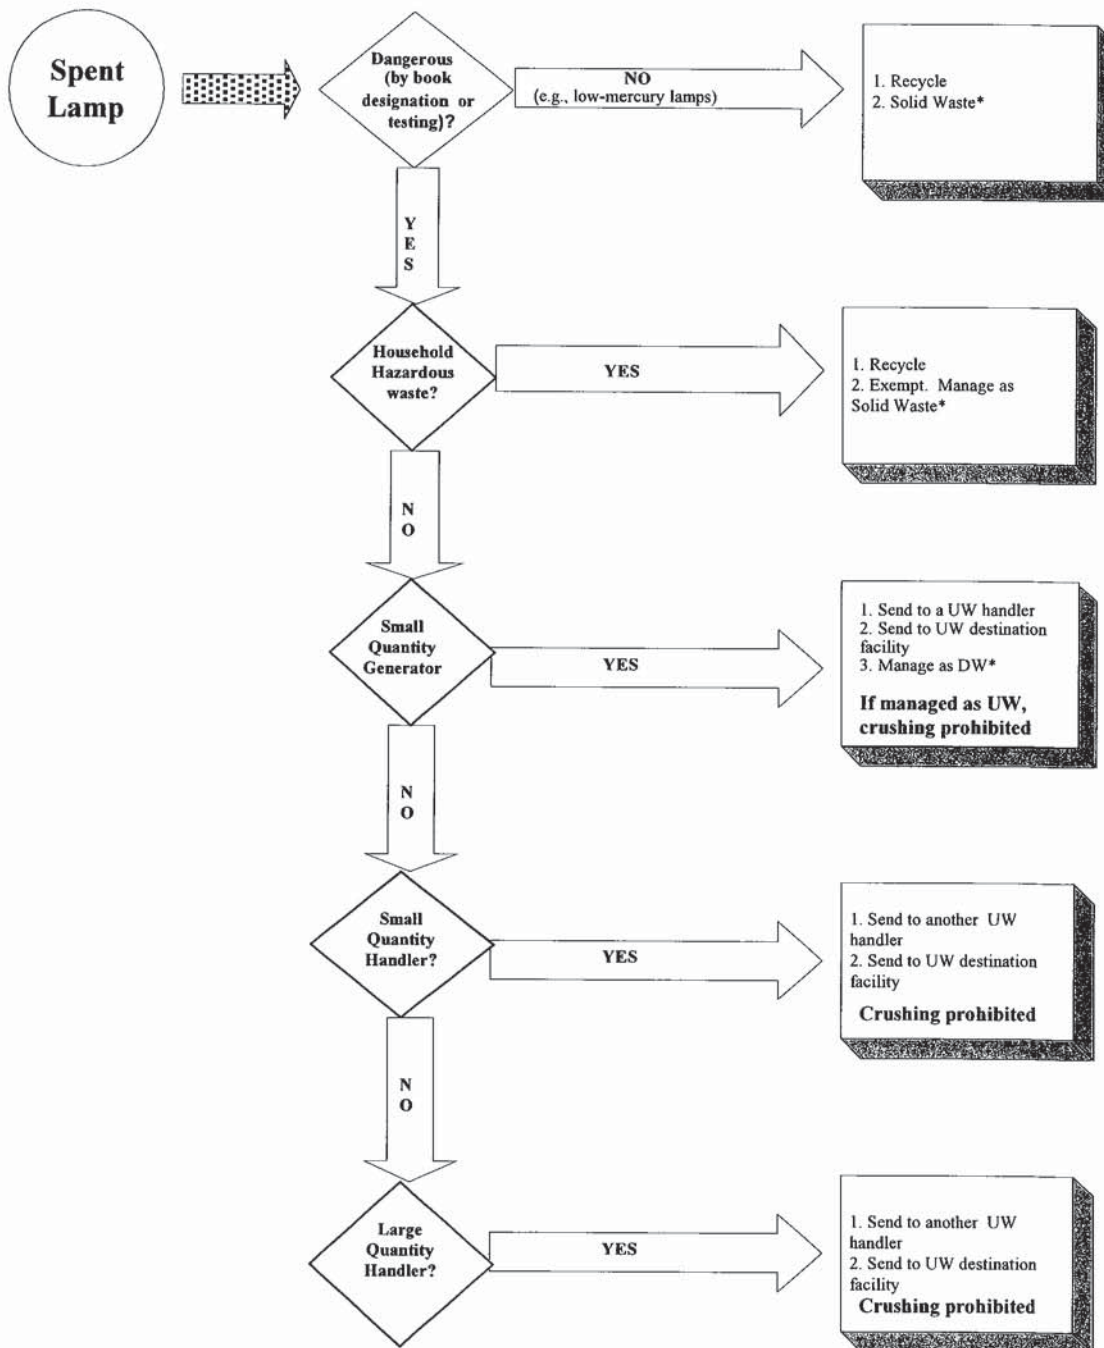
# Attachment 1

## GENERATOR MANAGEMENT OPTIONS FOR WASTE LAMPS

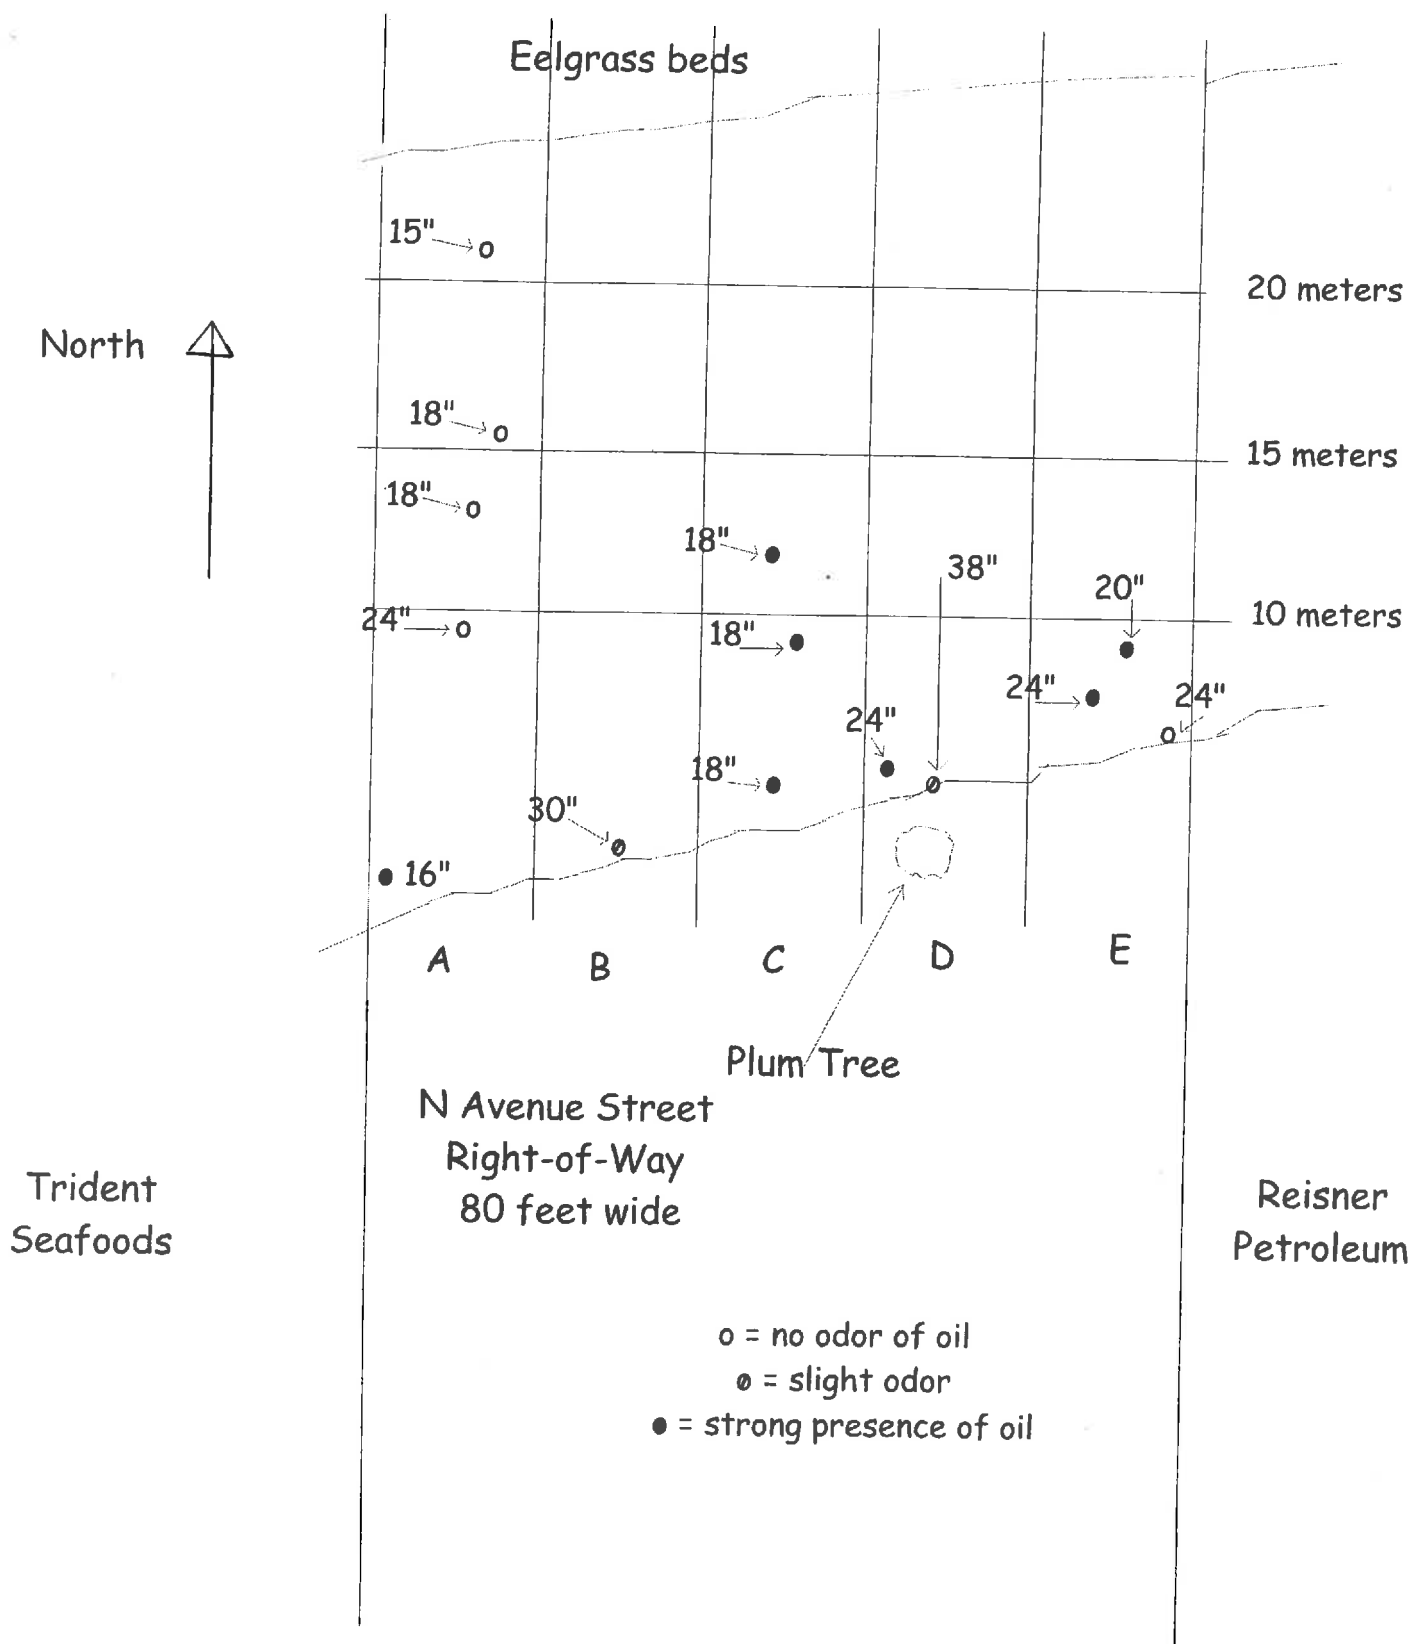
**Conclusions:** Where the oily contamination exists, it is well consolidated and well defined. Before a professional assessment is done, it would be helpful to research the historical location of any pipelines around the beach to indicate where the worst contamination may exist.

Drawing not to scale

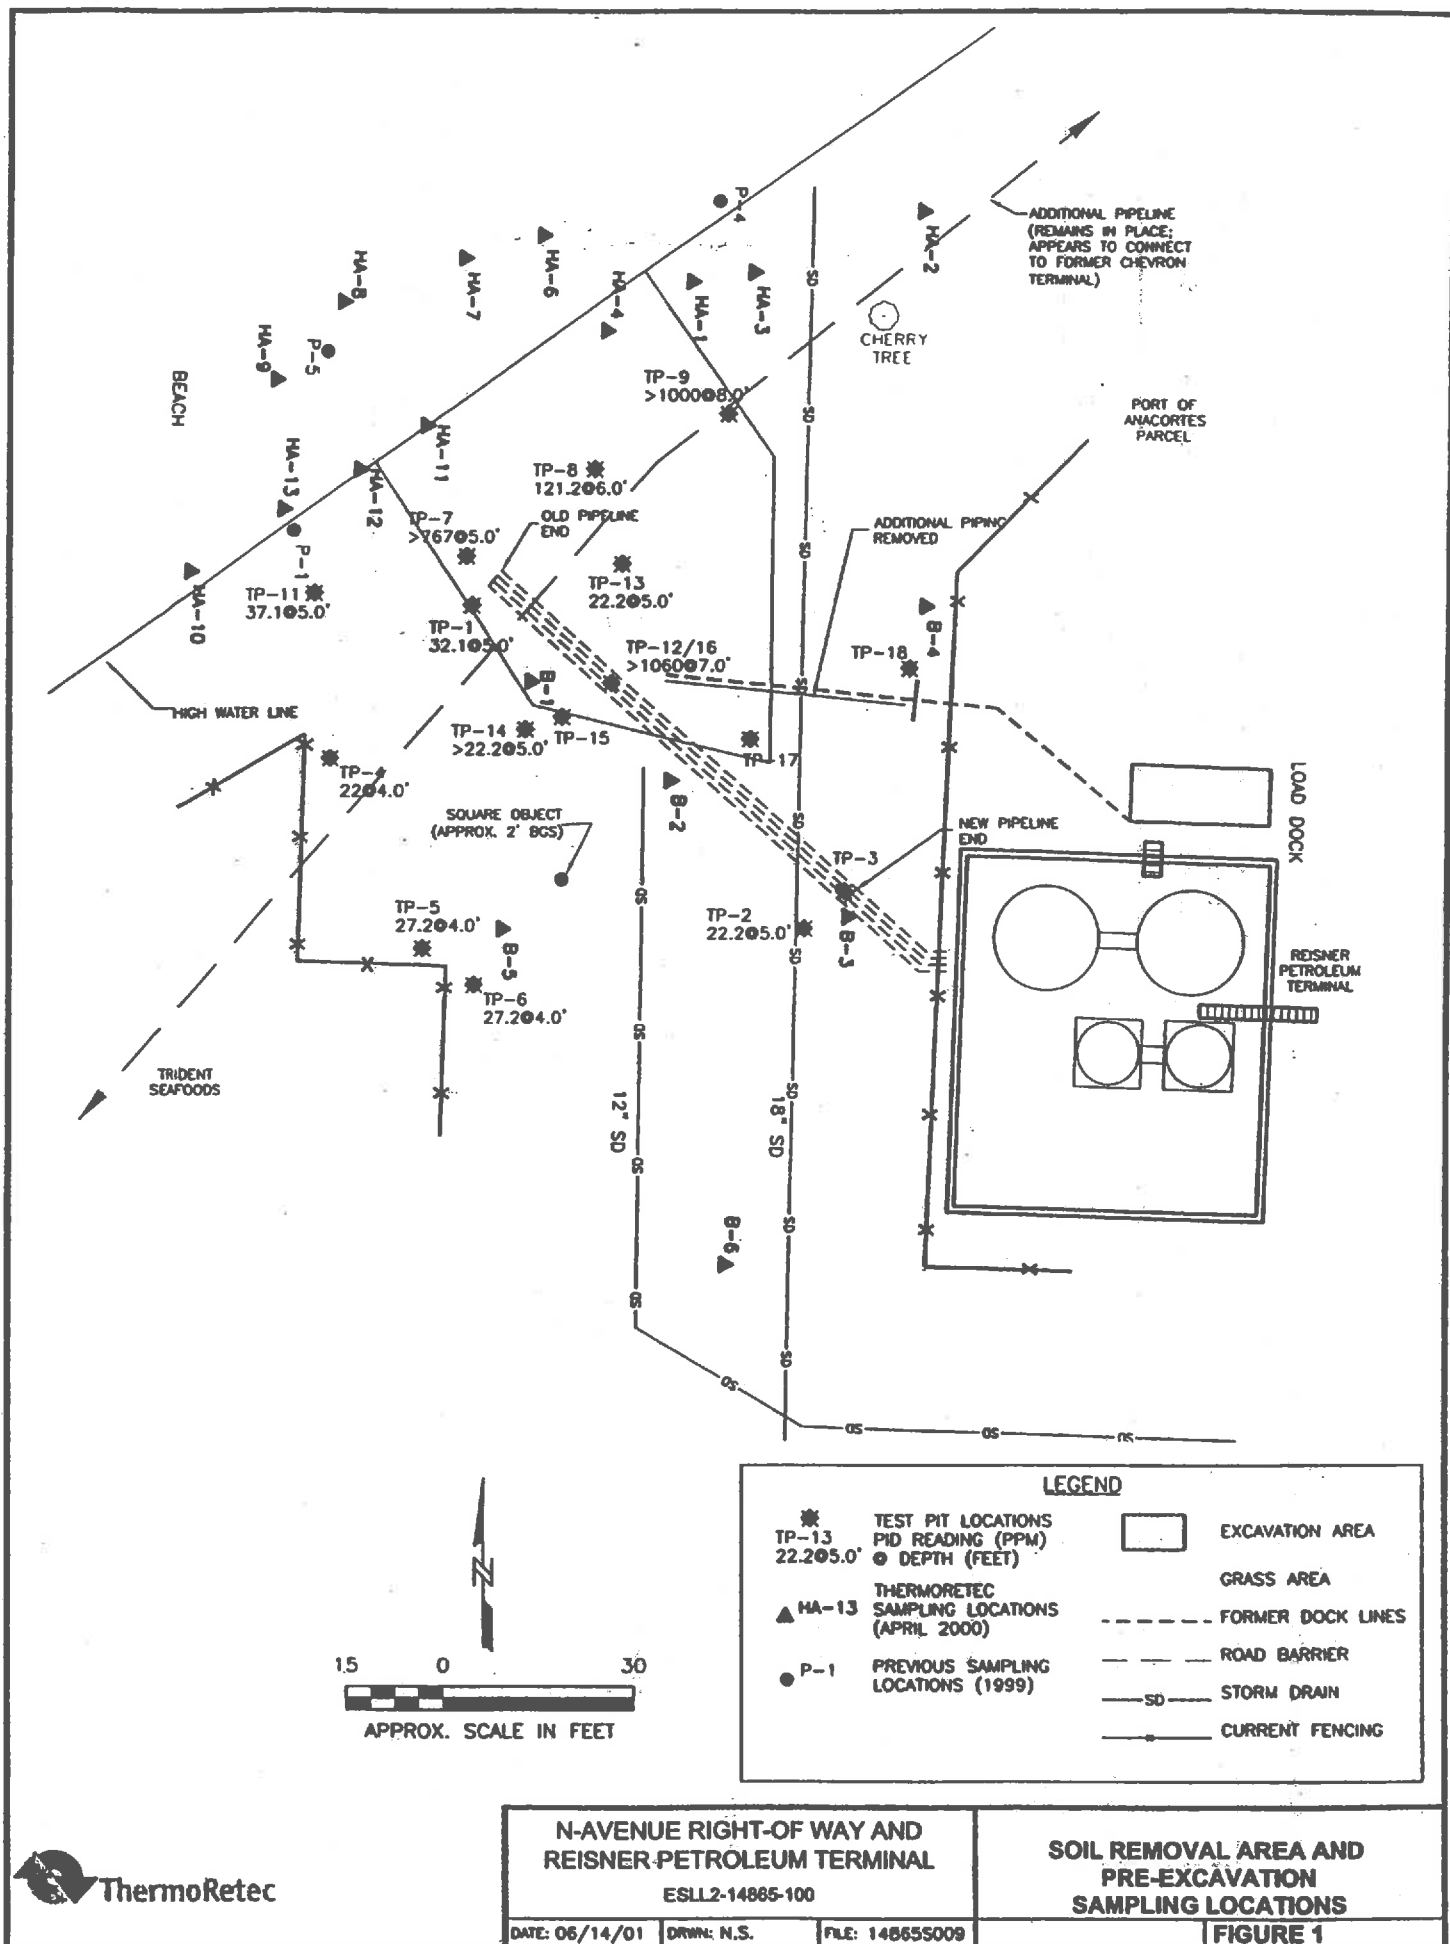
FIGURE 1

## SOIL REMOVAL AREA AND PRE-EXCAVATION SAMPLING LOCATIONS

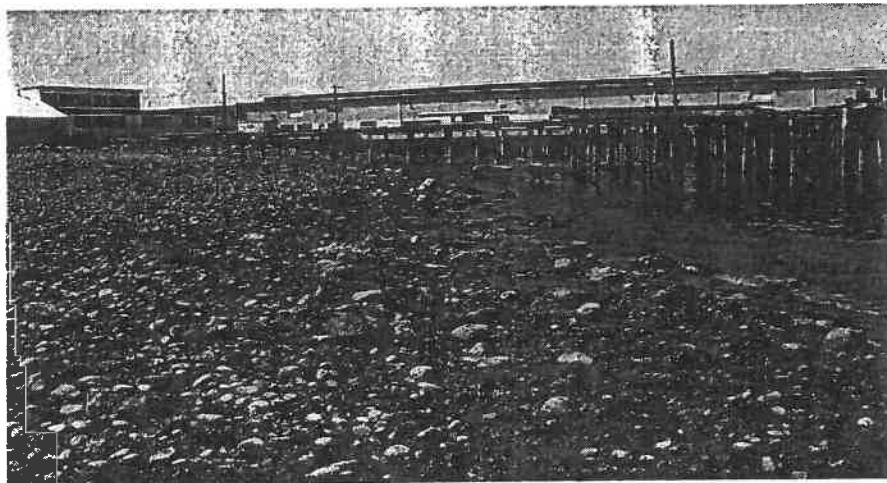
Figure 1. – This is the N-avenue beach zero tide line. At this point in the day the tide was about 6 inches below the zero tide mark

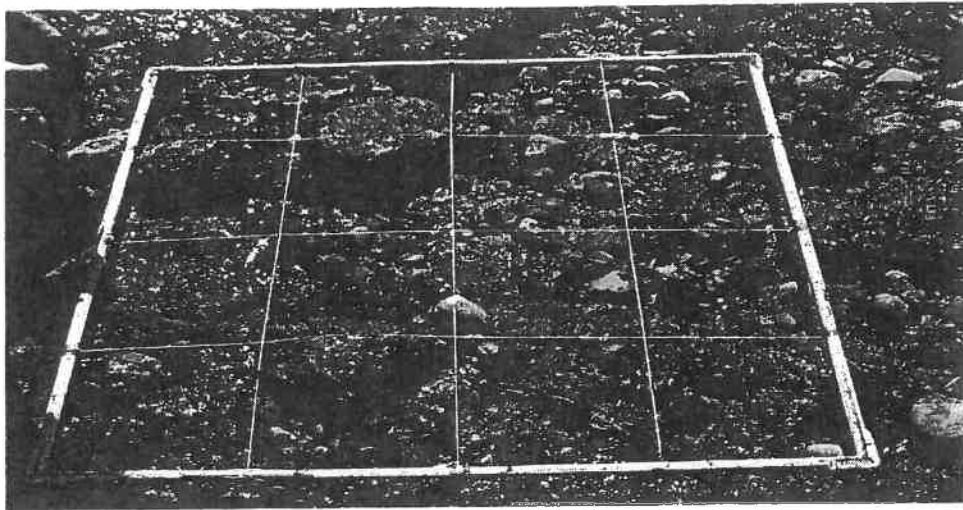
Figure 3 – Square meter quadrat at the N-avenue beach.

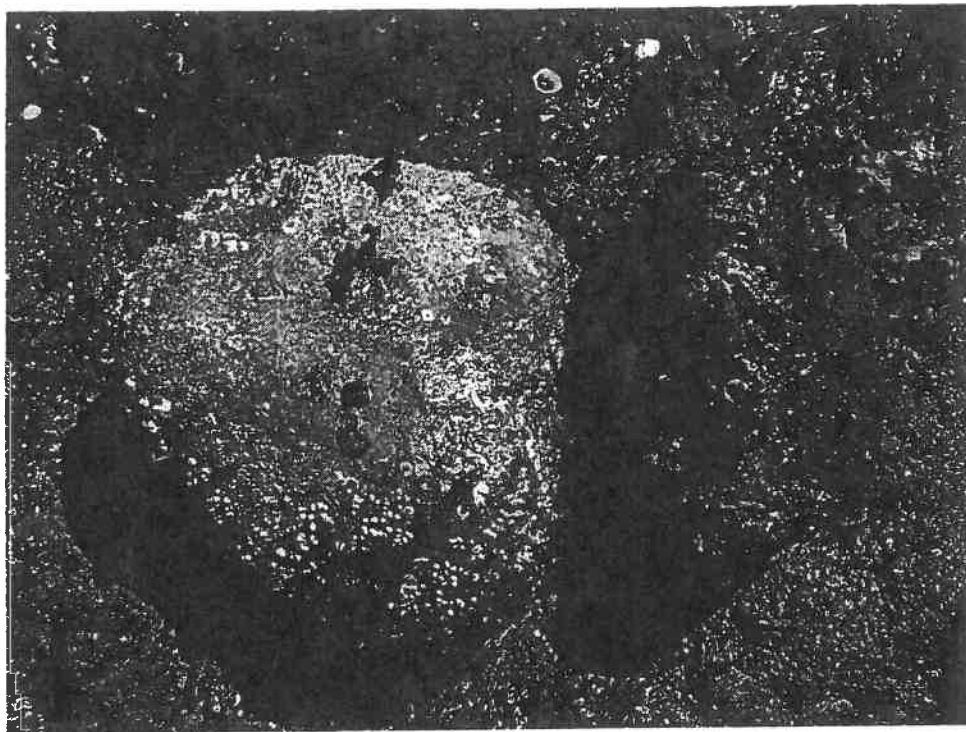
Figure 6 – The underside of two rocks at the N-avenue beach. The one on the right is covered in oil and appears almost completely black. Almost nothing was alive underneath it.

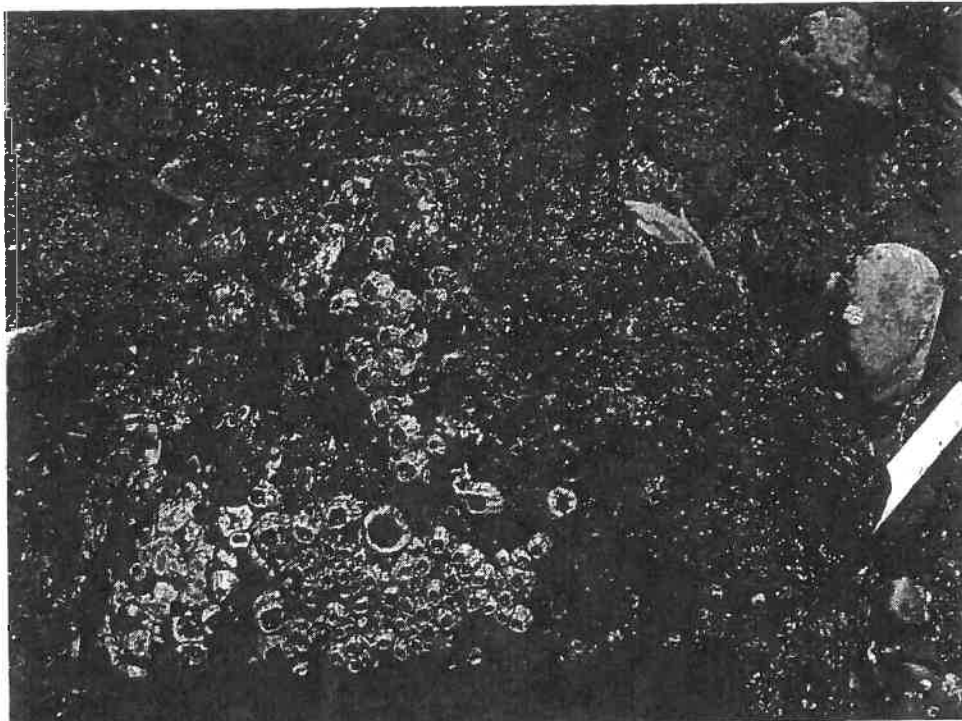
Figure 7 – Another rock from the N-avenue beach. This rock was half covered with oil underneath. A striking difference can be seen between the colors.

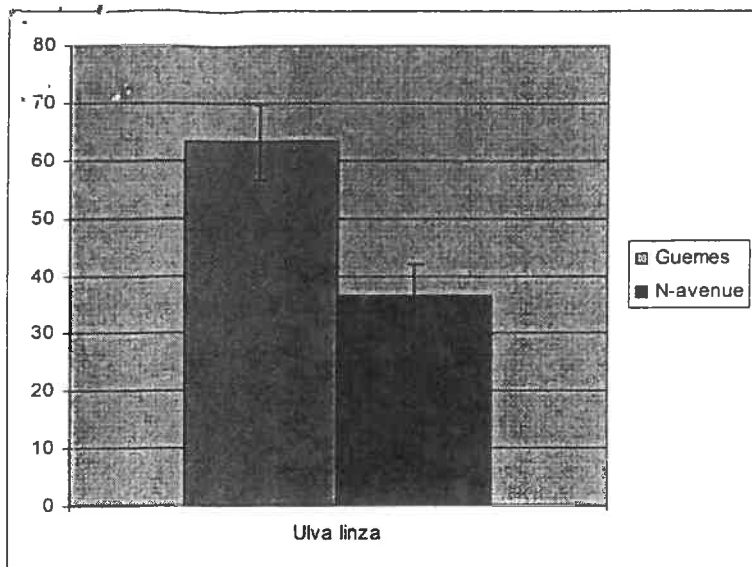
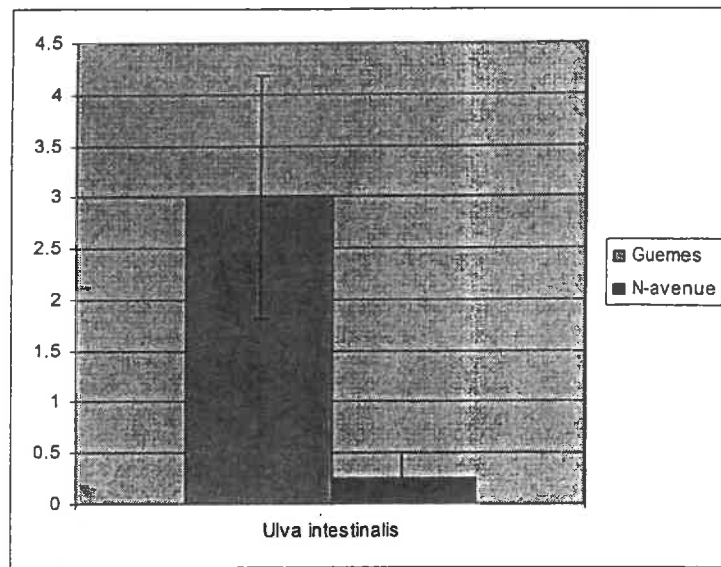
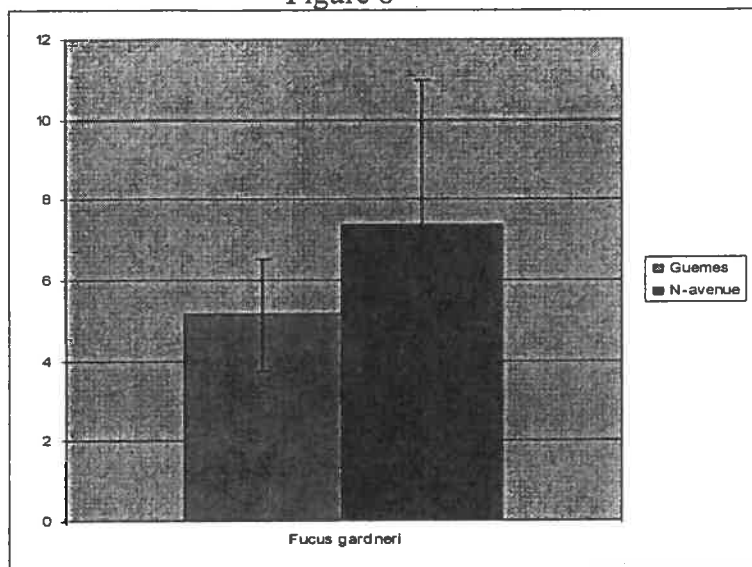
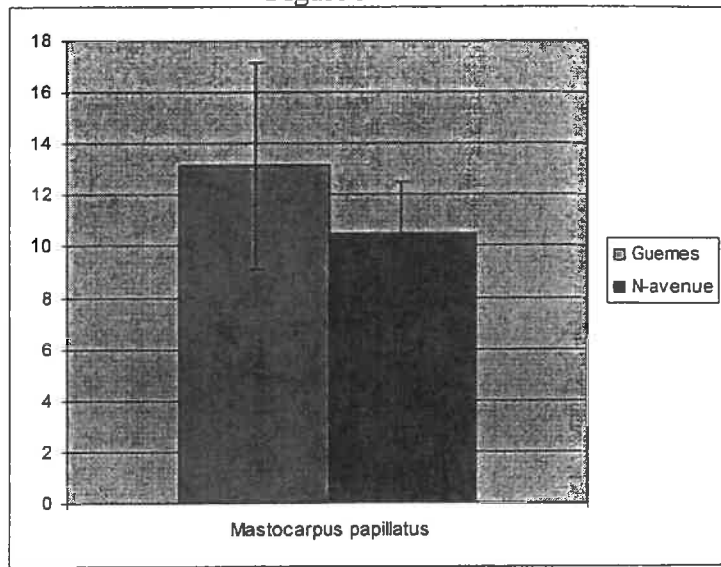
Figures 8-11 – These graphs show the average amounts of species of algae from the two beaches. The y axis shows the average number of species per quadrat at each beach. The error bars represent the standard deviation.

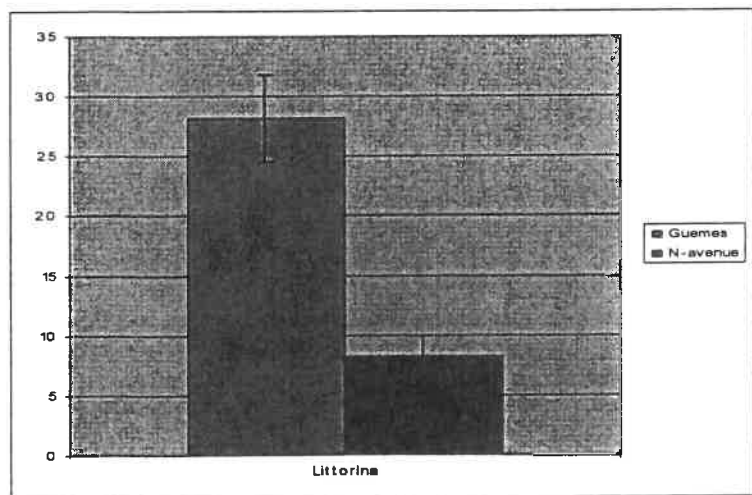
Figure 12

Figures 12-17 – These graphs show the average amounts of species of animals from the two beaches. The y axis shows the average number of species per quadrat at each beach. The error bars represent the standard deviation

While only one animal species, *Littorina*, showed a significant difference in abundance, favoring the Guemes Ferry beach (figure 12), most of the *Littorina* that we found were on *U. linza*. There was much more *U. linza* at the Guemes beach and so it was not surprising to see such a greater abundance of *Littorina* there as well. The Mann Whitney test for *Hemigrapsis nudus* (figure 14) for both sites showed no significant difference; however, the greater population was found to be at the N-avenue beach. Although Mann Whitney showed that there was no significant difference in counts of *Balanus glandula*, (table 4), we found that there was an obvious difference in their visual appearance. Most of the *B. glandula* in the quadrats at the N-avenue beach were concentrated on tops of the larger rocks away from the sediment, as opposed to the barnacles in the quadrats at the Guemes Ferry Landing which were almost evenly distributed over the tops and sides of the larger and smaller rocks throughout the transect. The *B. glandula* at the Guemes Ferry Landing were larger and whiter in color, as opposed

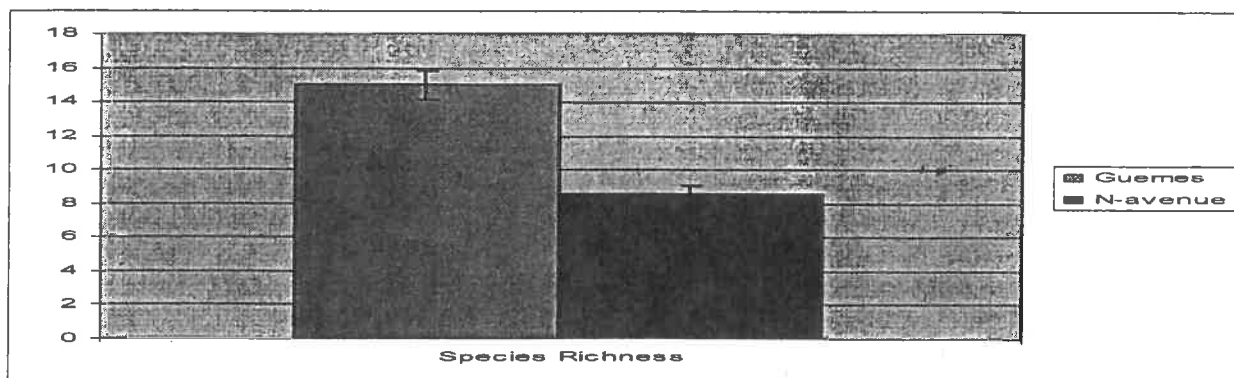
Figure 18 – This graph shows the relationship of species richness between the two beaches. The y axis shows the average species richness for each quadrat. The error bars represent the standard deviation

There was a <sup>highly</sup> significant difference in the species richness between the two beaches, and it was found to favor the Guemes Ferry Landing (figure 18). <sup>table 7</sup> At the Guemes beach there were a total of 29 species present in our quadrats. At the N-avenue beach there were only a total of 15 species present. Not only were there less species present, but most of the species present appeared in lower numbers as well. The P value recorded after performing a t-test comparing species richness on the two beaches was less than 0.0001. This was by far the lowest P value obtained and emphatically states that the species richness at the N-avenue beach was significantly lower than at the Guemes Ferry beach.

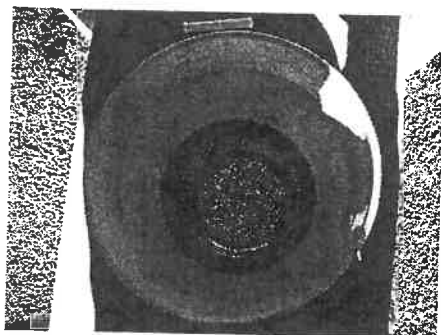
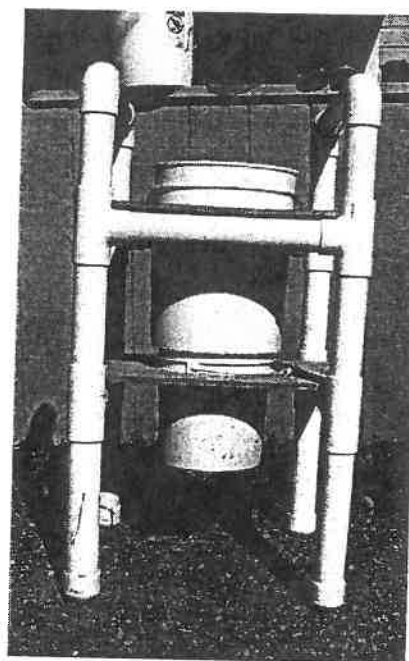
Figure 1: Sifting device. Top bucket contains  $\frac{1}{4}$  screen, bottom contains 1 mm sieve.

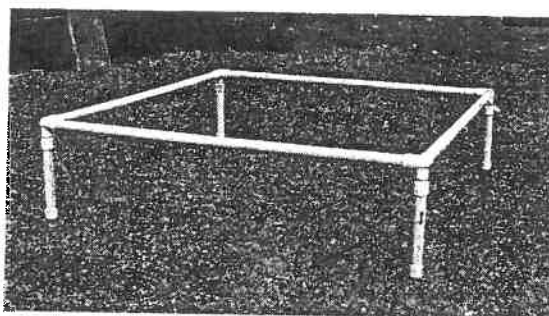
Figure 2: PVC frame for measuring size and depth of quadrats. Legs marked in 1 cm increments for measuring depth.

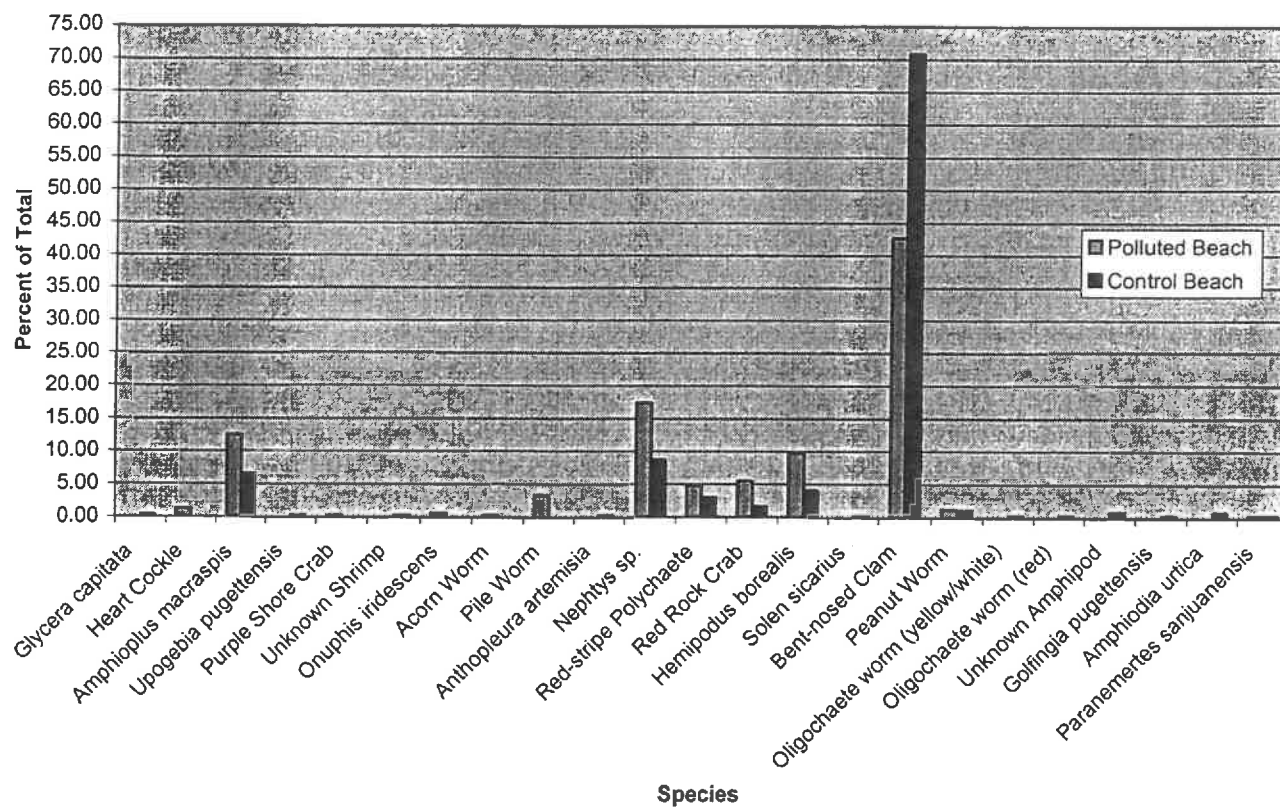
Figure 3: Comparison of percentages of species on each beach.

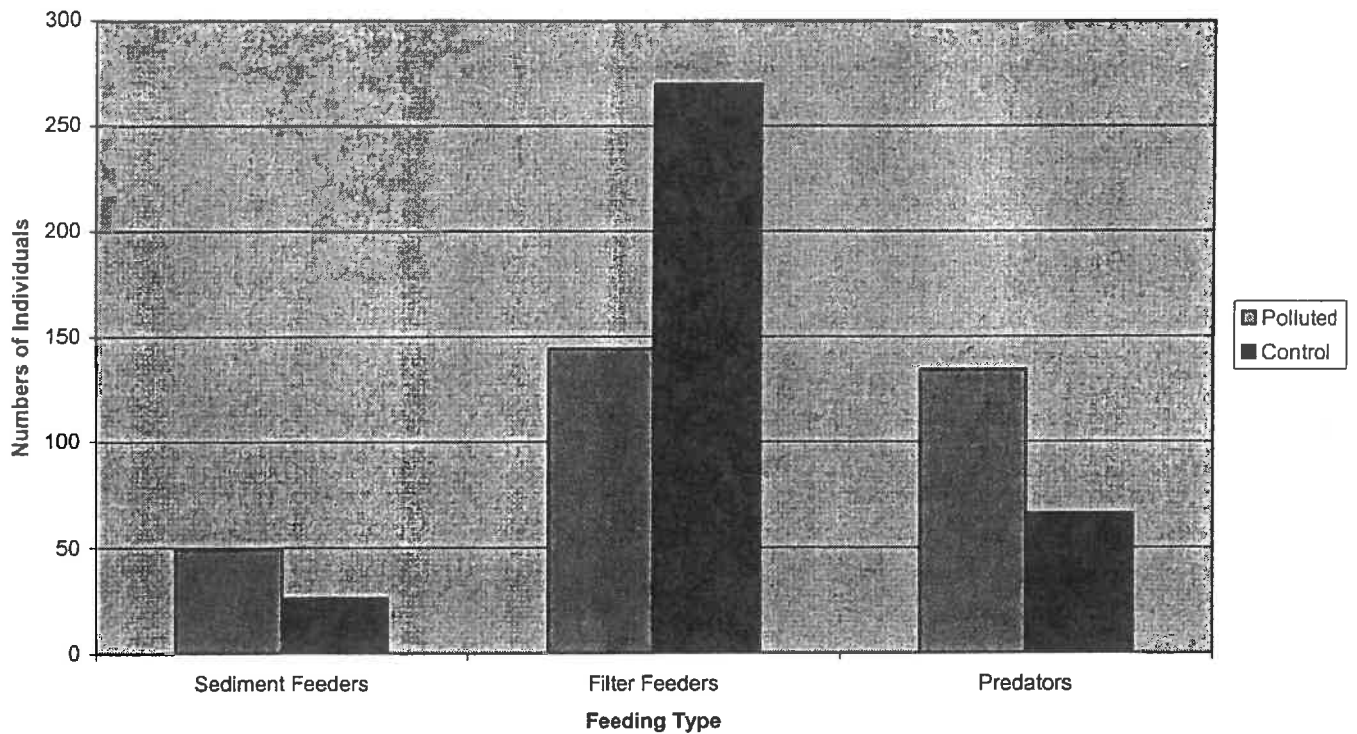
Figure 4: Comparison of organism feeding types at each beach.

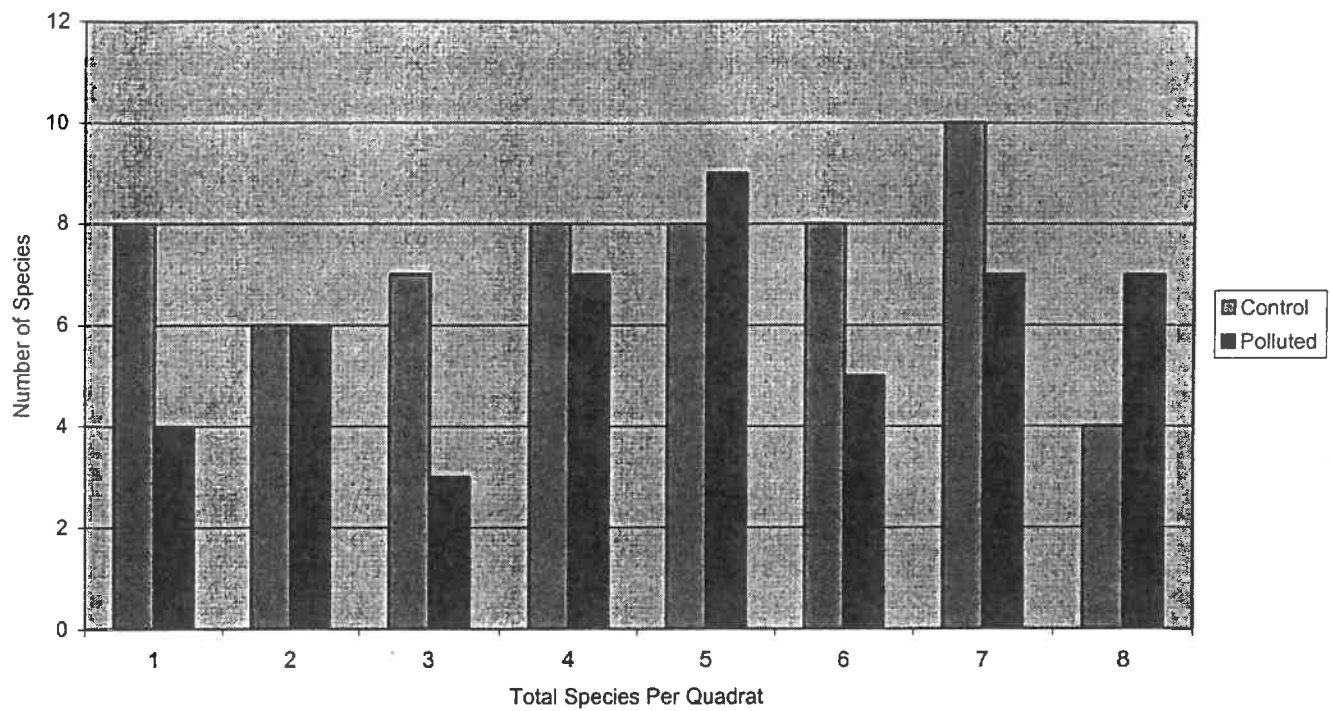
Figure 5: Comparison of species richness on each beach. No significant statistical difference was found.

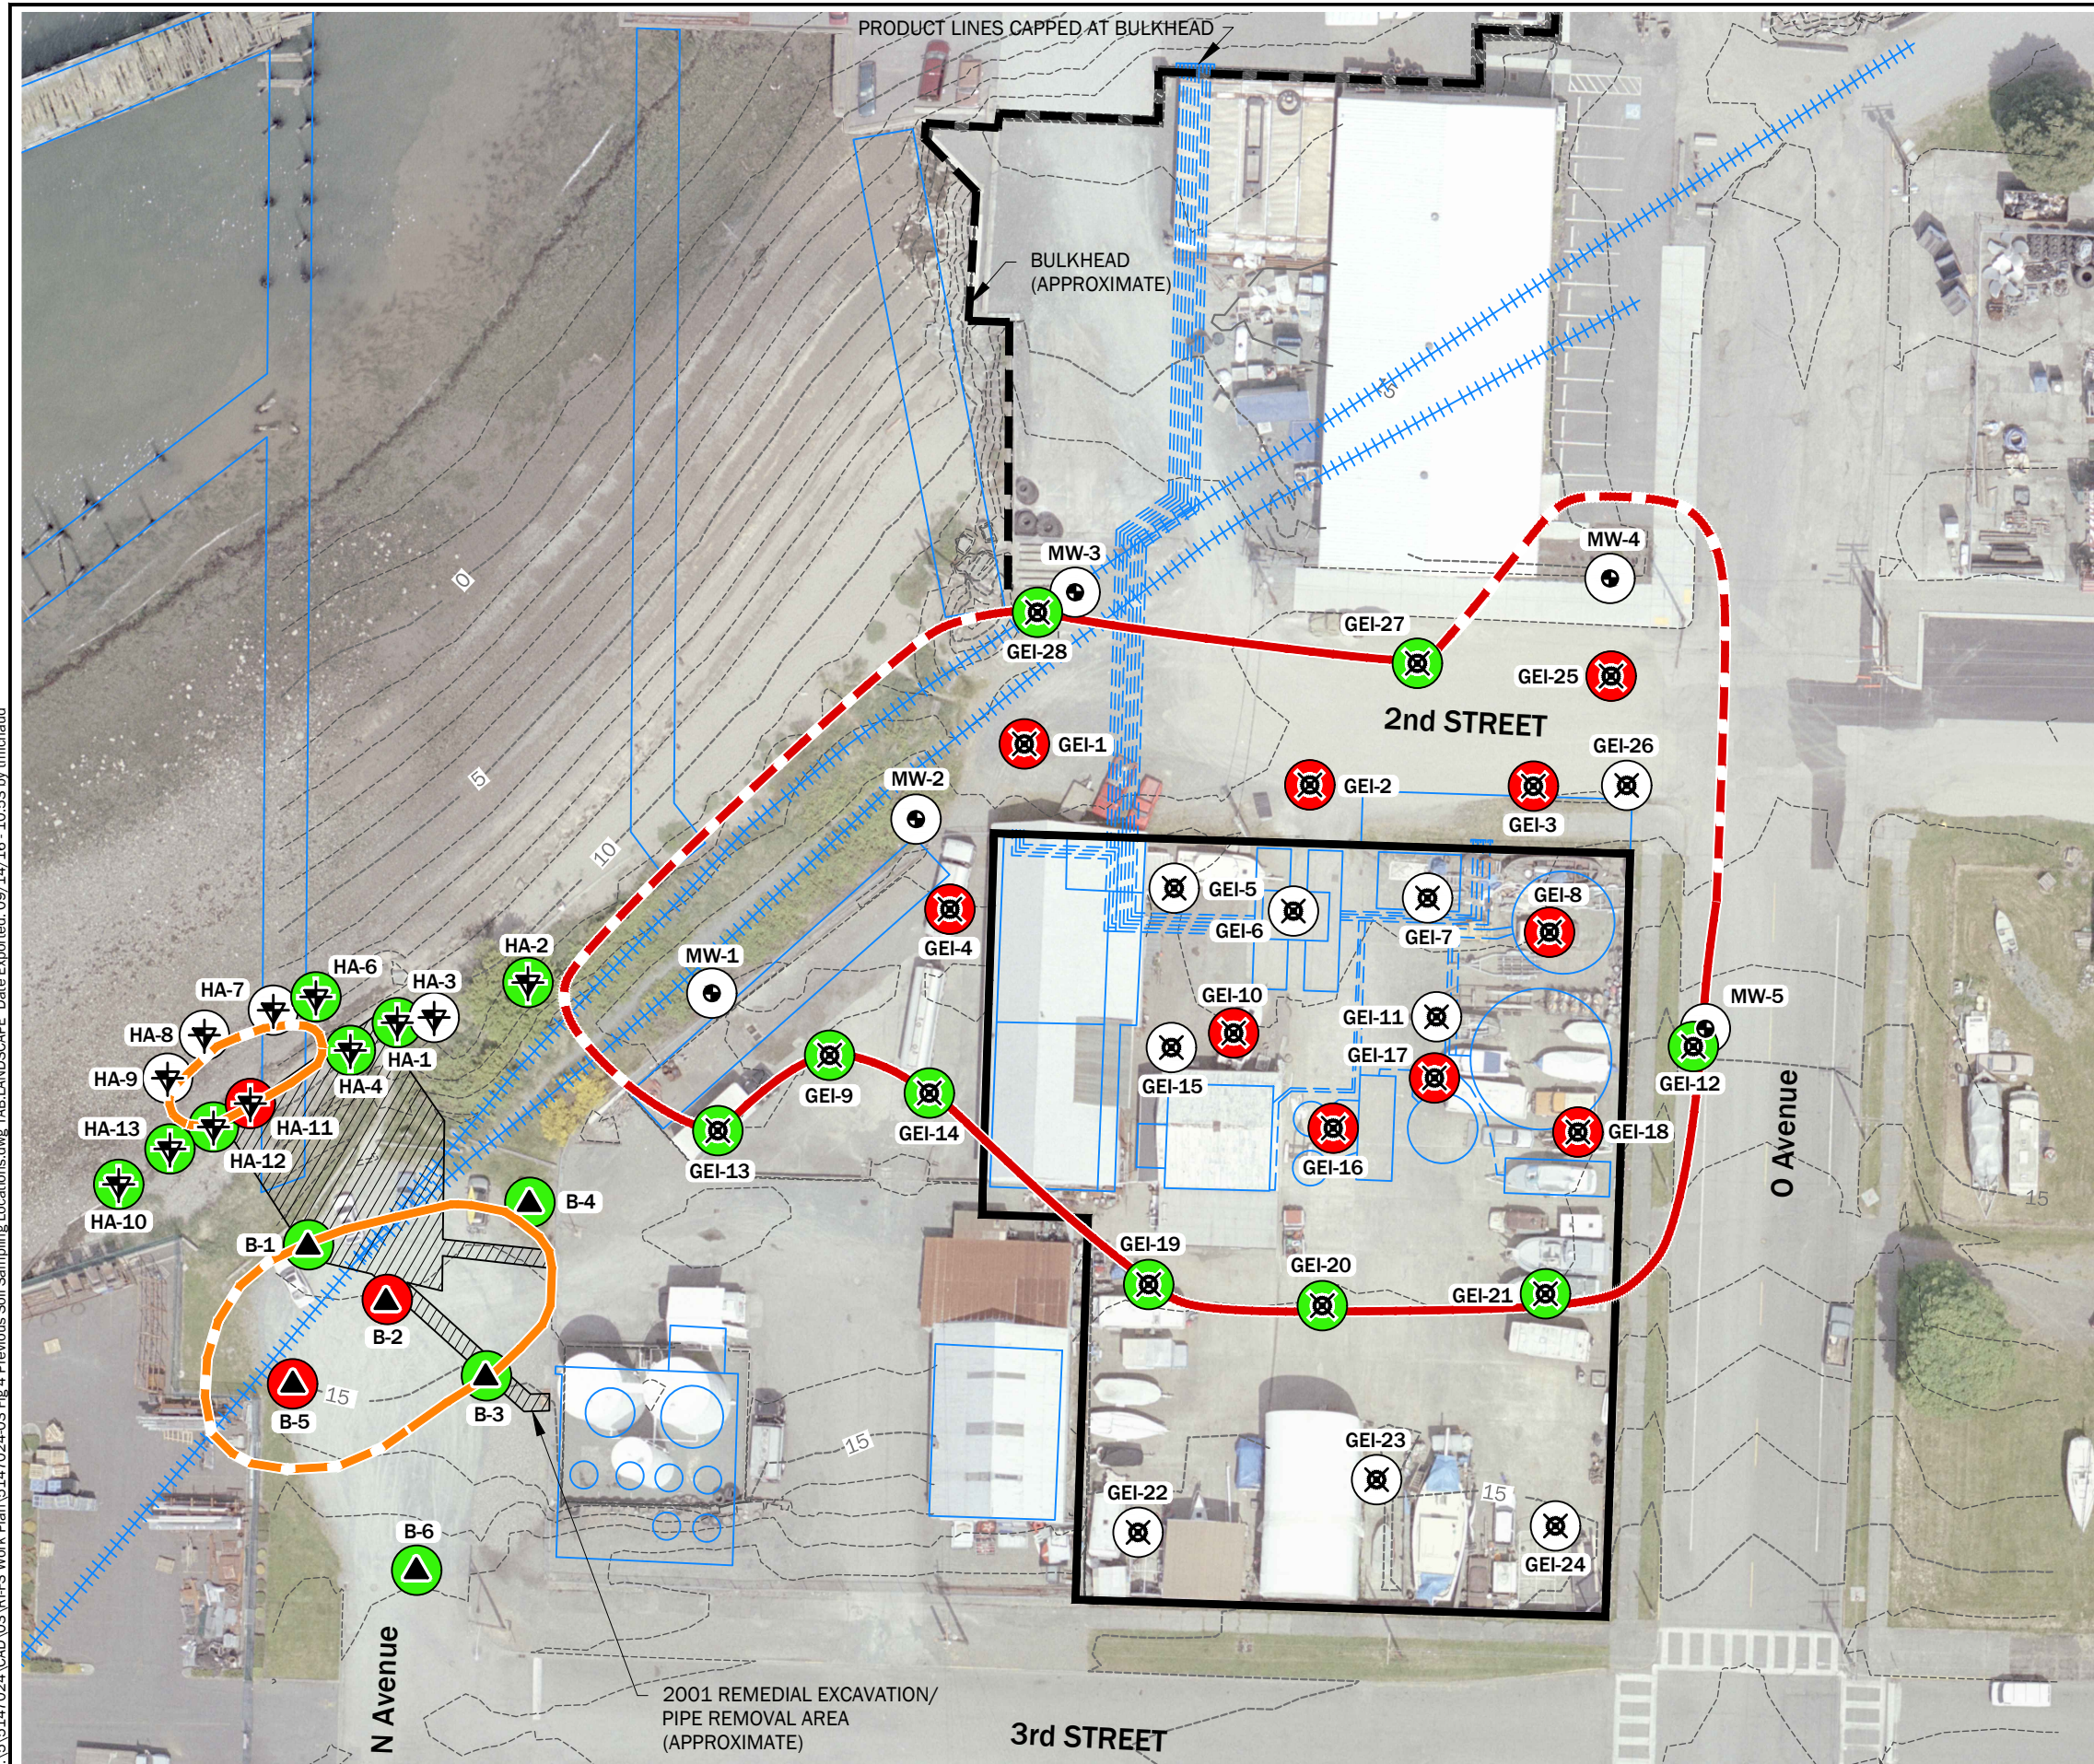
Figure 3

- Quiet Cove Property Boundary
- Historical Features
- Topographic Contour
- Boring Location (Thermo Retec, 2000)
- Hand Auger Boring Location (Thermo Retec, 2000)
- Boring Location (GeoEngineers, 2014)
- Monitoring Well Location (GeoEngineers, 2014)
- Exceedance of Screening Level(s) in Soil
- No Exceedance Screening Level(s) in Soil
- No Soil Data
- Quiet Cove Site  
Approximate Extent of Contaminated Soil (Defined by Existing Data)
- Approximate Extent of Contaminated Soil (Inferred from Existing Data)
- Off-Property Contaminant Sources  
Approximate Extent of Contaminated Soil (Defined by Existing Data)
- Approximate Extent of Contaminated Soil (Inferred from Existing Data)
