## ANACORTES PLANNING COMMISSION

**May 24, 2023**

### **AGENDA**

- A. Roll Call**
- B. Minutes**
  - 1) Minutes of May 8, 2023
- C. Correspondence**
- D. New Business**
  - 1) Appoint new vice chair.
  - 2) Open Record Public Hearing and Decision for Shoreline Substantial Development Permit SDP-2023-0002 Port of Anacortes 2nd Street and Curtis Wharf project.
- E. Old Business**

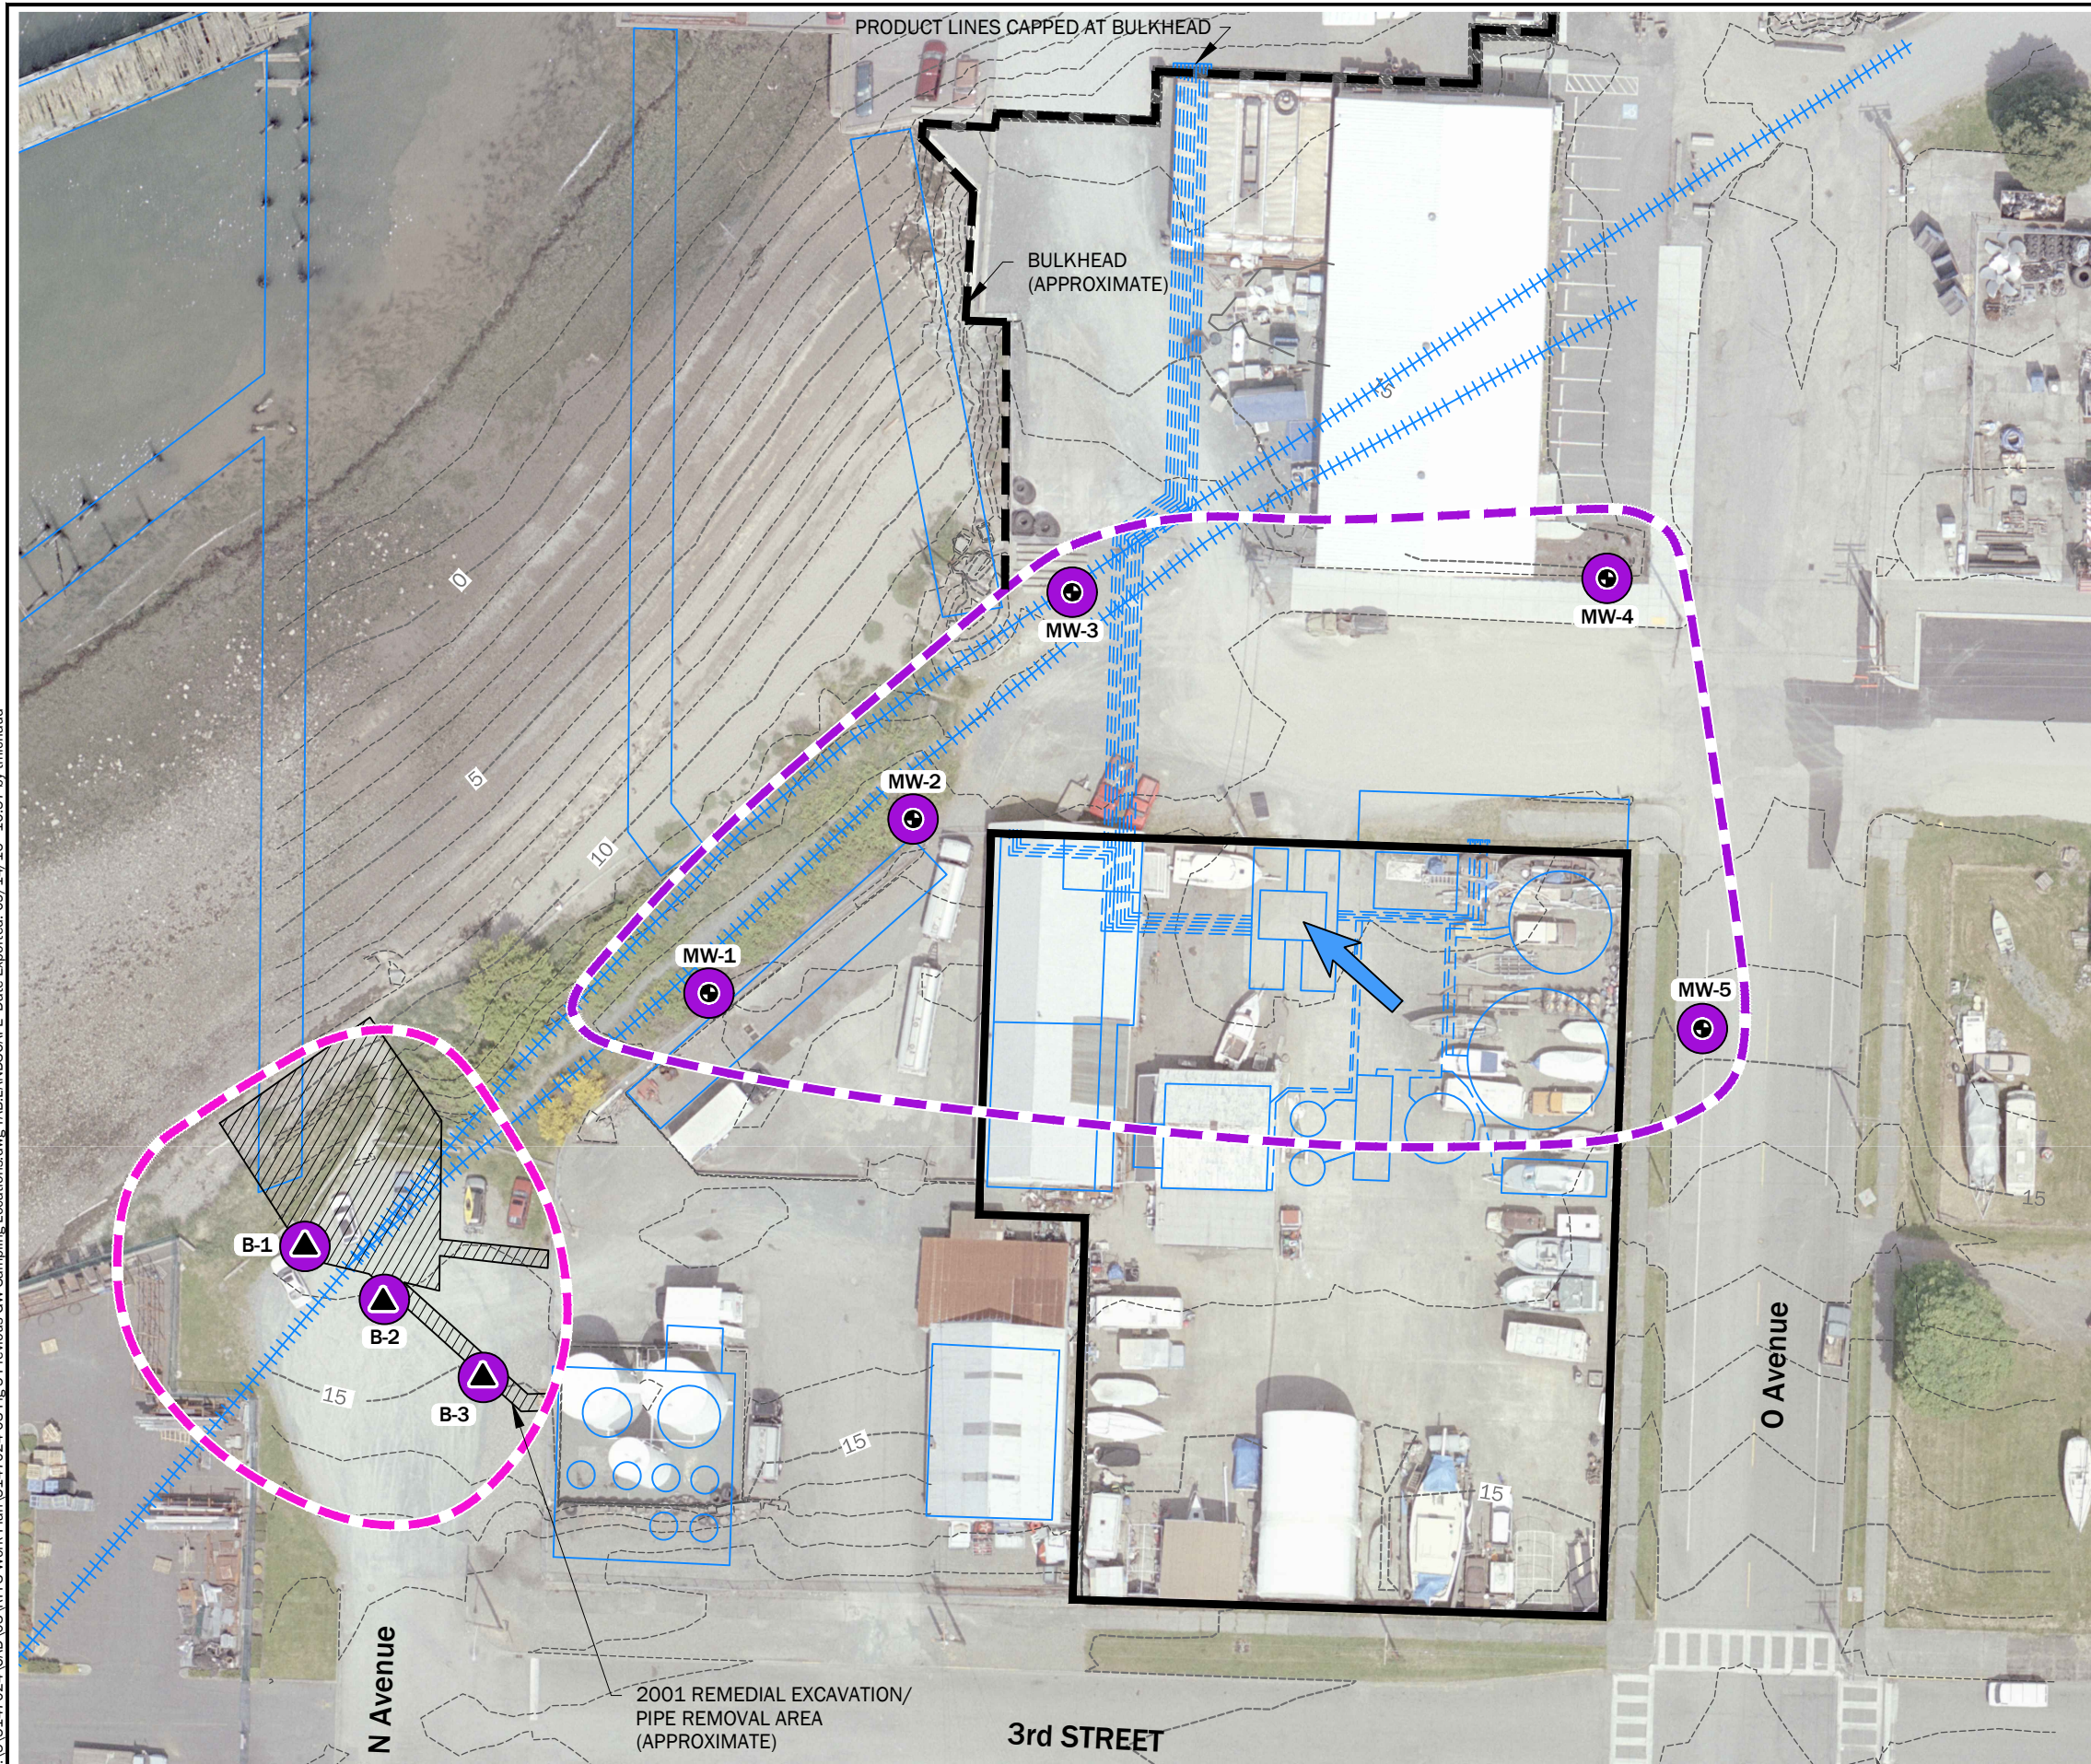
Figure 4

- Quiet Cove Property Boundary
- Historical Features
- Topographic Contour
- Grab Sample Location (Thermo Retec, 2000)
- Monitoring Well Location (GeoEngineers, 2014)
- Exceedance of Screening Level(s) in Groundwater
- No Exceedance Screening Level(s) in Groundwater
- Inferred Groundwater Flow Direction
- Quiet Cove Site  
Approximate Extent of Contaminated Groundwater  
(Inferred from Existing Data)
- Off-Property Contaminant Sources  
Approximate Extent of Contaminated Groundwater  
(Inferred from Existing Data)

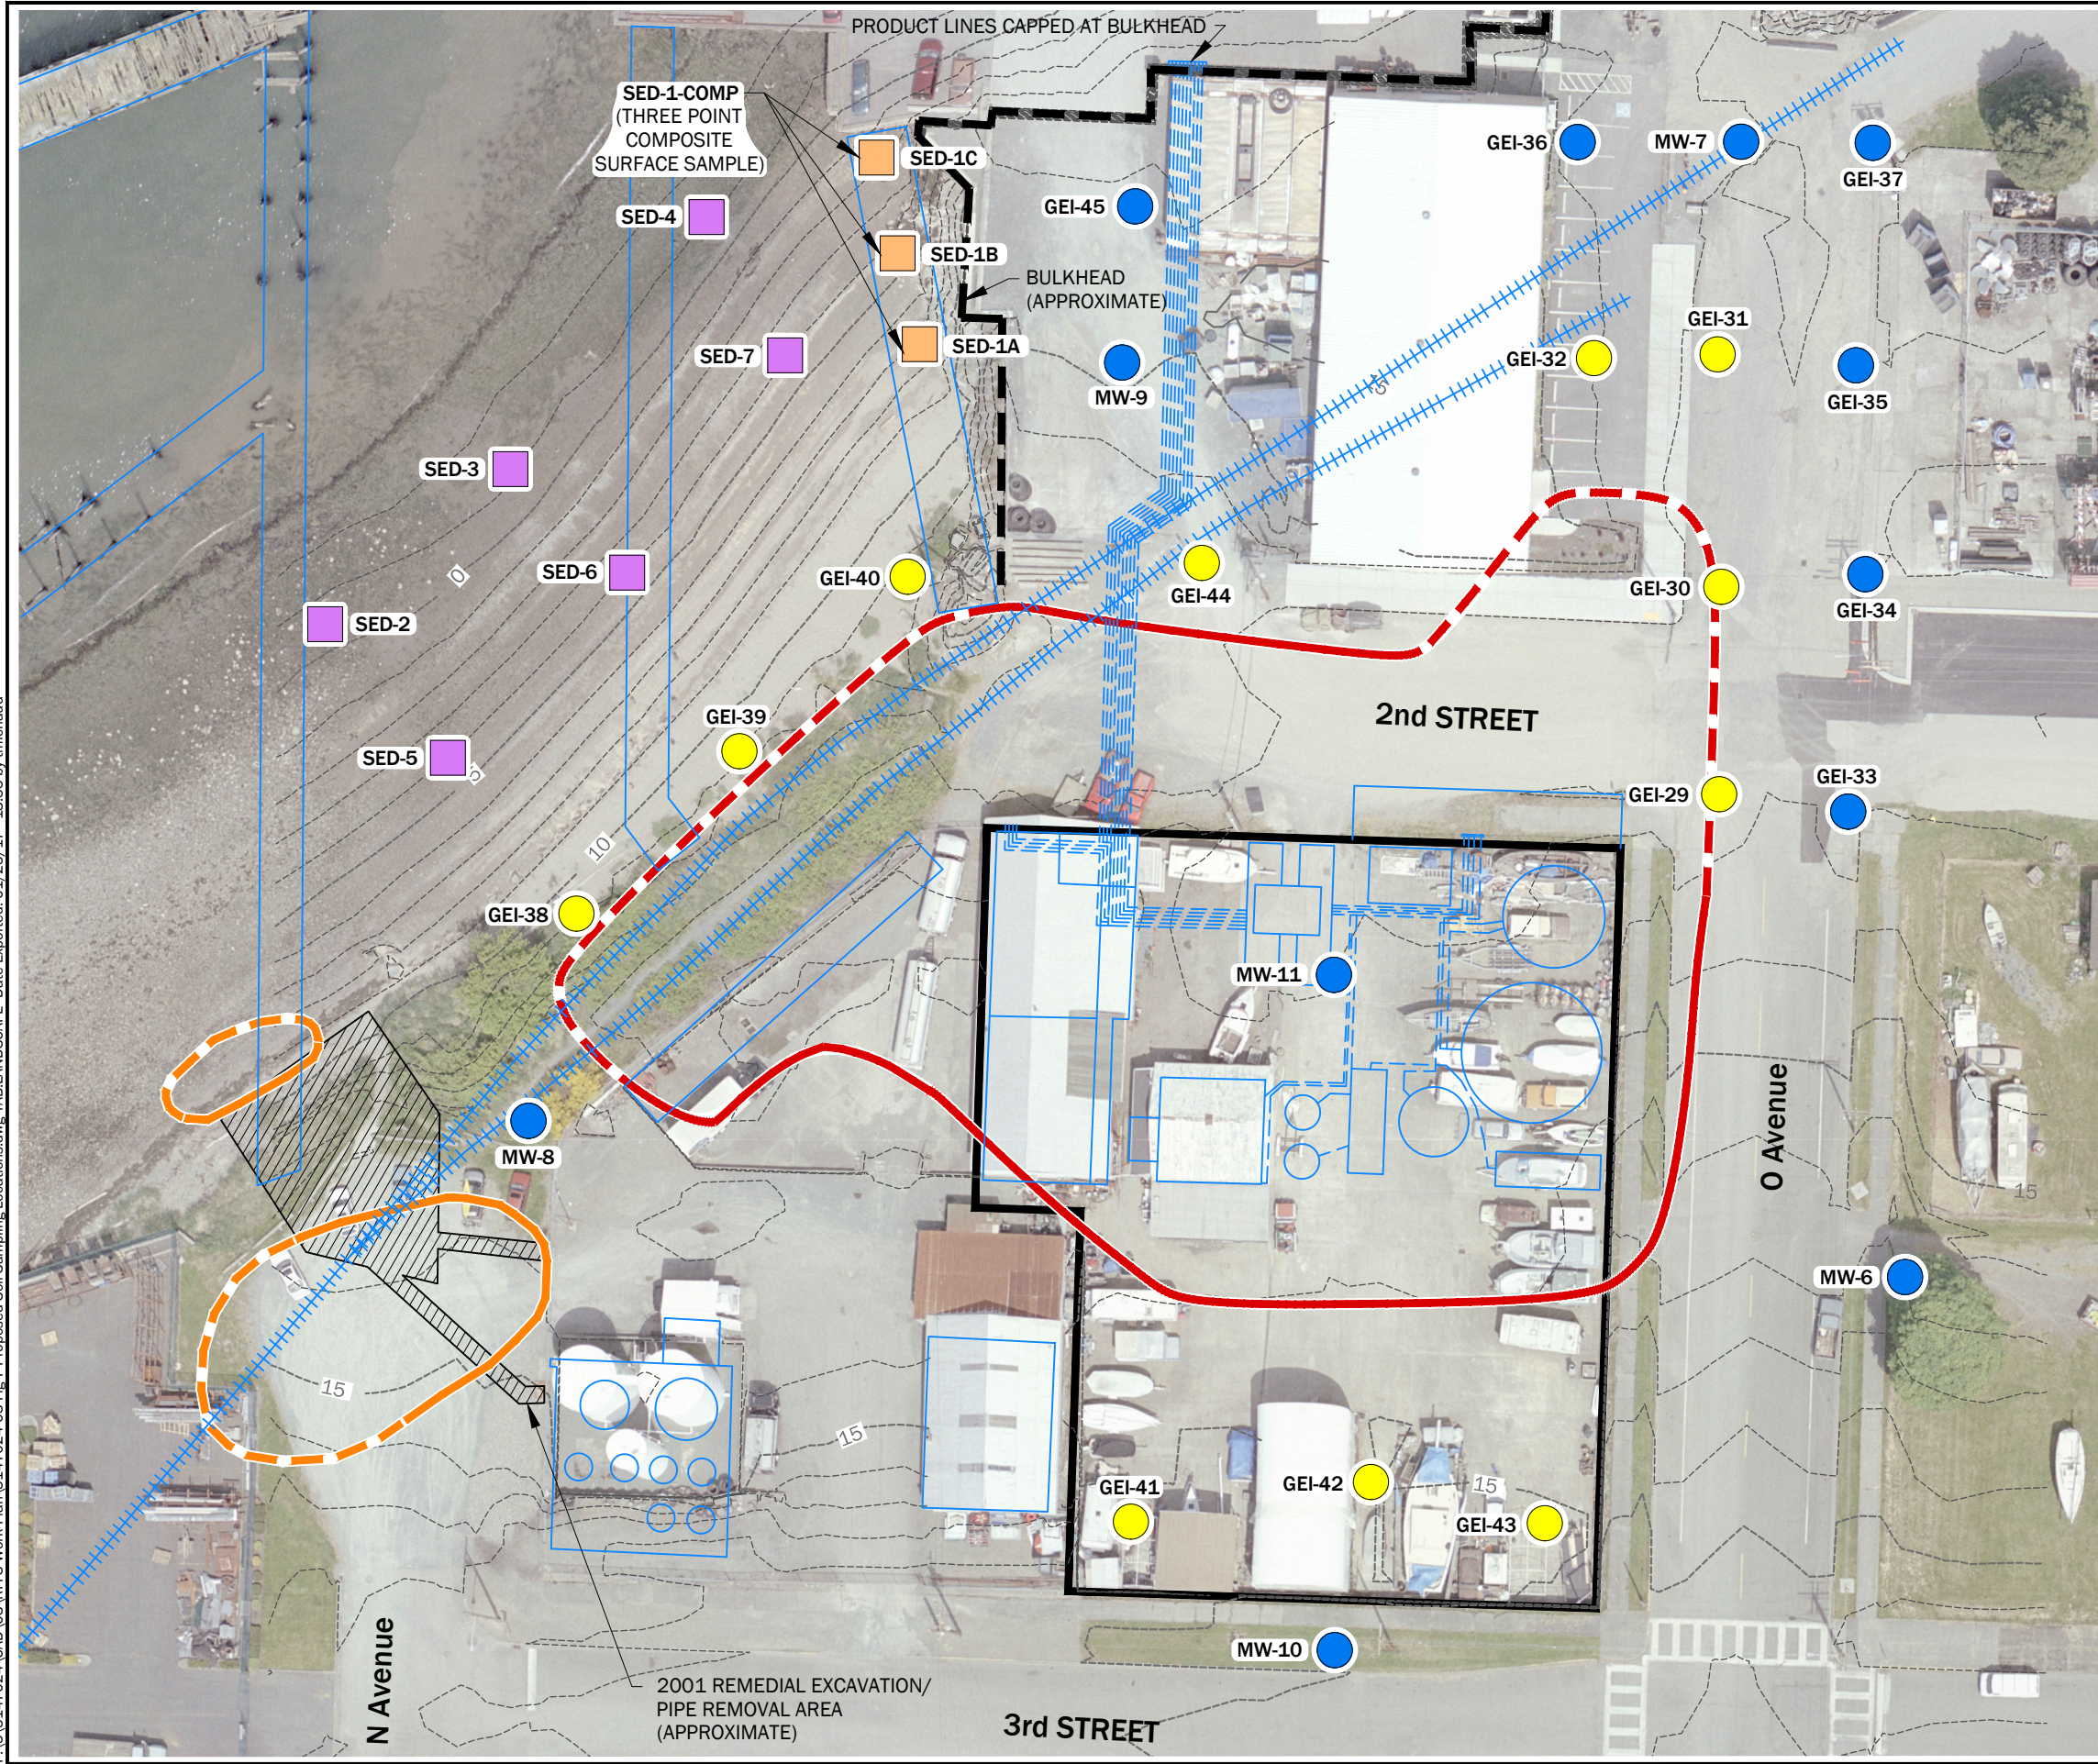
\*Refer to Table 8 for Sample Approach and Rationale. Refer to Tables 9 and 11 for Sample and Analysis Plan. Unless otherwise noted, borings will be advanced to at least three feet into native or fifteen feet below ground surface, whichever occurs first.

HSA borings for obtaining soil samples will be drilled using a truck-mounted HSA drilling rig. It is anticipated that the HSA borings at the Site will be advanced at least 3 feet into the native soil or to approximately 15 feet bgs, whichever occurs first. If evidence of petroleum contamination is observed, the boring will be advanced to at least 3 feet below the observed depth of contamination, or until refusal. HSA borings will be completed by a licensed driller in the State of Washington. A representative from GeoEngineers, Inc.'s

At least one soil sample will be collected from each location from the fill, vadose zone/saturated zone interface (i.e., from the water table) observed at the time of sampling, and native soil horizon. The native soil sample will be collected from a depth of at least 1 foot below the fill/native soil interface to ensure that the sample is representative of native material. If field screening (i.e., visual observation of staining, sheen, measurement of VOCs, etc.) indicates the presence of potentially contaminated soil, additional samples

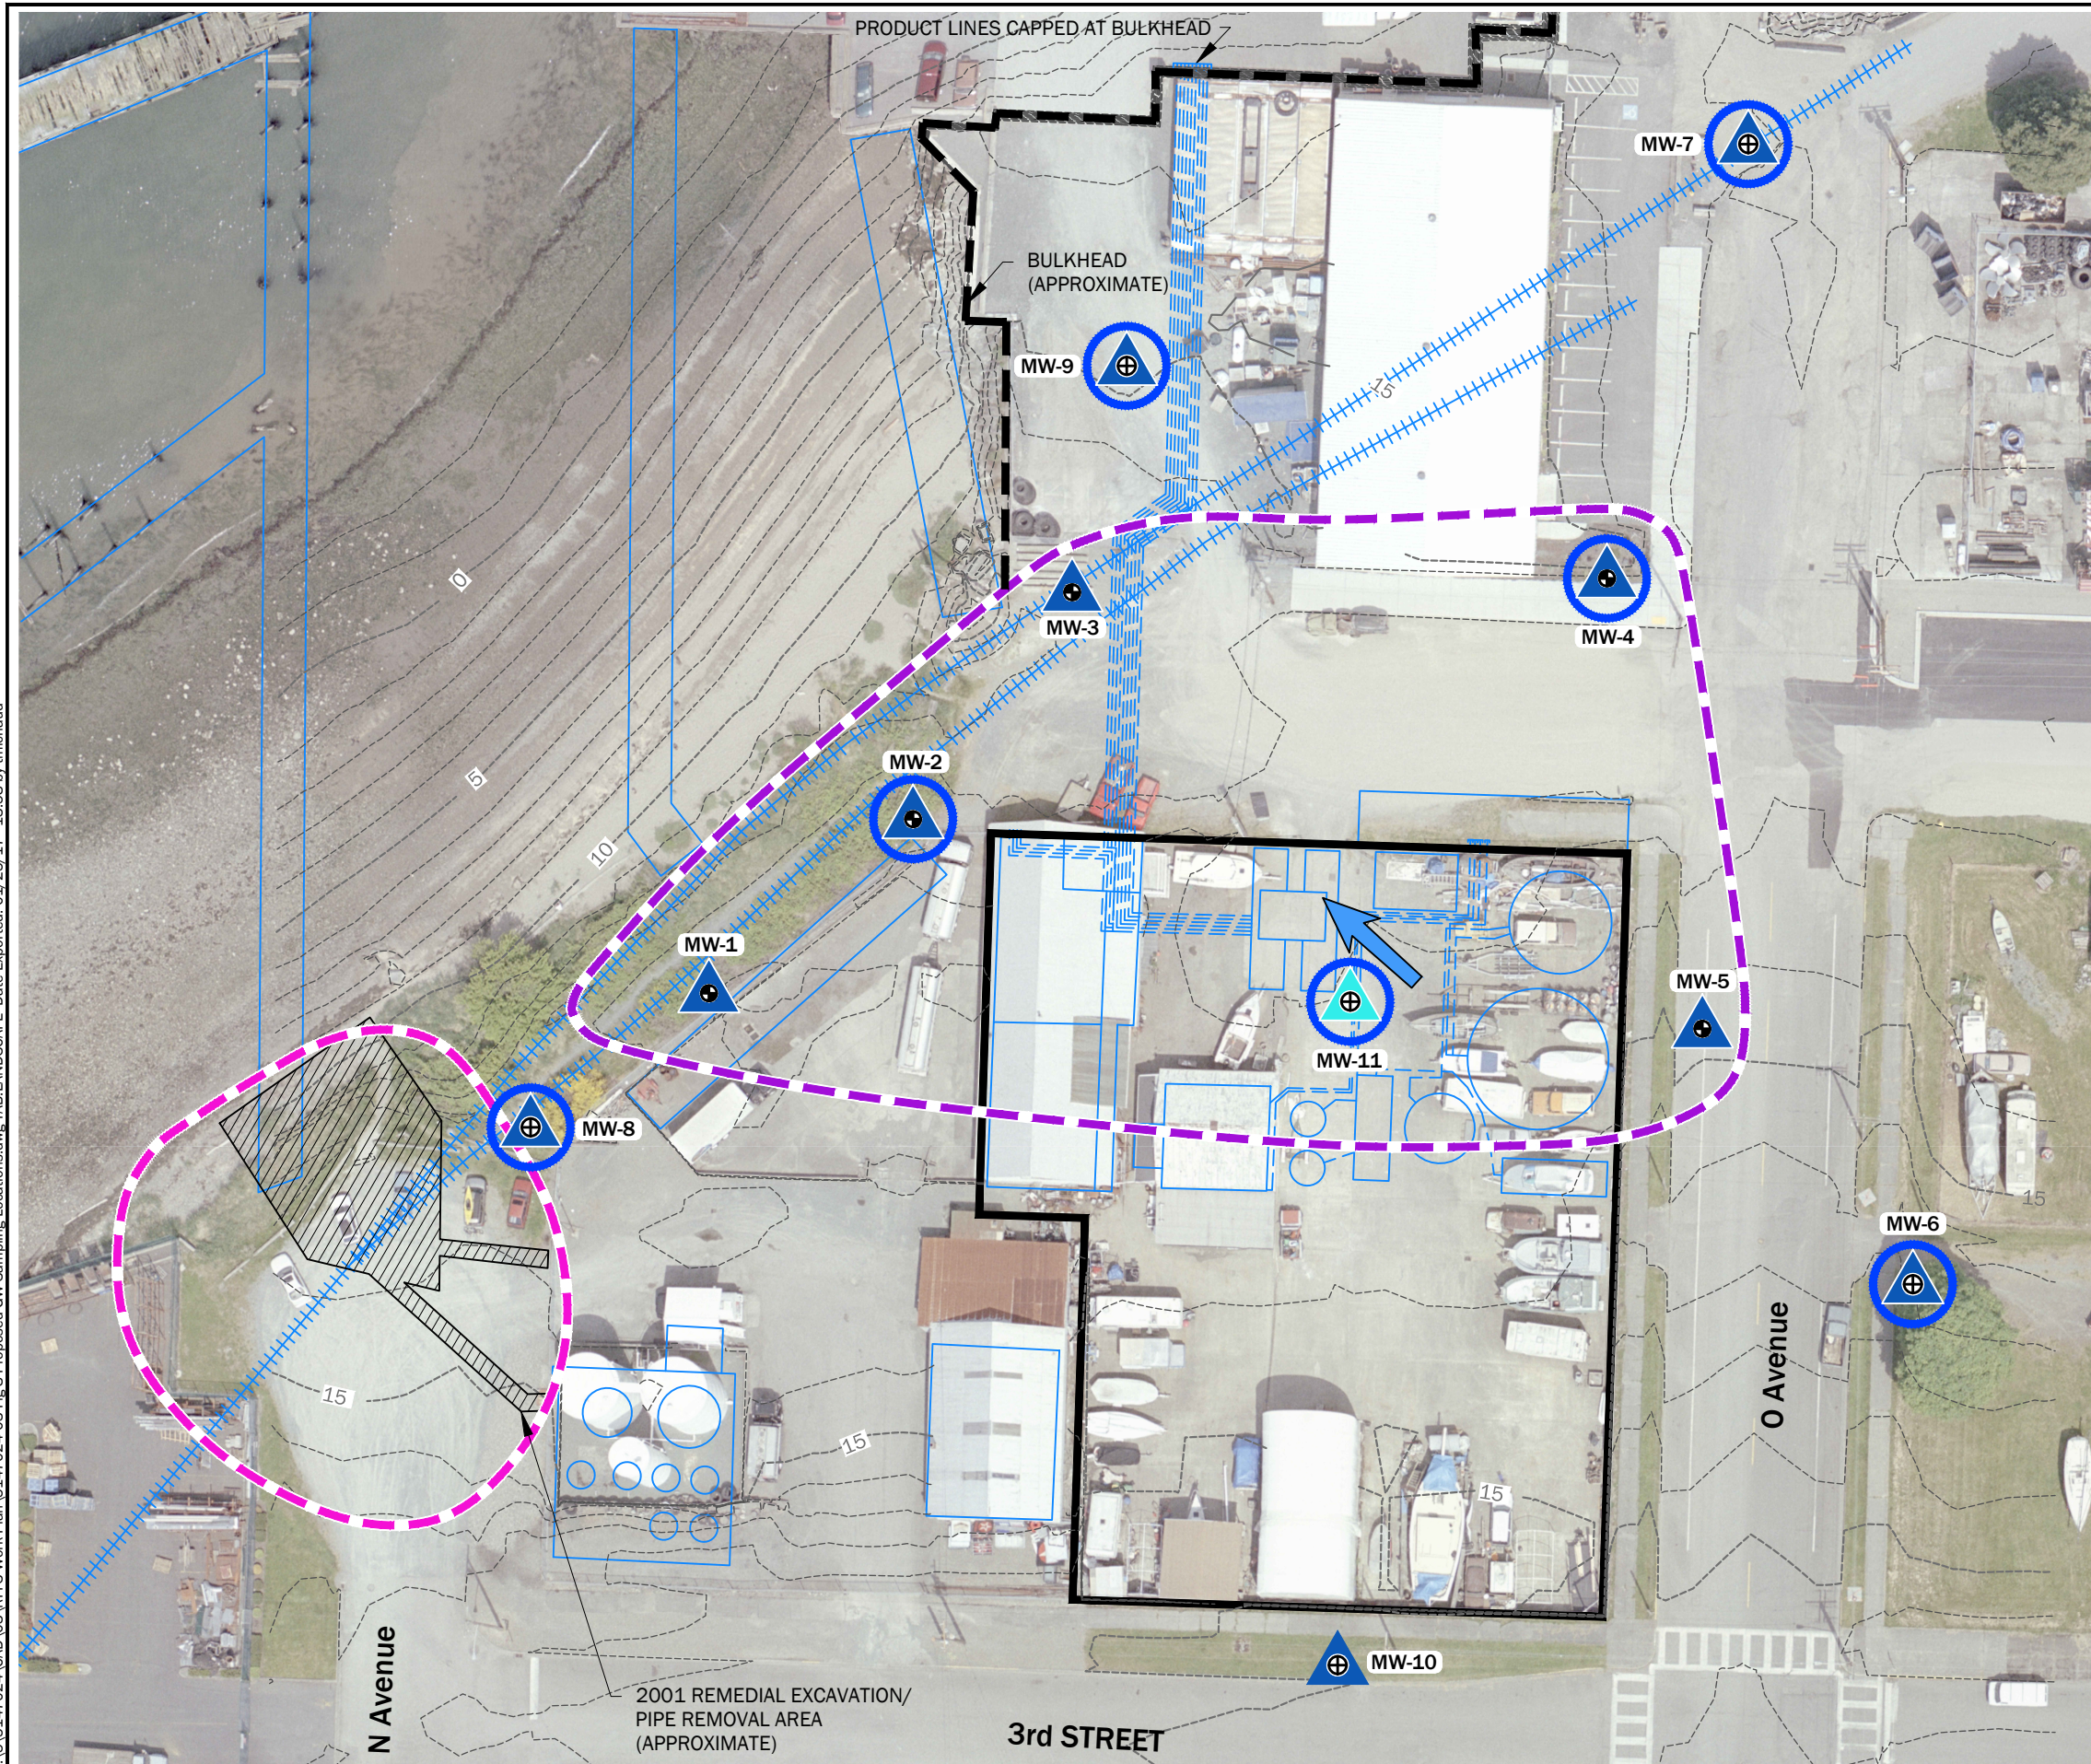
Figure 7

\*Refer to Table 8 for Sample Approach and  
Rationale. Refer to Table 10 for Sample and  
Analysis Plan.

Groundwater samples will be collected from new and existing Site monitoring wells for chemical analysis of hazardous substances as identified in Table 8. Information obtained from previous investigations was used to support selection of the groundwater sample locations.

Wells will be constructed of 2-inch-diameter, flush-threaded, Schedule 40 polyvinyl chloride (PVC) casing with machine-slotted PVC screen (0.010-inch). The top of the well screens will be located approximately 5 feet above the observed groundwater level, or within 3 feet of the ground surface, whichever is deeper. The wells' location and the potential for influence on groundwater levels in the well from changes in water levels relative to adjacent marine surface water will be considered when placing the well screen. The well screen intervals may be modified based on field screening results or variations in soil type. Screened intervals of approximately 10 to 15 feet in length are anticipated.

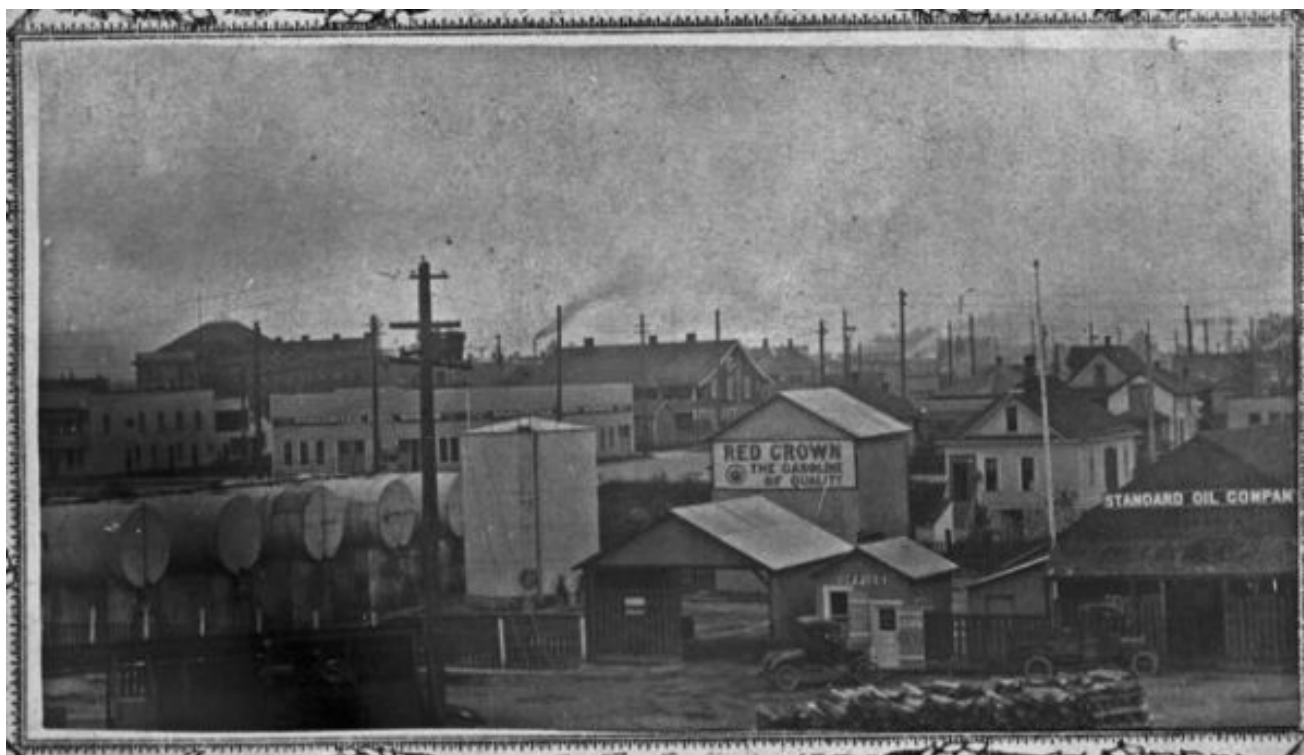
Photocopy of photograph (Original print, Anacortes Museum.) The Standard Oil complex is forefront in this image with tanks, a Red Crown gasoline facility (part of Standard Oil) and Standard Oil Company offices in the lower right. Anacortes Iron Works (1019 3rd Street) is located behind the tanks at 3rd Street and O Avenue.

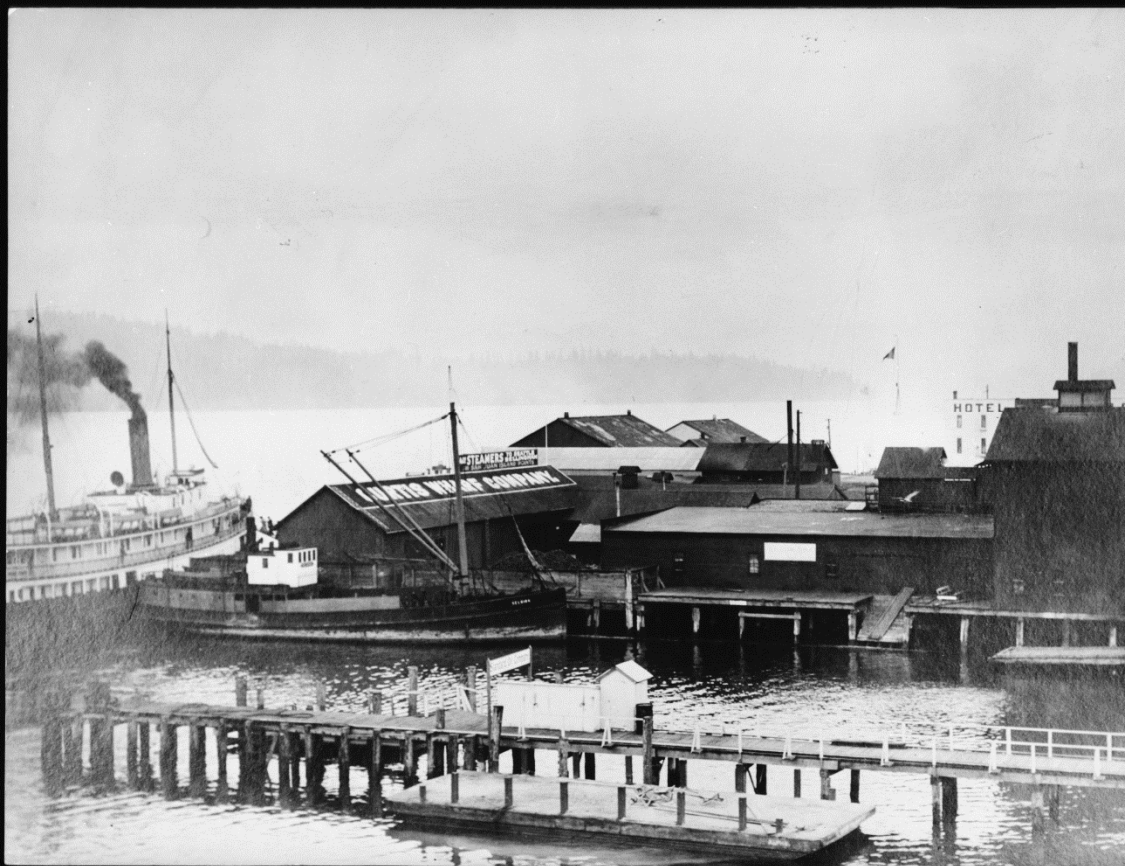
HABS NO. WA-198-16

Photocopy of photograph (Original print, Wallie V. Funk Collection.) Photographer unknown. Published in the Anacortes American, 19 March 1914, 'Curtis Wharf Company Handles City's Extensive Maritime Traffic.' View looking northeast. In the foreground, the Standard Oil Dock; behind it, the west side of the main dock. In the center, west facade, Hay and Grain Warehouse (Bottling Works not yet built.) To the right, Feed Mill. Note coal bin at northwest corner of the Hay and Grain Warehouse. - Curtis Wharf, O & Second Streets, Anacortes, Skagit County, WA

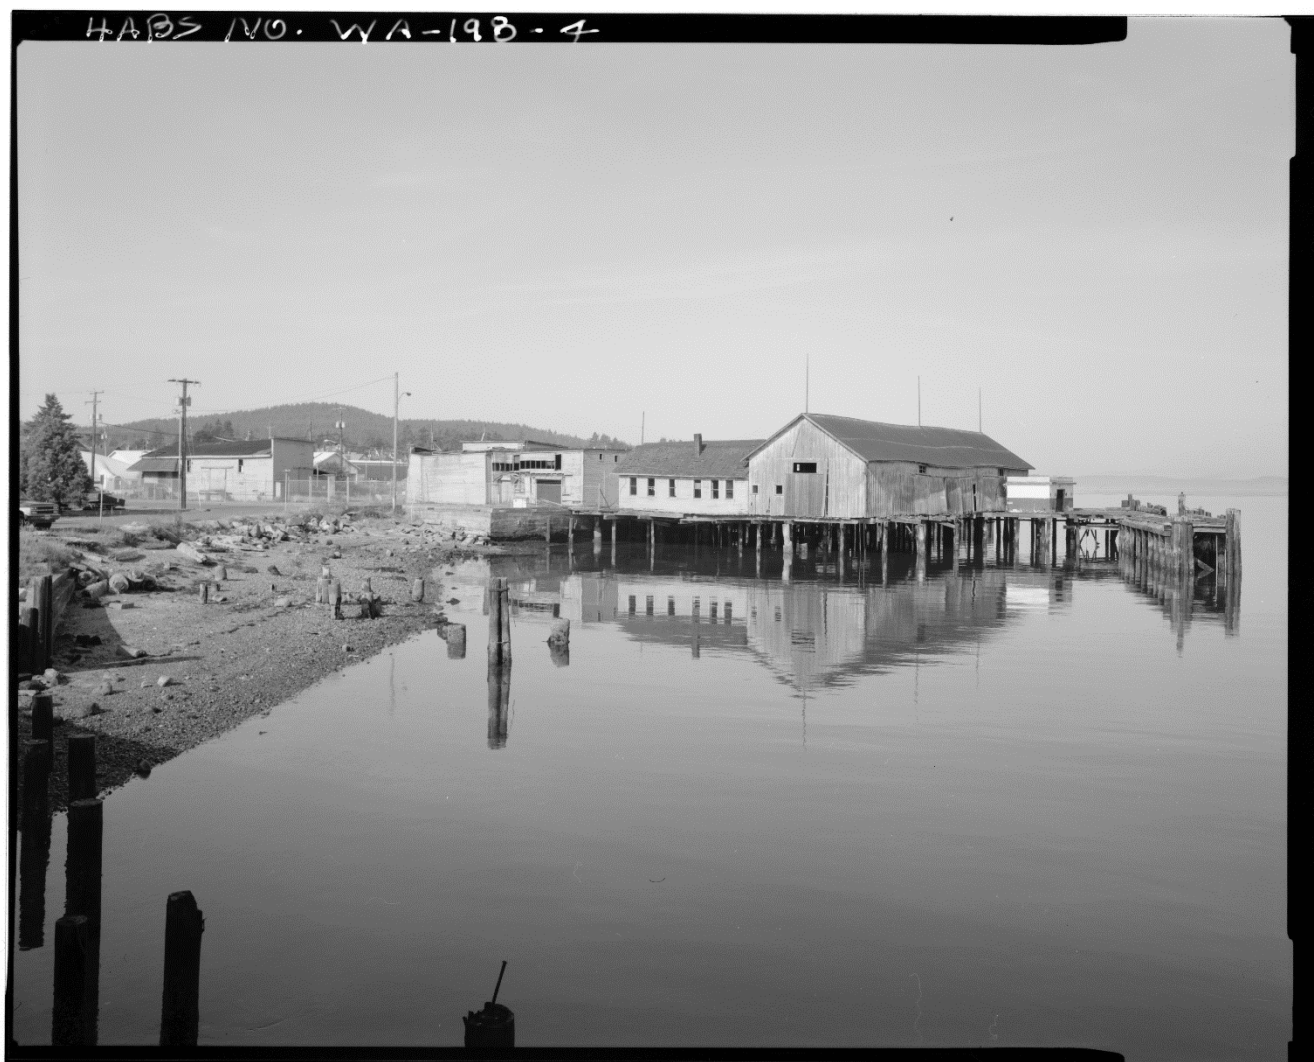
Photo from Survey HABS WA-198-04

East side of Curtis Wharf, as seen from the pier at the Port of Anacortes. View looking south and west. - Curtis Wharf, O & Second Streets, Anacortes, Skagit County, WA

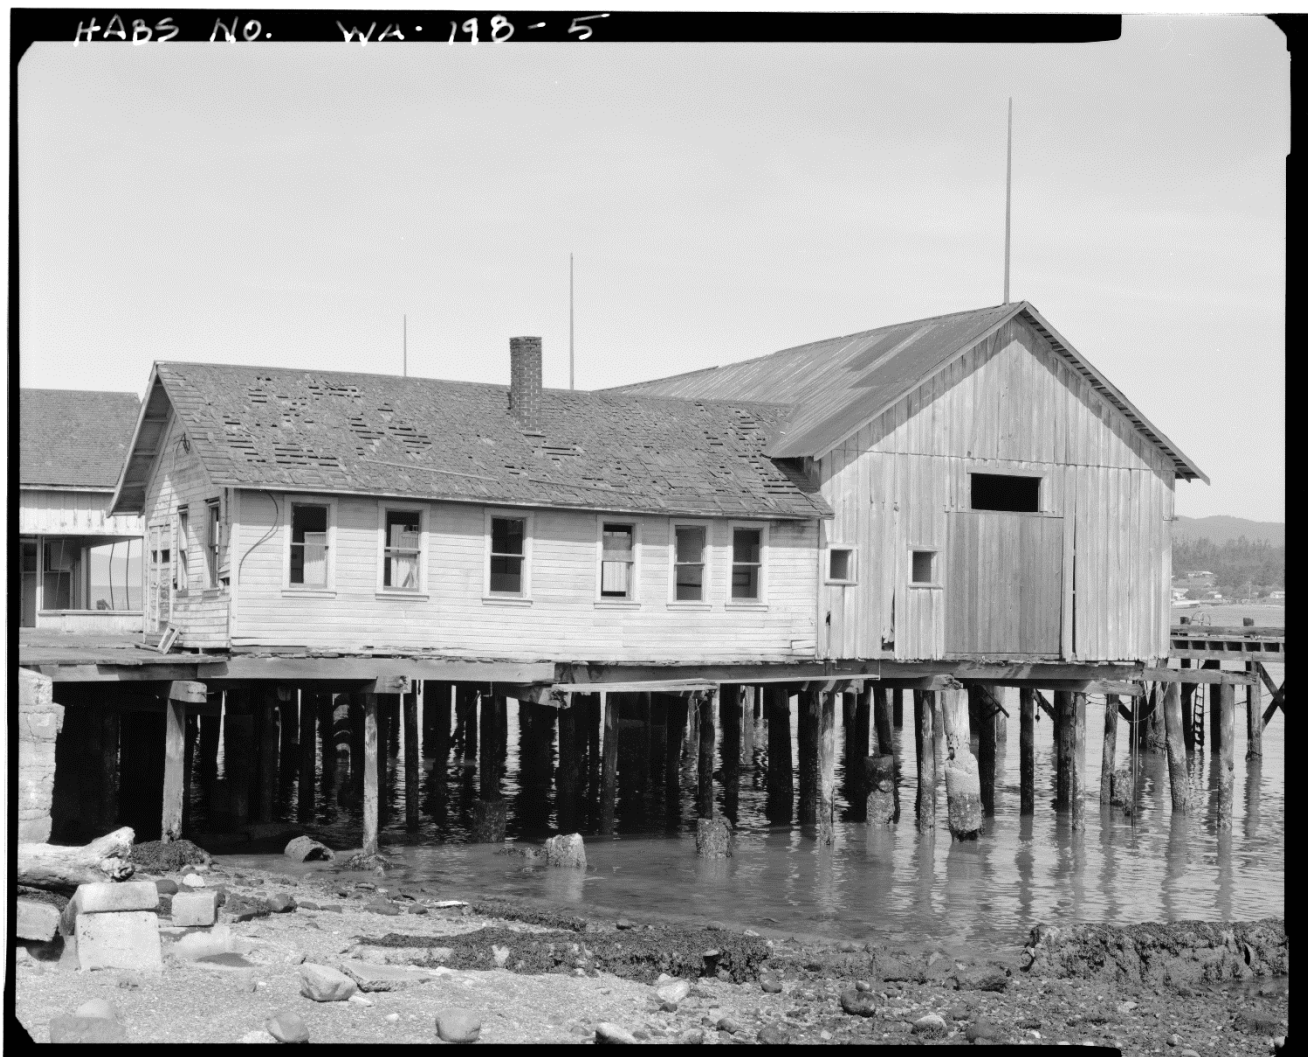
Photo from Survey HABS WA-198-05

Freight Warehouse, east facade, on the right; east facade and southeast corner of Ticket Office on the left.  
- Curtis Wharf, O & Second Streets, Anacortes, Skagit County, WA

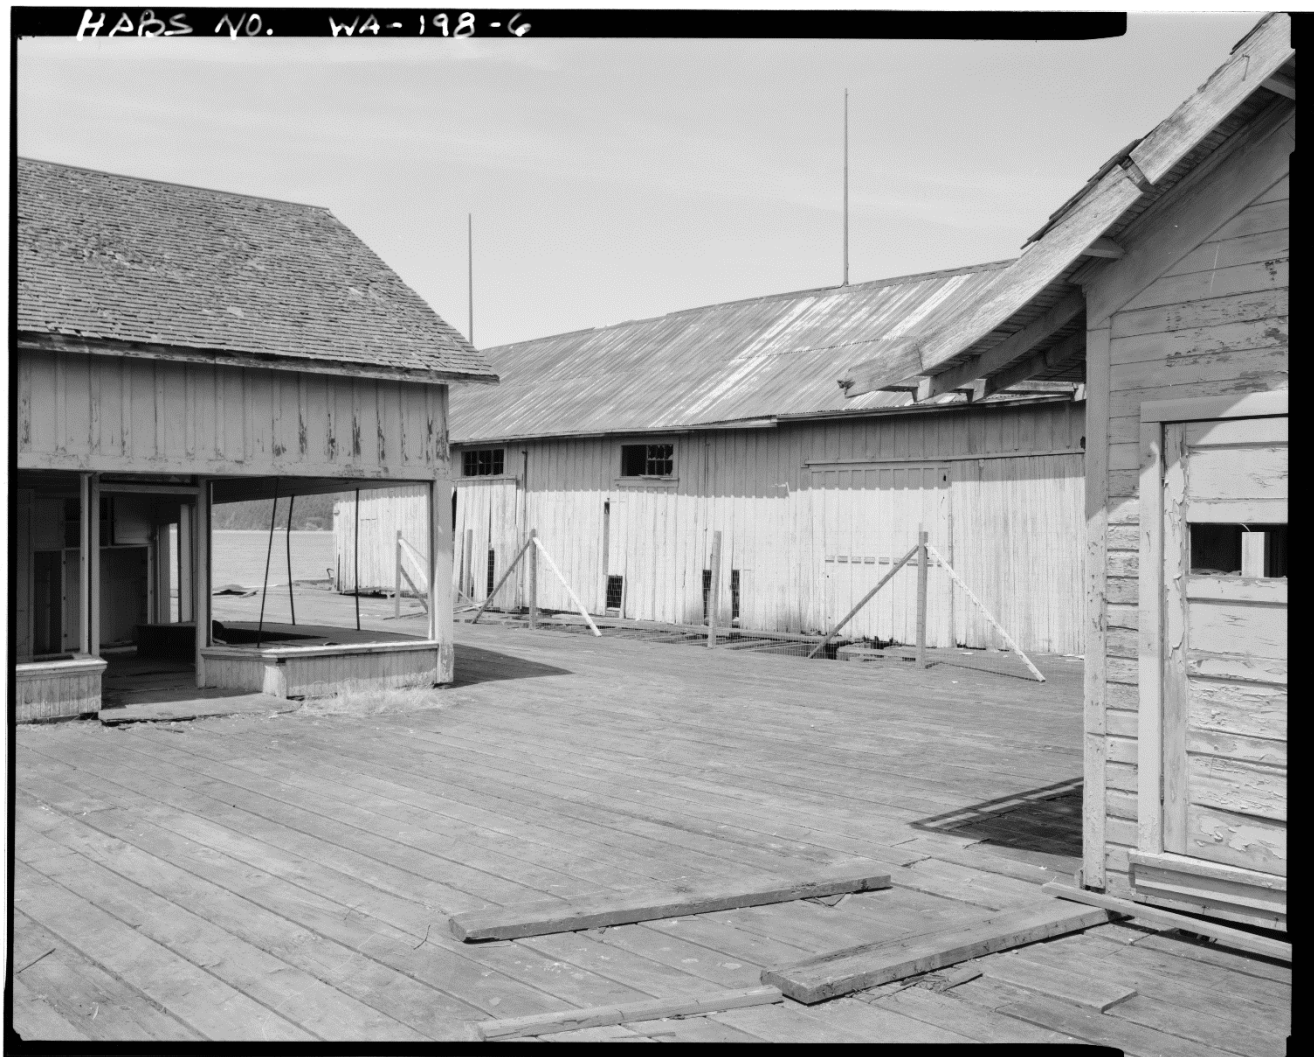
Photo from Survey HABS WA-198-06

Looking into the inner court. Left to right: Cold Storage Warehouse, east facade; Freight Warehouse, south facade; Ticket Office, southwest corner. - Curtis Wharf, O & Second Streets, Anacortes, Skagit County, WA

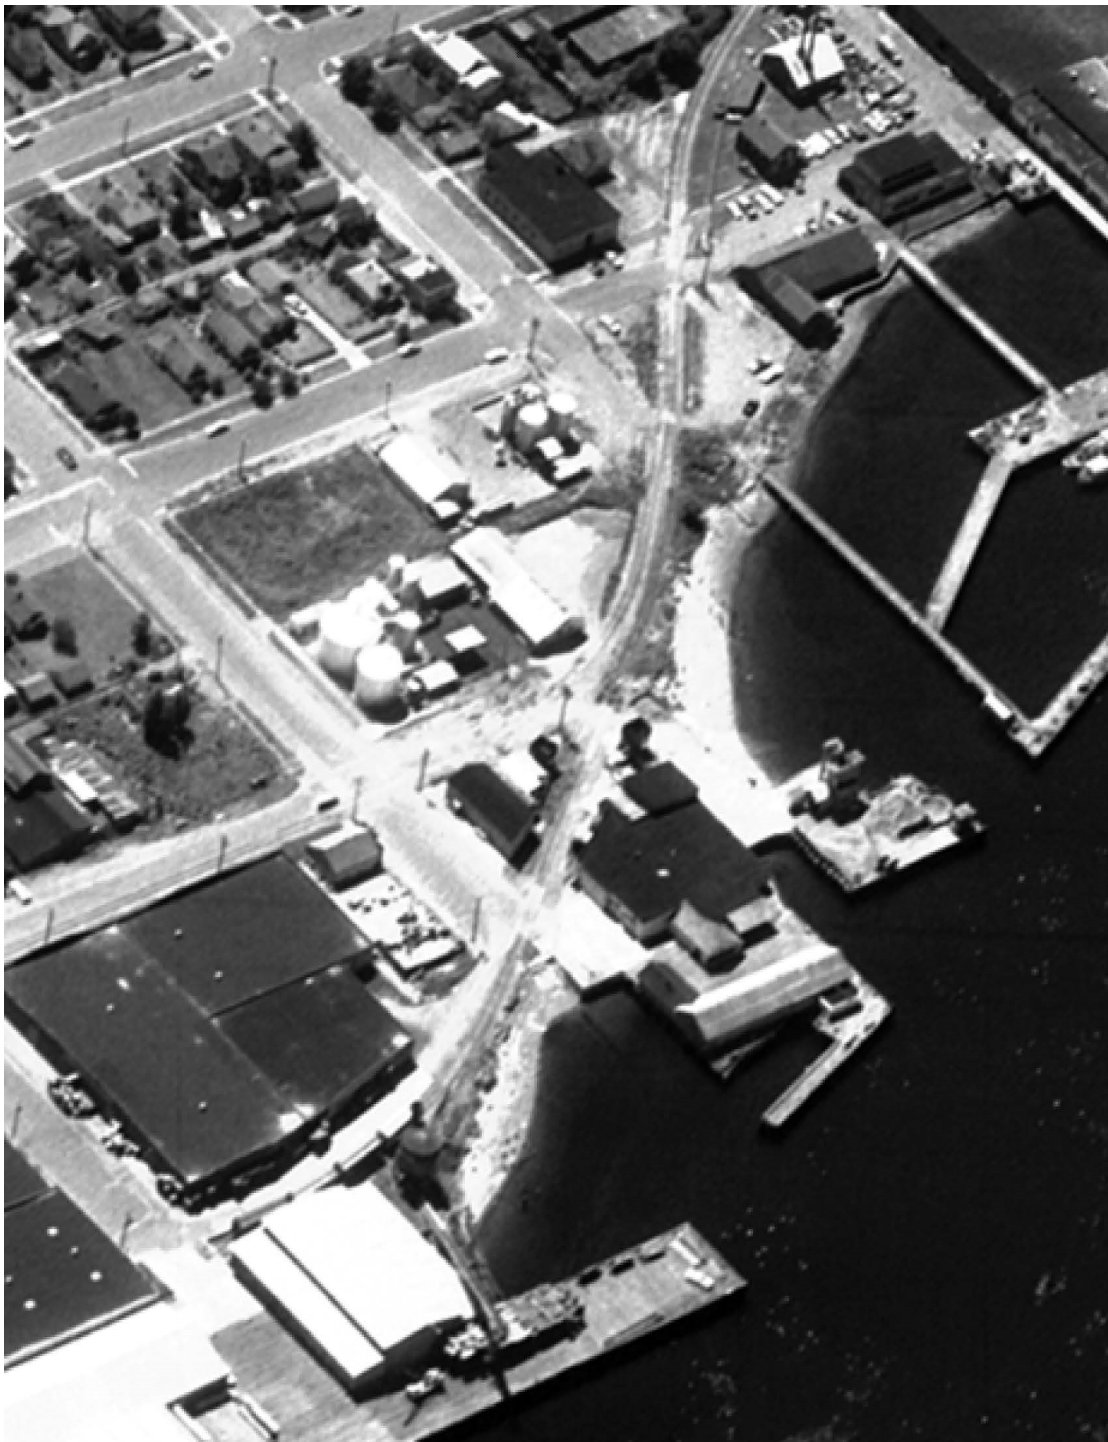
Overview of Quiet Cove and surrounding area. Reisner Petroleum Terminal to the south of Curtis Wharf is intact; Standard Oil Facility and railroad line in central portion of photograph. - O & Second Streets, Anacortes, Skagit County, WA

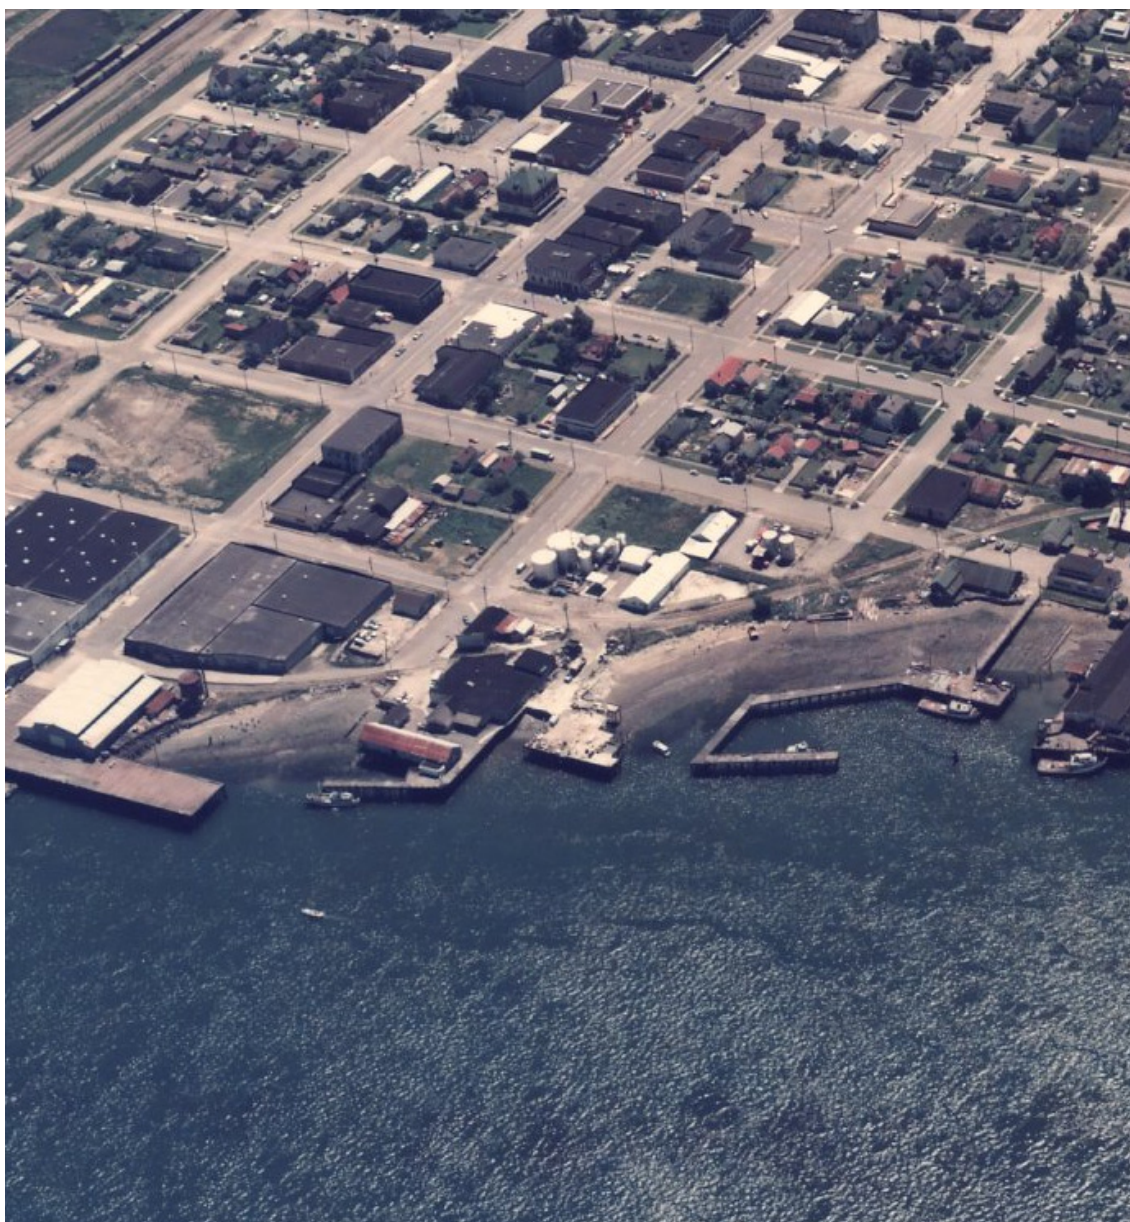
Overview of Quiet Cove and surrounding area. Reisner Petroleum Terminal to the southwest of Curtis Wharf is no longer intact; Standard Oil Facility and railroad line in central portion of photograph. - O & Second Streets, Anacortes, Skagit County, WA

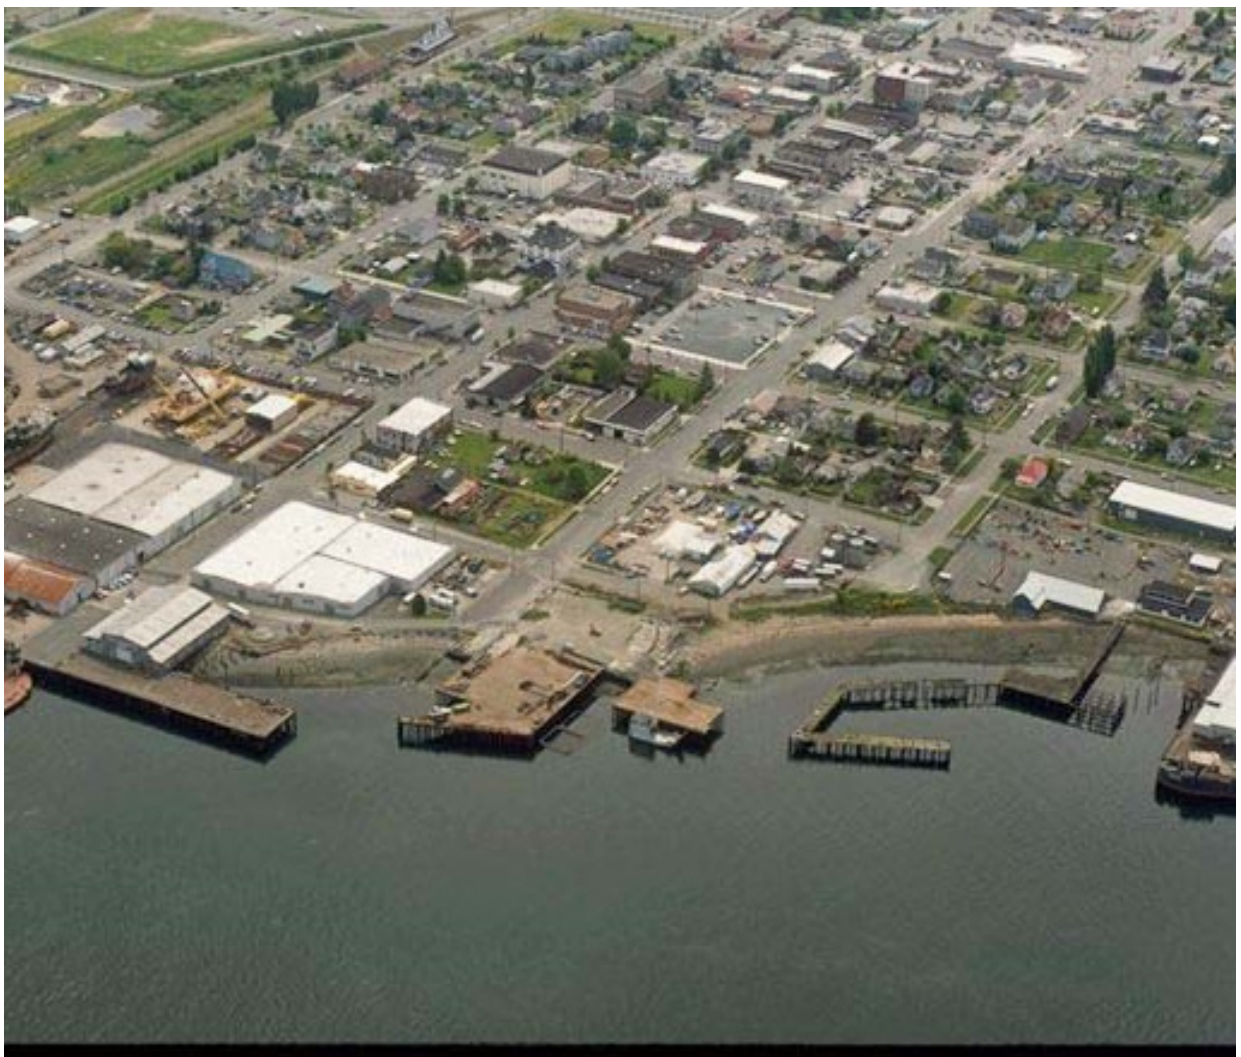
Overview of Quiet Cove and surrounding area. Standard Oil Facility and railroad line is no longer intact. - O & Second Streets, Anacortes, Skagit County, WA
