## ANACORTES PLANNING COMMISSION

**May 24, 2023**

### **AGENDA**

- A. Roll Call**
- B. Minutes**
  - 1) Minutes of May 8, 2023
- C. Correspondence**
- D. New Business**
  - 1) Appoint new vice chair.
  - 2) Open Record Public Hearing and Decision for Shoreline Substantial Development Permit SDP-2023-0002 Port of Anacortes 2nd Street and Curtis Wharf project.
- E. Old Business**

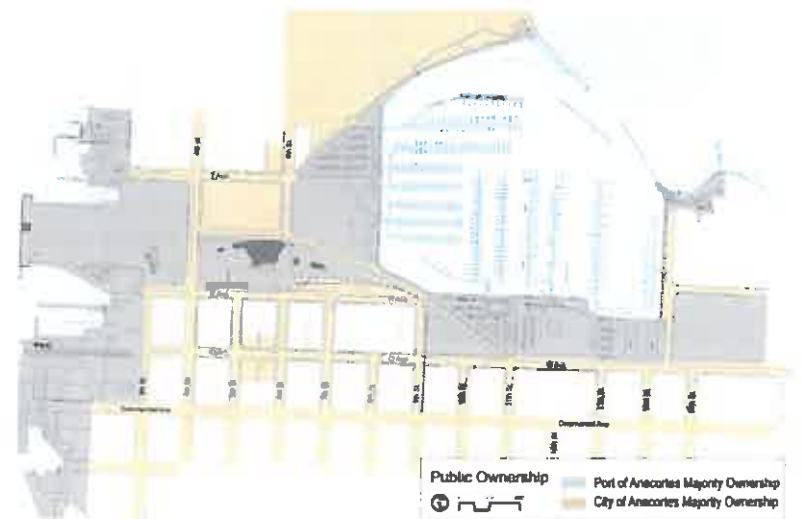
Figure 4. Public Ownership

The study area contains a high percentage of publicly owned land. (See Figure 4.) This public ownership creates a unique opportunity to coordinate public access and connections to the shoreline without impacting private property. There are numerous cases throughout the plan where there are real estate implications of plan improvements. The Port and City will need to cooperatively address these real estate implications in order to facilitate plan implementation. Where known, these areas have been highlighted in the Plan.

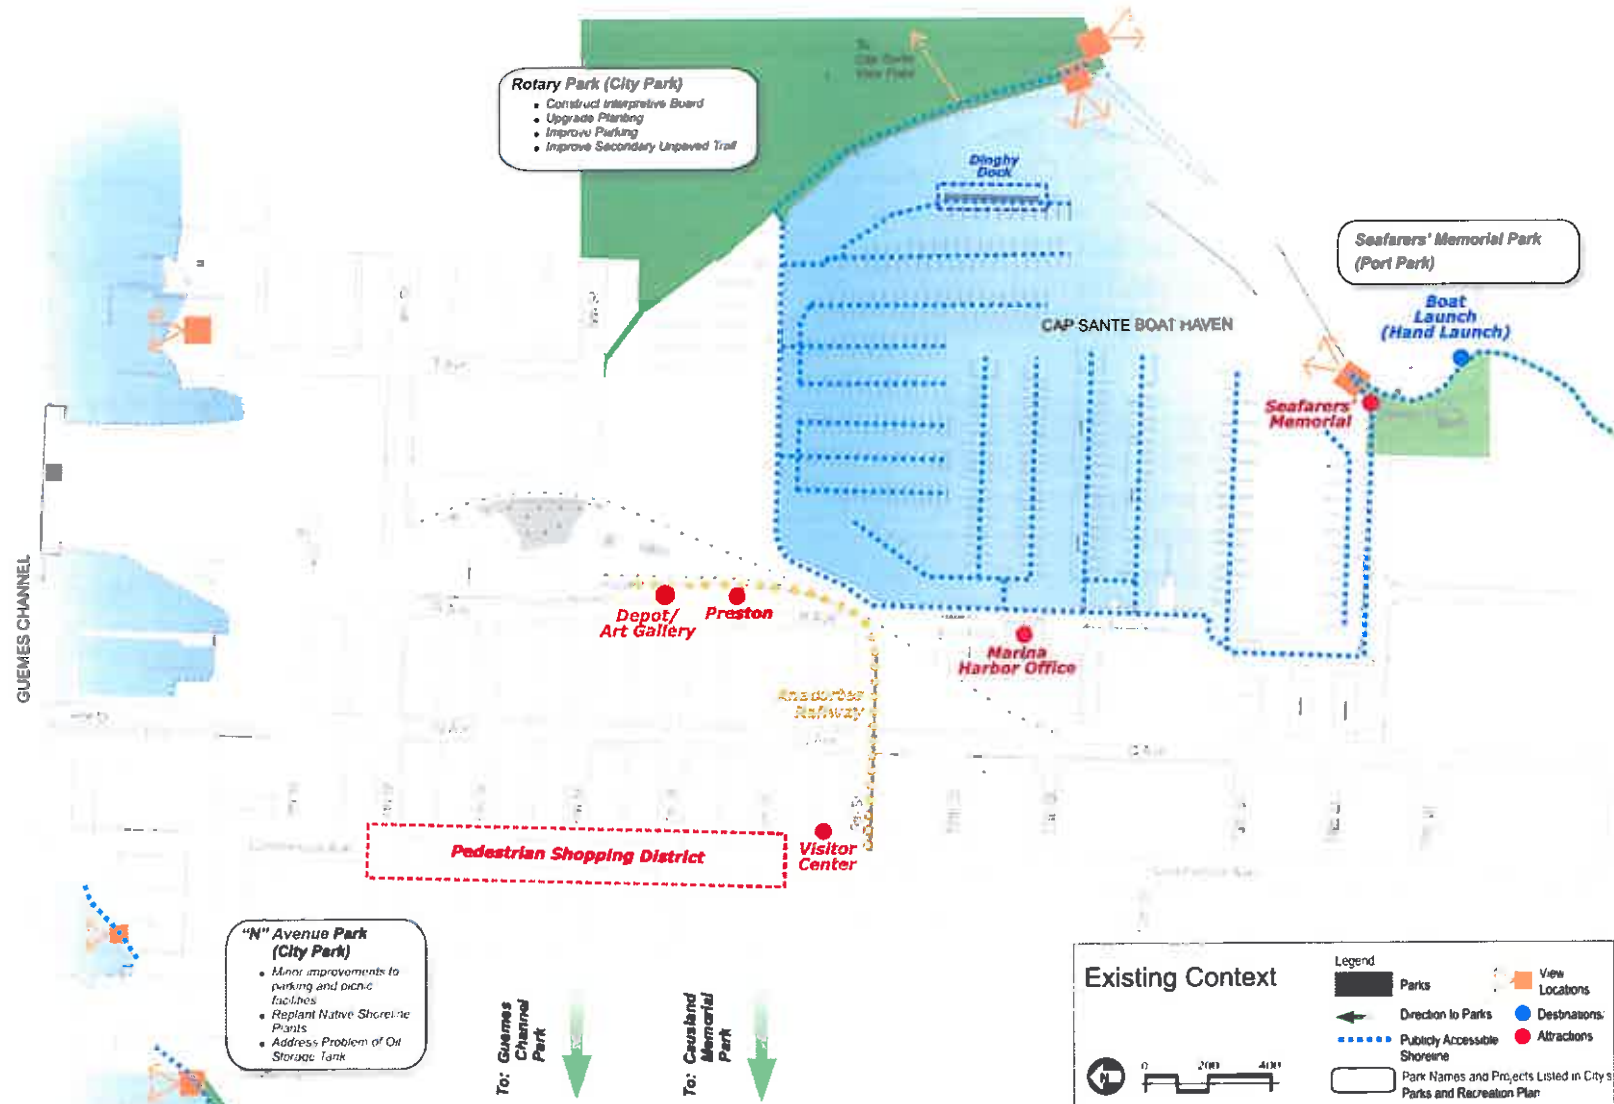
Figure 5. Site Analysis Map

The study area is close to several existing parks, numerous individual viewpoints, destinations, attractions, and accessible waterfront. These existing amenities are illustrated in Figure 5.

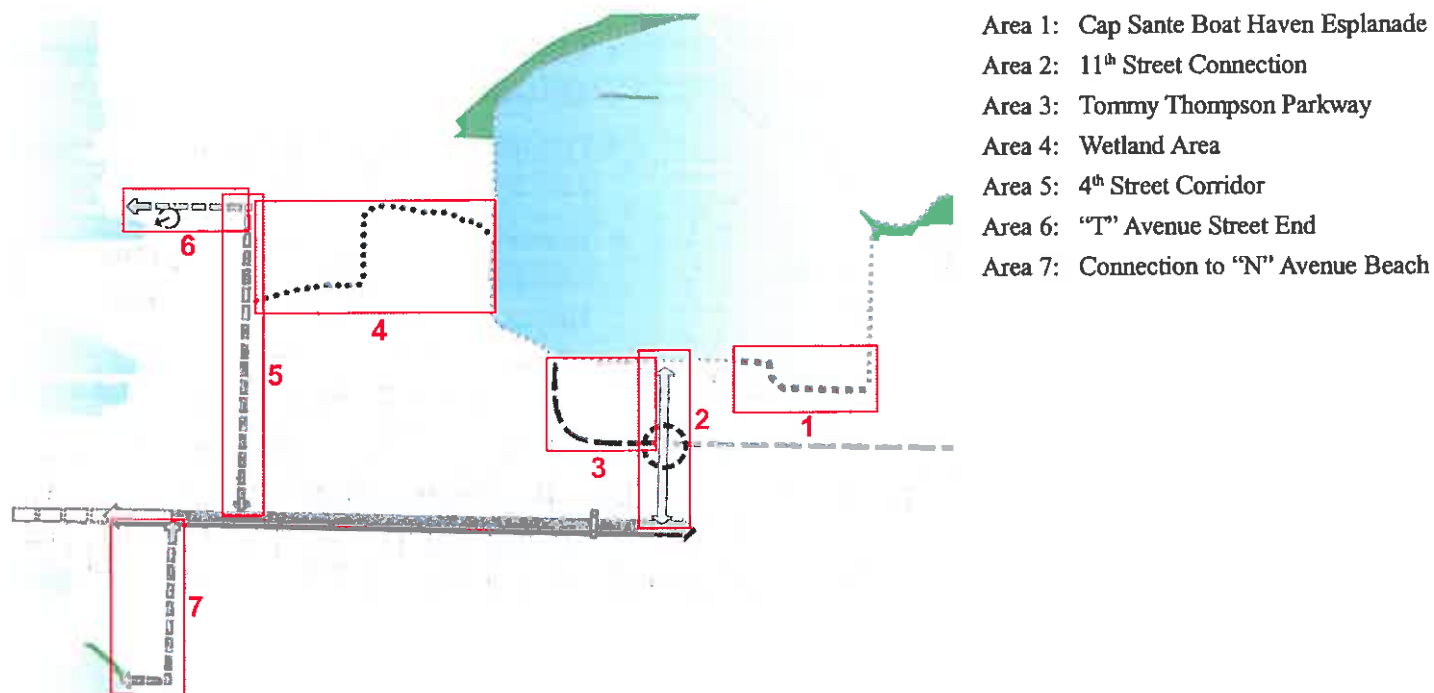
Figure 6. Public Access Focus Areas

Plan recommendations are divided into seven focus areas. These areas are illustrated in Figure 6. The background, goals, and specific recommendations for each focus area are described and illustrated on the following pages.

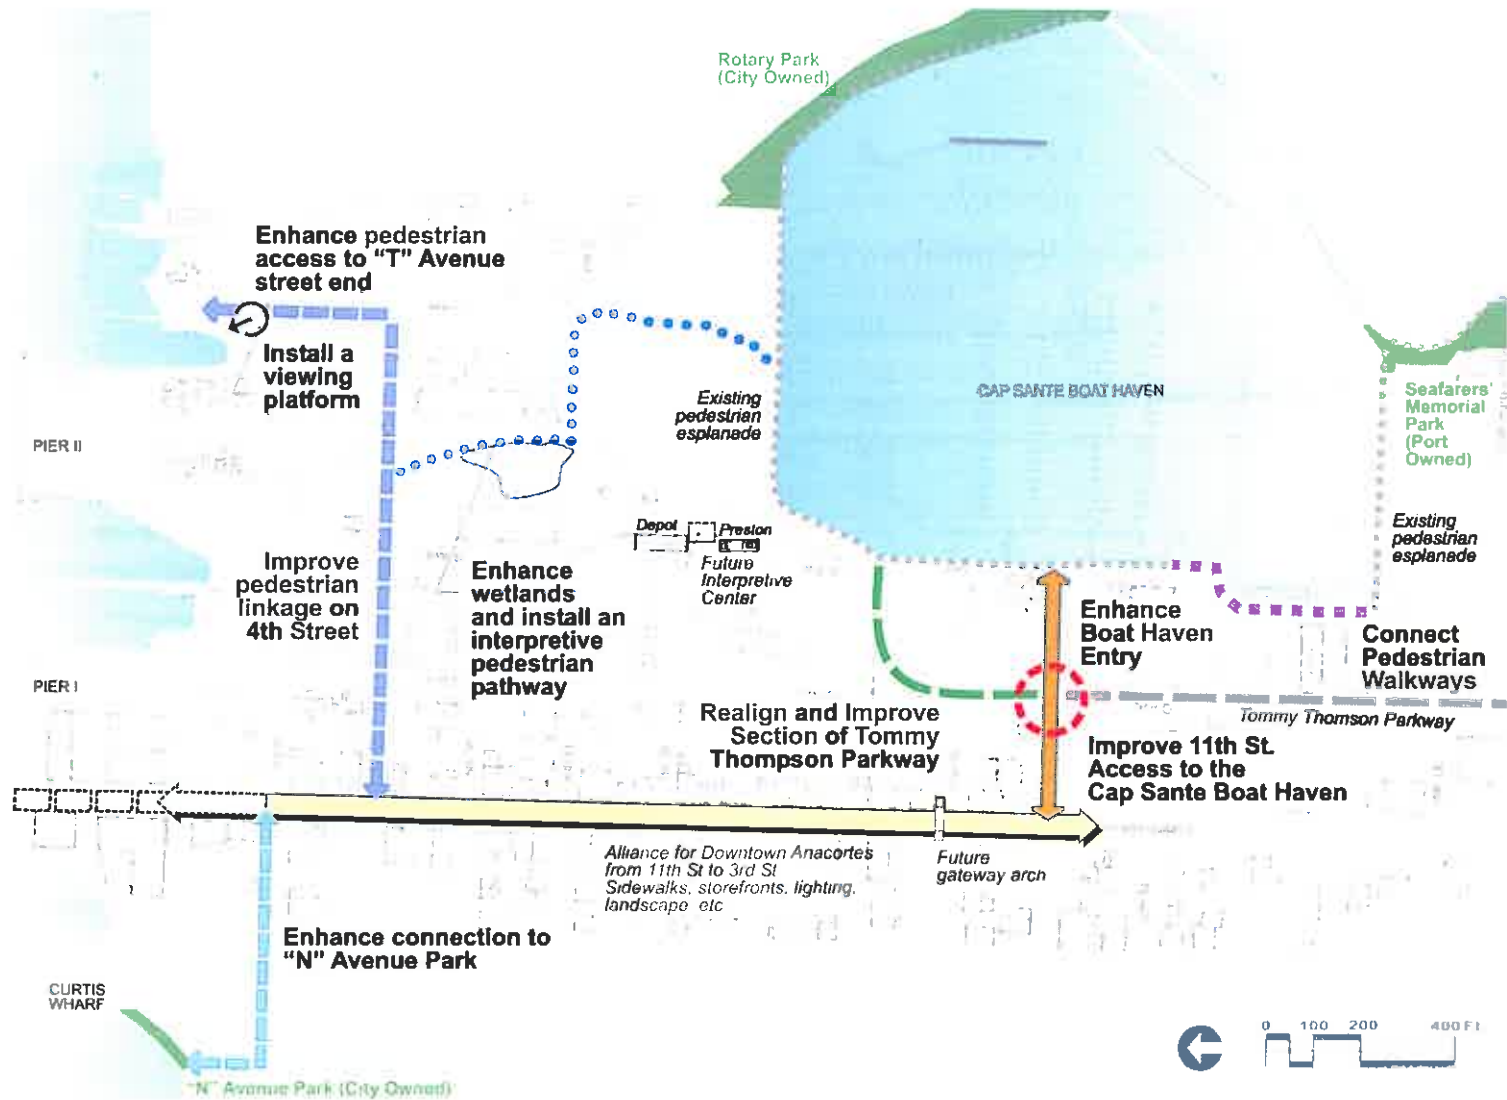
Figure 7. Public Access Plan Components

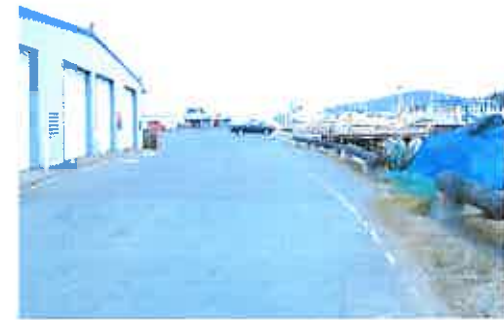
*Figure 10. Area without the Esplanade near  
the Web Lockers and "T" Dock*

The Cap Sante Boat Haven offers ample public access opportunities, since the marina and its docks are open to the public. Additionally, there is a pedestrian esplanade, which allows the public to stroll along the water and view boating activities and Fidalgo Bay. The esplanade consists of a north and south portion separated by an unimproved portion between the existing travel lift dock and Seafarers' Way. This area between the esplanades is currently home to a variety of maritime activities, including commercial fishing, pallet-sized cargo loading, and boat repair.

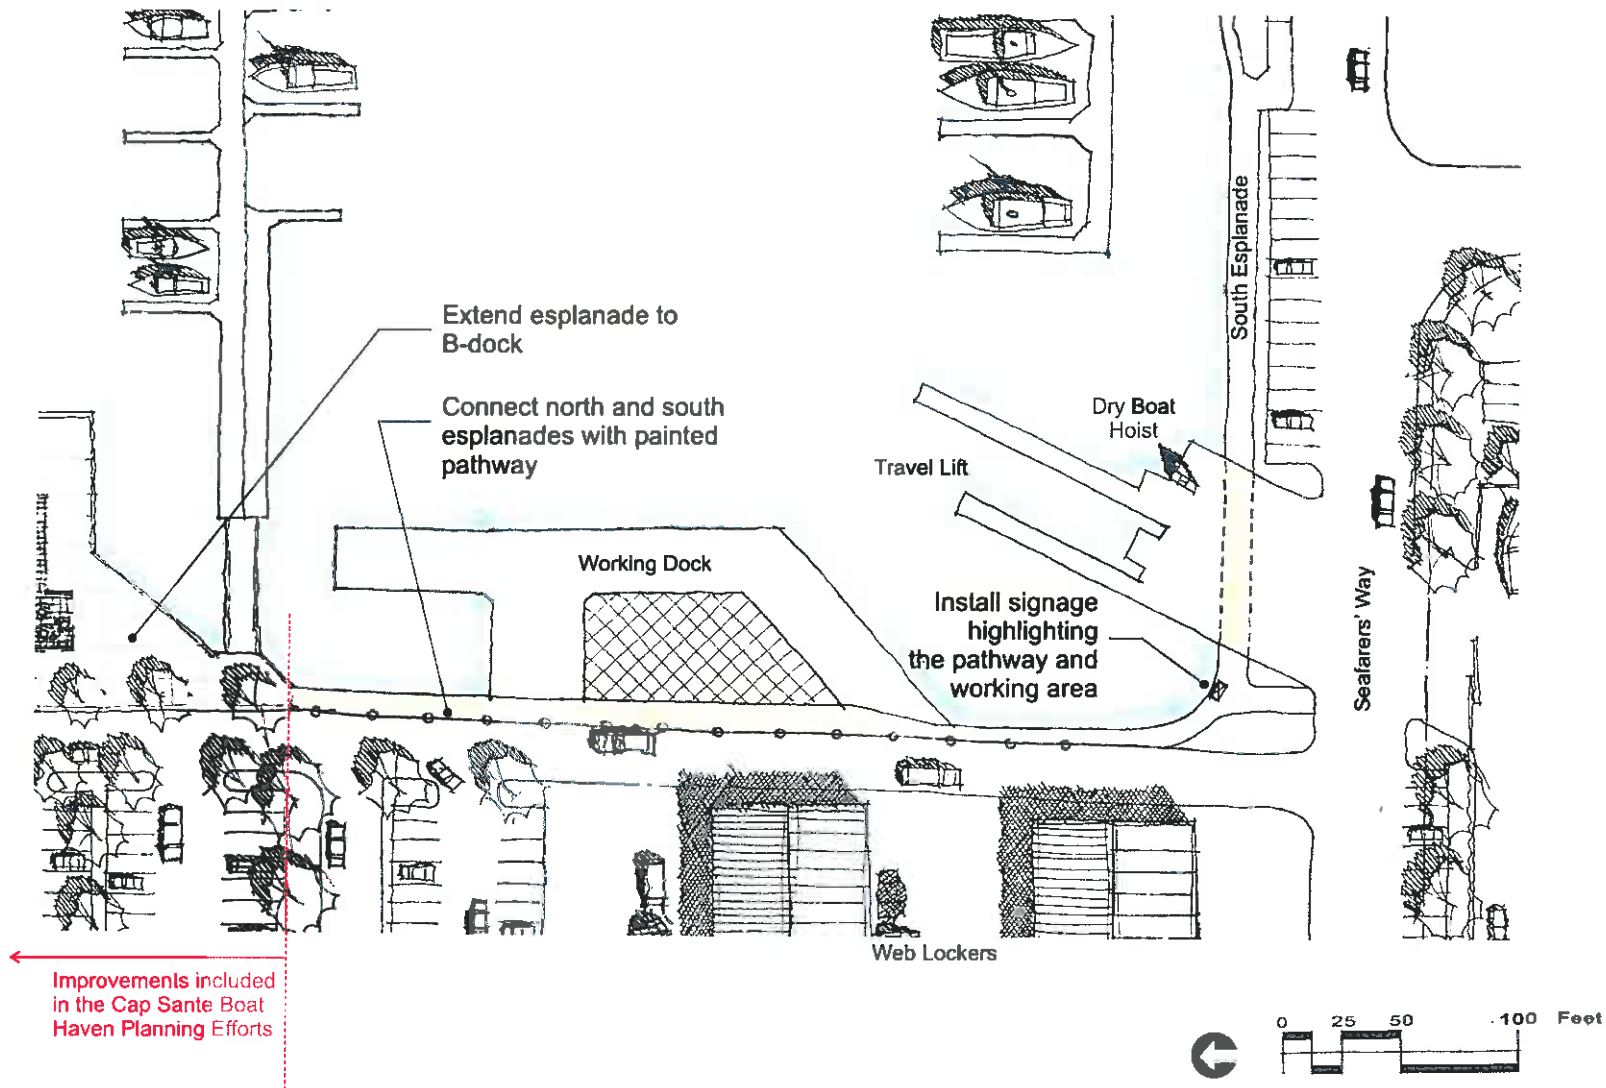
Figure 11. Cap Sante Boat Haven Esplanade Improvements Plan

- Provide a continuous walkway adjacent to the water at the Cap Sante Boat Haven, coordinated with improvements to the West Basin as envisioned in the Cap Sante Boat Haven Master Plan.
- Minimize disruption to users of B- and T-docks.

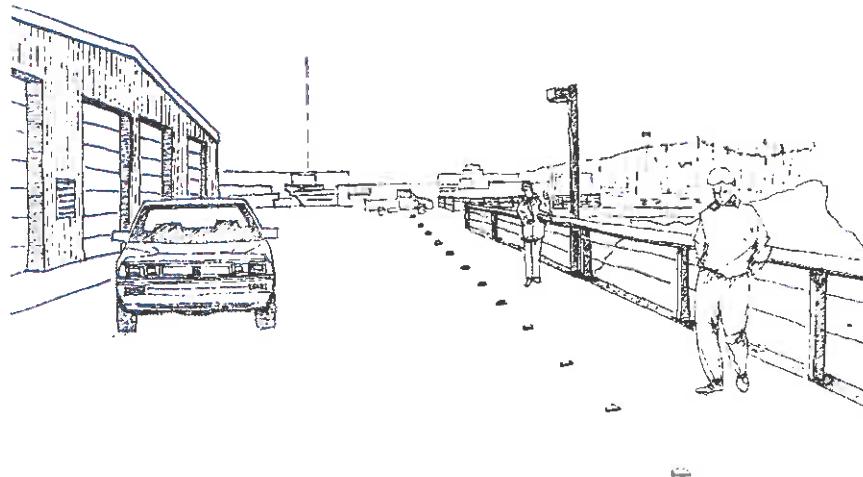
Figure 13.  
*Conceptual View of Painted Pathway*

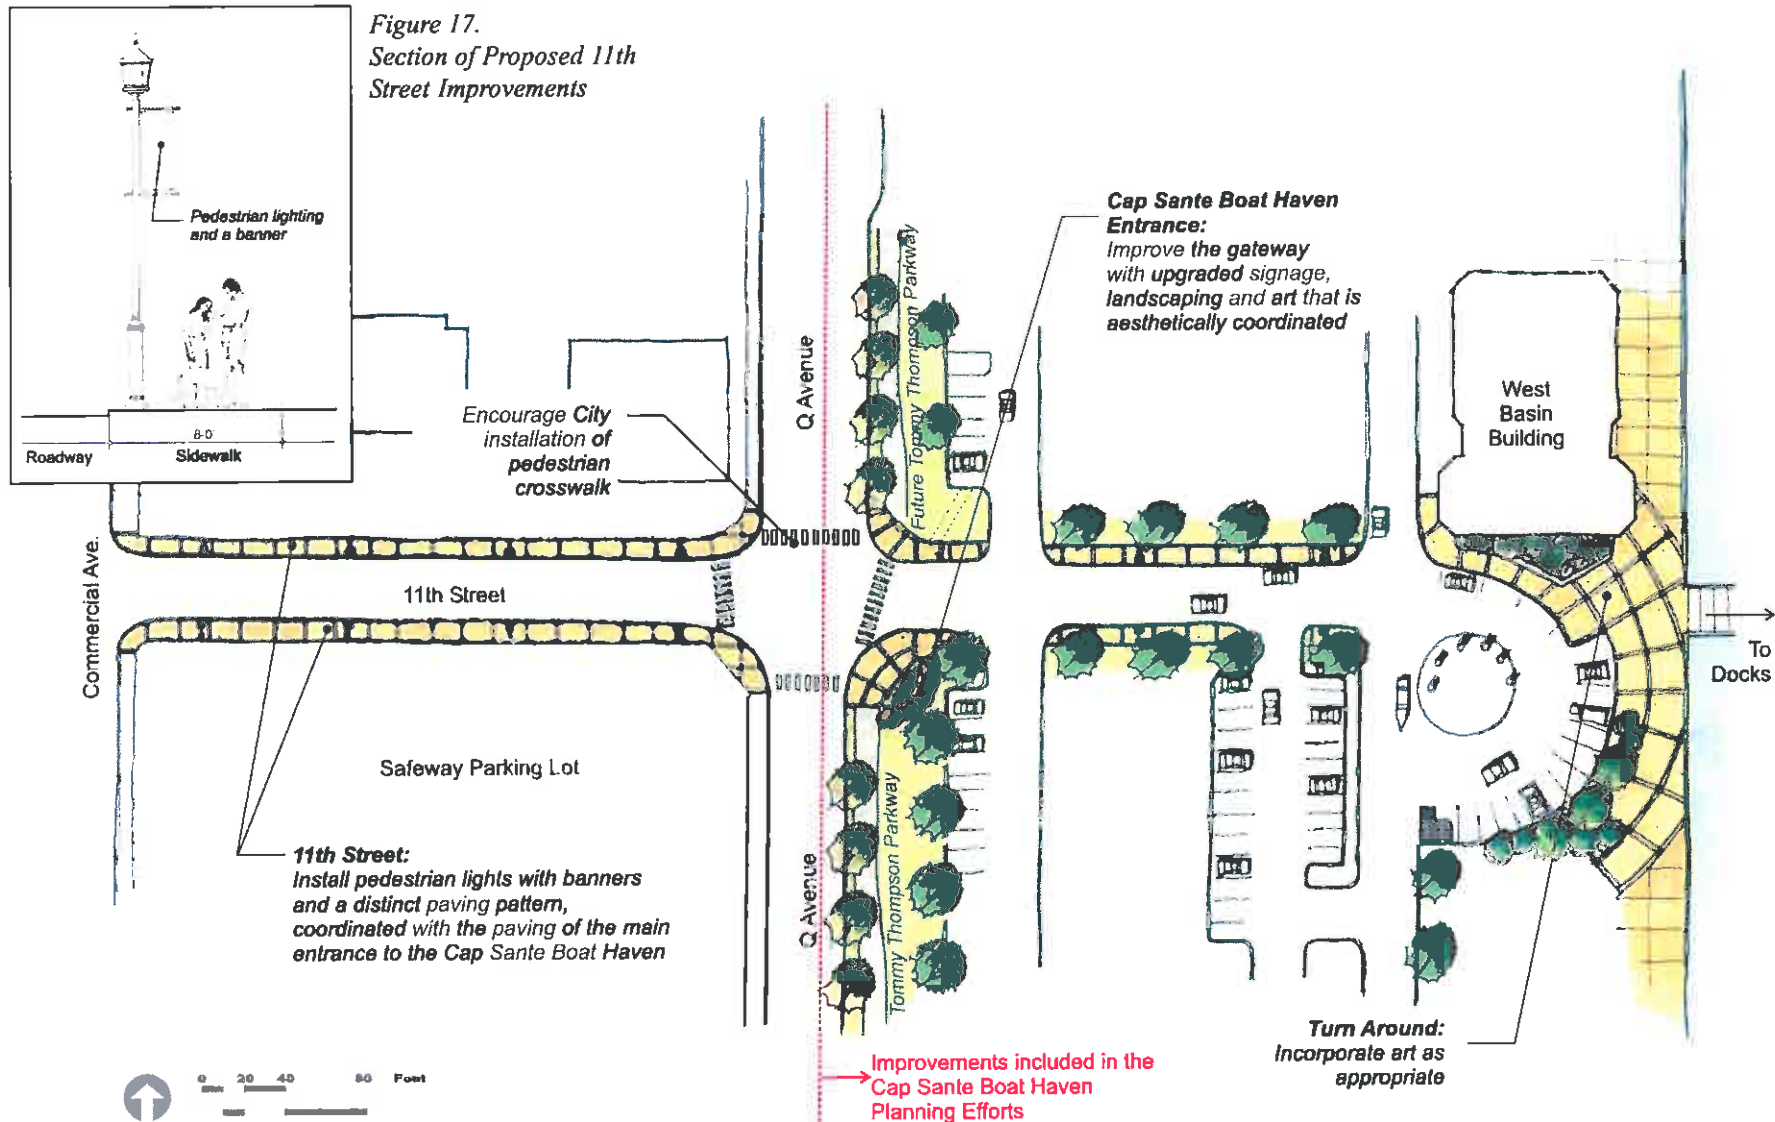
**Figure 18.** 11th Street Connection Improvements Plan

- Encourage pedestrian traffic between downtown Anacortes and the Cap Sante Boat Haven.
- Create a gateway entry to the Cap Sante Boat Haven that is recognizable from Commercial and "Q" Avenues.
- Coordinate improvements with the planning at the Cap Sante Boat Haven.
- Encourage the City to provide a pedestrian crosswalk across "Q" Avenue on the north side of 11th Street.

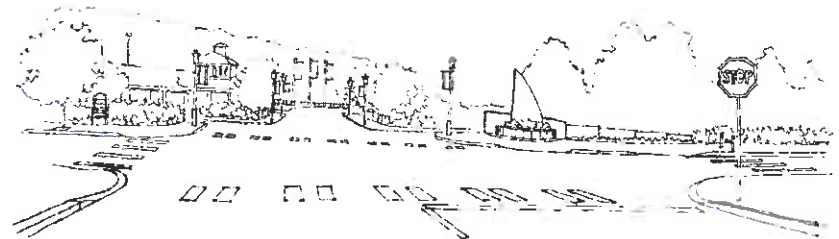
Figure 19. Conceptual Sketch of Marina Gateway Improvements

The existing sidewalk on 11<sup>th</sup> Street is narrow. The use of distinctive vertical design elements would create a visual gateway without taking up additional ground area. The installation of pedestrian lights with banners on 11th Street between Commercial Avenue and the Cap Sante Boat Haven is recommended to provide this visual statement. Lighting should be consistent with the fixtures recently installed by the City of Anacortes on Commercial Avenue. There are real estate implications of this project as these improvements would occur on City right-of-way.

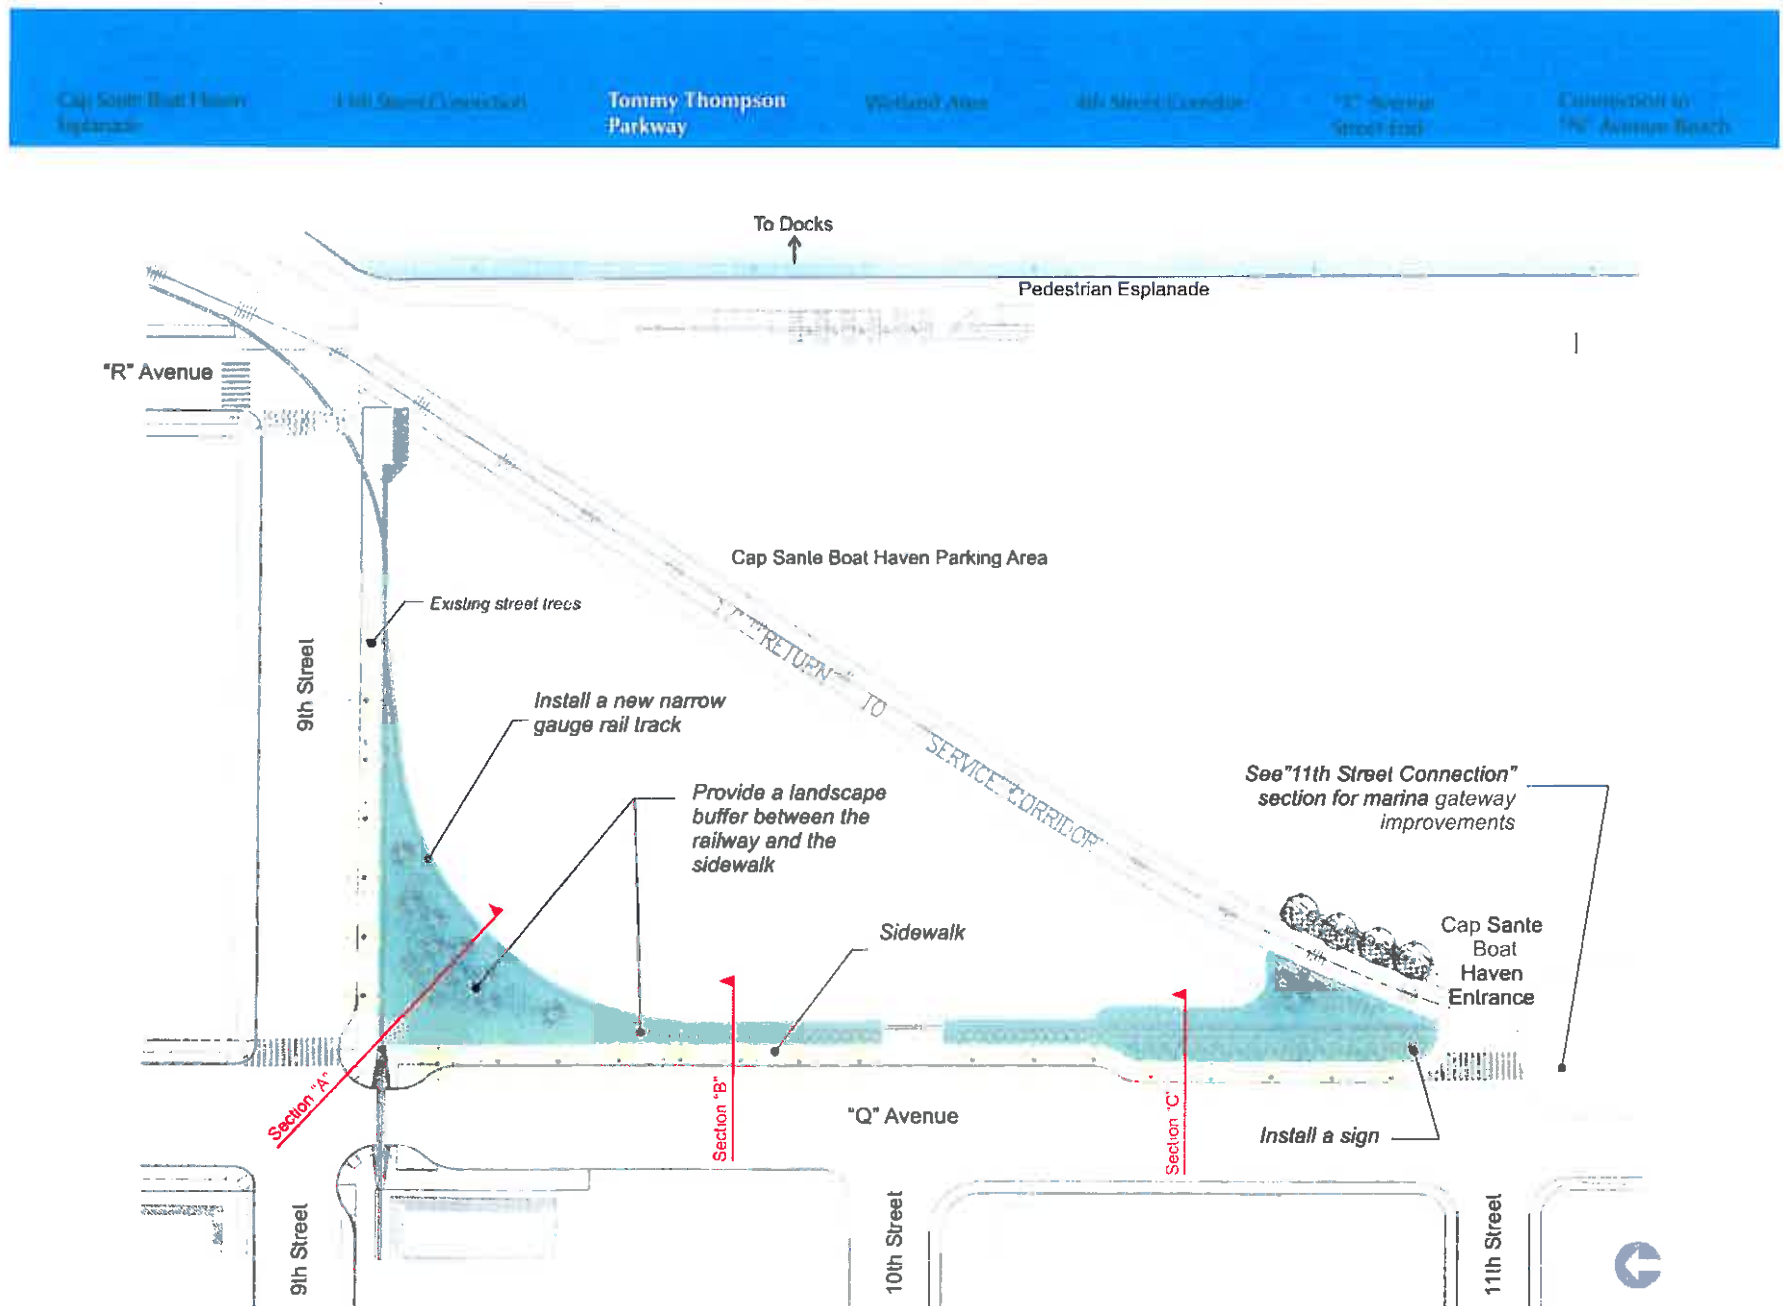
Figure 23. Tommy Thompson Parkway Improvements Plan

The parcel east of “Q” Avenue between 9<sup>th</sup> and 11<sup>th</sup> Streets at the Cap Sante Boat Haven is bisected by a railroad right-of-way. The Port examined the background, current status, and plans for this right-of-way in the 1998 report: *Vacated Market Street Railroad Right Of Way, September 1999*, prepared by Reid Middleton. Due to its complex legal history, there may be real estate implications or potential ownership issues surrounding this return to the service corridor. Information regarding ownership issues, the City’s guidelines, and the City’s stated intention to allow an extension of an adjacent narrow gauge franchise “Tommy’s Train” along this standard gauge right-of-way can be found in the Reid Middleton report. Its recommendations have been incorporated in this public access plan and are summarized below.

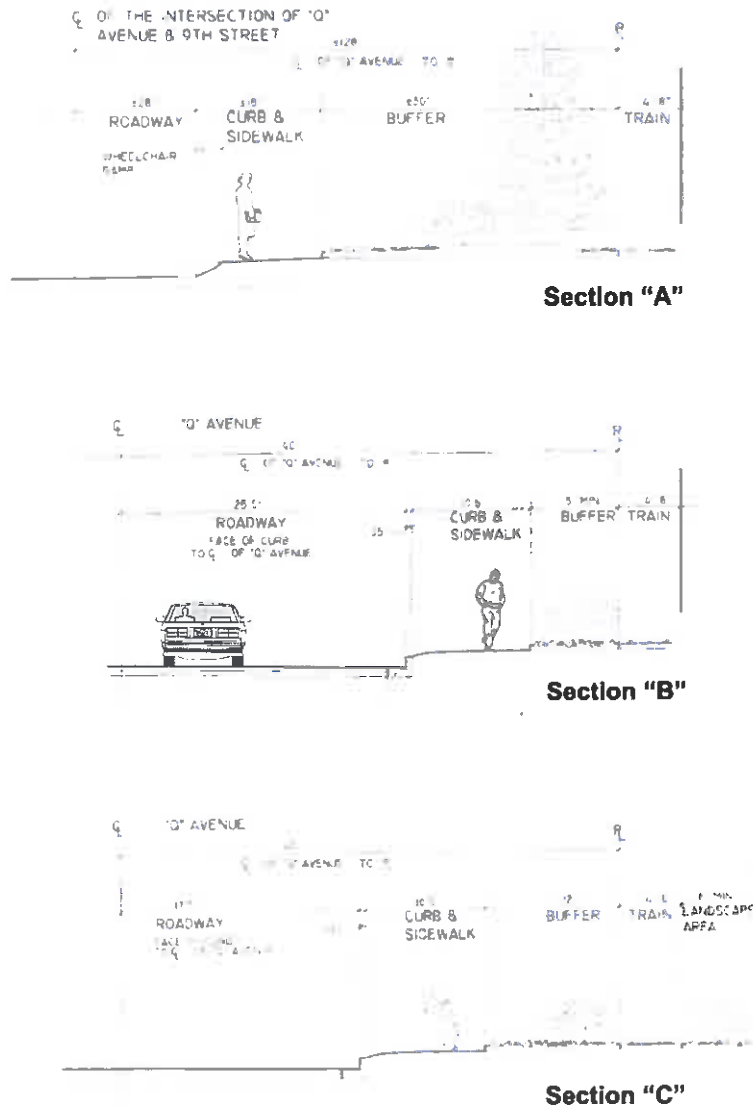
Figure 24. Tommy Thompson Parkway Improvements Sections

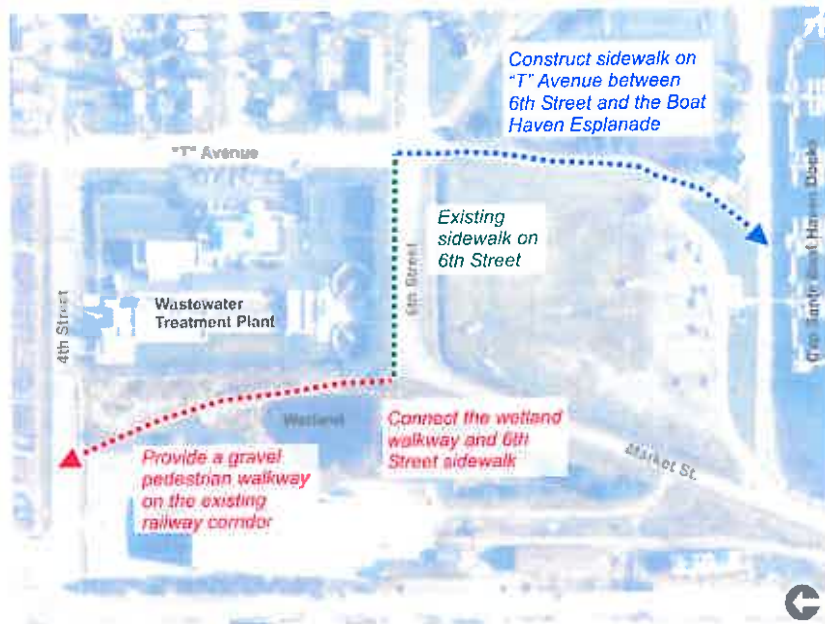
Figure 28.  
Pedestrian Connection from 4th Street to the Cap Sante Boat Haven

Link the south terminus of the wetland walkway and the Cap Sante Boat Haven Esplanade by routing pedestrians north on the existing 6th Street sidewalk and west on "T" Avenue. Constructing a sidewalk on west side of "T" Avenue, accompanied by landscaping the existing slope along the north basin property, is recommended to create a pleasant pedestrian environment.

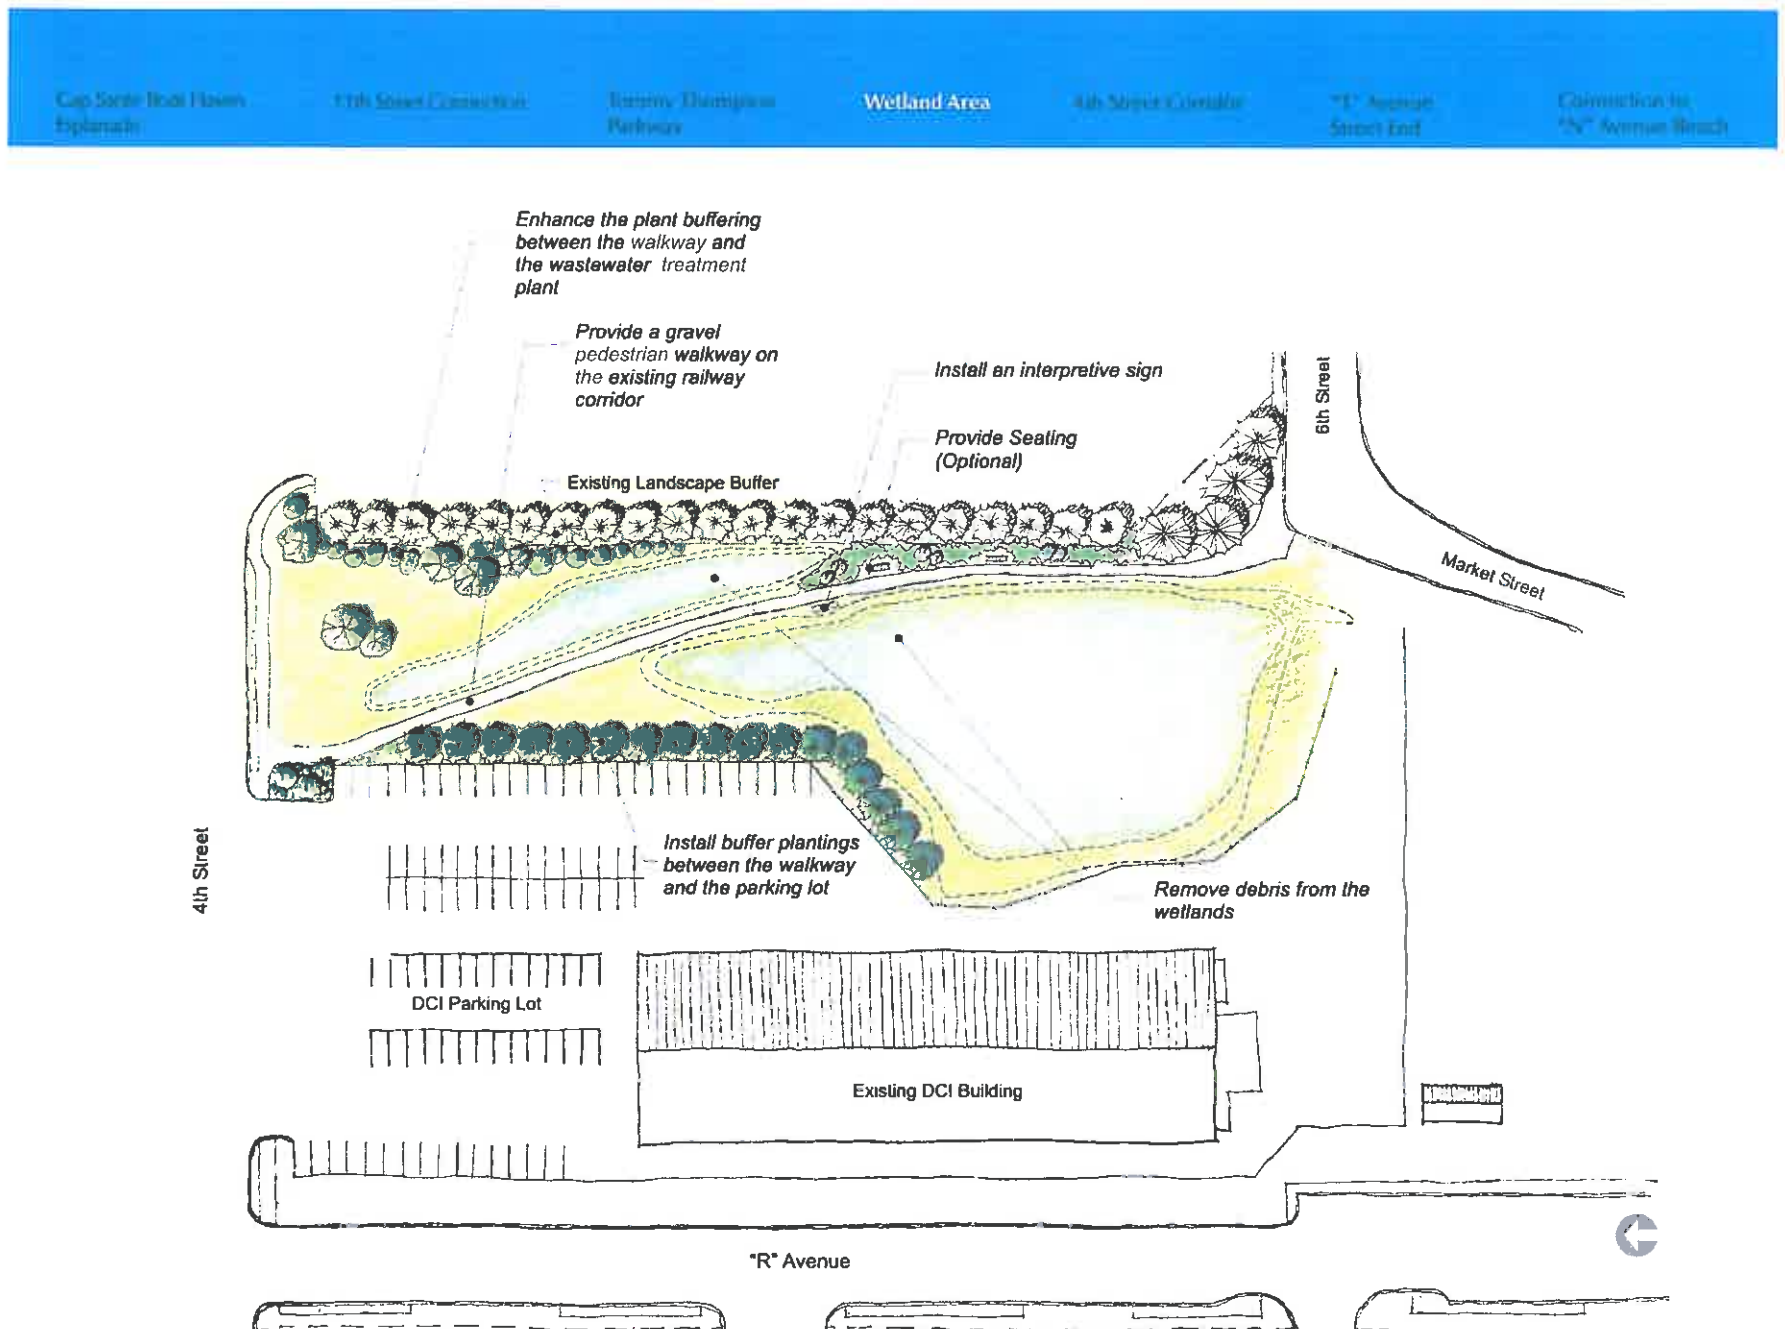
Figure 32. Wetland Area Improvements Plan

Selective removal of non-native vegetation, enhancement of existing wetland vegetation, providing a public access pathway, and installing interpretive signage are recommended to enhance and protect the wetland area. Installing a gravel pathway on the abandoned rail corridor would provide pedestrian access to the wetland that both blends with and helps protect the area's natural environment. This pathway would avoid the existing buffer zone as established in the 2002 wetland delineation. Although not anticipated, there may be ownership issues or real estate implications of this project. In addition, although not expected to be a problem, the Port should consider mosquito abatement methods if this becomes an issue.

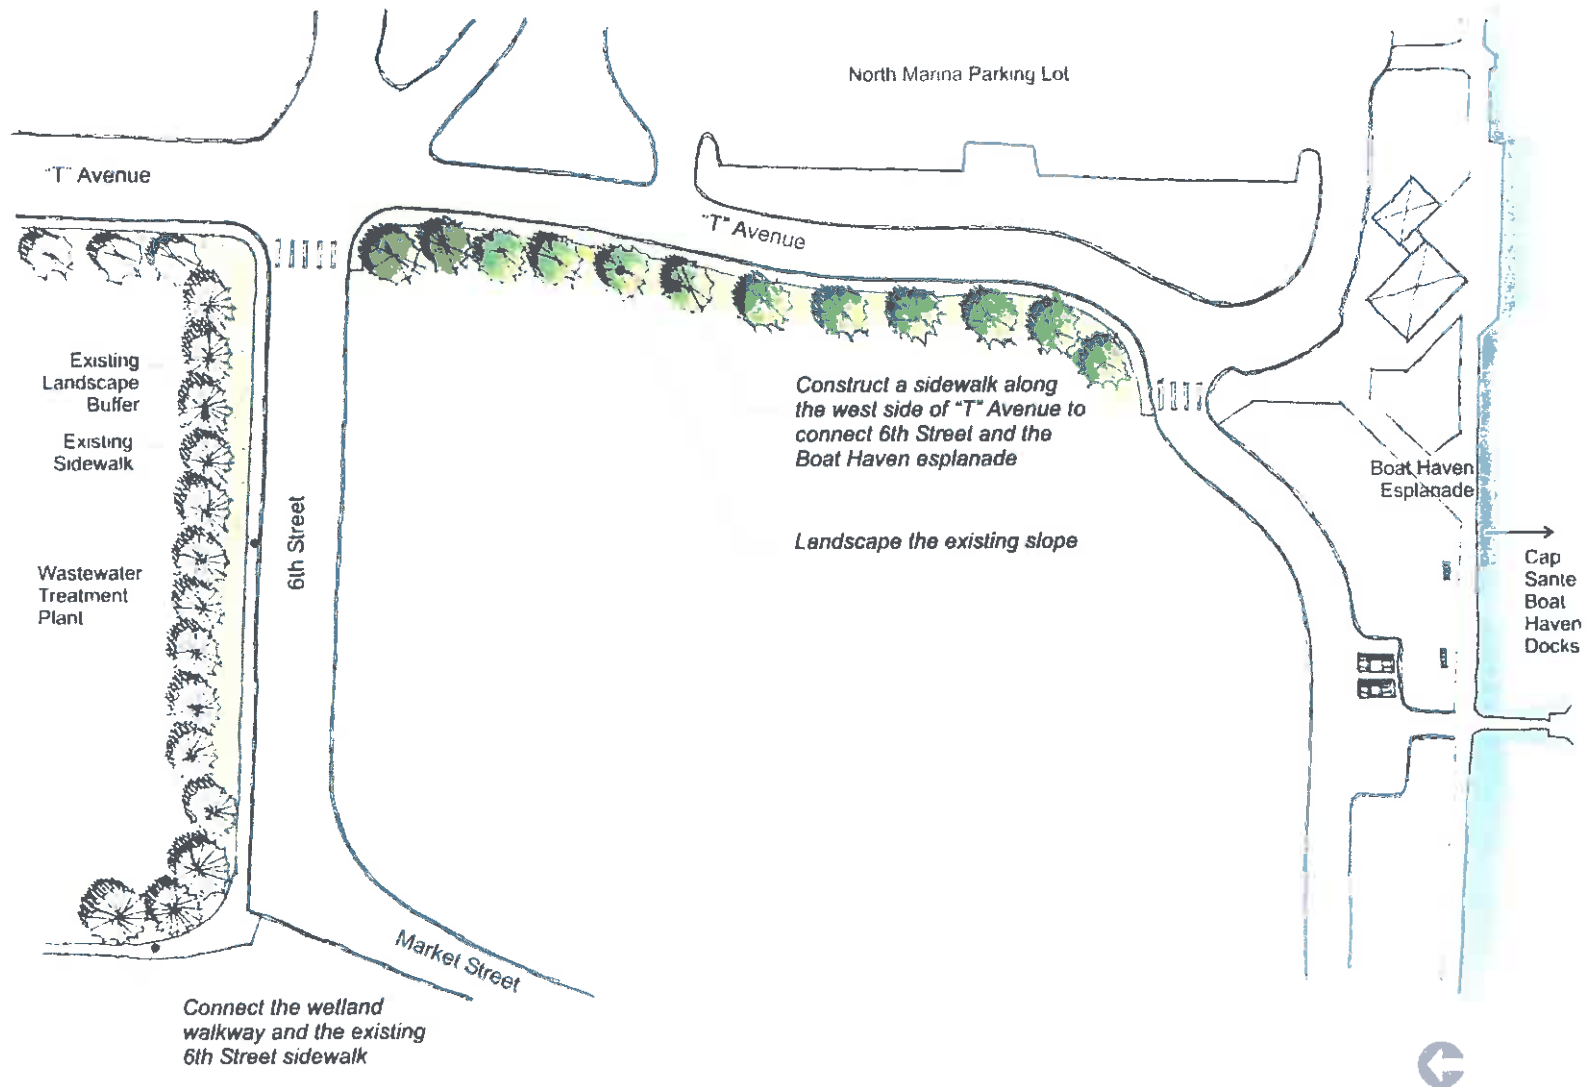
Figure 33. "T" Avenue Improvements Plan

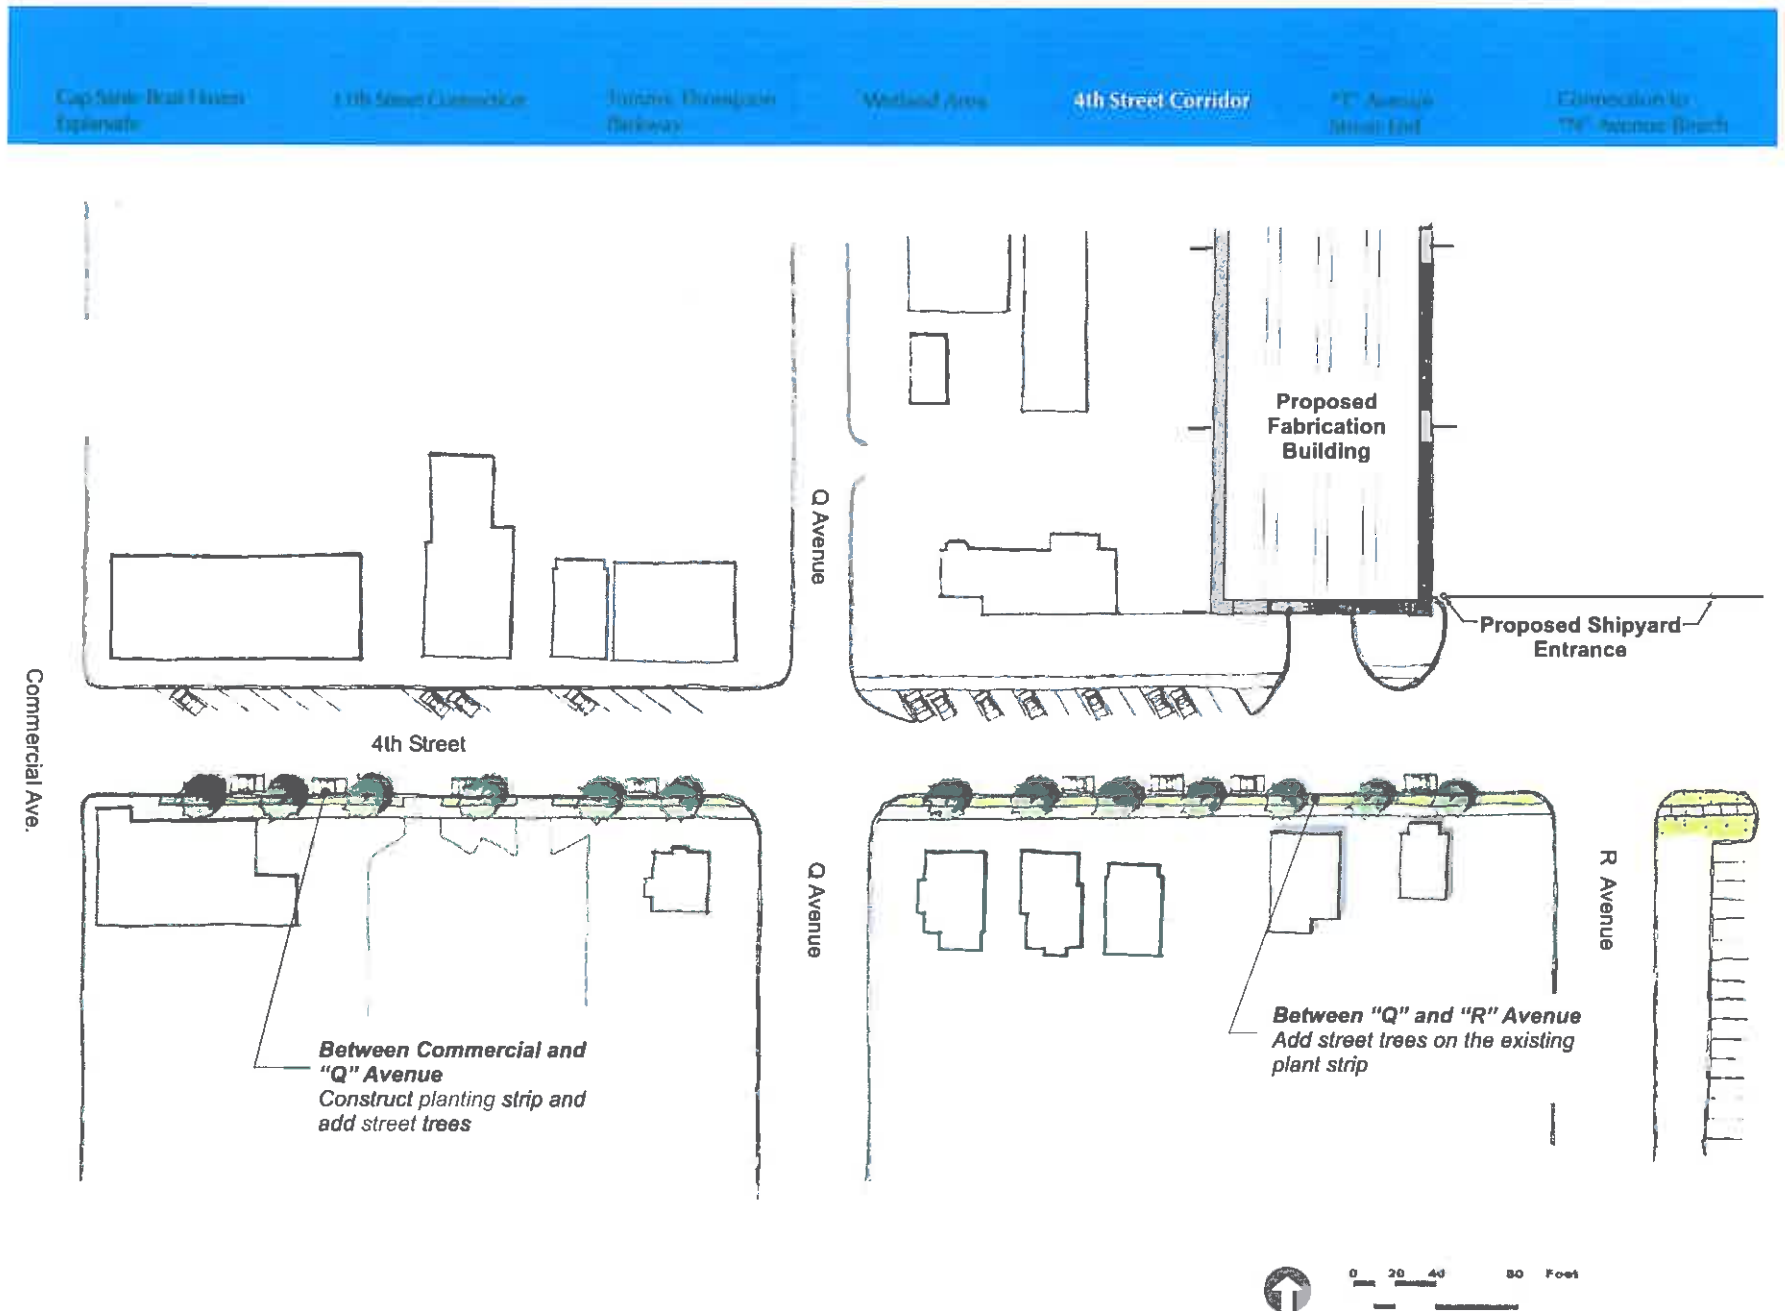
Figure 37. 4th Street Corridor Improvements Plan - West Section

Fourth Street is the main link between downtown and the Cap Sante neighborhood. The section of 4<sup>th</sup> Street between "Q" and "T" Avenues is the southern boundary of Piers 1 and 2. These piers support Dakota Creek Industries' ship building and repair operations, and the Port's bulk product shipping business. Fourth Street also generally functions as the southern project boundary of Pier 1 Redevelopment Project, an initiative to improve in-water and upland shipbuilding capacity.
