## ANACORTES PLANNING COMMISSION

**May 24, 2023**

### **AGENDA**

- A. Roll Call**
- B. Minutes**
  - 1) Minutes of May 8, 2023
- C. Correspondence**
- D. New Business**
  - 1) Appoint new vice chair.
  - 2) Open Record Public Hearing and Decision for Shoreline Substantial Development Permit SDP-2023-0002 Port of Anacortes 2nd Street and Curtis Wharf project.
- E. Old Business**

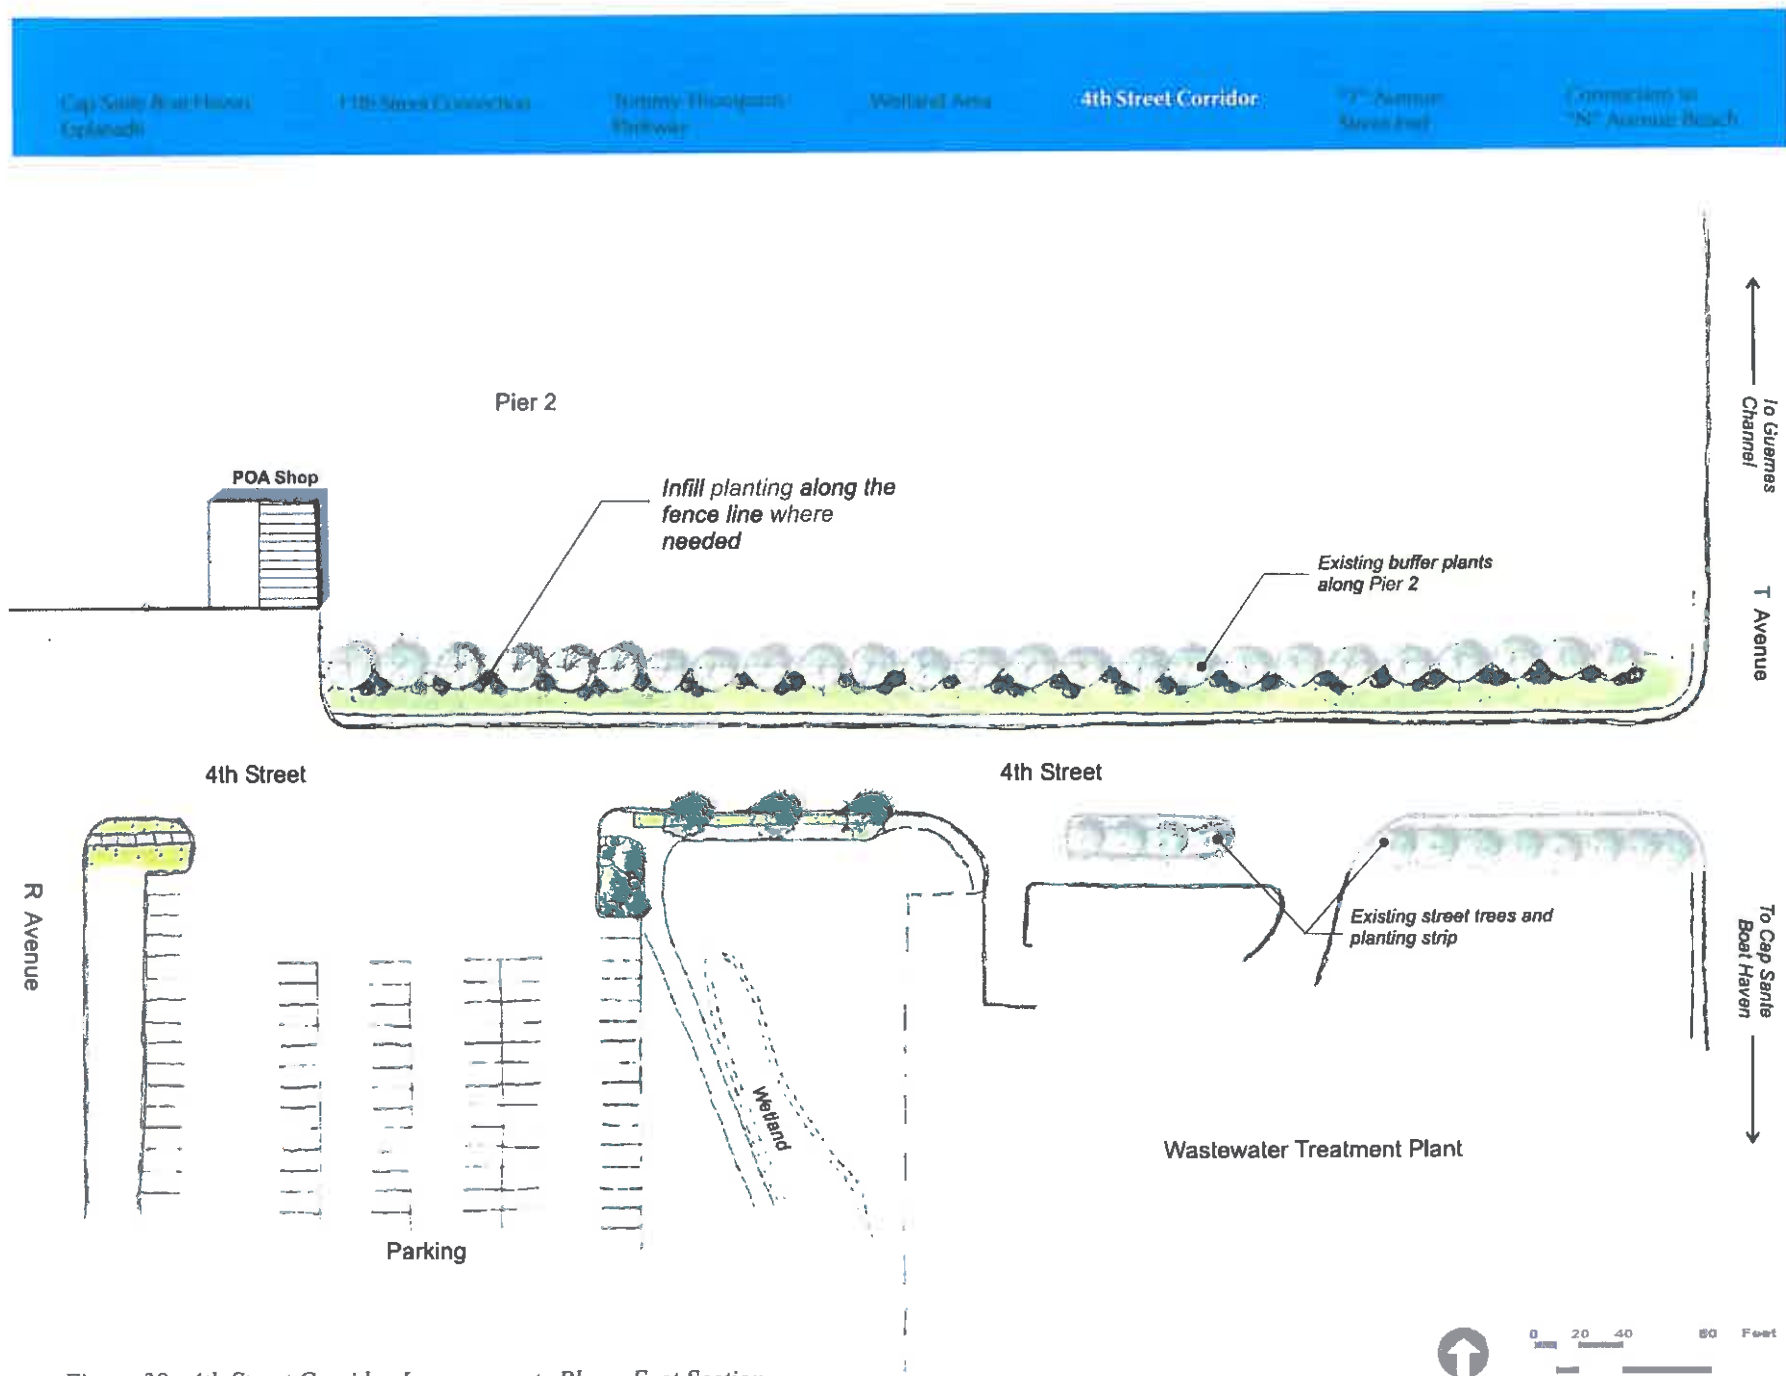
Figure 38. 4th Street Corridor Improvements Plan - East Section

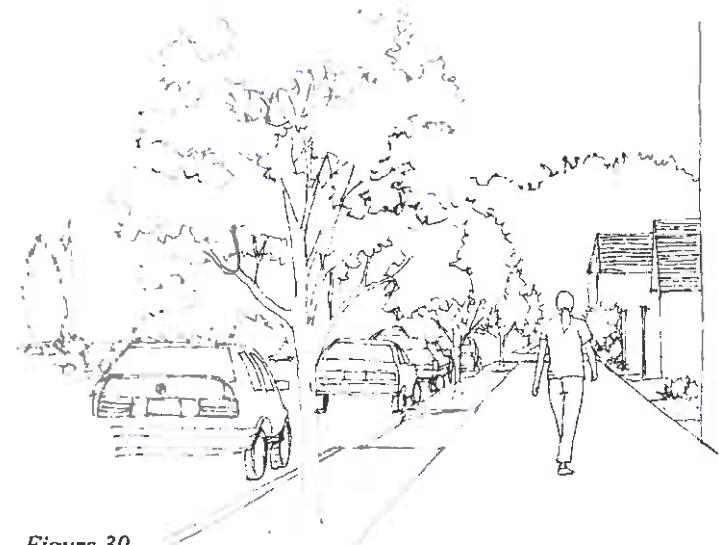
Figure 39.  
*Conceptual View of 4th Street Improvements*

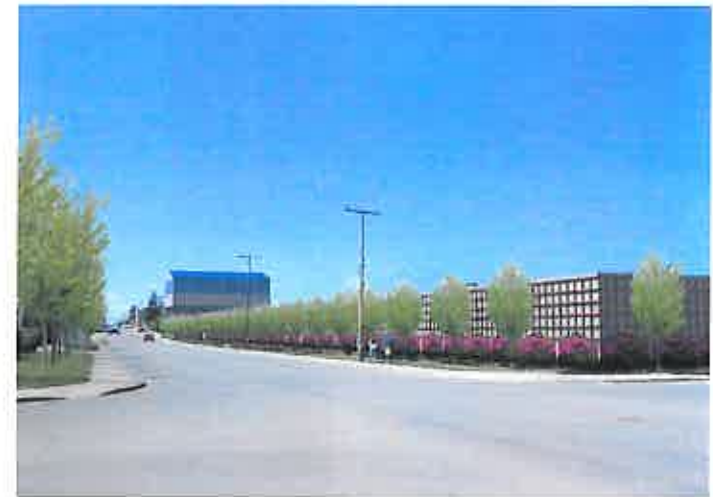
Figure 40.  
*Illustration of the Noise Wall and Landscaping on 4th Street*

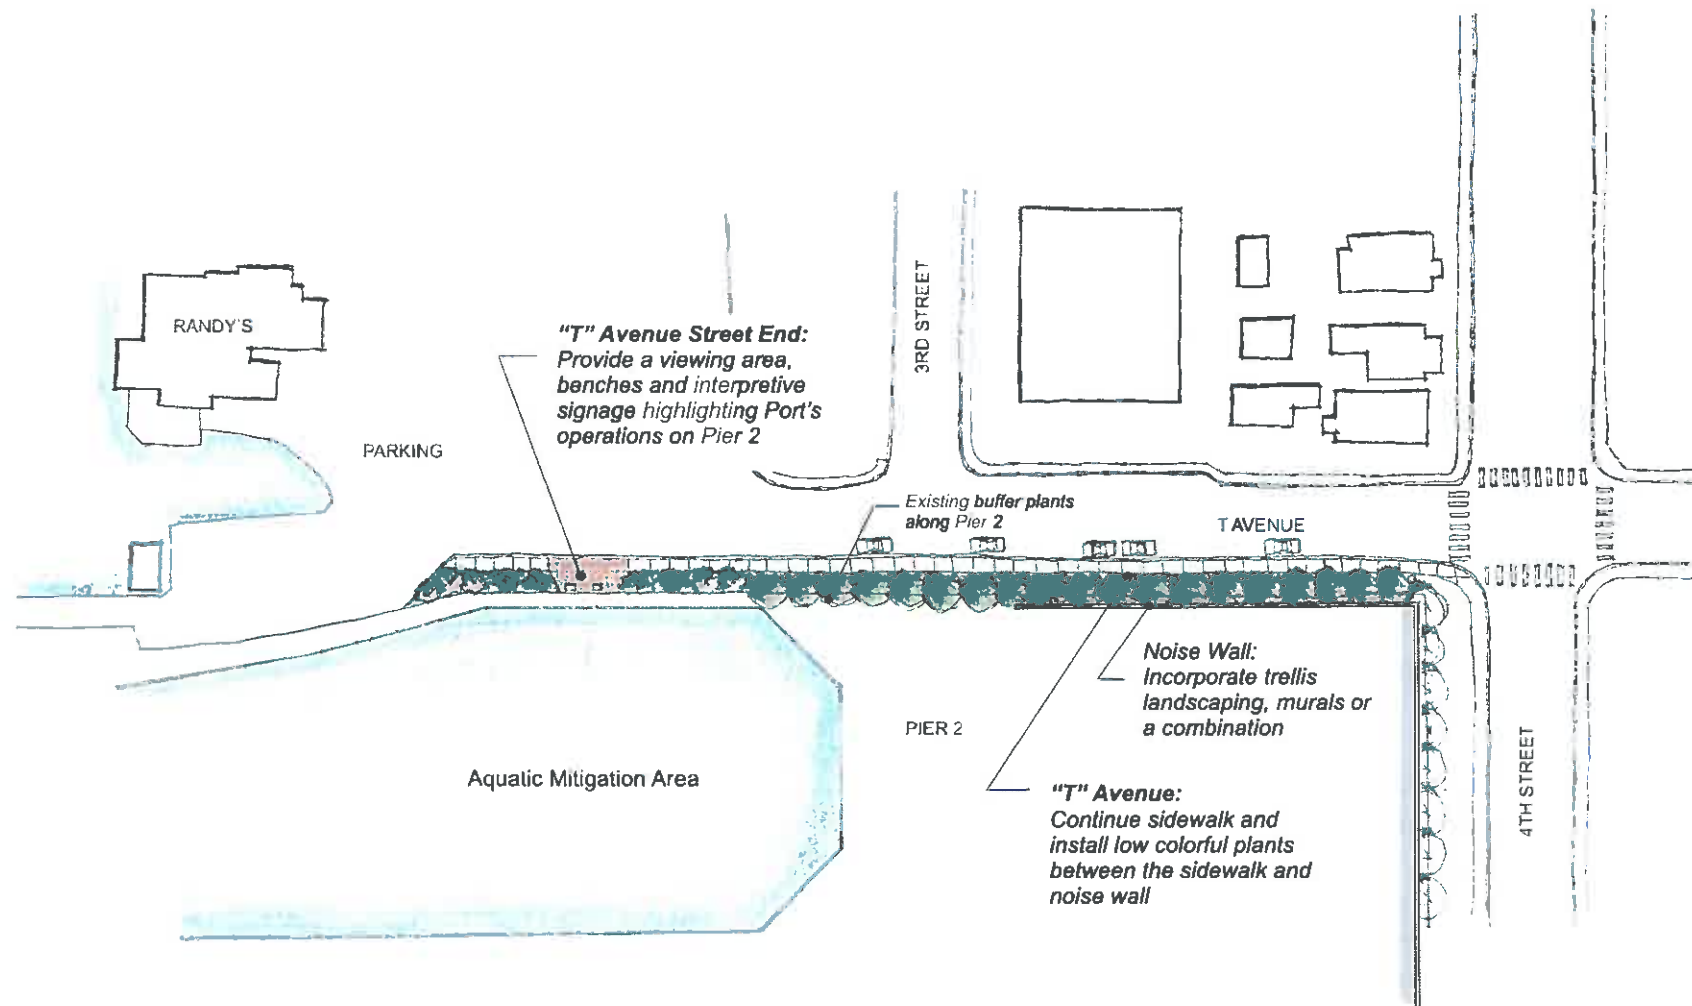
Figure 44. "T" Avenue Street End Improvements Plan

- Improve the pedestrian-orientation and condition of "T" Avenue.
- Allow viewing of Pier 2 activity at this location.
- Plan to incorporate a destination feature at the "T" Avenue street end into future development without limiting flexibility to respond to a variety of potential development opportunities.

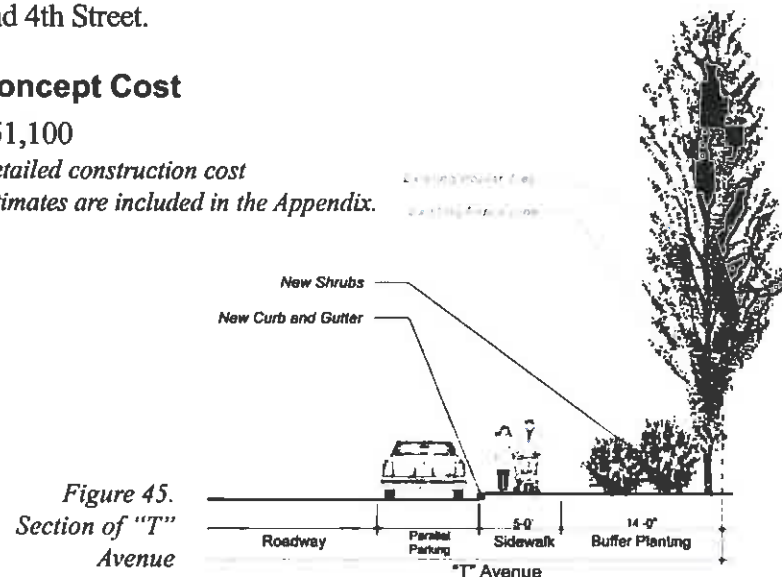
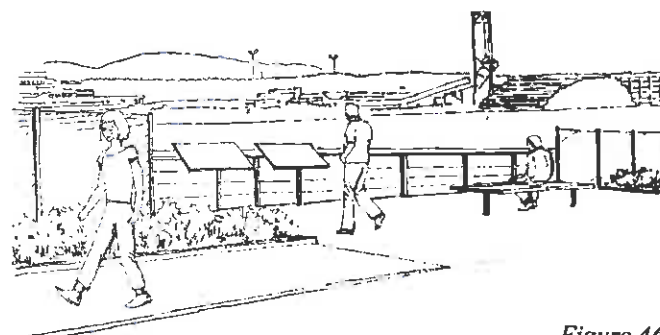
Figure 46.  
Conceptual Sketch of Pier 2 Viewing Area at "T" Avenue

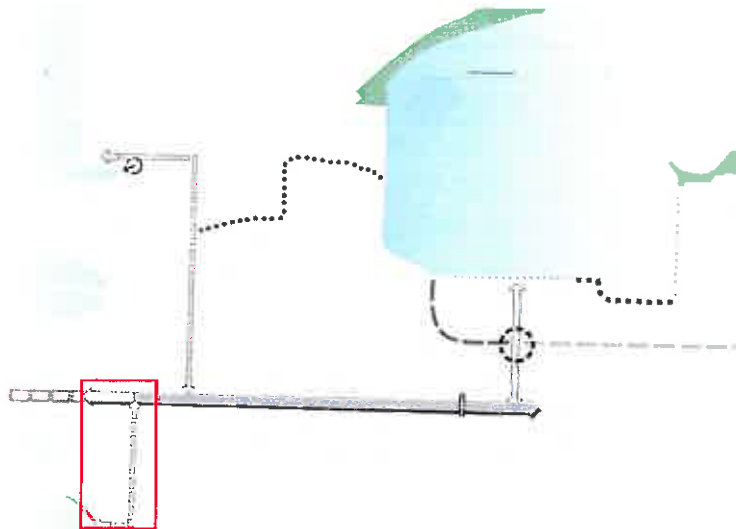
*Figure 47.  
Existing 3rd Street  
Sidewalk between  
Commercial and "O"  
Avenues*

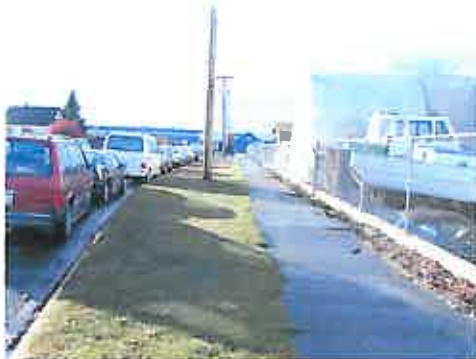
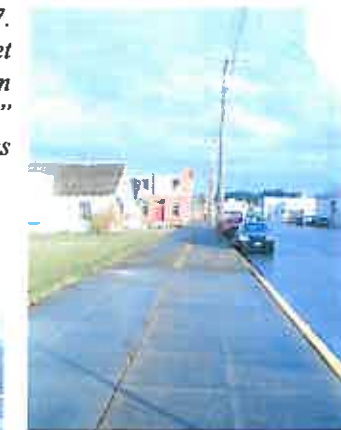
*Figure 48.  
Existing 3rd Street Sidewalk  
between "O" and "N" Avenues*

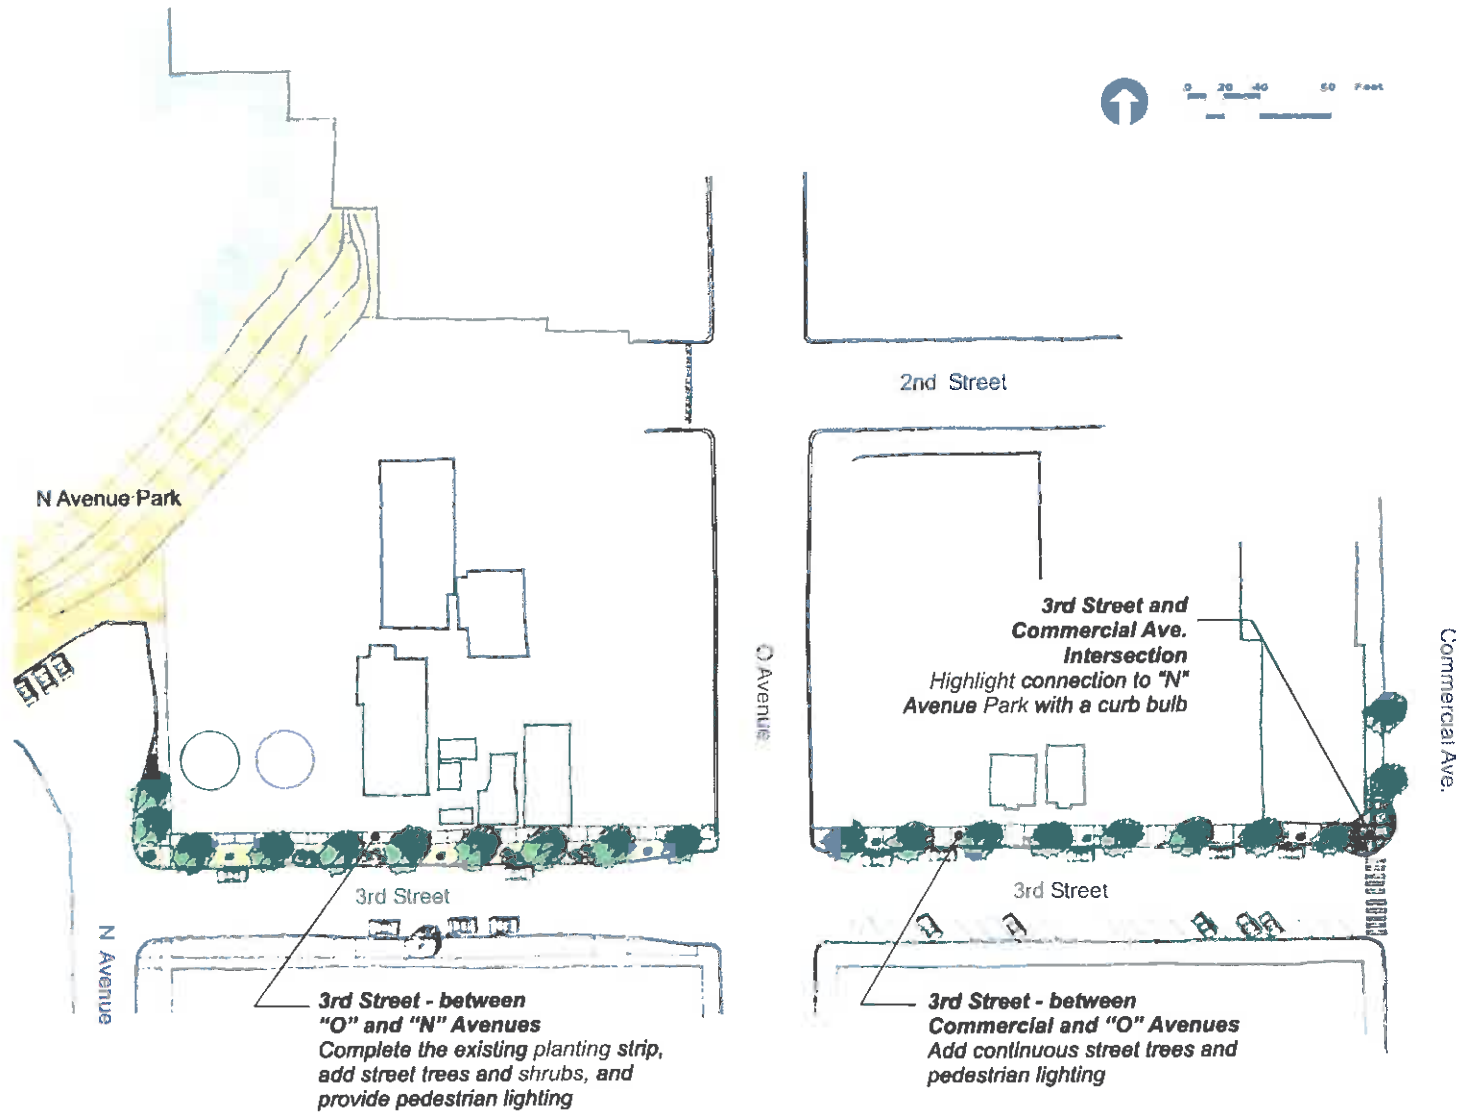
Figure 51. Connection to "N" Avenue Beach Improvements Plan

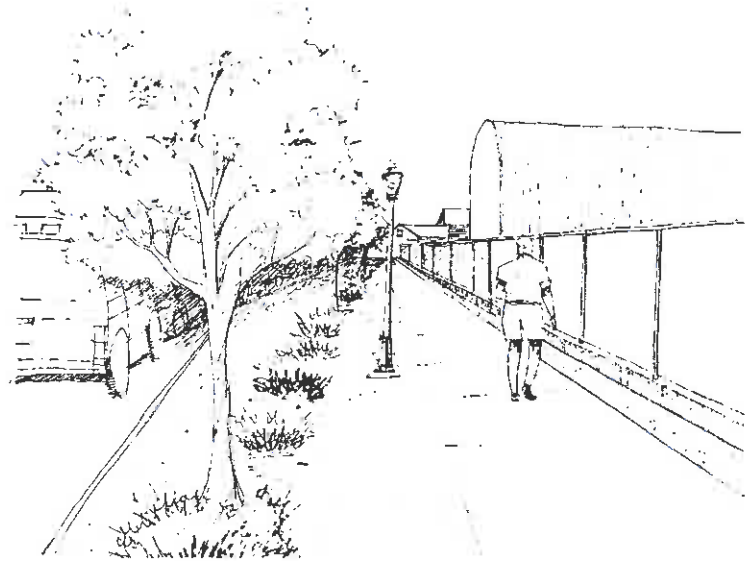
Figure 52.  
Conceptual Illustration of 3rd Street  
Improvements

Since the existing sidewalk does not have a planting strip, providing street trees with tree grates is recommended.

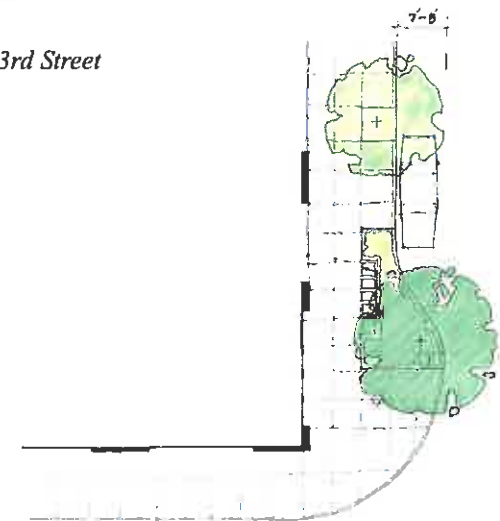
Figure 53.  
Illustration of a Typical Curb Bulb

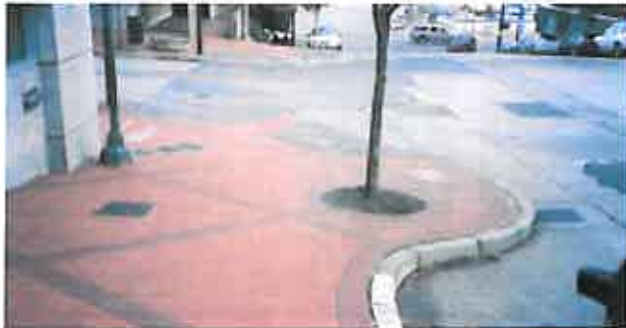
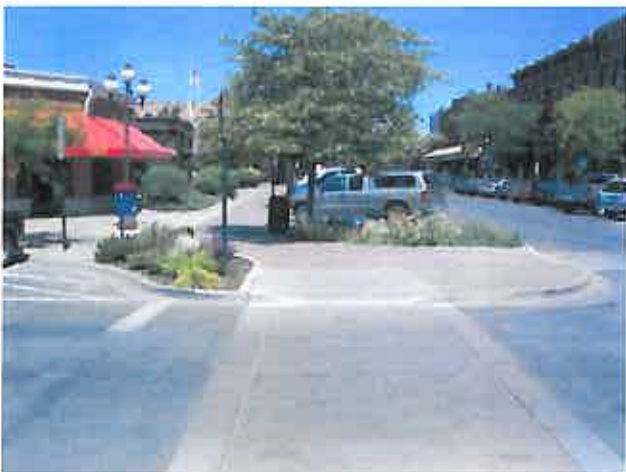
*Curb bulbs at street intersections and specially paved crosswalks can provide a safe and comfortable walking environment for pedestrians.*

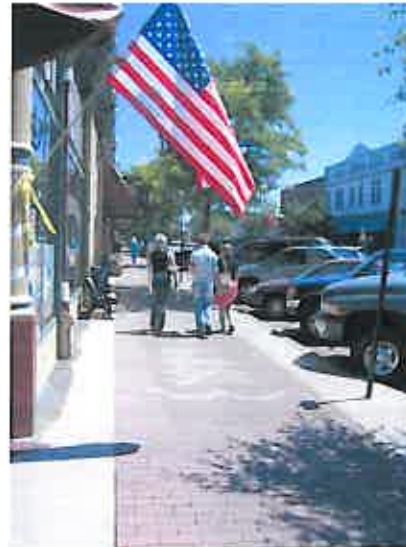
*Special surface material and design patterns can be incorporated into sidewalk designs.*

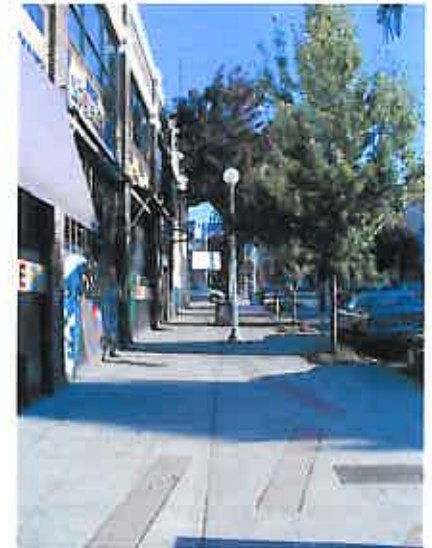
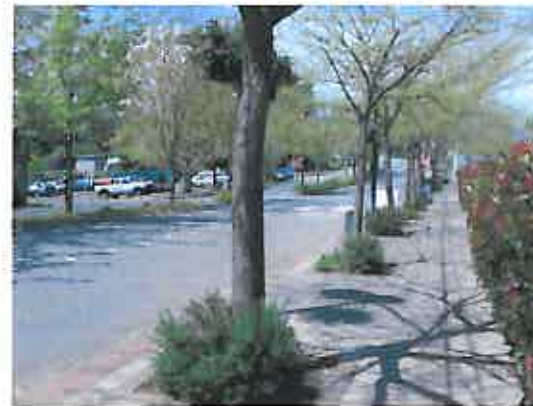
*A typical concrete sidewalk can be enhanced by providing street trees and planting beds.*

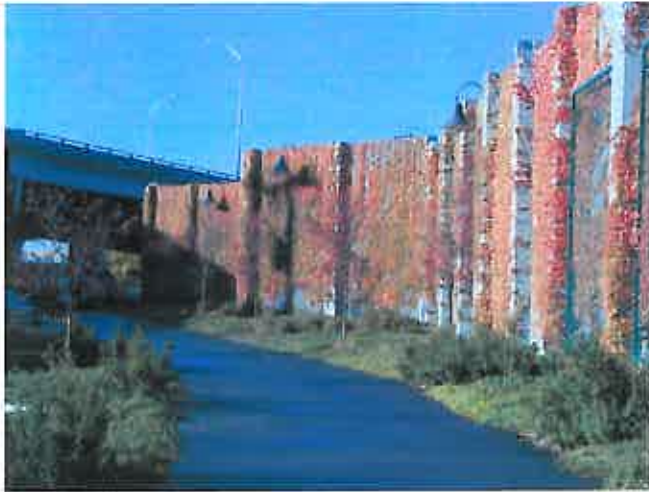
*Bare concrete walls can be aesthetically improved by applying trellis landscaping and lighting.*

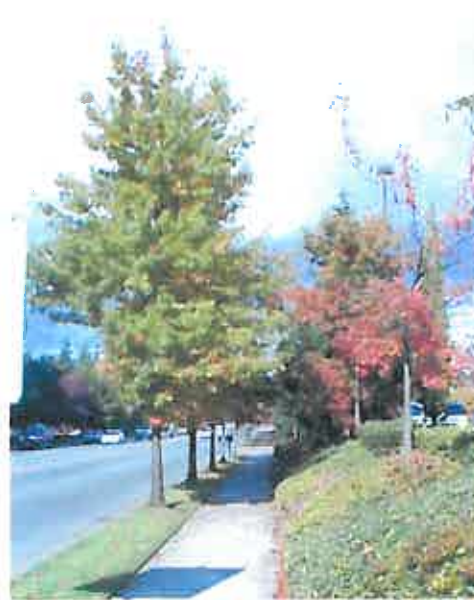
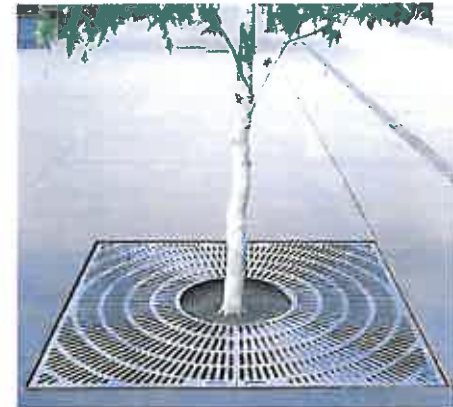
*Street trees can be planted on planting strips or in tree grates, depending on street conditions and available space*

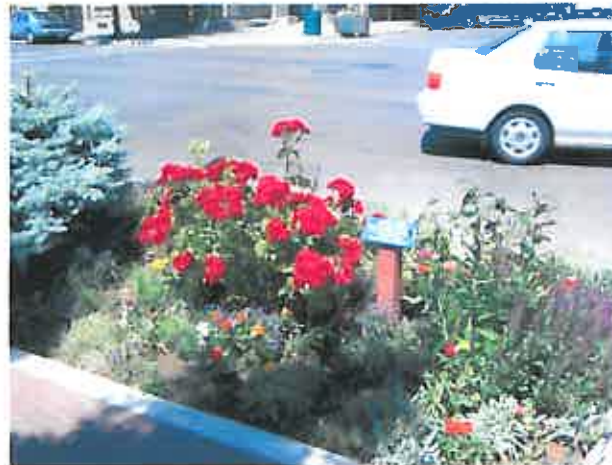
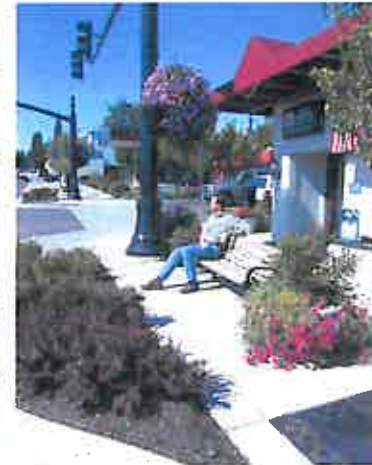
*Planting strips and curb bulbs can be landscaped with low-height plant material.*

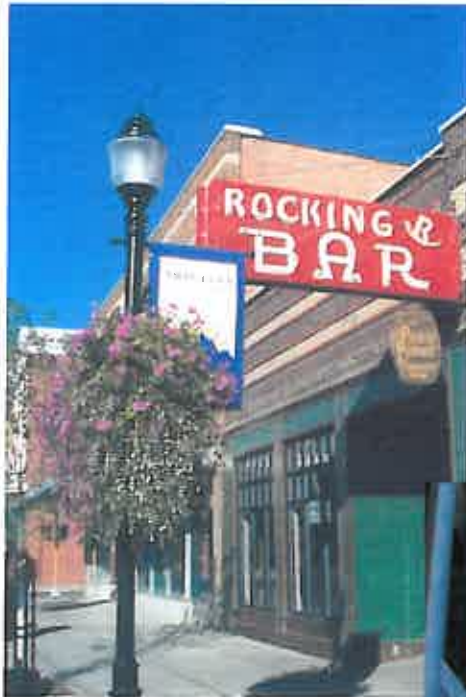
*Classic street light designs with  
hanging baskets and a banner*

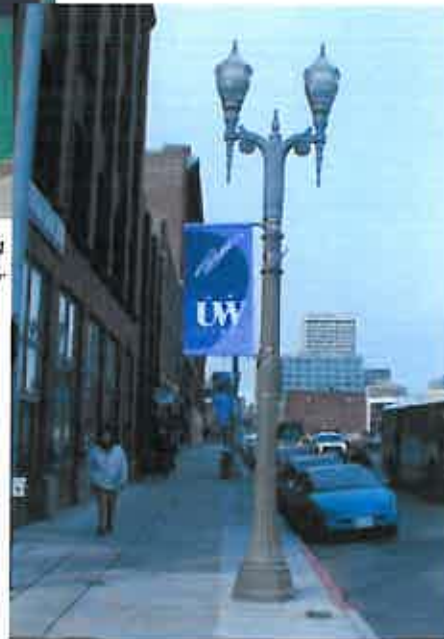
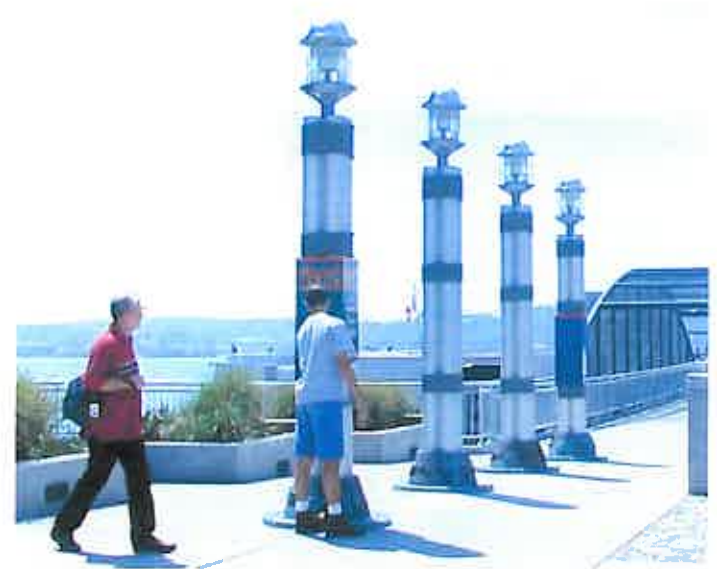
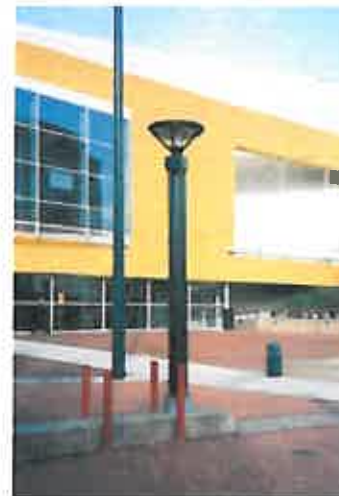
*Modern pedestrian  
light fixtures*

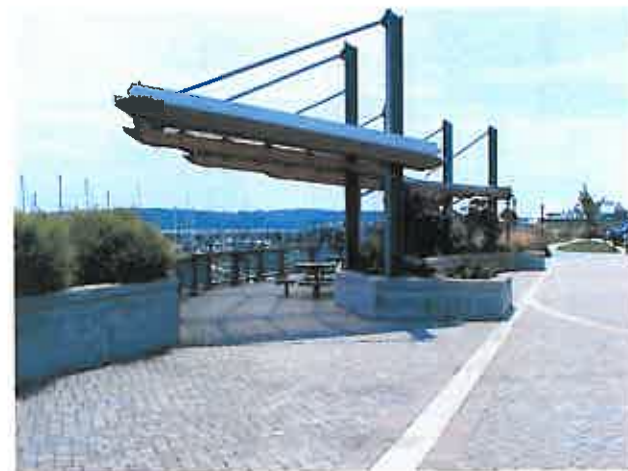
*A covered viewpoint with seating can draw and shelter pedestrians.*
